SAGUACHE CREEK DIVERSION INFRASTRUCTURE INVENTORY

Structure Name: RESERVOIR ENLR D

Date: April 11, 2019

Saguache Creek Stream Management Plan

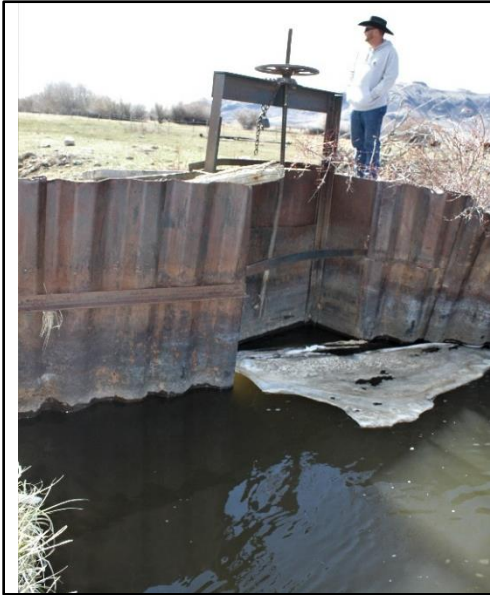
Structure Description: A diversion dam made of rocks and debris diverts water to the headgate on the north bank of the stream. The river is relatively stable here. This ditch has trouble accessing its full decree in low flow conditions. The headgate is in poor condition. The headwall is bulging and the screw gate is bent.

Headgate looking downstream

Repair(s) or Improvement(s) Currently Needed: The headgate should be repaired or replaced. The diversion dam should be improved to allow this ditch to access its full decree during low flows. No other repair needs were identified during inspection. The flume measures accurately. Fish passage and riparian restoration should be considered as part of any future repairs or improvements.

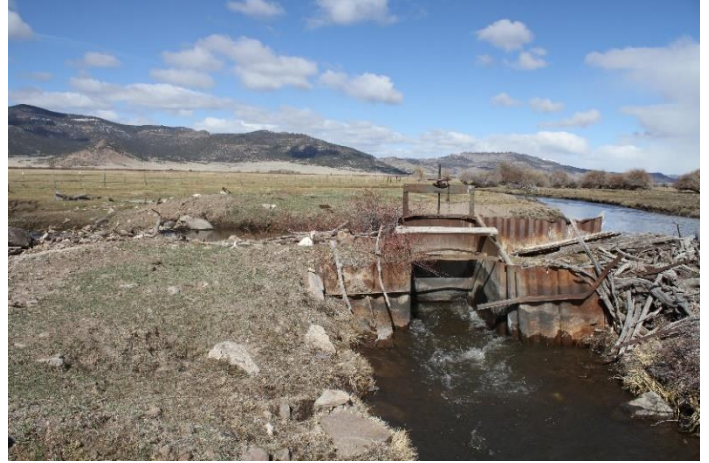
Headgate outlet

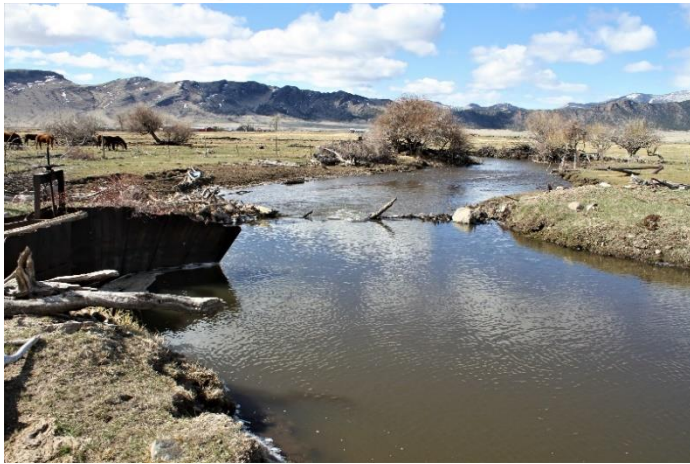
Headgate and diversion dam

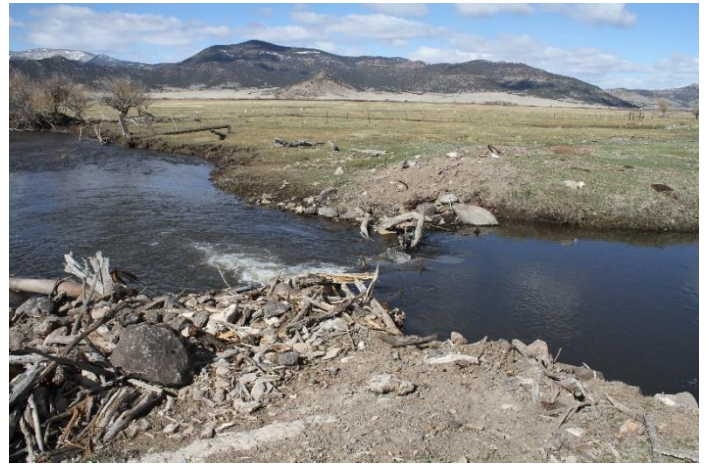
Diversion dam

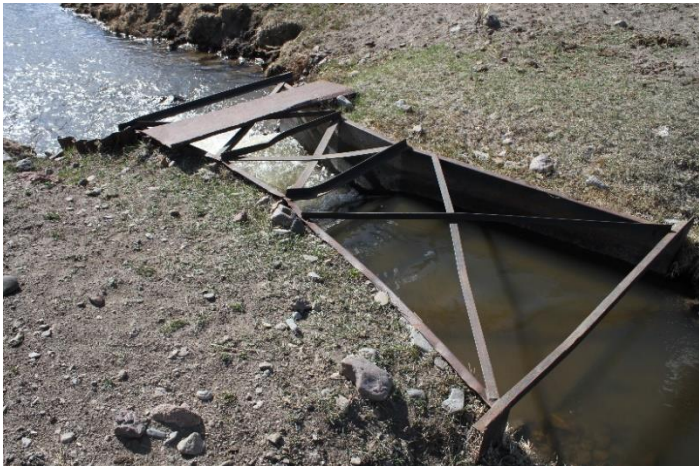
Flume looking downstream

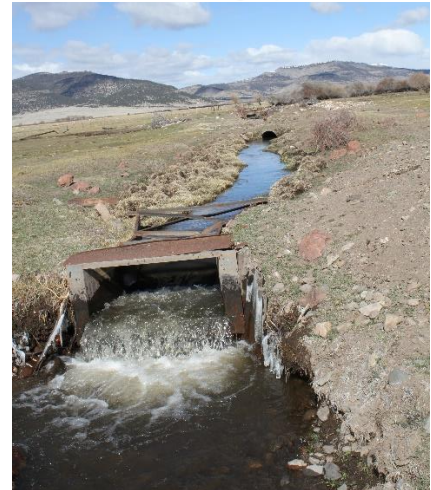
Flume looking upstream
