HAZARDOUS BUILDING MATERIALS SURVEY

CONDON GRADE SCHOOL
220 S. EAST STREET
CONDON, OREGON

Prepared for
CITY OF CONDON
May 17, 2022
Project No. M2053.01.002

Prepared by
Maul Foster & Alongi, Inc.
3140 NE Broadway Street, Portland, OR 97232

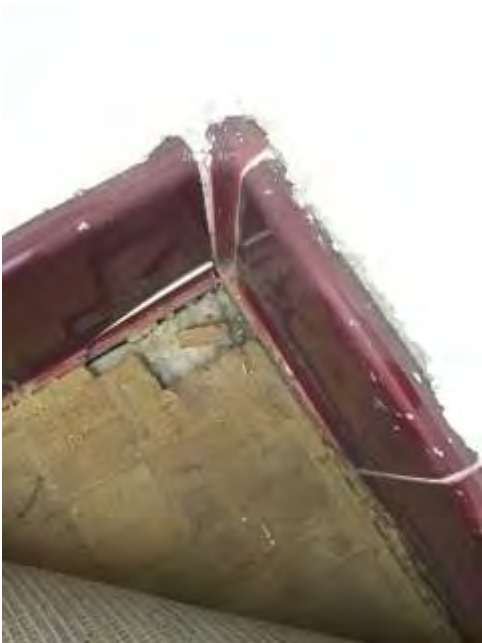
Additional Sample Notes:		
Sample ID:	Sample Type:	
2-2-MISC-7	MISC	
Sample Location:	Detailed Sample Location:	
Classroom education	Northwest wall of eastern most room	
Sample Quantity:	See 2-2-MISC-6	
Misc Sample Material:	Sample Condition:	Sample Friable?:
Tan tile with yellow carpet mastic and gray grout	Damaged or significantly damaged friable miscellaneous ACM	No
Sample Photo:

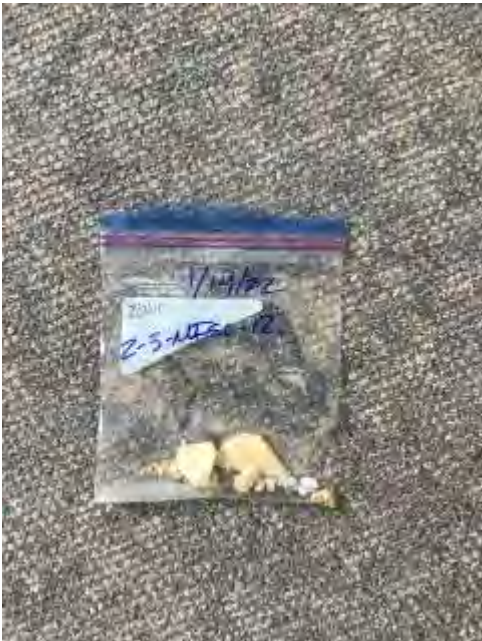
Additional Sample Notes:		
Sample ID:	Sample Type:	
2-3-MISC-12	MISC	
Sample Location:	Detailed Sample Location:	
Classroom Education	Northeast wall of shower	
Sample Quantity:	122 SF	
Misc Sample Material:	Sample Condition:	Sample Friable?:
5"x5" oatmeal color tile with gray grout	Damaged or significantly damaged friable miscellaneous ACM	Yes
Sample Photo:

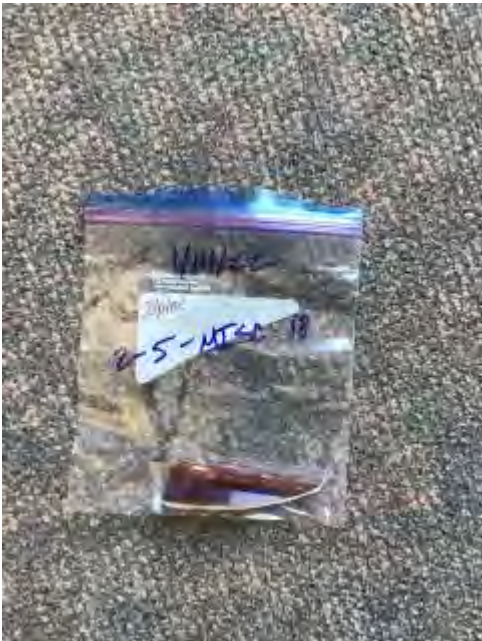
Additional Sample Notes:		
Sample ID:	Sample Type:	
2-5-MISC-18	MISC	
Sample Location:	Detailed Sample Location:	
Classroom Education	Northeast wall outside shower	
Sample Quantity:	140 LF	
Misc Sample Material:	Sample Condition:	Sample Friable?:
6"x6" maroon tile with gray grout	Damaged or significantly damaged friable miscellaneous ACM	No
Sample Photo:

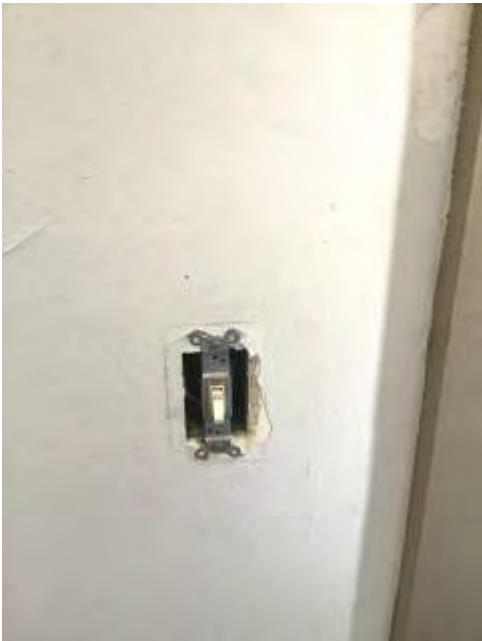
Additional Sample Notes:		
Sample ID:	Sample Type:	
2-7-MISC-26	MISC	
Sample Location:	Detailed Sample Location:	
Classroom Education	Southwest wall of easternmost room	
Sample Quantity:	See 2-7-MISC-24	
Misc Sample Material:	Sample Condition:	Sample Friable?:
White wallboard	Damaged or significantly damaged friable miscellaneous ACM	Yes
Sample Photo:

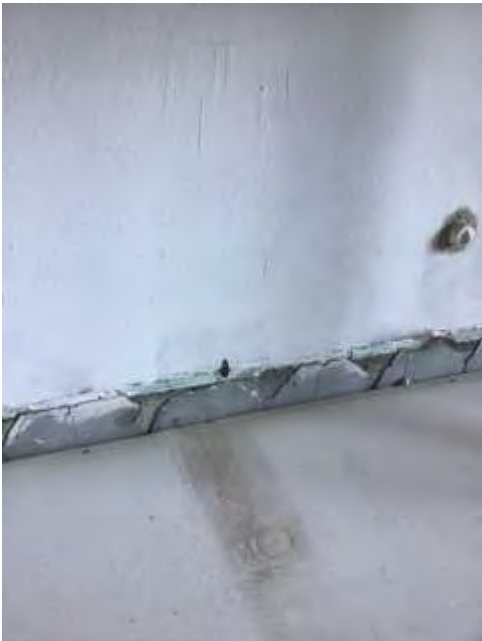
Additional Sample Notes:		
Sample ID:	Sample Type:	
2-7-MISC-27	MISC	
Sample Location:	Detailed Sample Location:	
Classroom Education	West wall of westernmost room	
Sample Quantity:	See 2-7-MISC-24	
Misc Sample Material:	Sample Condition:	Sample Friable?:
White wallboard	Damaged or significantly damaged friable miscellaneous ACM	Yes
Sample Photo:

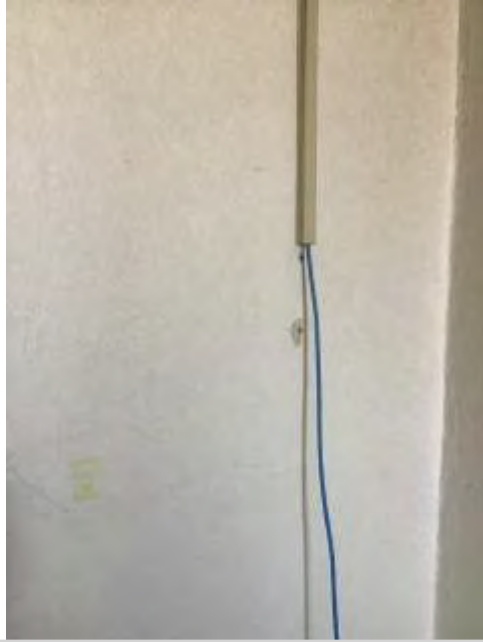
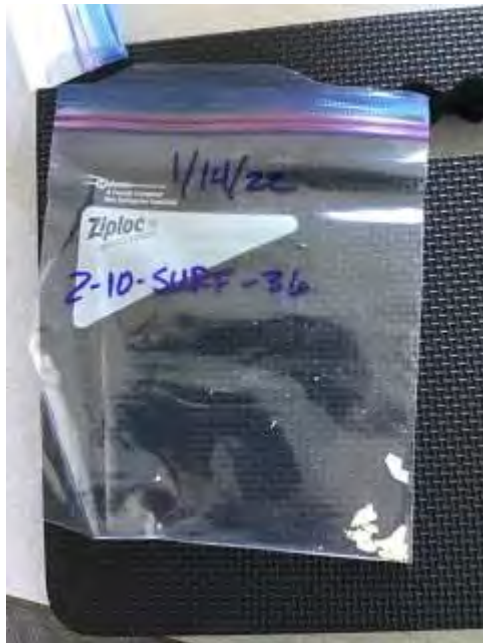
Additional Sample Notes:		This accounts for ceiling and south pop out wall.	
Sample ID:		Sample Type:	
2-10-SURF-36		SURF	
Sample Location:		Detailed Sample Location:	
Classroom 25		Southwest wall	
Sample Quantity:		See 2-10-SURF-35	
Sample Color:		XRF:	
Misc Sample Material:		Sample Condition:	Sample Friable?:
		Damaged friable surfacing ACM	No
Sample Photo:

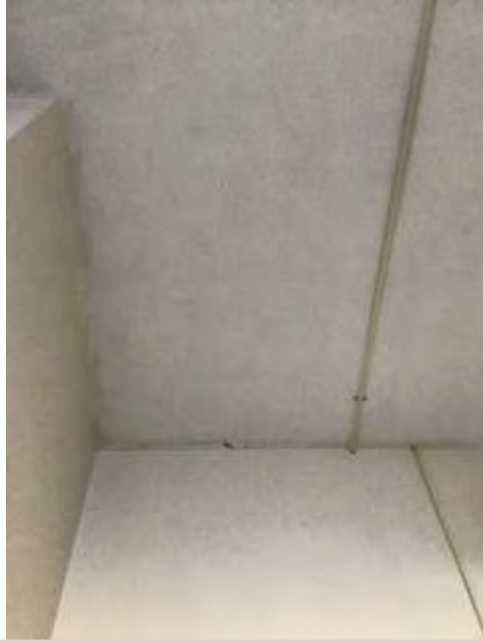
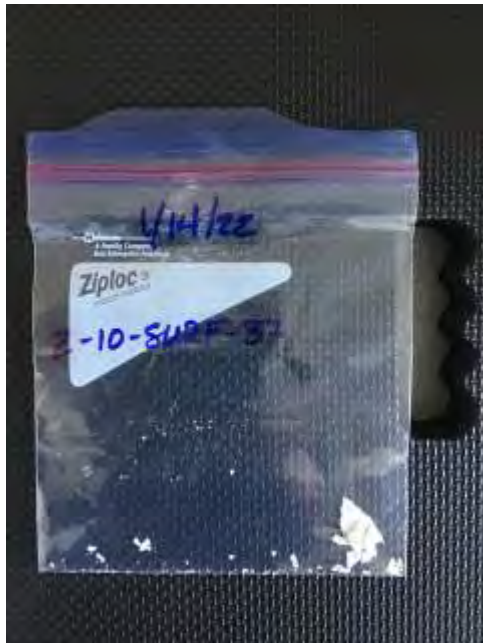
Additional Sample Notes:		This accounts for ceiling and south pop out wall	
Sample ID:		Sample Type:	
2-10-SURF-37		SURF	
Sample Location:		Detailed Sample Location:	
Classroom 25		South ceiling	
Sample Quantity:		See 2-10-SURF-35	
Sample Color:		XRF:	
Misc Sample Material:		Sample Condition:	Sample Friable?:
		Damaged friable surfacing ACM	No
Sample Photo:

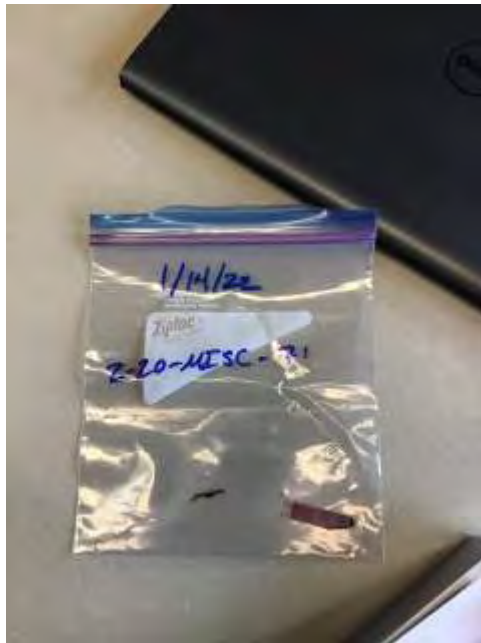
Additional Sample Notes:		
Sample ID:	Sample Type:	
2-20-MISC-71	MISC	
Sample Location:	Detailed Sample Location:	
Counselor's room	Middle of room under desk	
Sample Quantity:	See 2-20-MISC-69	
Misc Sample Material:	Sample Condition:	Sample Friable?:
9"x9" red vinyl flooring with black mastic	Damaged or significantly damaged friable miscellaneous ACM	Yes
Sample Photo:

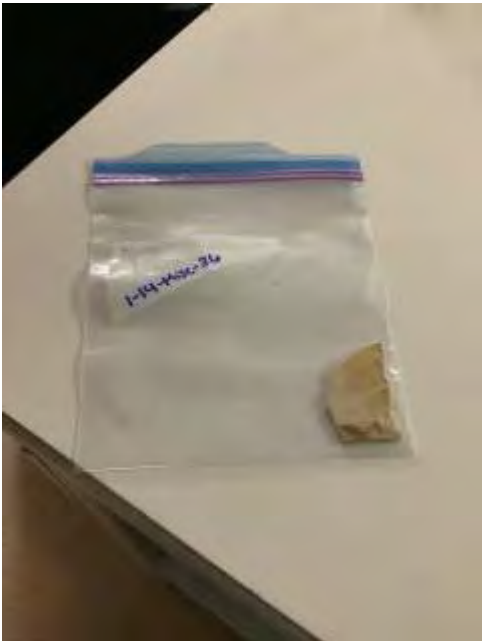
Additional Sample Notes:		
Sample ID:	Sample Type:	
1-14-MISC-36	MISC	
Sample Location:	Detailed Sample Location:	
Office	North edge of main office behind printer	
Sample Quantity:	See 1-14-MISC-35	
Misc Sample Material:	Sample Condition:	Sample Friable?:
12x12 light and dark tan floor tiles with yellow mastic	Damaged or significantly damaged friable miscellaneous ACM	No
Sample Photo:

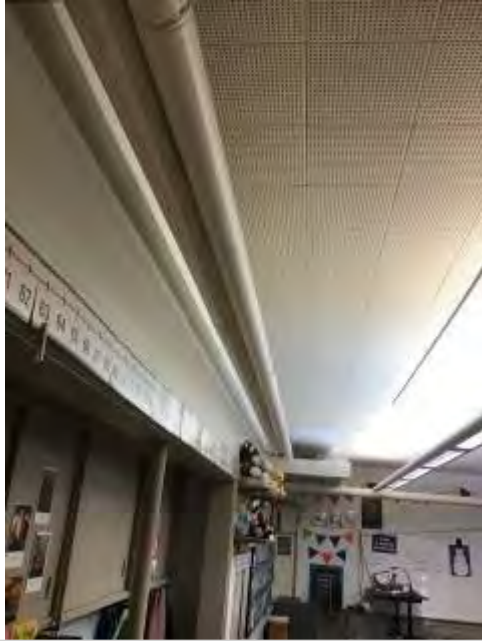
Additional Sample Notes:		
Sample ID:	Sample Type:	
1-59-MISC-191	MISC	
Sample Location:	Detailed Sample Location:	
Classroom 7	South edge of ceiling next to air duct	
Sample Quantity:	See 1-59-MISC-183	
Misc Sample Material:	Sample Condition:	Sample Friable?:
9x9 white dotted acoustic ceiling tiles with no mastic	Damaged or significantly damaged friable miscellaneous ACM	No
Sample Photo:
