YOUR INSPECTION REPORT

Downtown
Calgary, AB

Saturday, June 21, 2014

RE: Report No. 1008, v.0
Downtown
Calgary, AB

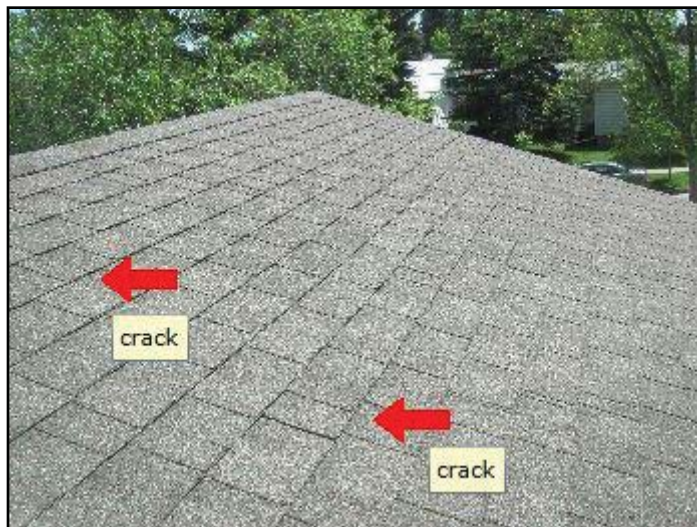
1. Cracked

1. Condition: • [Cracked](#)

Implication(s): Chance of water damage to contents, finishes and/or structure

Location: Front

Task: Monitor

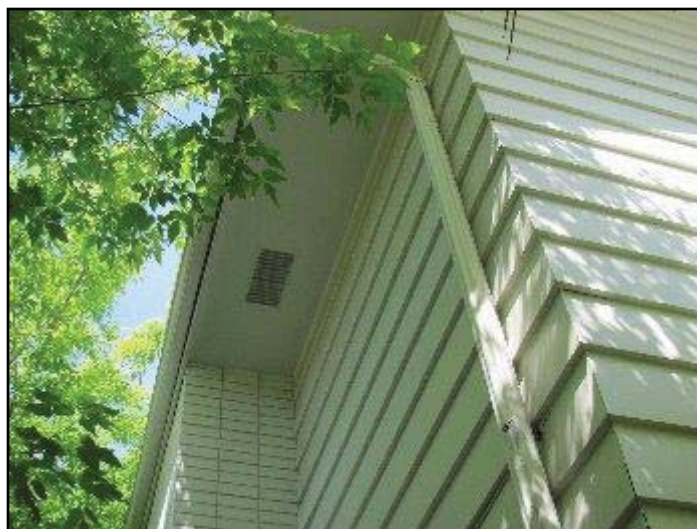
2. Missing, loose or torn

2. Condition: • [Missing, loose or torn](#)

a section of roof cover torn by tree branches, cutting back the tree branches to avoid further damages.

Implication(s): Chance of water damage to contents, finishes and/or structure

Location: Left Side

Task: Correct

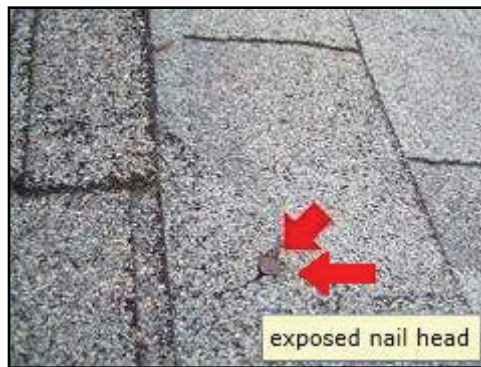
3. Exposed fasteners

3. Condition: • [Exposed fasteners](#)

Implication(s): Chance of water damage to contents, finishes and/or structure

Location: Various

Task: Provide

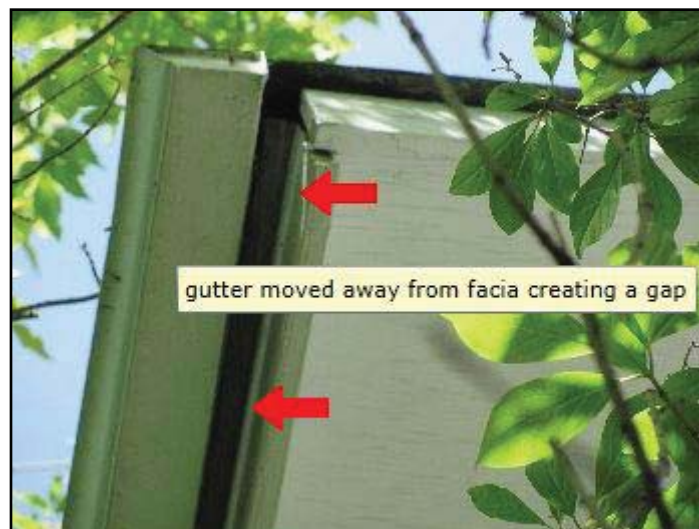
4. Loose or damaged

4. Condition: • [Loose or damaged](#)

Implication(s): Chance of water damage to contents, finishes and/or structure

Location: Left Side

Task: Repair or replace

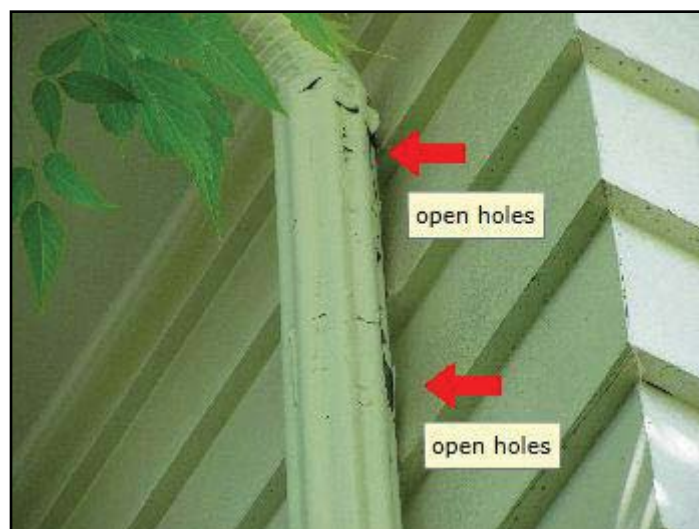
5. leak

5. Condition: • [Leak](#)

Implication(s): Chance of water damage to contents, finishes and/or structure

Location: Right Side

Task: Repair or replace

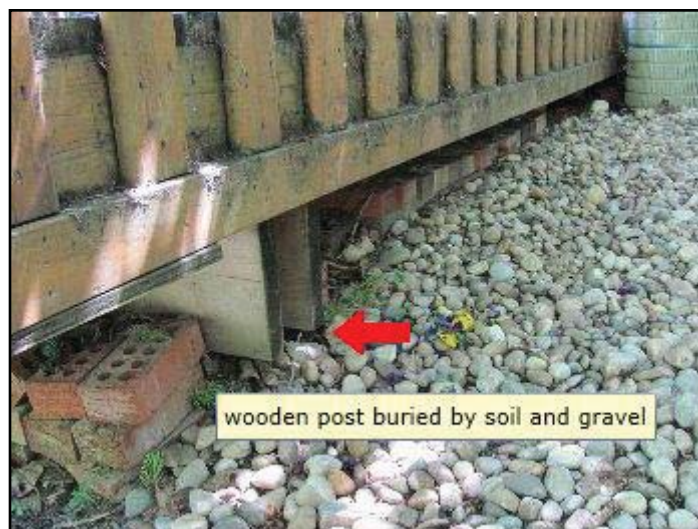
6. Wood/soil contact

8. Condition: • [Wood/soil contact](#)

Implication(s): Weakened structure | Chance of movement | Rot | Insect damage

Location: Rear

Task: Improve

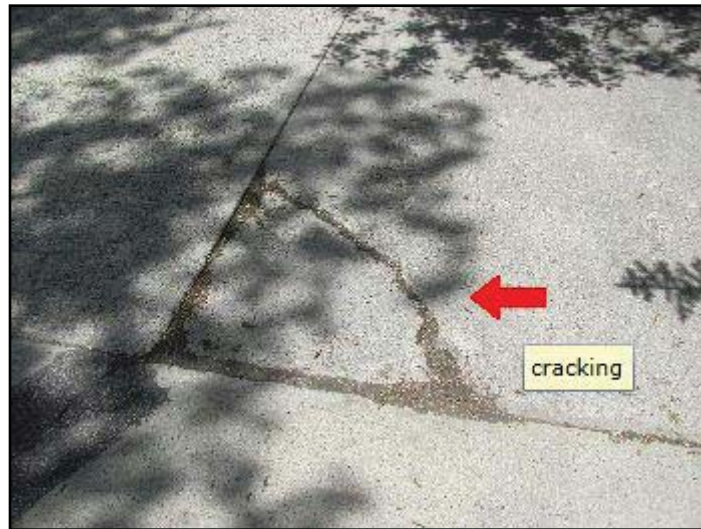
7. Cracked or damaged surfaces

9. Condition: • [Cracked or damaged surfaces](#)

Implication(s): Trip or fall hazard

Location: Front Exterior

Task: Monitor

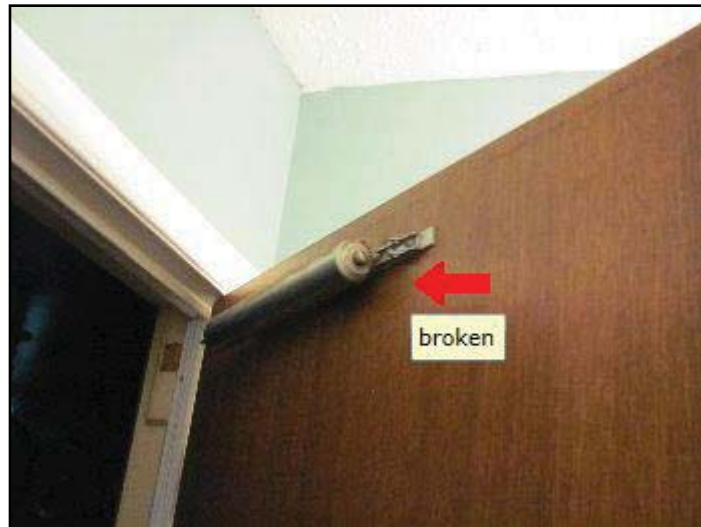
8. self-closer damaged

10. Condition: • self-closer mechanism damaged, causing door not self-closing

Location: Garage

Task: Repair or replace

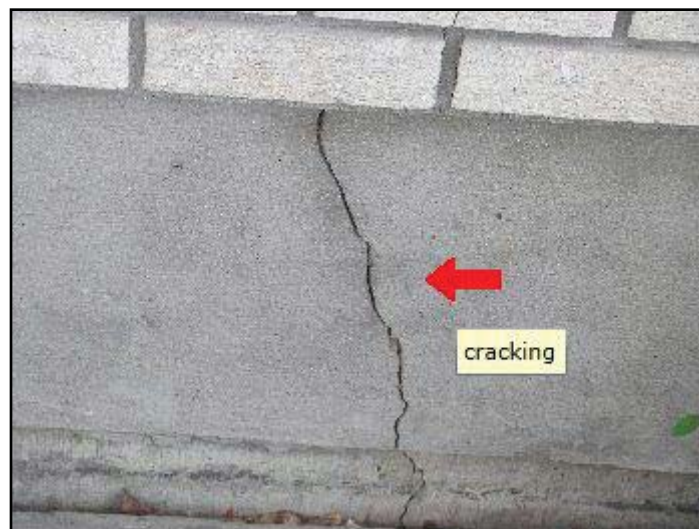
9. Typical minor cracks

11. Condition: • Typical minor cracks

Implication(s): Chance of water entering building

Location: Front Left Side

Task: Monitor; Patching as needed.

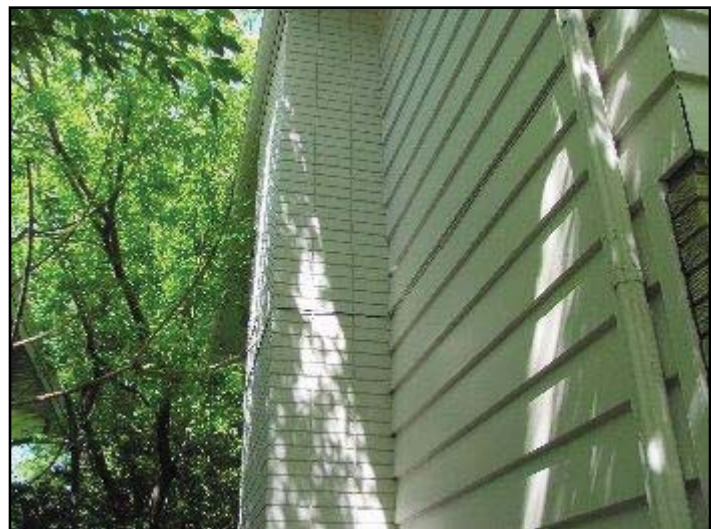
10. trees close to building

12. Condition: • [Large trees close to building](#)

Implication(s): Weakened structure | Chance of structural movement

Location: Front Exterior

Task: Monitor

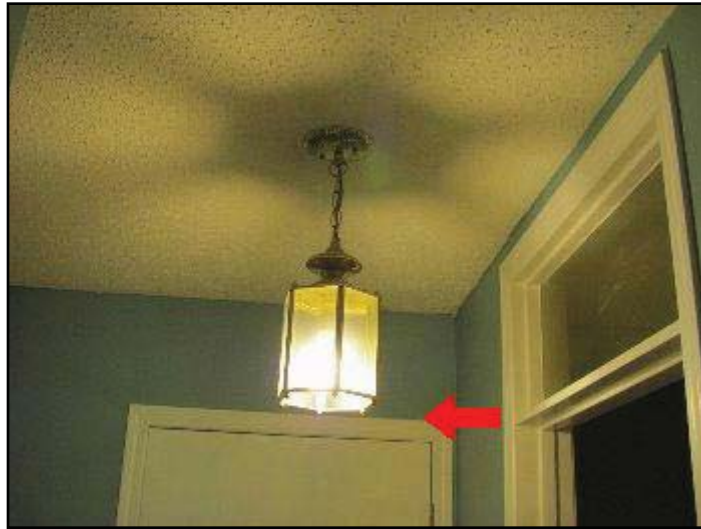
11. *too low*

13. Condition: • ceiling light mounted too low, obstructing traffic may causing safety concerns

Location: First Floor Hall

Task: correcting

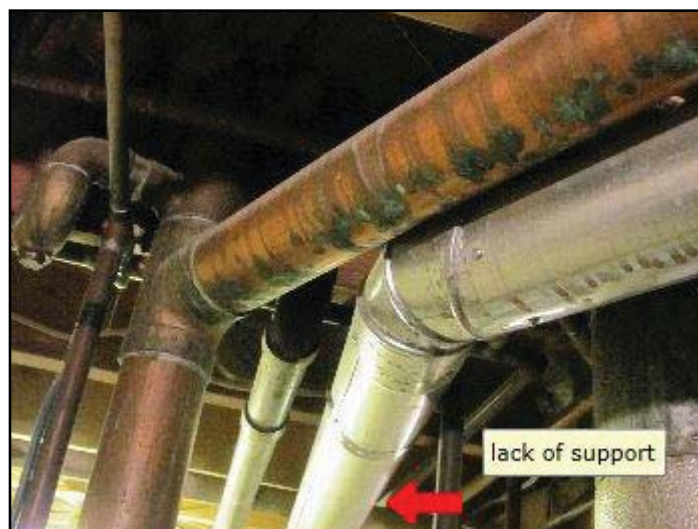
12. Poor support

15. Condition: • [Poor support](#)

Implication(s): Equipment not operating properly | Hazardous combustion products entering home

Location: Basement

Task: Provide

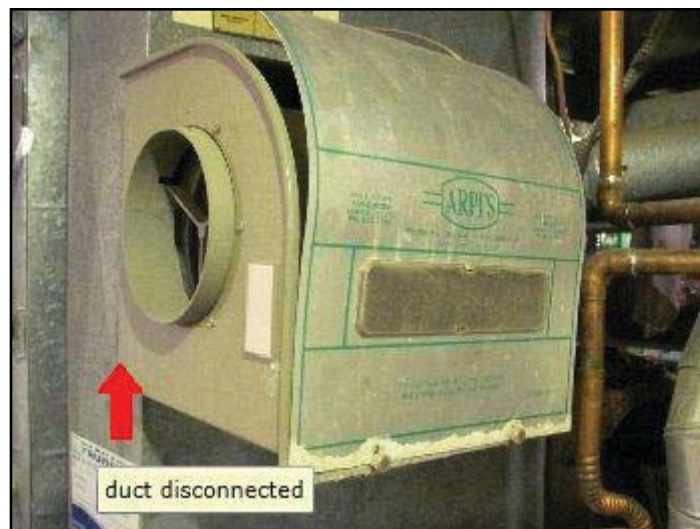
13.

17. Condition: • in-operative; duct disconnected.

Location: Basement

Task: Provide

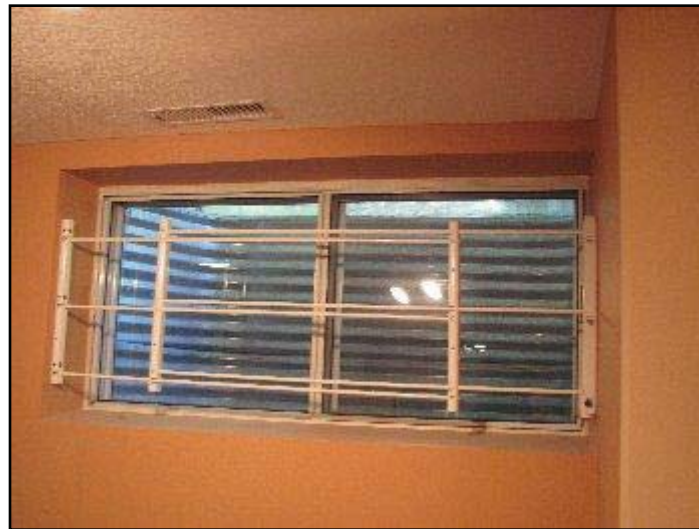
16. Burglar bars not operable without tools

22. Condition: • Burglar Bars not operable without tools.

Location: Basement

Task: Repair or replace
