CONEJOS RIVER

DIVERSION INFRASTRUCTURE INVENTORY

Structure Name: STOVER D

Date: April 15, 2019

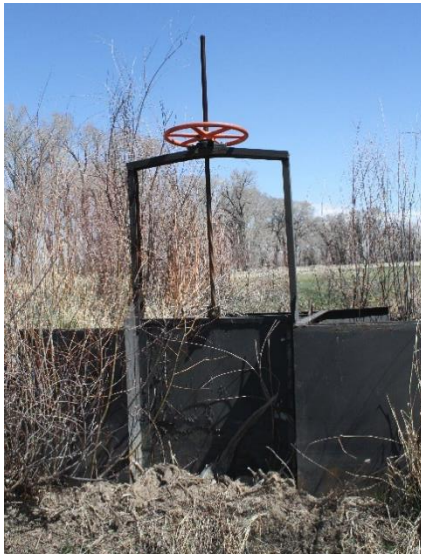
Headgate looking downstream

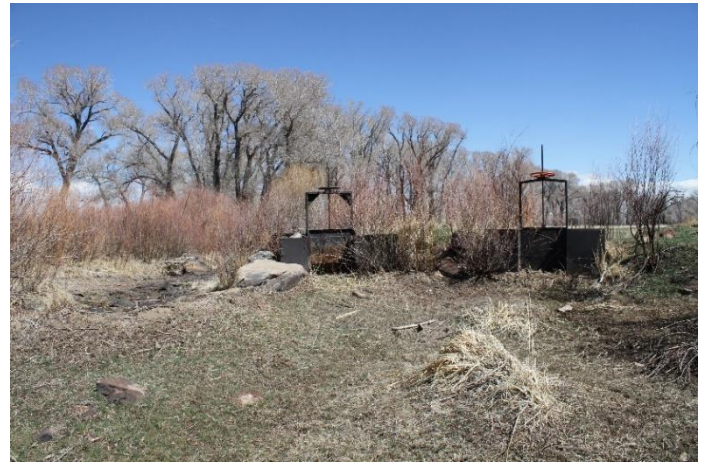
Headgate, diversion dam, and return gate

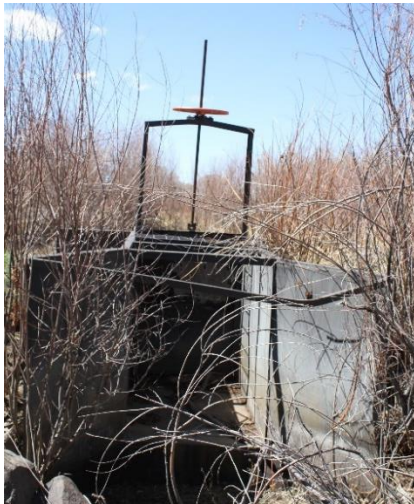
Headgate outlet

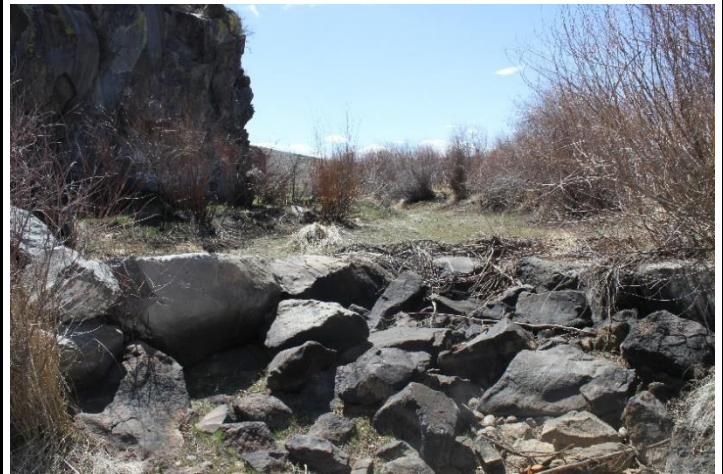
Diversion dam looking upstream

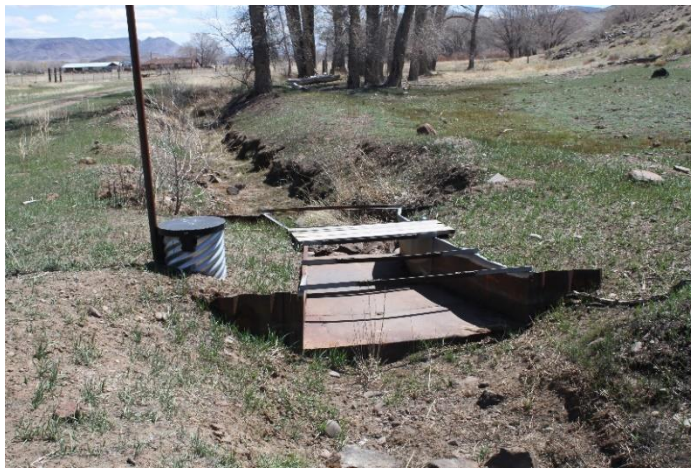
Parshall flume looking downstream

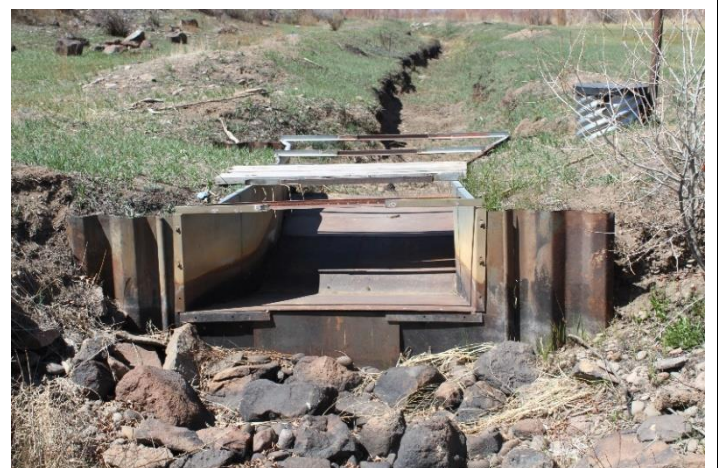
Parshall flume looking upstream
