RIO GRANDE DIVERSION INFRASTRUCTURE INVENTORY

Structure Name: RABER D

RABER DITCH

Rio Grande Stream
Management Plan

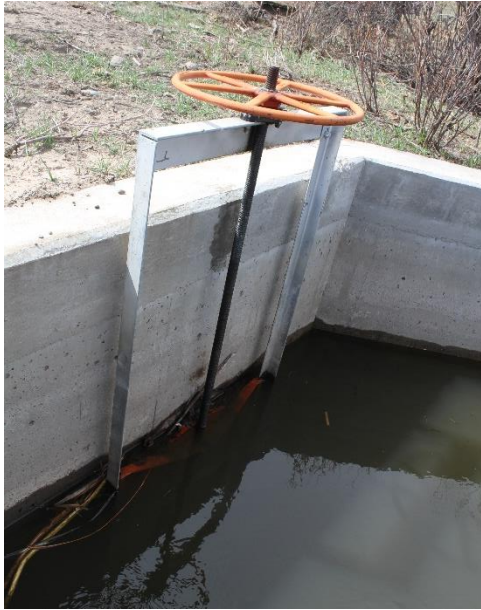
Headgate looking downstream

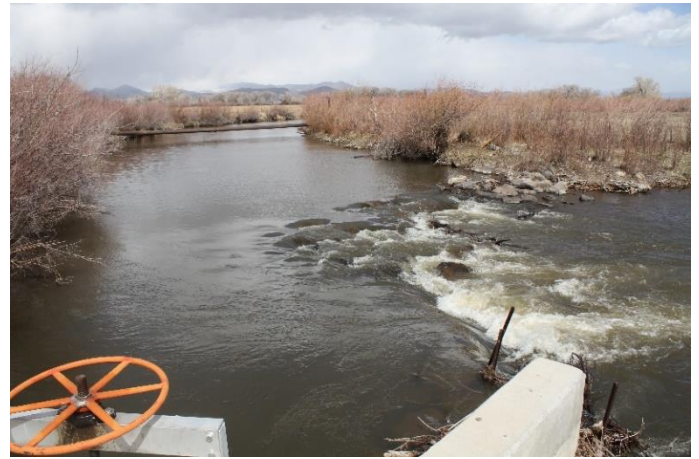
Structure Description: Located on the North Channel of the Rio Grande. Channel migration analysis shows the channel in this area is very stable. A stacked rock diversion dam directs water to the headgate, which is located on the south bank of the river. Diversion dam functions well.

Headgate and diversion dam

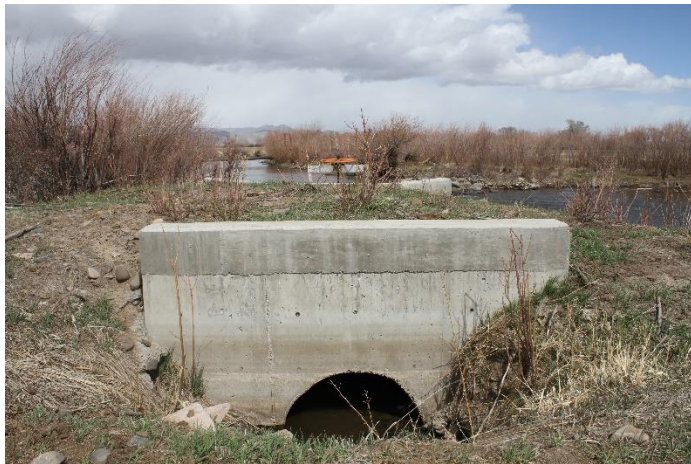
Headgate outlet

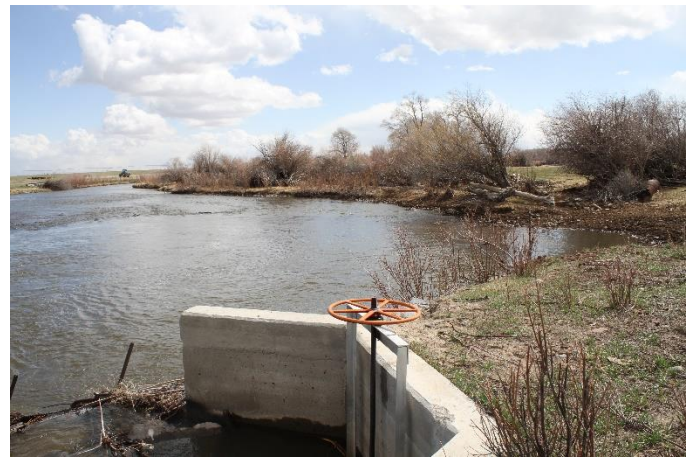
Headgate and channel looking downstream

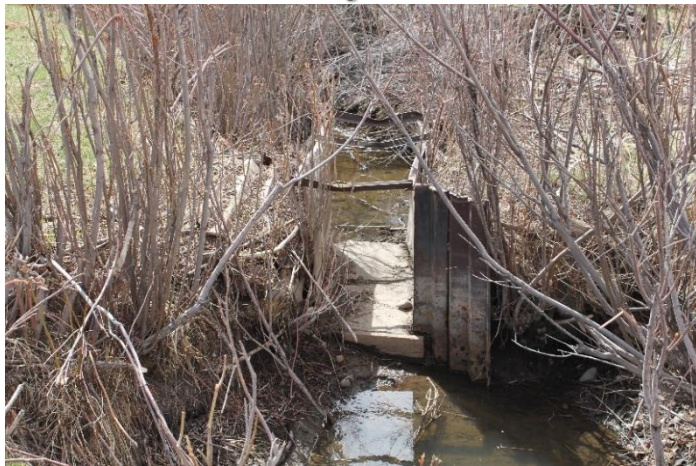
Flume looking downstream

Repair(s) or Improvement(s) Currently Needed: Flume functions but is aging and should be replaced soon. Fish passage and riparian restoration should be considered as part of any repairs or improvements.

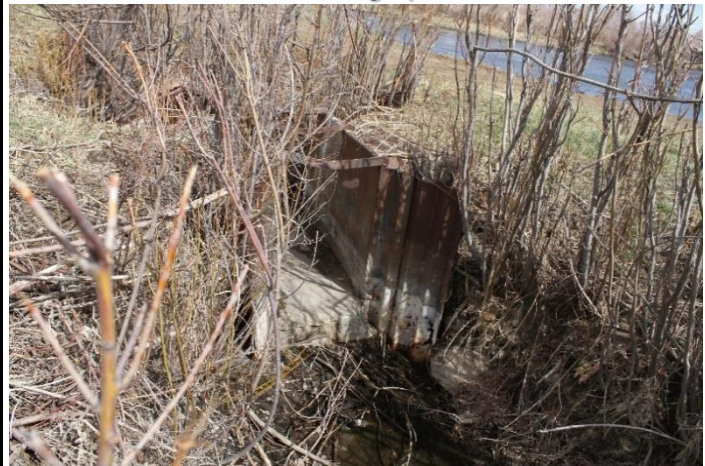
Flume looking upstream
