DEPARTMENT OF REGULATORY
AND ECONOMIC RESOURCES

MINIMUM INSPECTION PROCEDURAL GUIDELINES
FOR BUILDING ELECTRICAL RECERTIFICATION

- a. Name on Title: Village at Dadeland Condominiums (B)
- b. Street Address: 7320 SW 82nd St. Miami, Florida 33143
- c. Legal Description: Village at Dadeland Condominiums
- d. Owner's Name: Village at Dadeland Condominiums
- e. Owner's Mailing Address: 7320 SW 82nd St. Miami, Florida 33143
- f. Folio Number of Property on which Building is Located: 30-4035-047-XXXX
- g. Building Code Occupancy Classification: R2 - Residential
- h. Present Use: Condominium, Residential
- i. General Description, Type of Construction, Size, Number of Stories, and Special Features

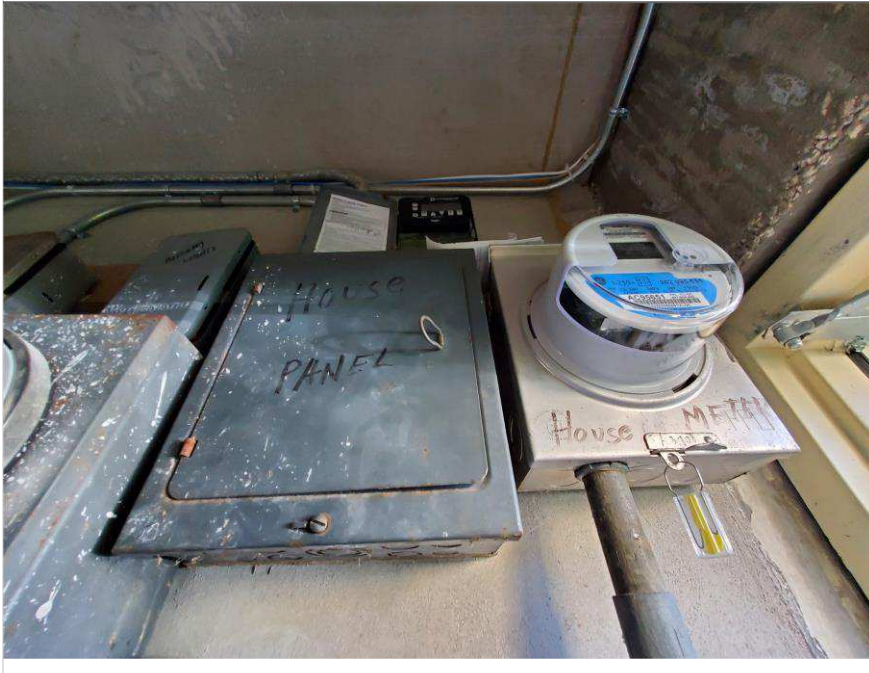
Photo 5 – Village of Dadeland Condominium Association

Existing Electrical Room – 1st FL
House Main Meter and Panel
Board - oxidized
50 year old electrical
component.

Time clocks installed too high.

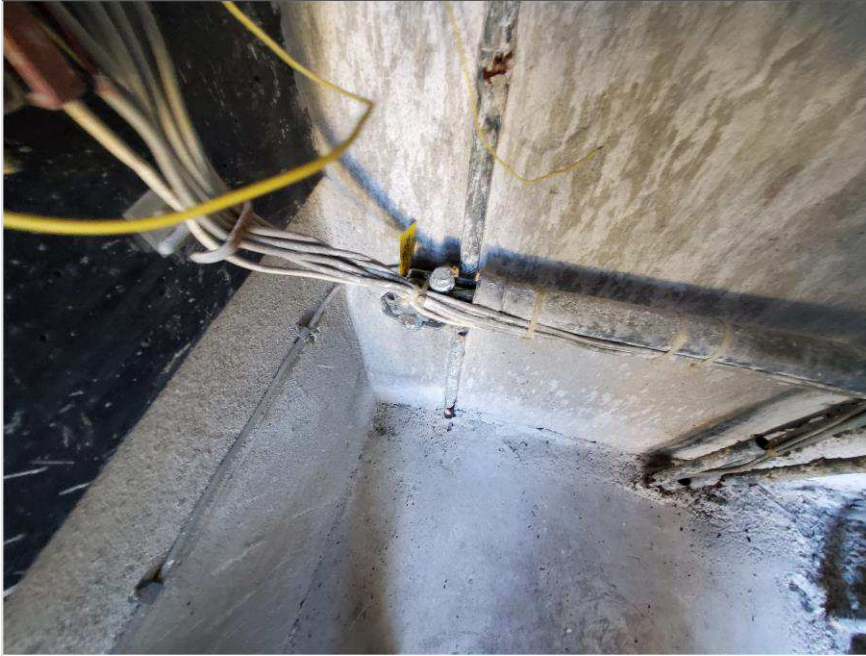
Photo 10 – Village of Dadeland Condominium Association

Existing Electrical Room – 1st FL
Main Distribution – Grounding

Grounding resistance to be
tested to determine if repairs
and /or maintenance are
required.

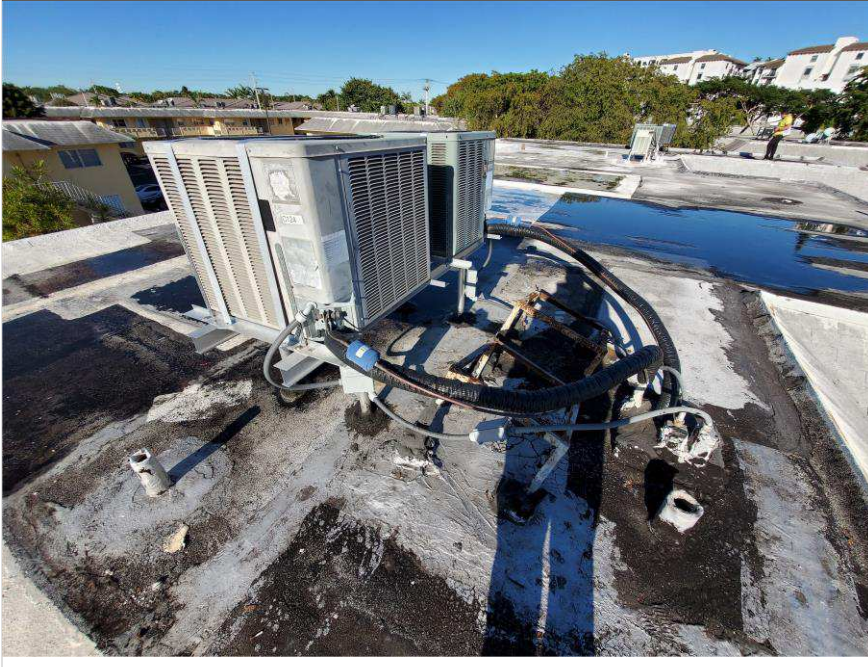
Photo 11 – Village of Dadeland Condominium Association

Rooftop Condenser Units –
Oxidized junction boxes and
conduits.

Junction boxes not properly
supported.

Missing disconnect switches.

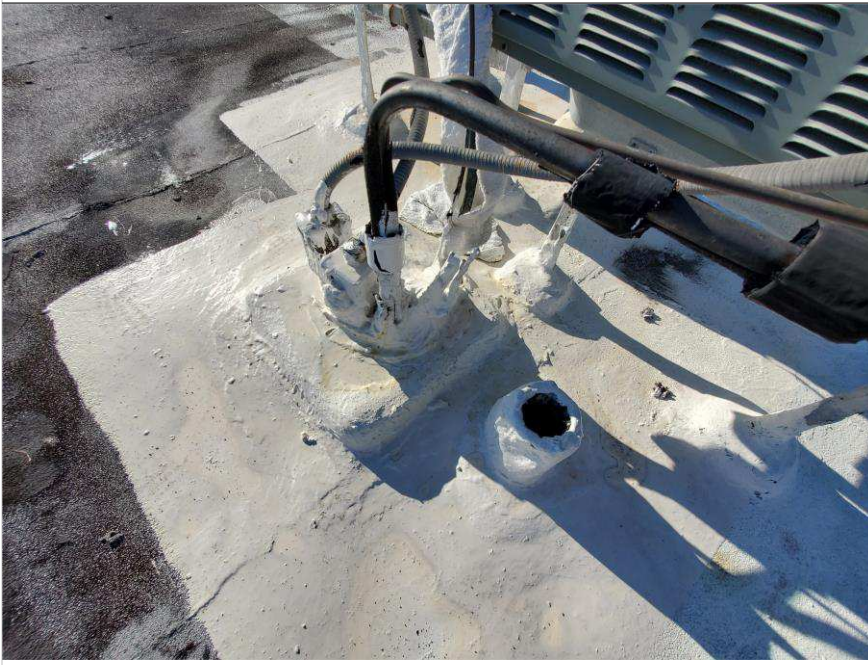
Photo 12 – Village of Dadeland Condominium Association

Rooftop Condenser Units –
Oxidized junction boxes and
conduits.

Junction boxes not properly
supported.

Missing disconnect switches.

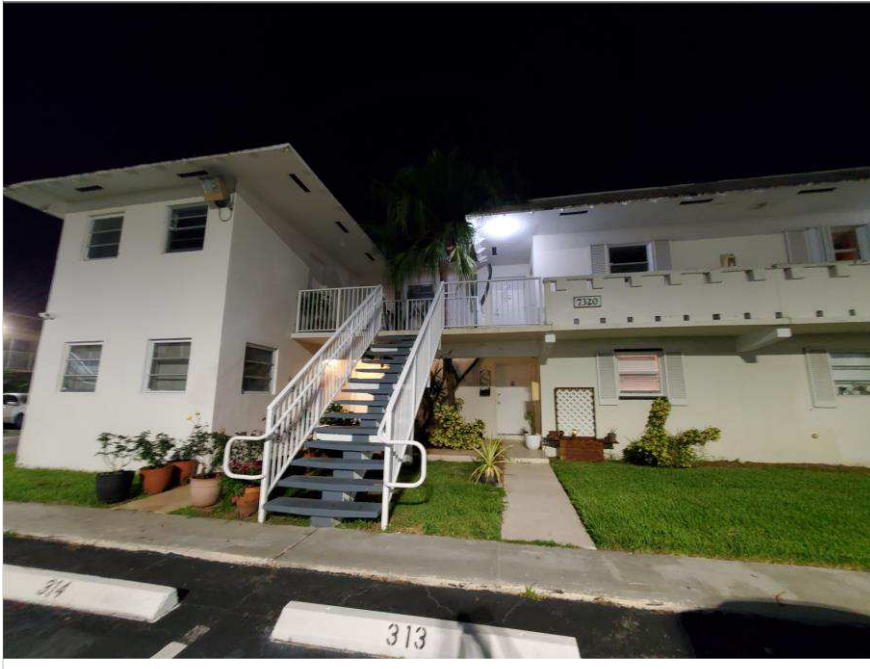
Photo 13 – Village of Dadeland Condominium Association

Parking – Poorly Illuminated
Exterior lights not functional.

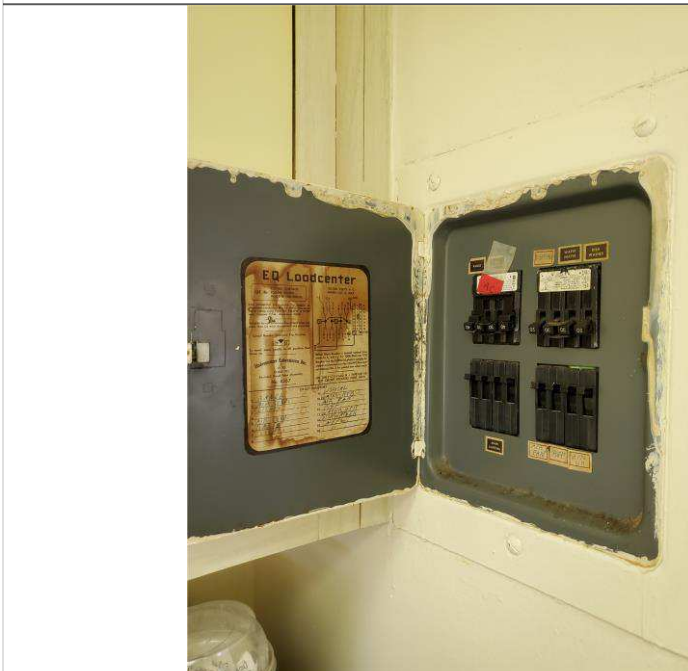
Photo 16 – Village of Dadeland Condominium Association

Apartments – Old Electrical Panels

Old, oxidized breaker to be replaced.

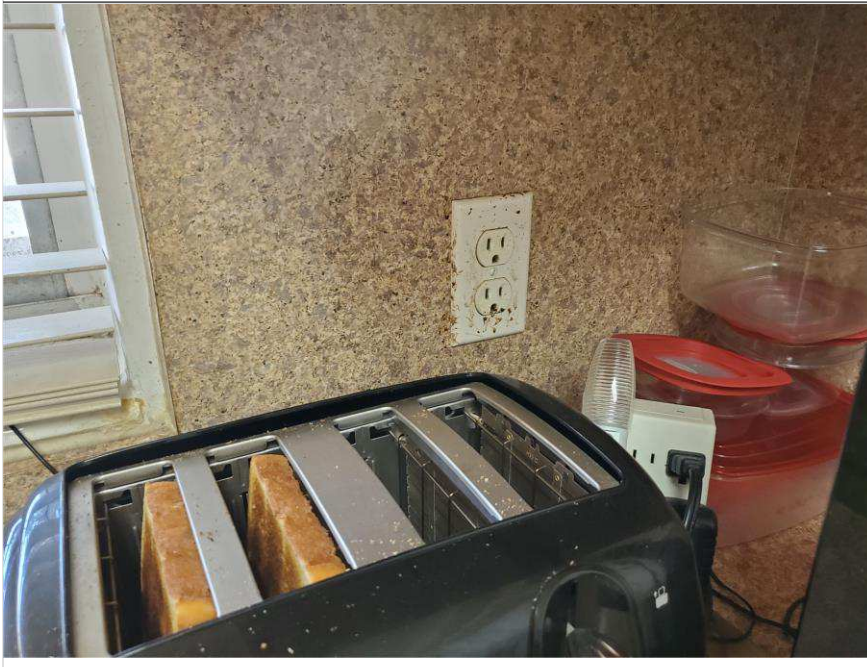
Photo 17 – Village of Dadeland Condominium Association

Apartments – Kitchen outlets

Kitchen outlets that are not GFCI type or miswired need to be replaced/corrected.

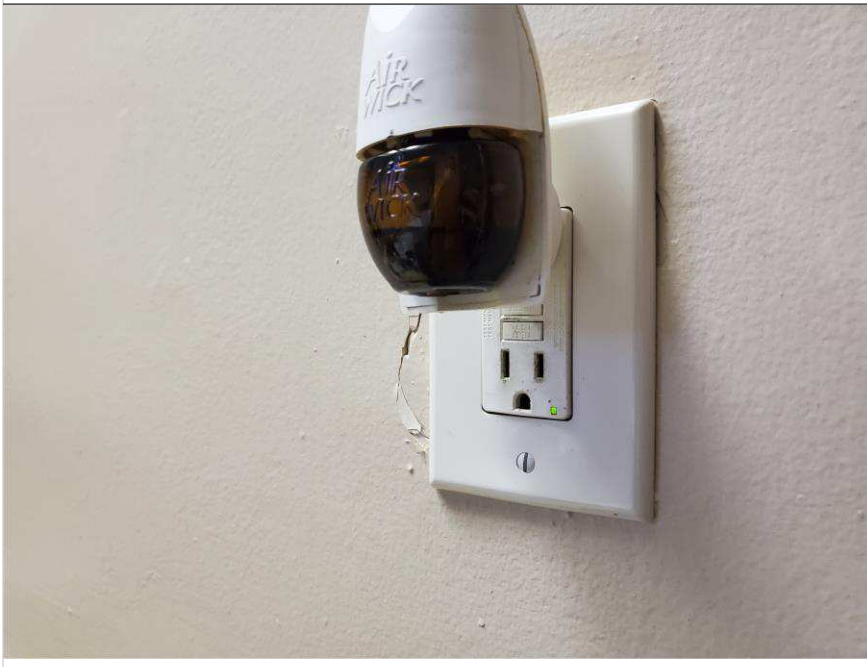
Photo 18 – Village of Dadeland Condominium Association

Apartments – Bathroom outlets

Bathroom outlets are defective or miswired.

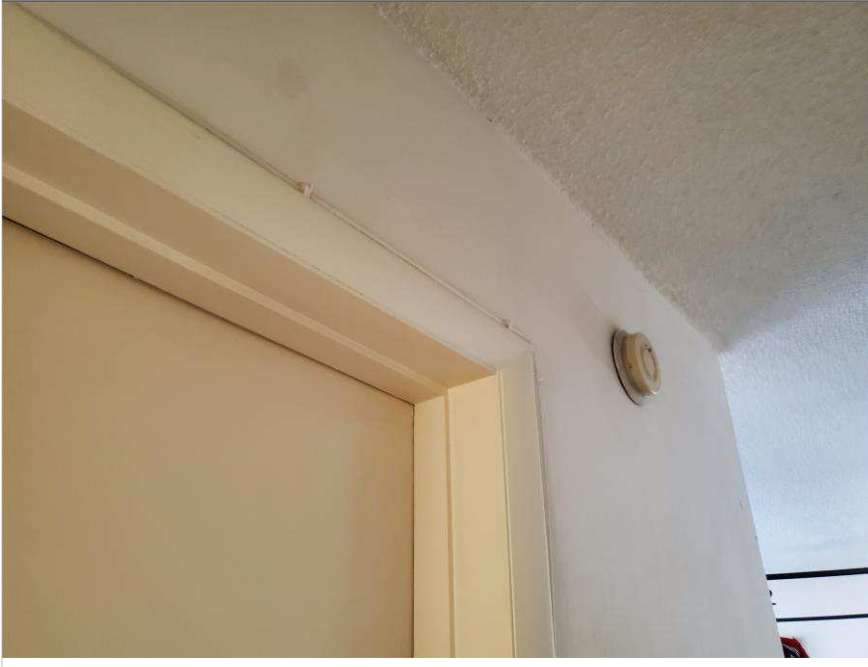
Photo 20 – Village of Dadeland Condominium Association

Apartments – Old Smoke Detectors

Old Smoke Detectors to be replaced.

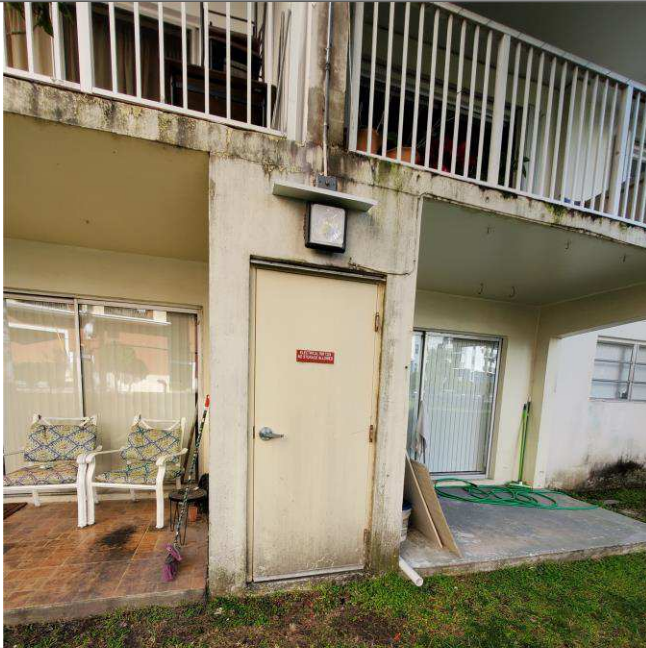
Photo 1 – Village of Dadeland Condominium Association

Existing Electrical Room - 1st FL
No Storage Permitted

Building Number sign is missing.

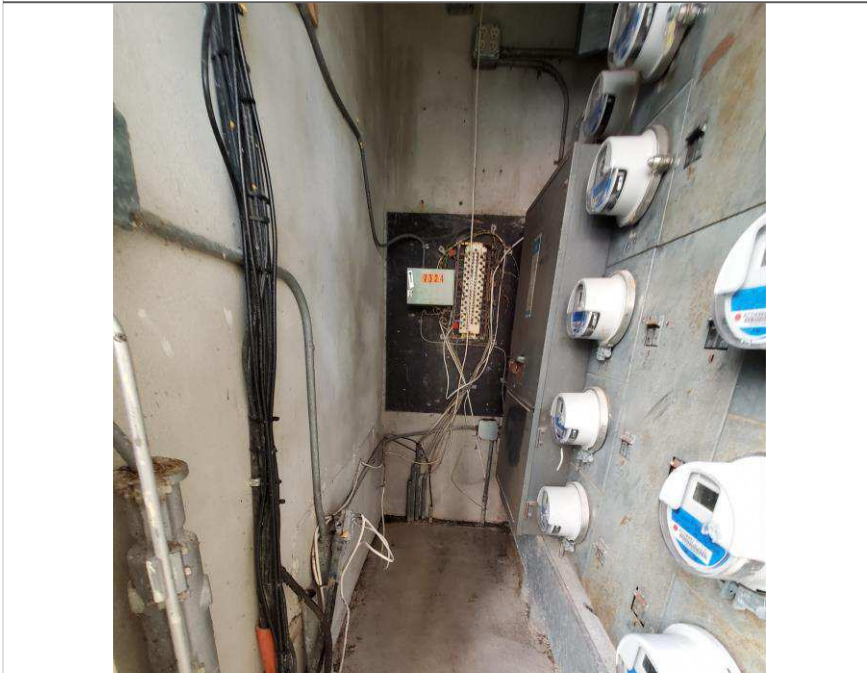
Photo 11 – Village of Dadeland Condominium Association

Existing Electrical Room - 1st FL
Apartment Meters and Main
Gutter

Old and oxidized meter stacks
and gutter.

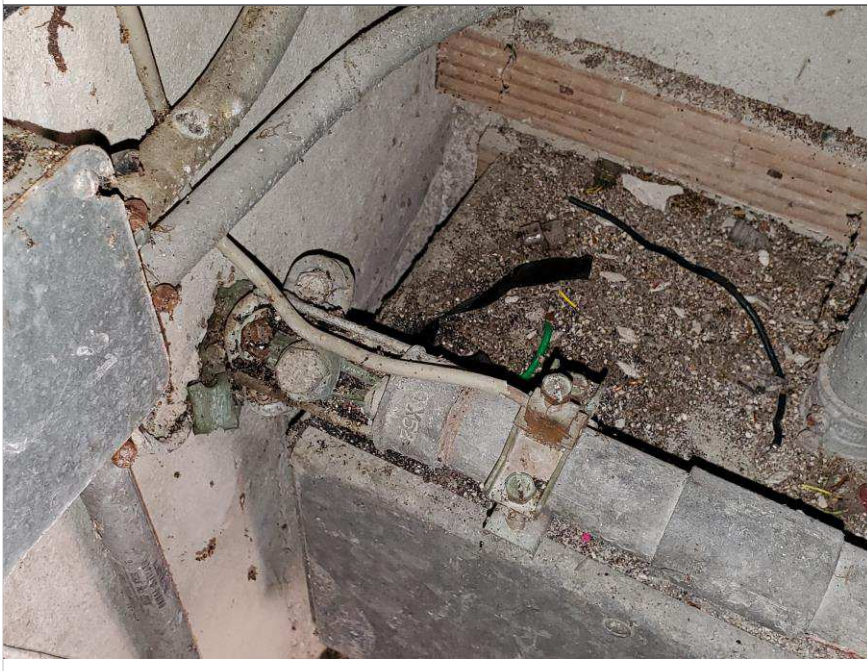
Photo 12 – Village of Dadeland Condominium Association

Existing Electrical Room - 1st FL
Main Distribution – Grounding

Grounding resistance to be
tested to determine if repairs
and /or maintenance are
required.

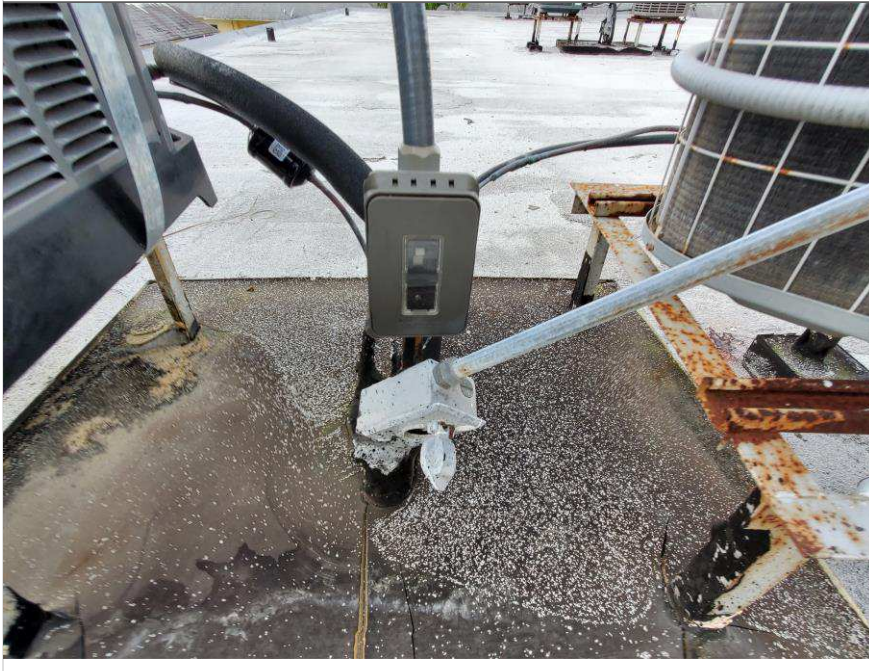
Photo 13 – Village of Dadeland Condominium Association

Rooftop Condenser Units -
Oxidized junction boxes and
conduits.

Junction boxes not properly
supported.

Missing disconnect switches.

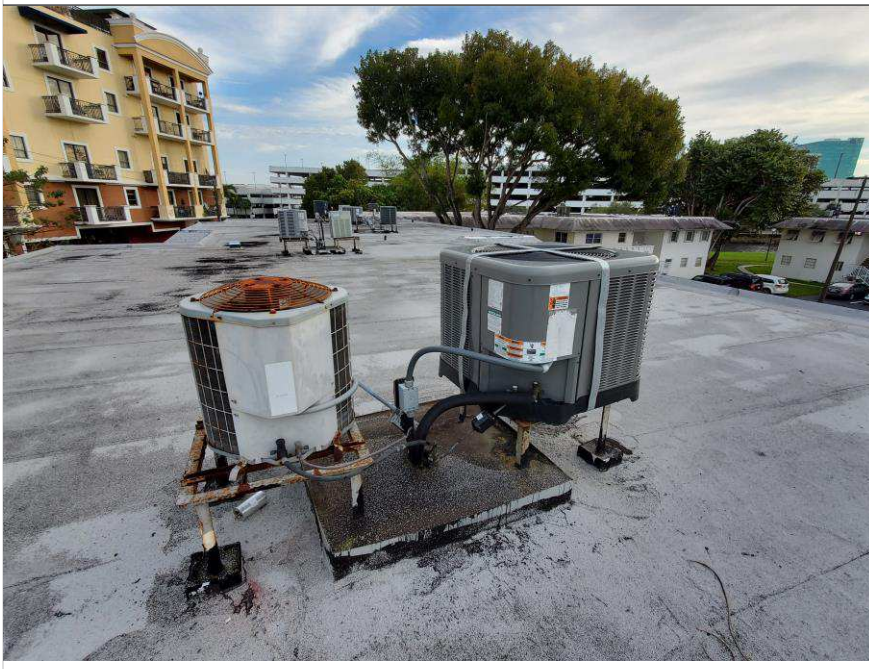
Photo 14 – Village of Dadeland Condominium Association

Rooftop Condenser Units -
Oxidized junction boxes and
conduits.

Junction boxes not properly
supported.

Missing disconnect switches.

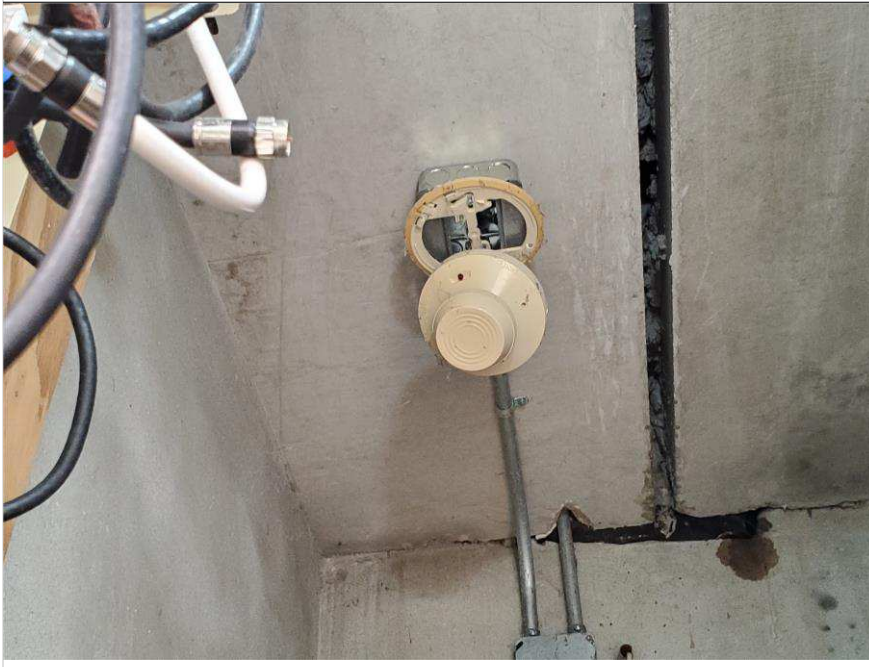
Photo 16 – Village of Dadeland Condominium Association

Existing Main electrical room:
Fire Alarm - Old and Weathered
Fire Alarm Devices and Control
Center

All old Smoke Alarm Devices to
be replaced.
This device is not properly
connected.
All wall penetrations to be fire
caulked.

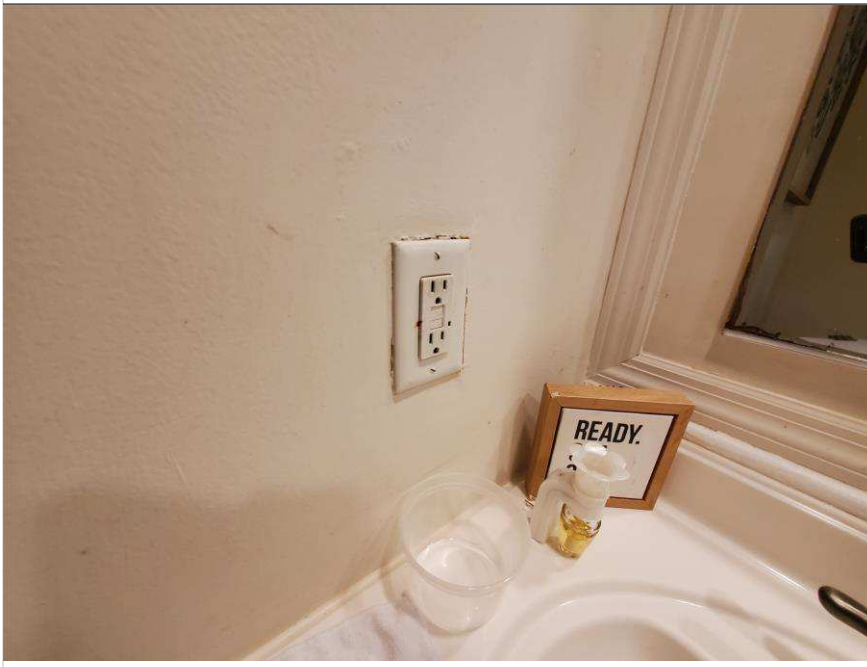
Photo 26 – Village of Dadeland Condominium Association

Apartments - the GFCI outlets in
bathroom are defective or
miswired.

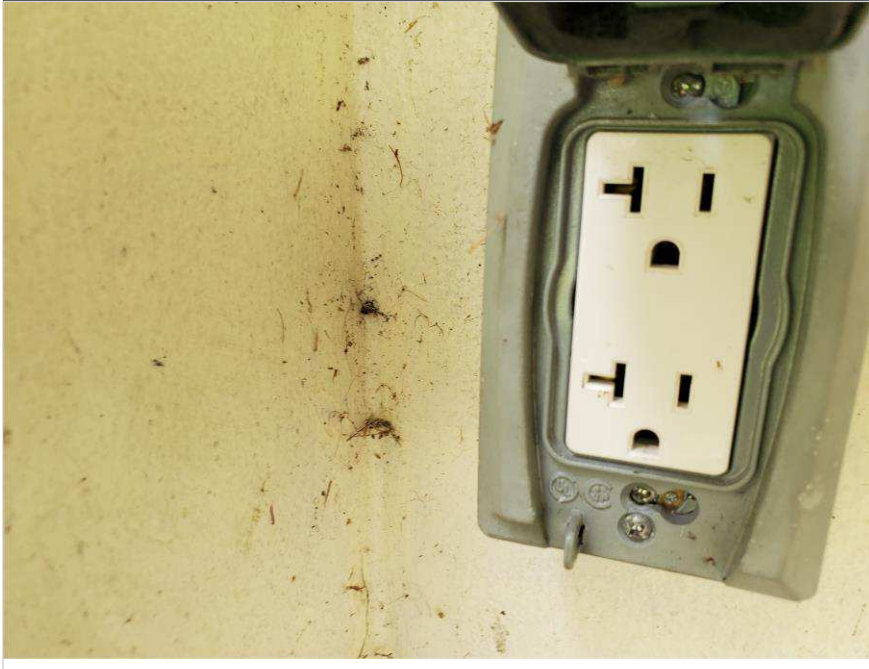
Photo 27 – Village of Dadeland Condominium Association

Apartments - Balcony/Patio outlets not GFCI type.

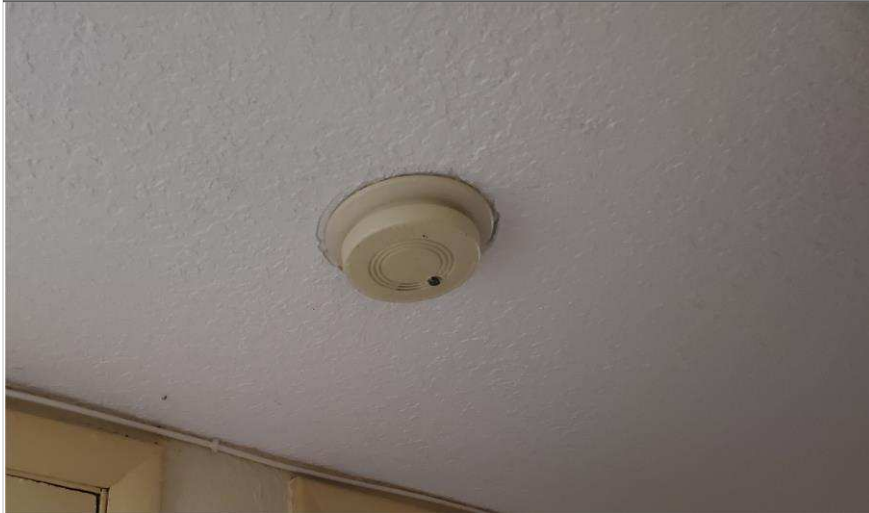
Photo 28 – Village of Dadeland Condominium Association

Apartments - Old Smoke Detectors

Old Smoke Detectors to be replaced.

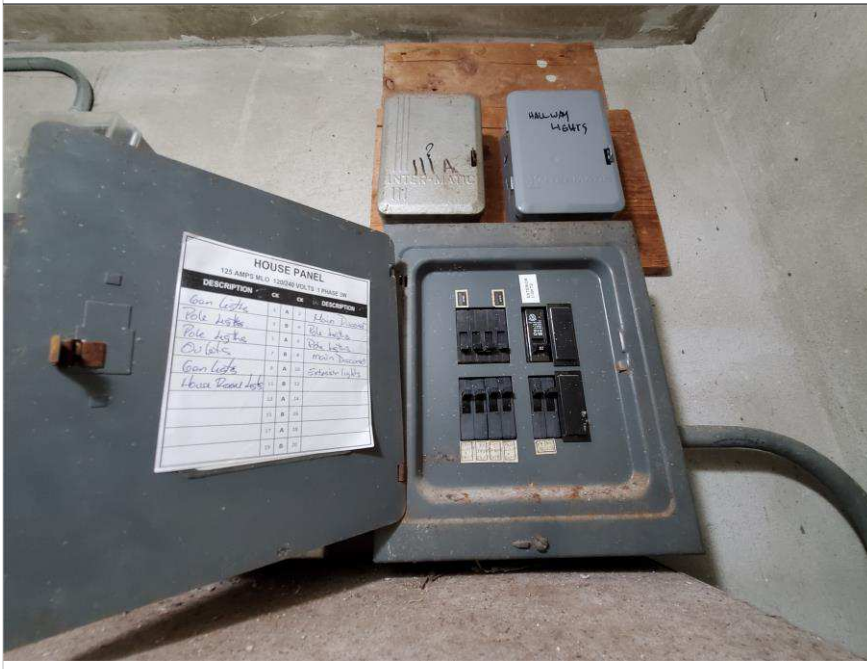
Photo 6 – Village of Dadeland Condominium Association

Existing Electrical Room - 1st FL
House Panel Board and breakers
are oxidized.
50 year old electrical
components.

Missing Name Plate Rating.

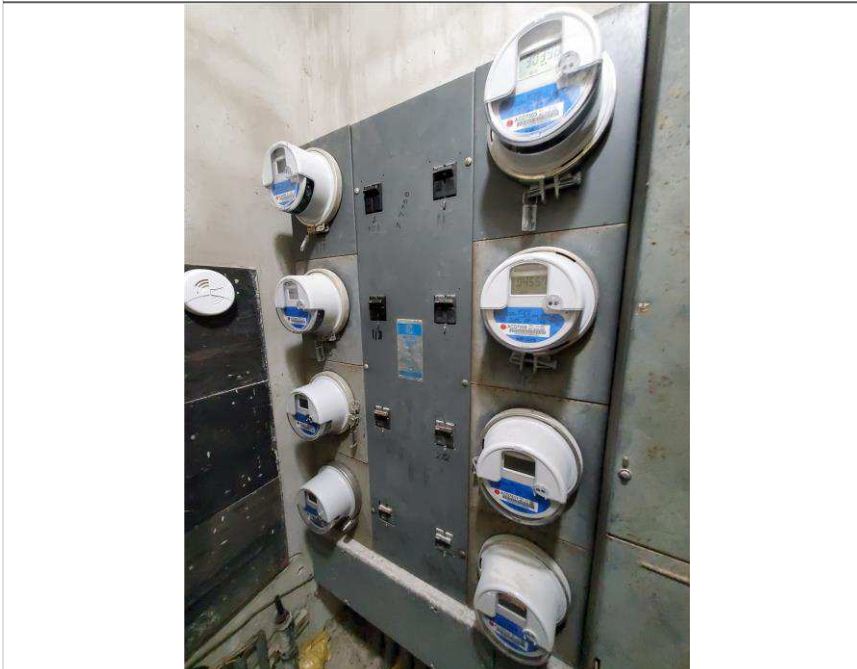
Photo 7 – Village of Dadeland Condominium Association

Existing Electrical Room - 1st FL
Apartment Meters and Main
Switches.

Old and oxidized meter stacks.

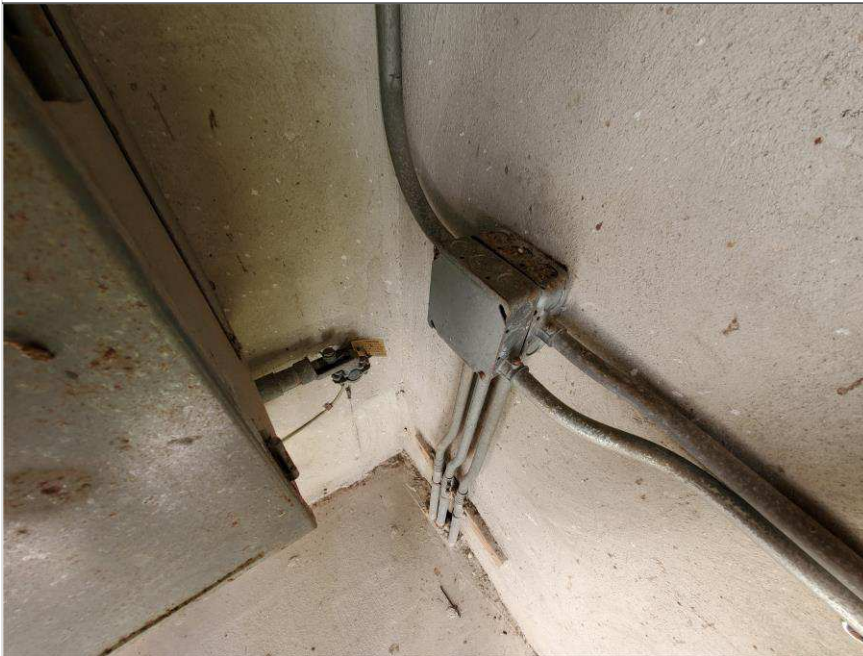
Photo 10 – Village of Dadeland Condominium Association

Existing Electrical Room - 1st FL
Main Service – Grounding

Grounding resistance to be
tested to determine if repairs
and /or maintenance are
required.

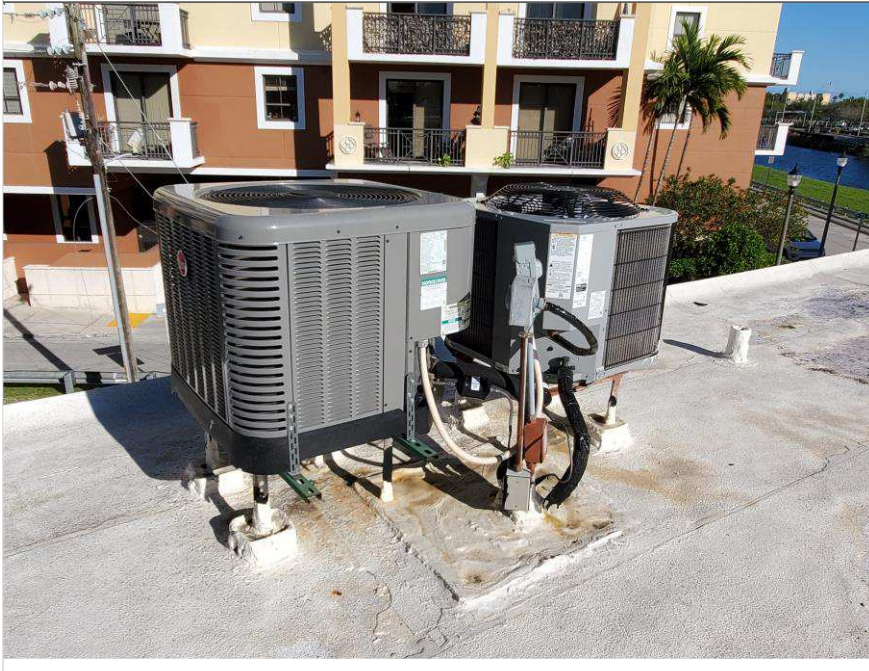
Photo 11 – Village of Dadeland Condominium Association

Rooftop Condenser Units -
Oxidized junction boxes and
conduits.

Junction boxes not properly
supported.

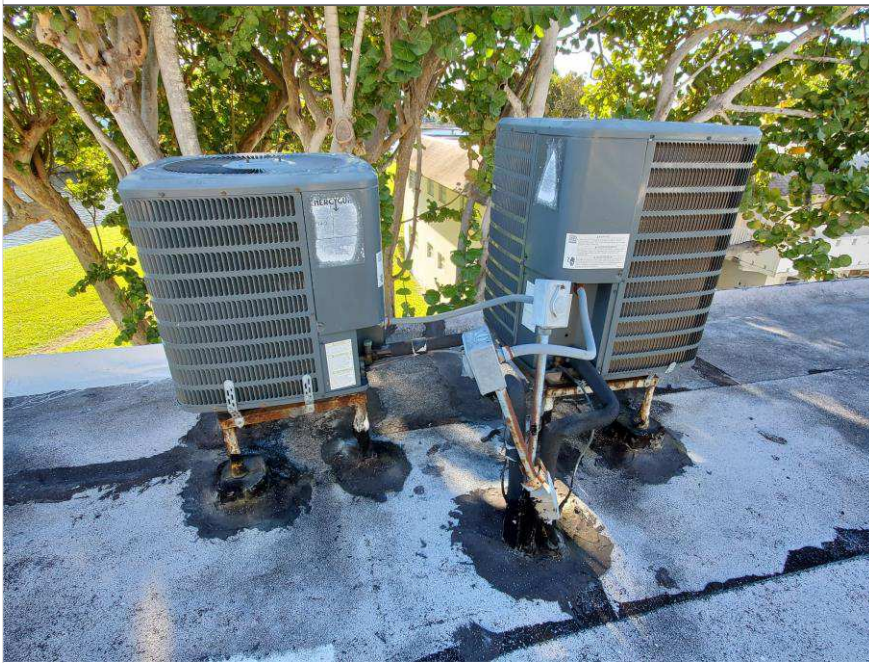
Photo 12 – Village of Dadeland Condominium Association

Rooftop Condenser Units -
Oxidized junction boxes and
conduits.

Junction boxes not properly
supported.

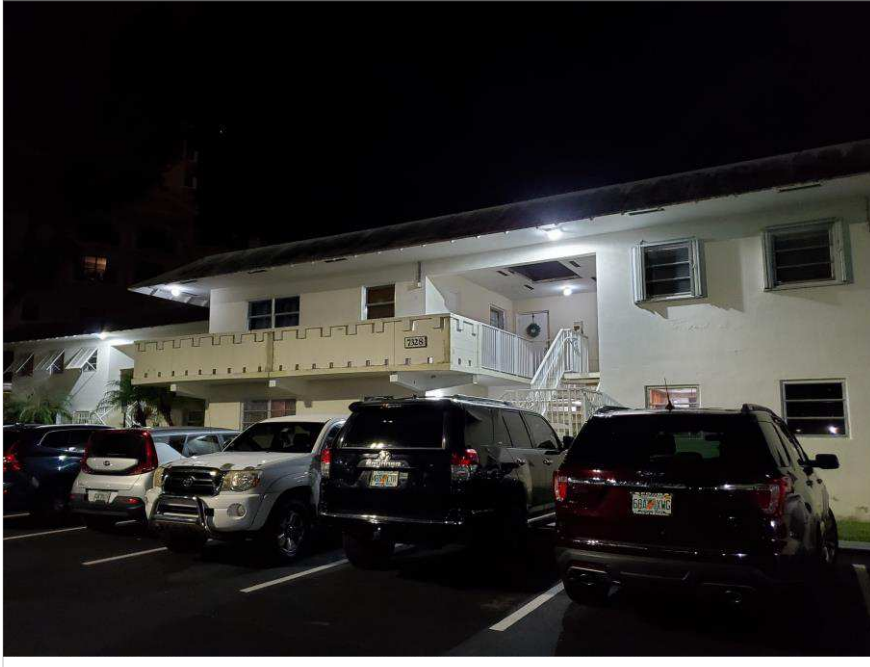
Photo 13 – Village of Dadeland Condominium Association

Parking - Poorly Illuminated
Exterior light not functional.

No light fixture over section of
the catwalk.

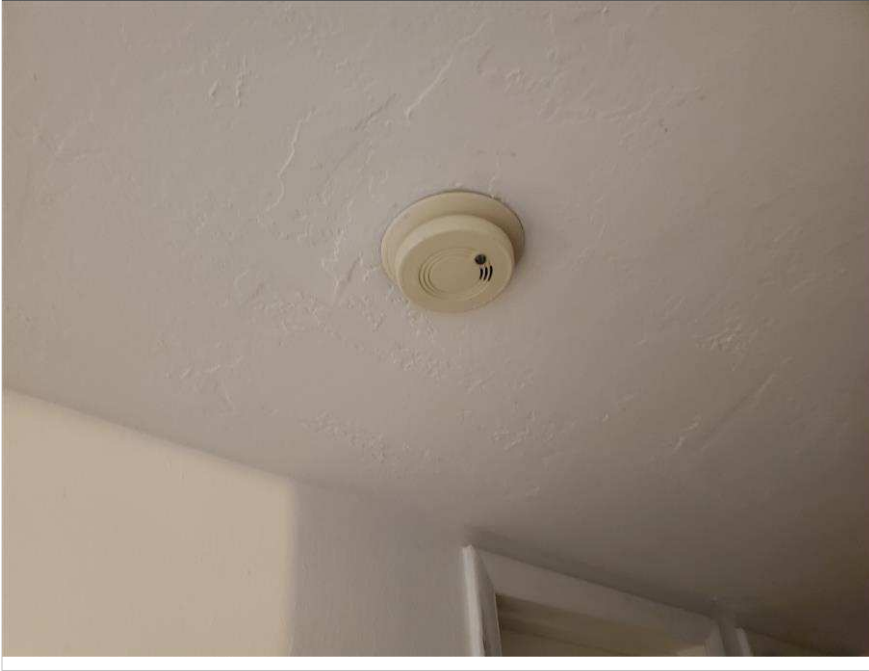
Photo 19 – Village of Dadeland Condominium Association

Apartments - Old Smoke
Detectors

Old Smoke Detectors to be
replaced.
This photo is an example.

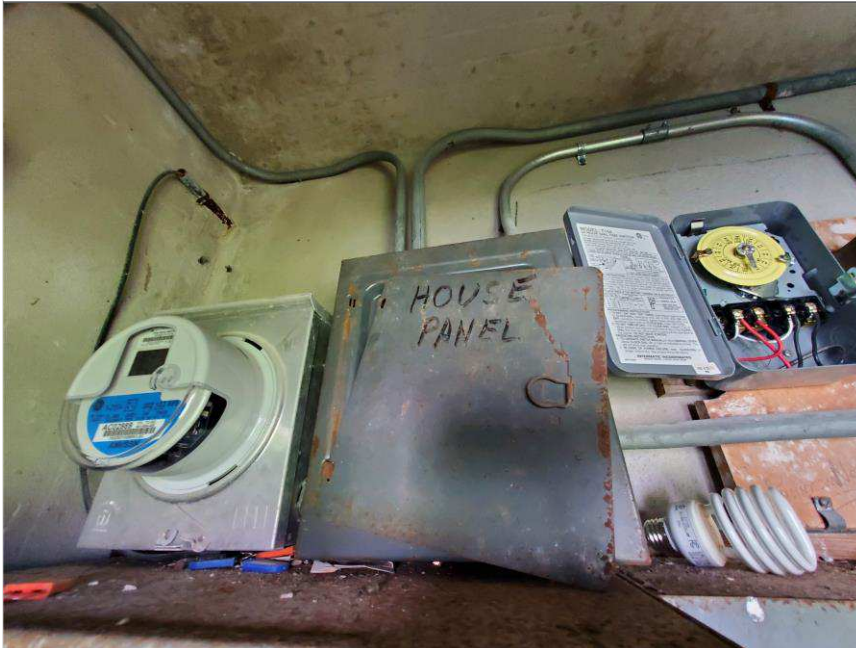
Photo 4 – Village of Dadeland Condominium Association

Existing Electrical Room - 1st FL
House Main Meter and Panel
Board are oxidized.
50 year old electrical
component.

Broken Panel Door.

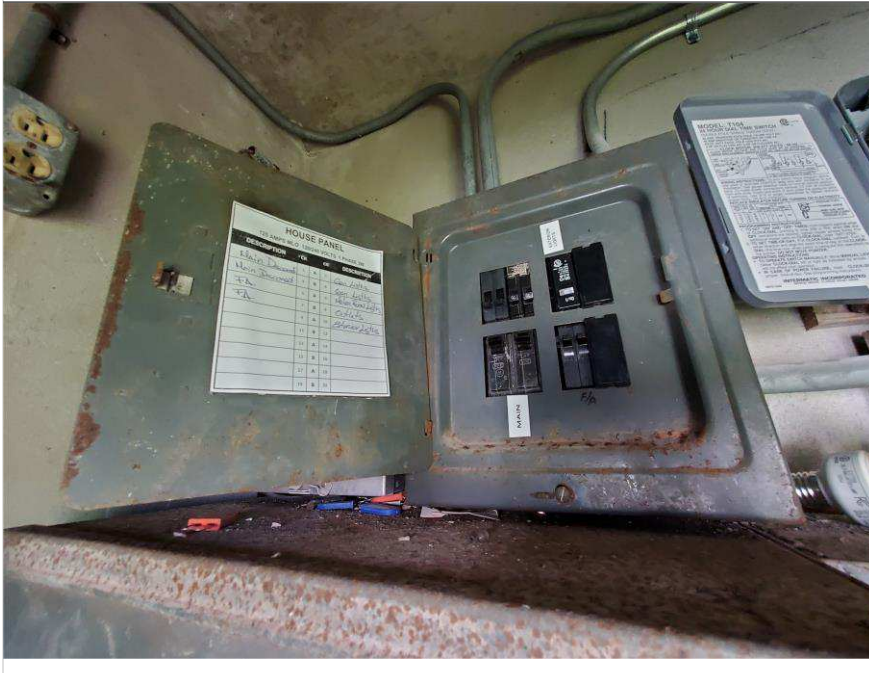
Photo 5 – Village of Dadeland Condominium Association

Existing Electrical Room - 1st FL
House Panel Board and Meter –
oxidized.

50 year old electrical
component.

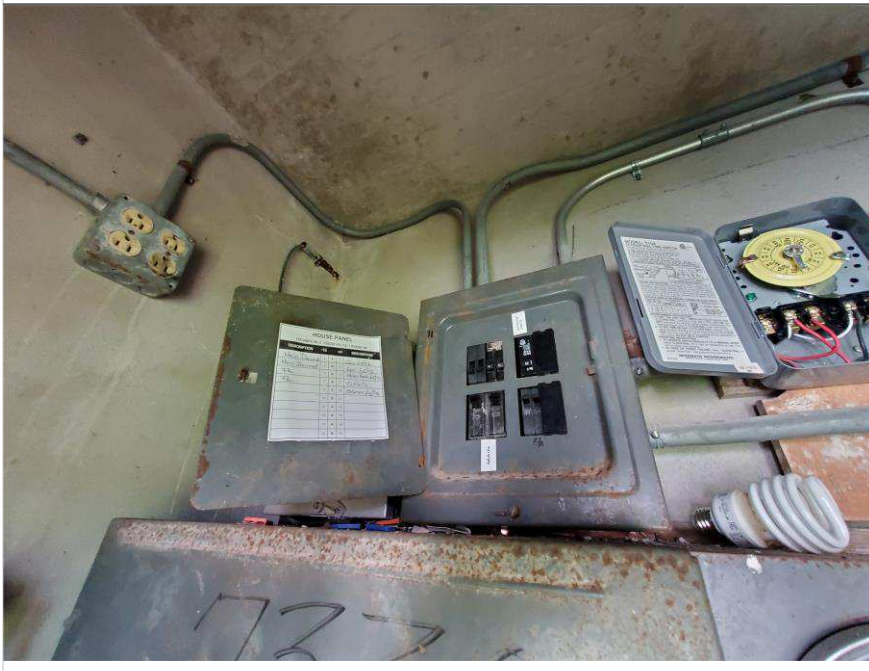
Photo 6 – Village of Dadeland Condominium Association

Existing Electrical Room - 1st FL
House Panel Board and
Breakers are oxidized.

50 year old electrical
components.

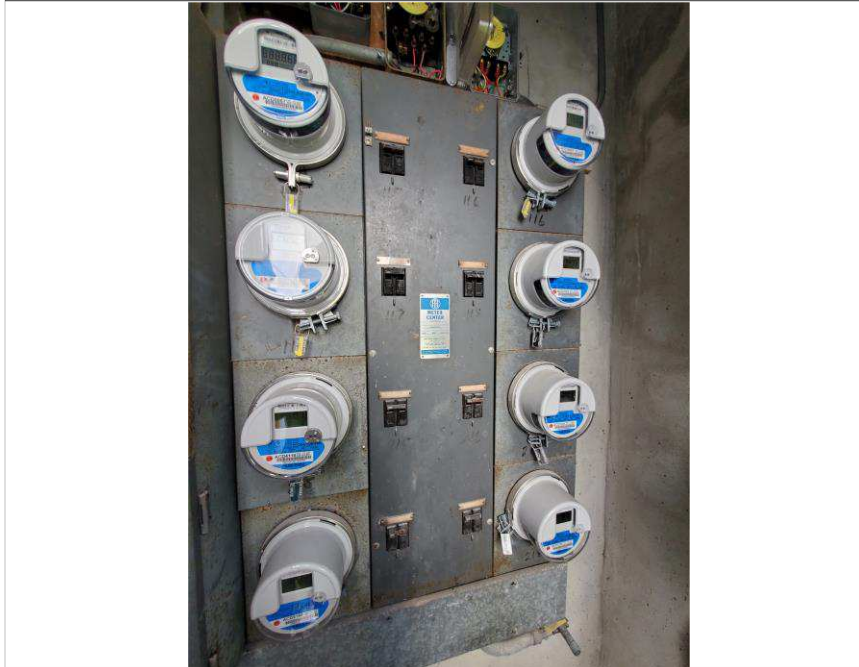
Photo 7 – Village of Dadeland Condominium Association

Existing Electrical Room - 1st FL
Apartment Meters, Main
Switches and Gutter

Old and oxidized meter stacks.

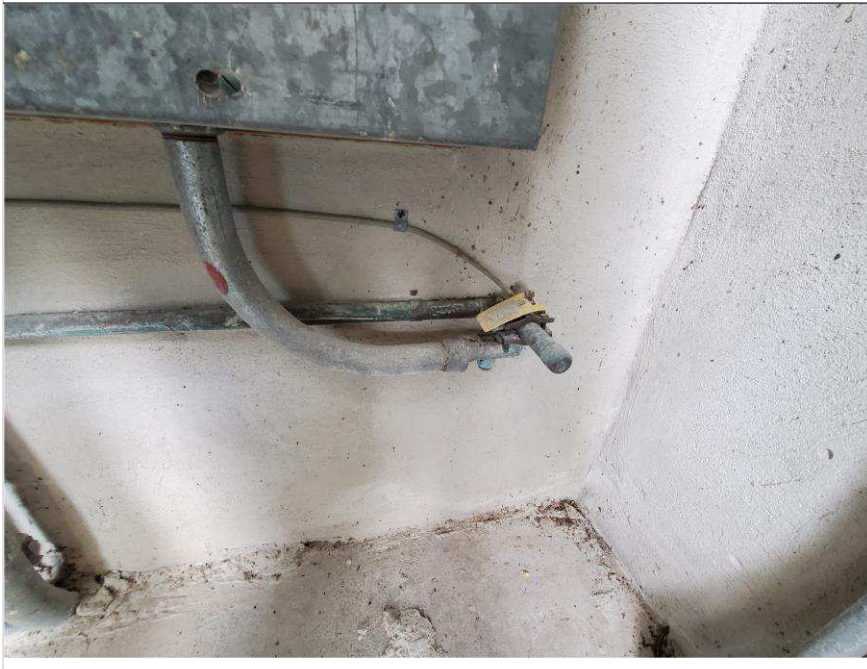
Photo 10 – Village of Dadeland Condominium Association

Existing Electrical Room - 1st FL
Main Service - Grounding

Grounding resistance to be tested to determine if repairs and /or maintenance are required.

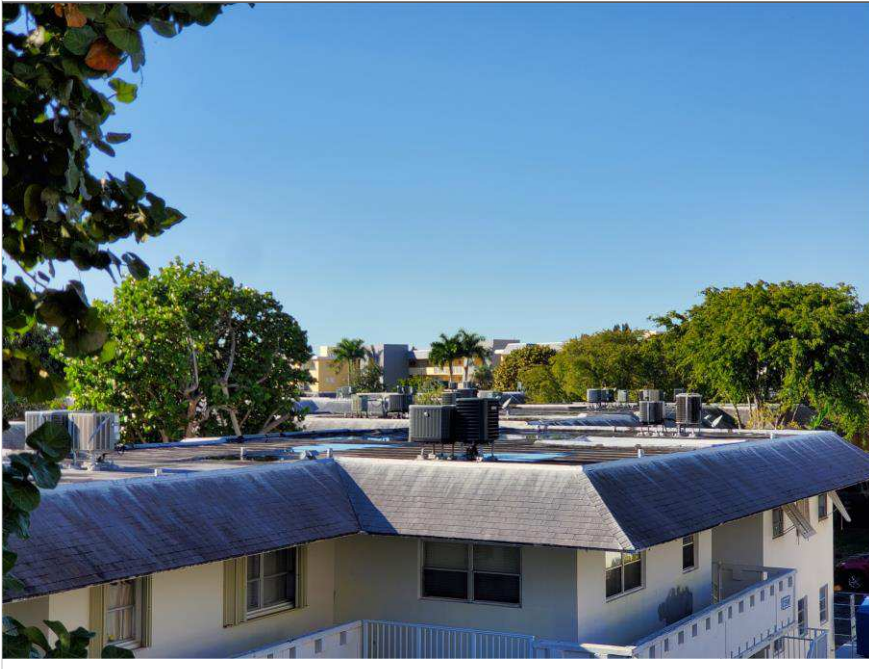
Photo 11 – Village of Dadeland Condominium Association

Rooftop Condenser Units -
Oxidized junction boxes and
conduits.

Junction boxes not properly
supported.

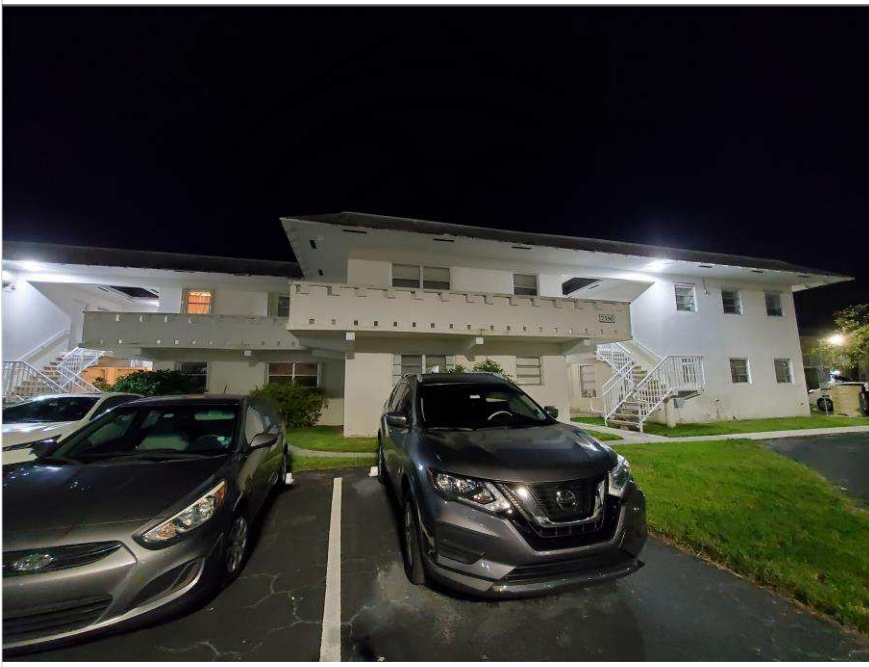
Photo 12 – Village of Dadeland Condominium Association

Parking/Catwalks/ Sidewalks -
Poorly Illuminated
Exterior light not functional.

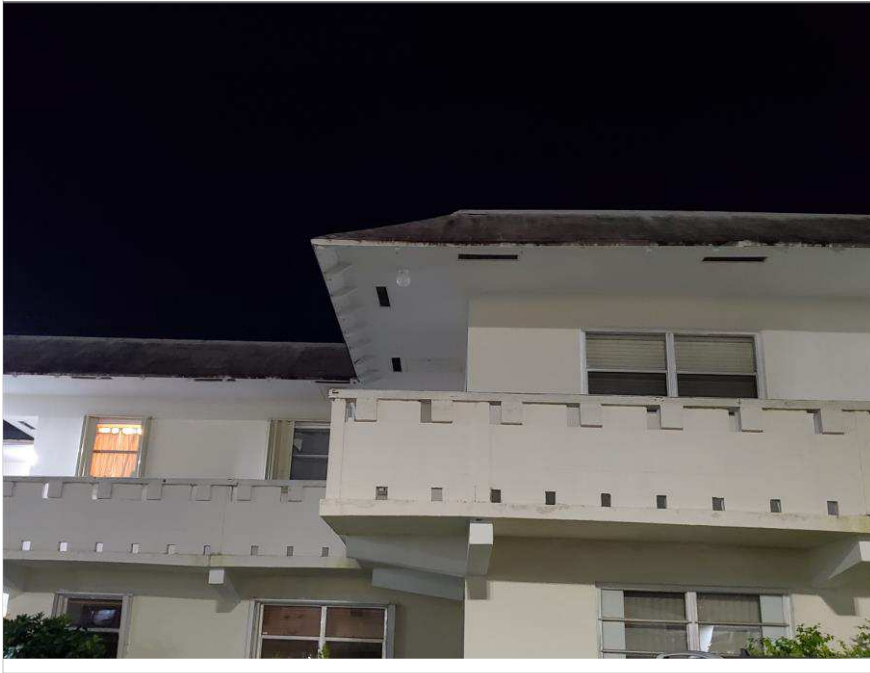
Photo 13 – Village of Dadeland Condominium Association

Catwalks - Poorly illuminated.
Exterior light not functional.

No light fixture over this section
of the catwalk.

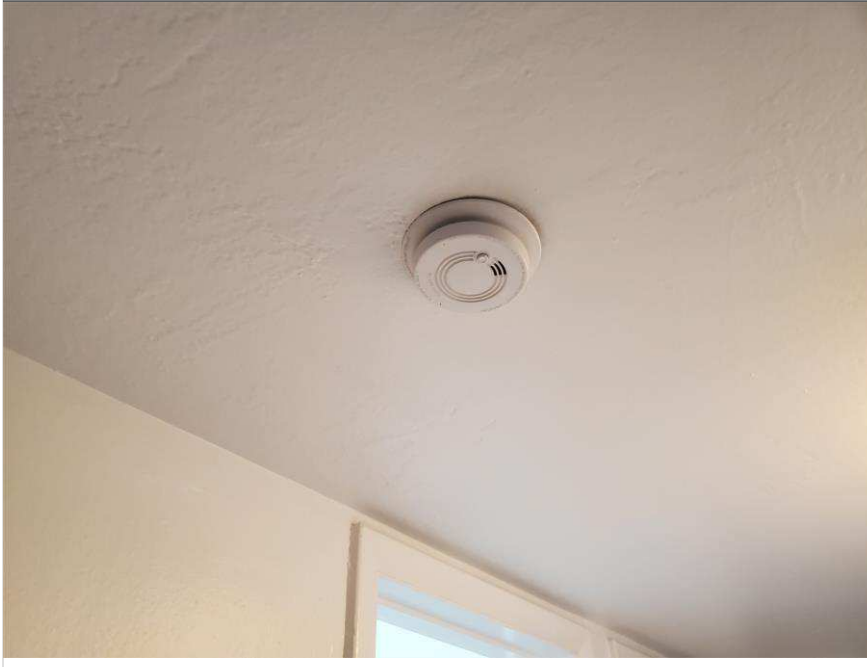
Photo 18 – Village of Dadeland Condominium Association

Apartments - Old Smoke Detectors

Old Smoke Detectors to be replaced.
Photo is an Example

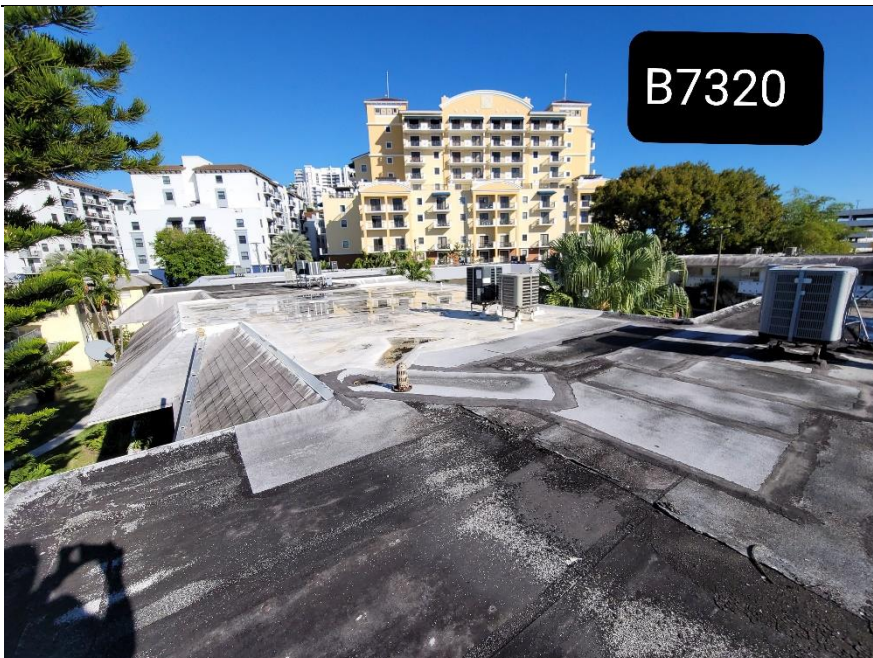
Photo #2:

Water ponding observed on the roof.

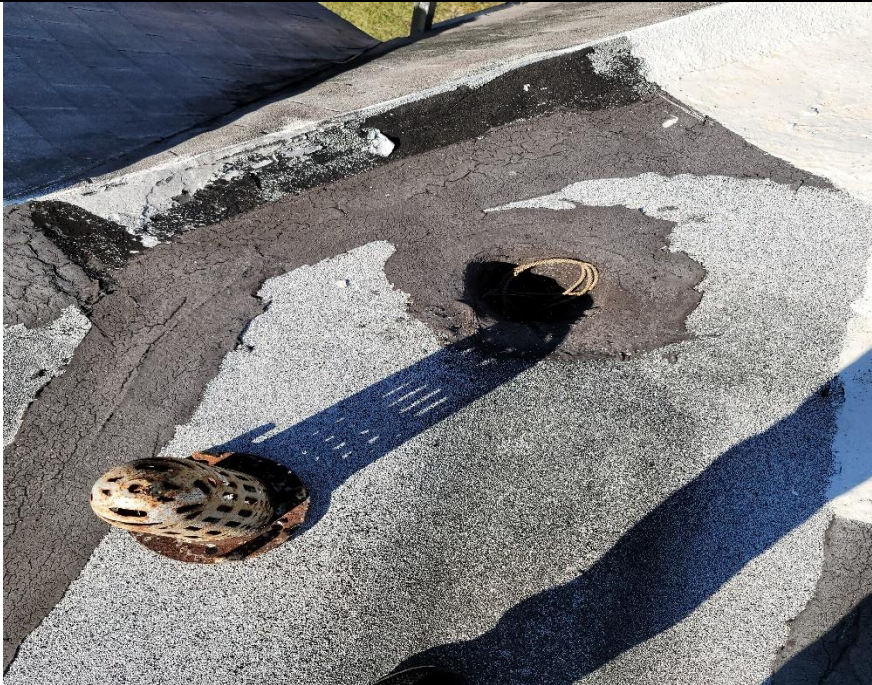
Photo #3:

The strainers for the interior drain lines were found to be rusted or non-functional since many of them are missing or not in their proper position.

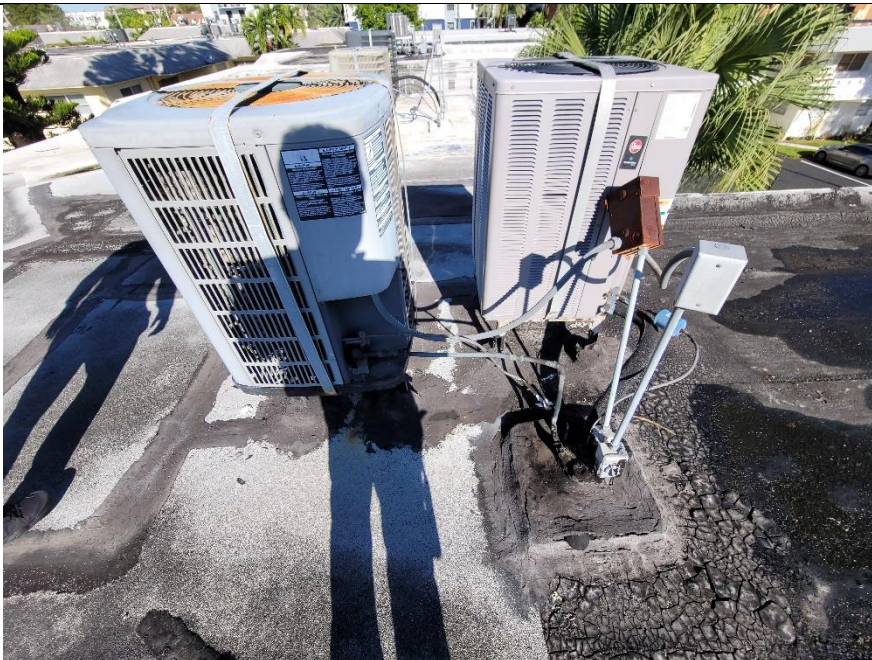
Photo #4:

The bituminous roof membrane was deemed to be in fair condition but sign of weathering/distress are evident.
