DEPARTMENT OF REGULATORY
AND ECONOMIC RESOURCES

MINIMUM INSPECTION PROCEDURAL GUIDELINES
FOR BUILDING ELECTRICAL RECERTIFICATION

- a. Name on Title: Village at Dadeland Condominiums (B)
- b. Street Address: 7320 SW 82nd St. Miami, Florida 33143
- c. Legal Description: Village at Dadeland Condominiums
- d. Owner's Name: Village at Dadeland Condominiums
- e. Owner's Mailing Address: 7320 SW 82nd St. Miami, Florida 33143
- f. Folio Number of Property on which Building is Located: 30-4035-047-XXXX
- g. Building Code Occupancy Classification: R2 - Residential
- h. Present Use: Condominium, Residential
- i. General Description, Type of Construction, Size, Number of Stories, and Special Features

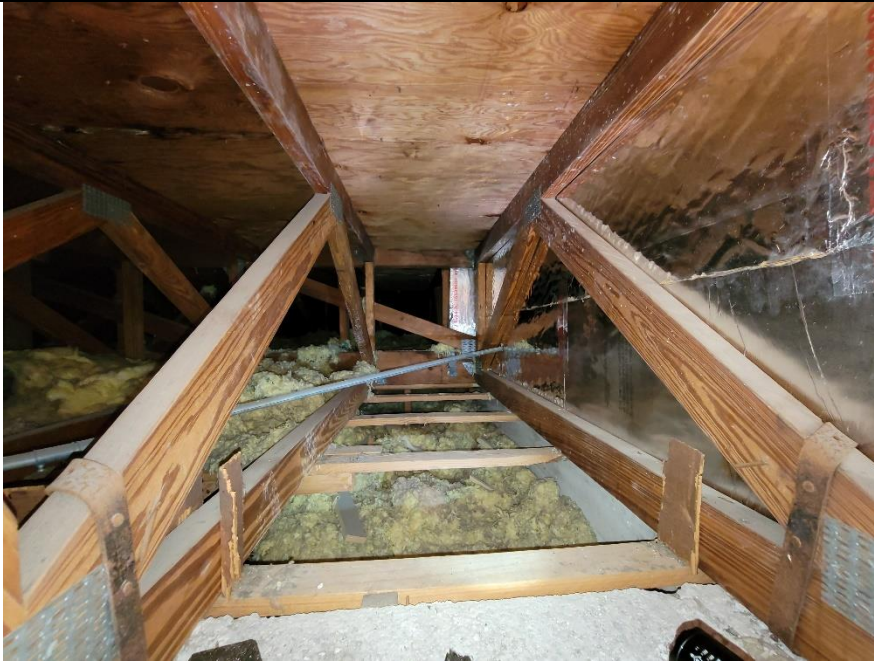
Photo #5:

Where accessible the roof structure was observed and found to be in fair condition.

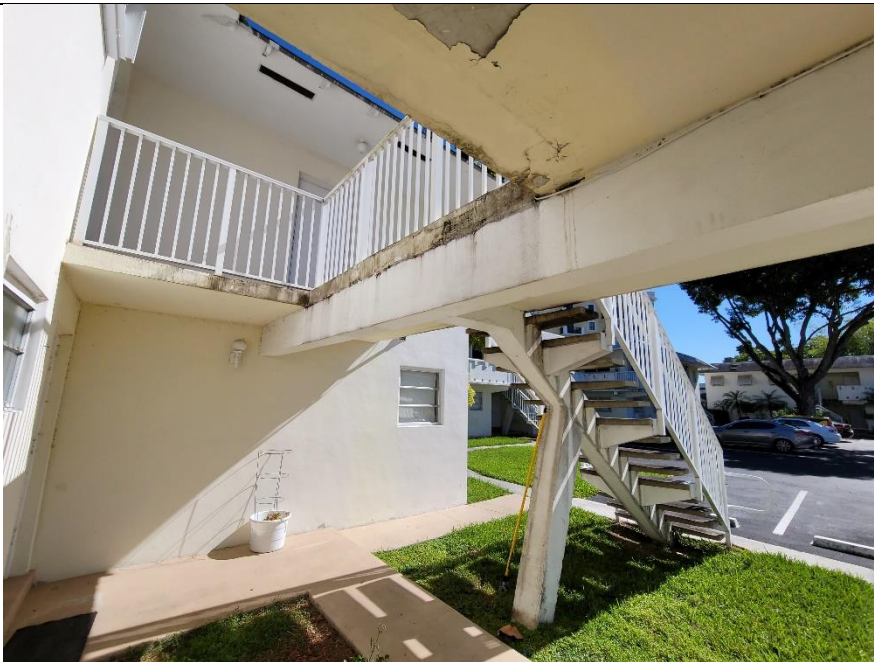
Photo #6:

Staining and vegetation growth was observed at the exposed edges of the concrete beams supporting the catwalks. The members are still sound but maintenance of the paint/waterproofing is required to prevent deterioration of the concrete.

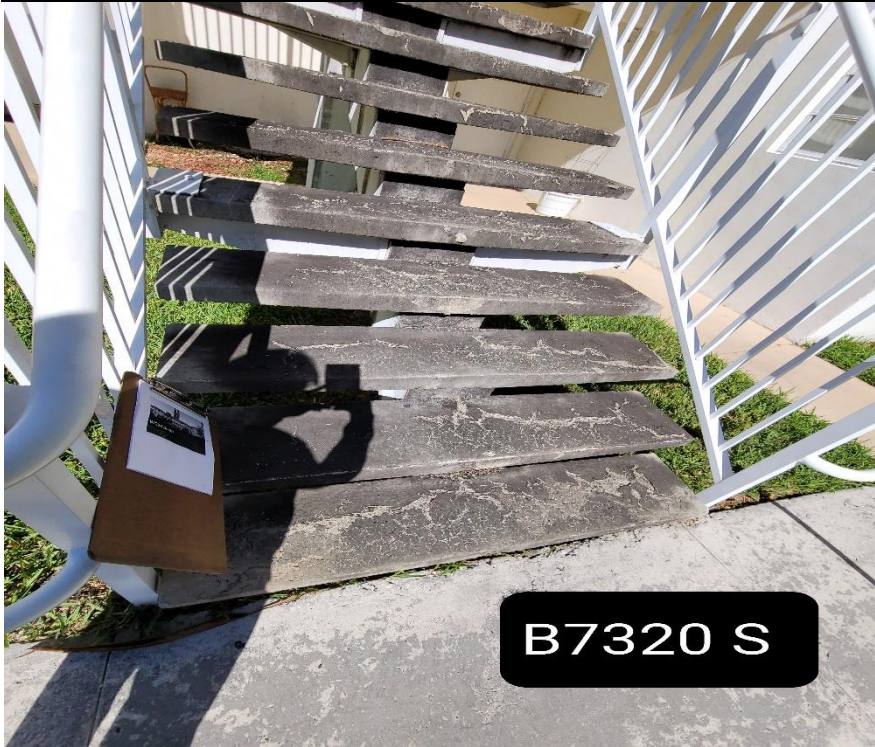
Photo #7:

The precast steps are heavily weathered down and should be replaced in the next exterior repair/maintenance cycle of the building.

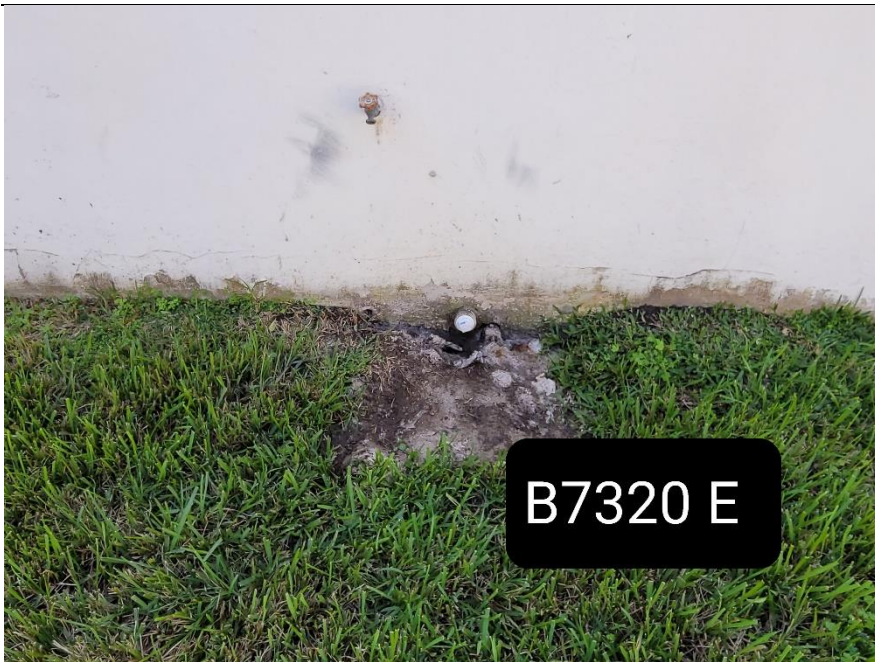
Photo #8:

Miscellaneous wall penetrations should be properly sealed to prevent water infiltration into the building, and/or surface decay of the stucco membrane in the vicinity of the penetration.

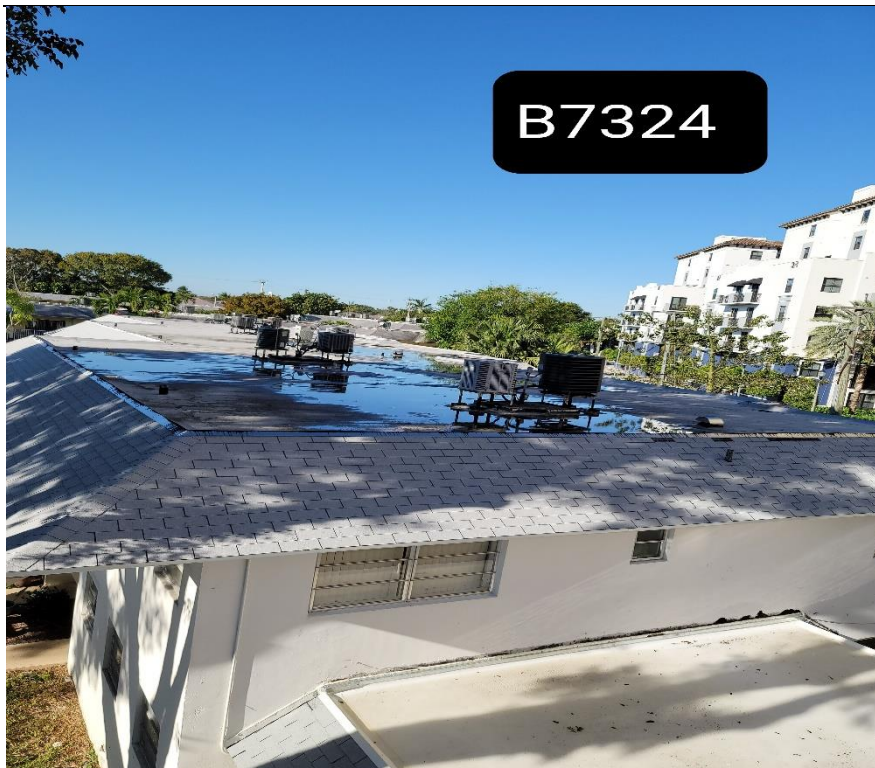
Photo #2:

Water ponding observed on the roof.

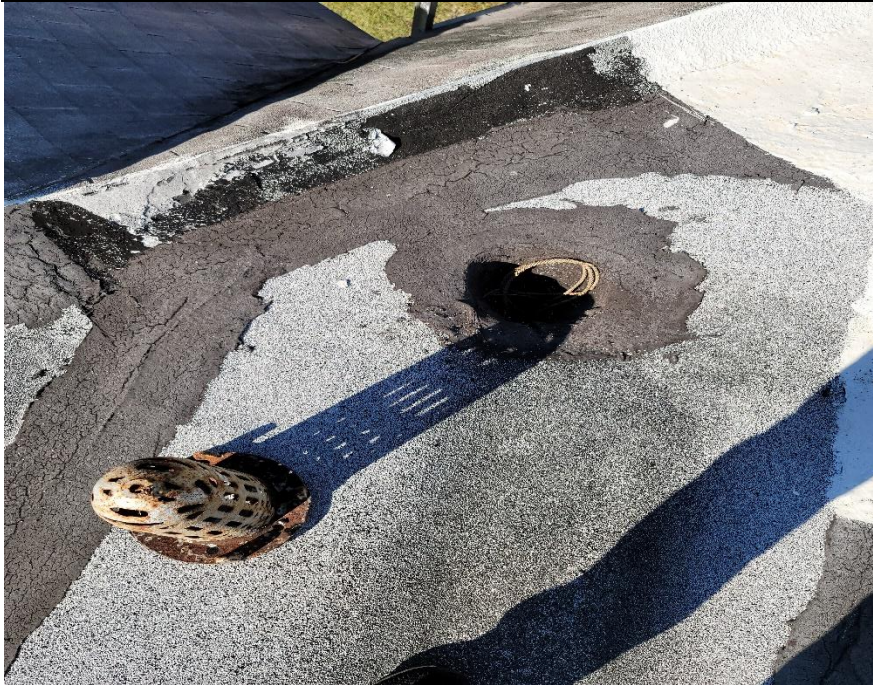
Photo #3:

The strainers for the interior drain lines were found to be rusted or non-functional since many of them are missing or not in their proper position.

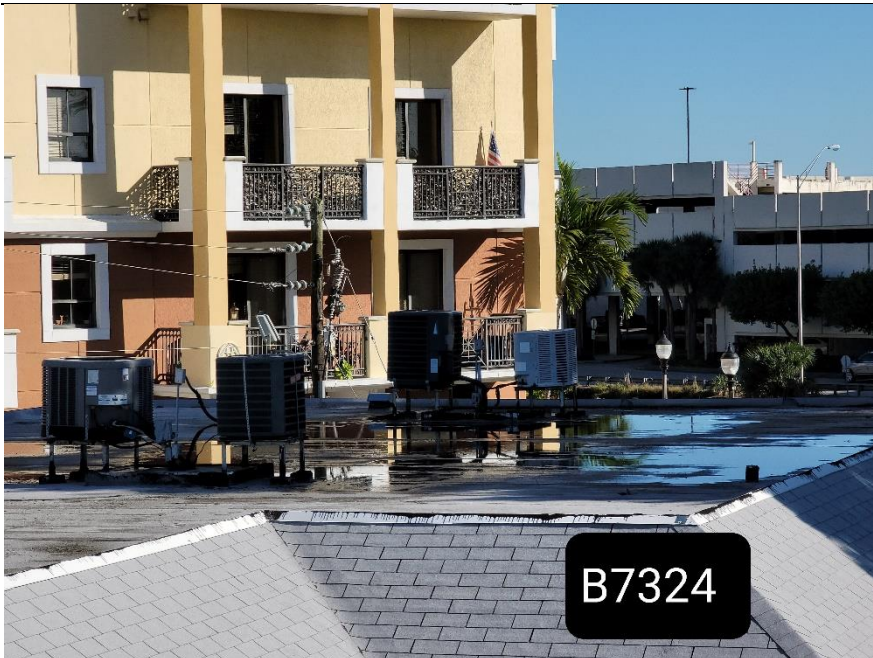
Photo #4:

The bituminous roof membrane was deemed to be in fair condition but sign of weathering/distress are evident.

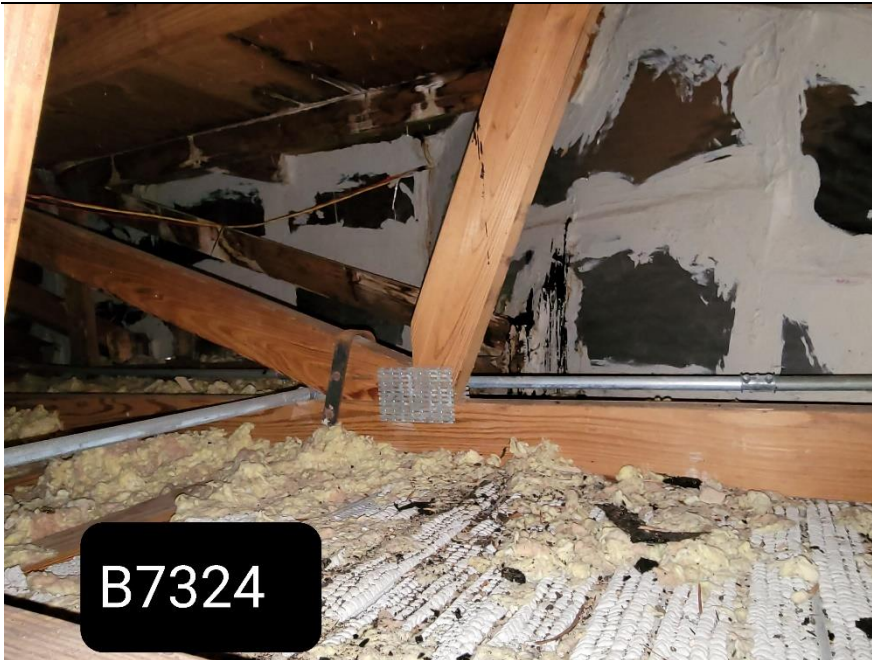
Photo #5:

Where accessible the roof structure was observed and found to be in fair condition.

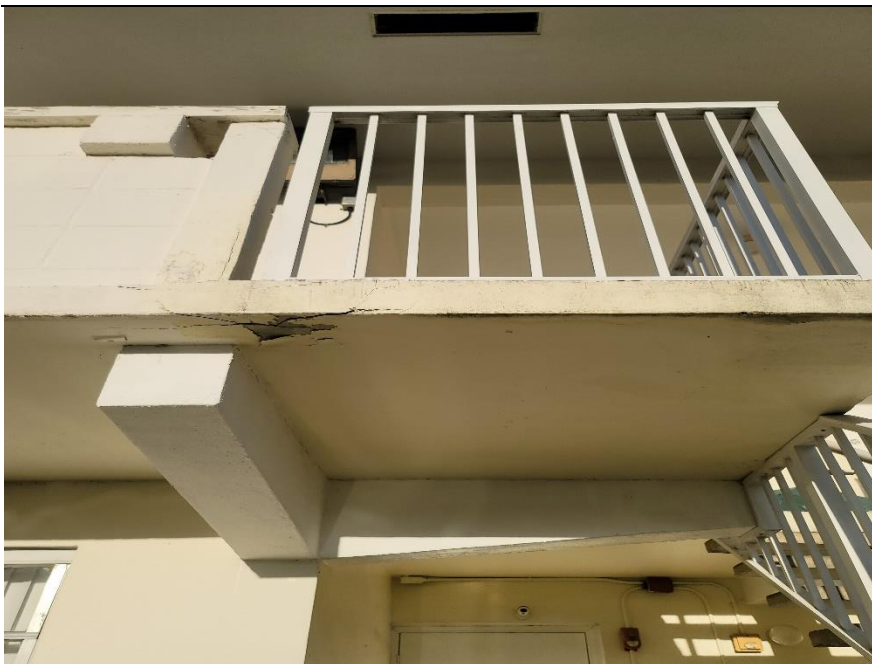
Photo #6:

Cracks and small spalls were observed near the ends of the cantilevered concrete beams.

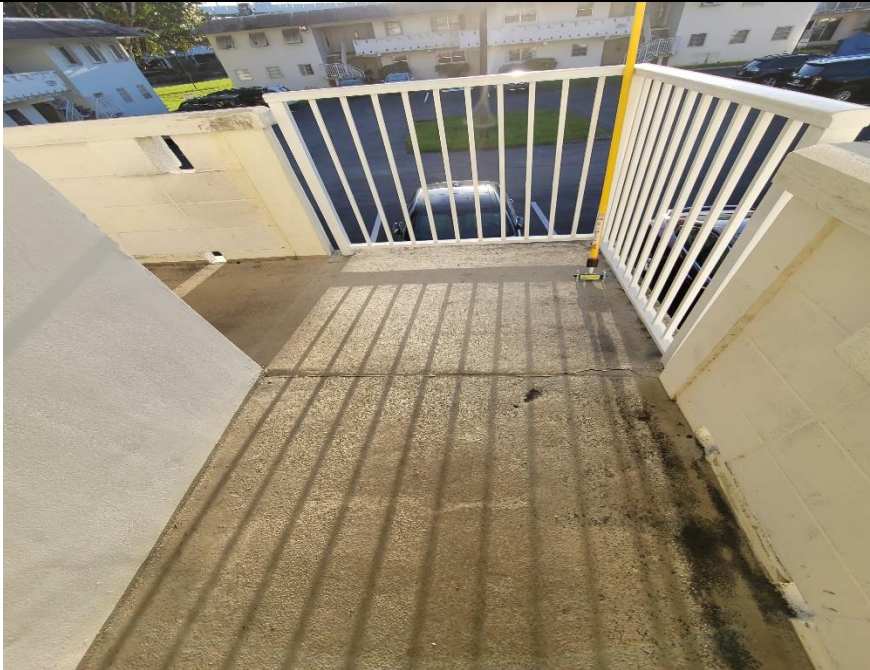
Photo #7:

Cracking and unsound surface areas observed on the catwalk surfaces in the vicinity of the cantilevered beams

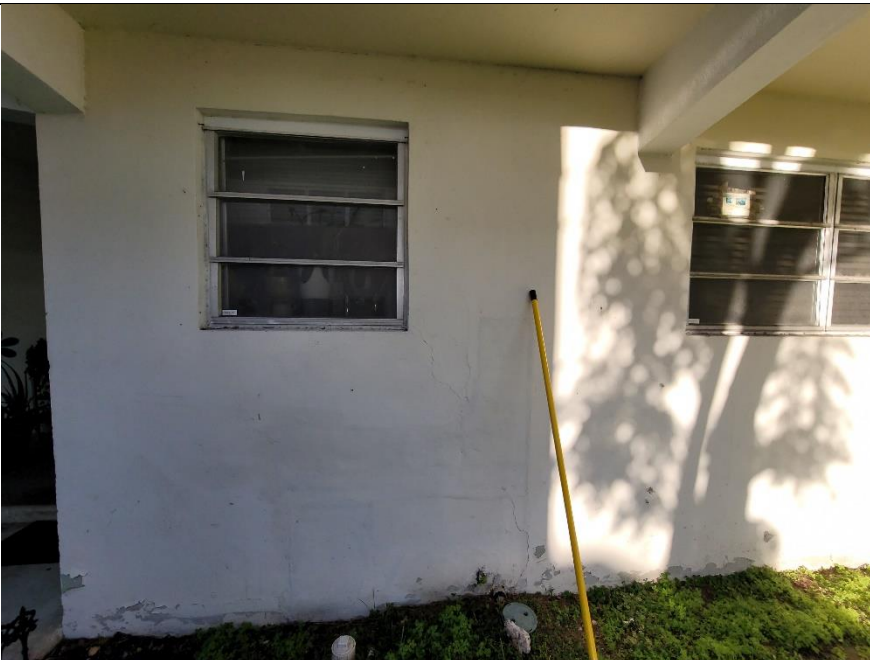
Photo #8:

Miscellaneous penetrations of the exterior walls should be properly sealed to prevent water infiltration into the building and/or surface decay of the stucco membrane in the vicinity of the penetration.

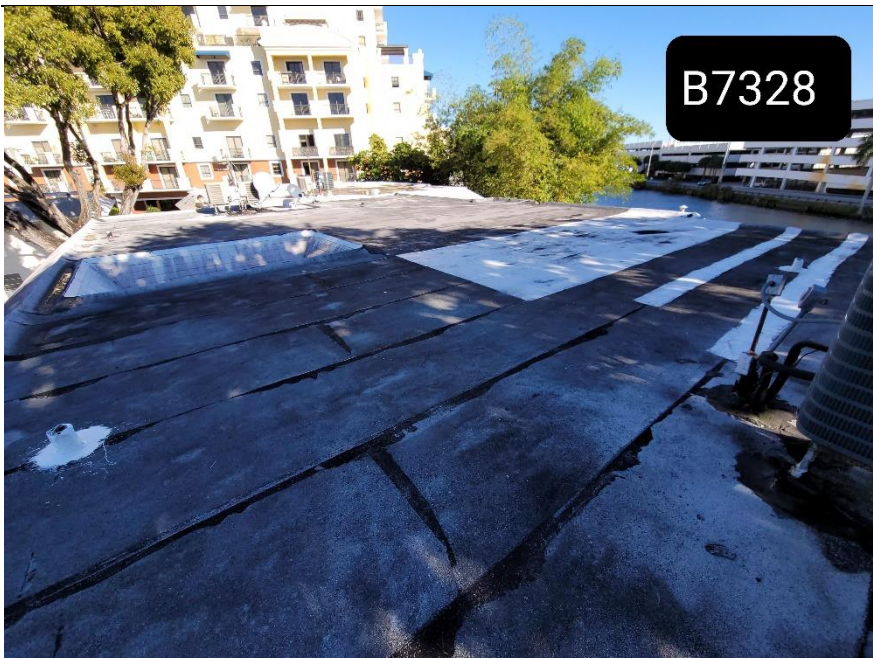
Photo #2:

Water ponding stains observed on the roof.

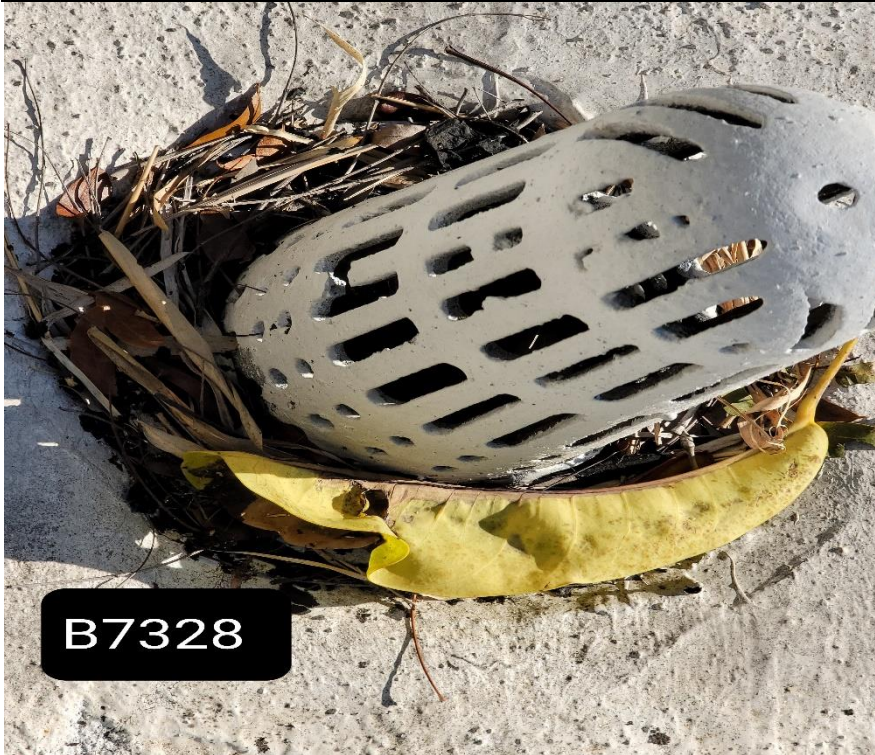
Photo #3:

The strainers for the interior drain lines were found to be rusted or non-functional since many of them are missing or not in their proper position. Others need maintenance to remove debris.

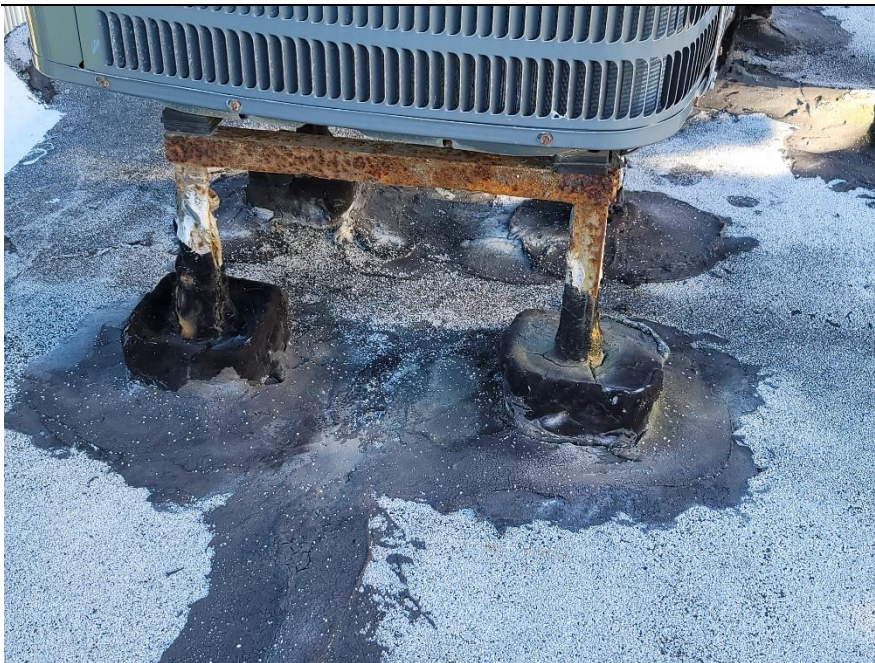
Photo #4:

The bituminous roof membrane was deemed to be in fair condition but sign of weathering/distress are evident.

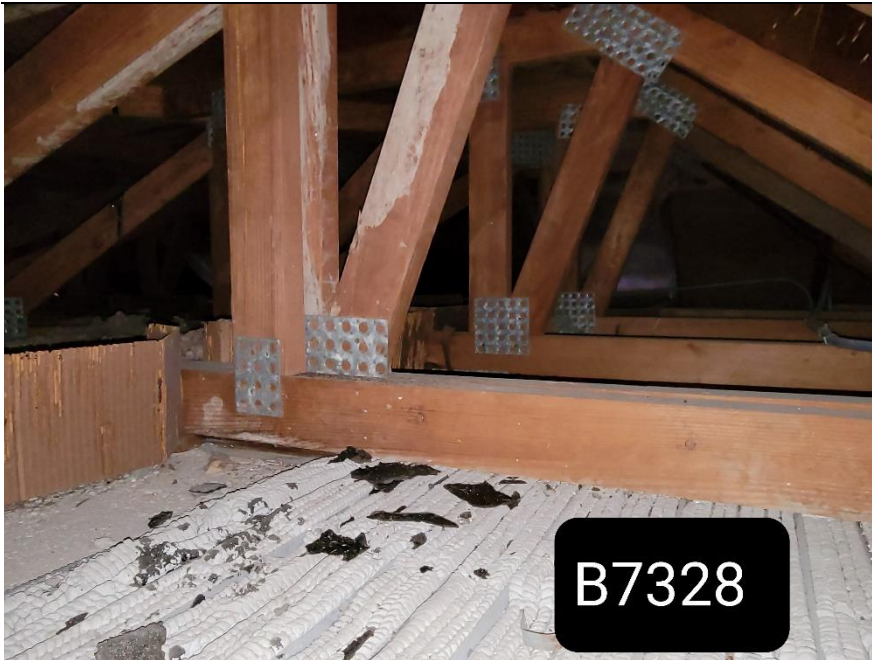
Photo #5:

Where accessible the roof wood structure was observed and found to be in fair condition.

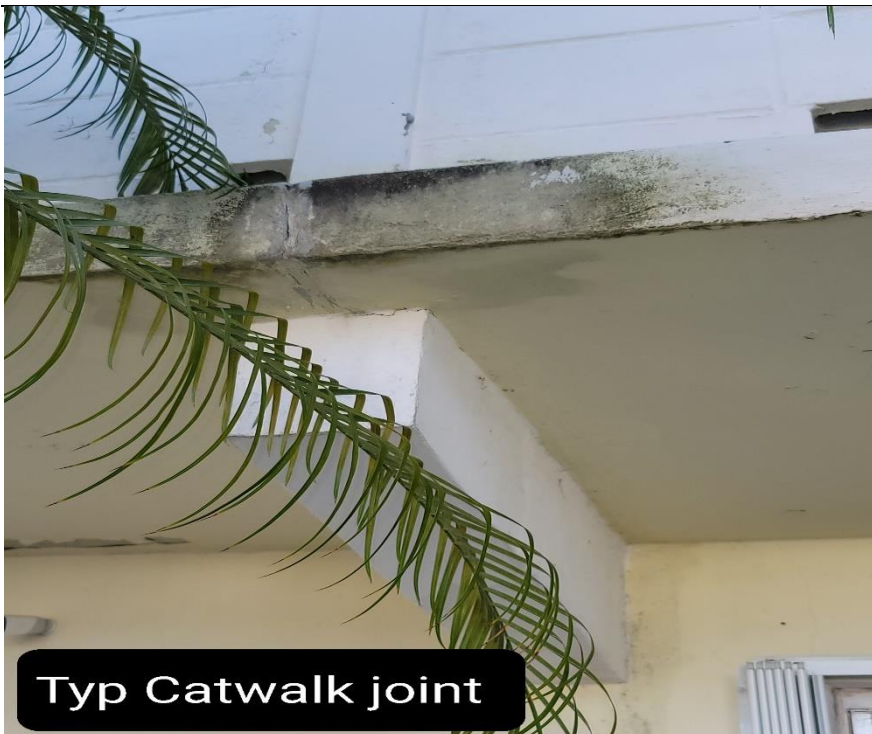
Photo #6:

Cracks and small spalls were observed near the ends of the cantilevered concrete beams.

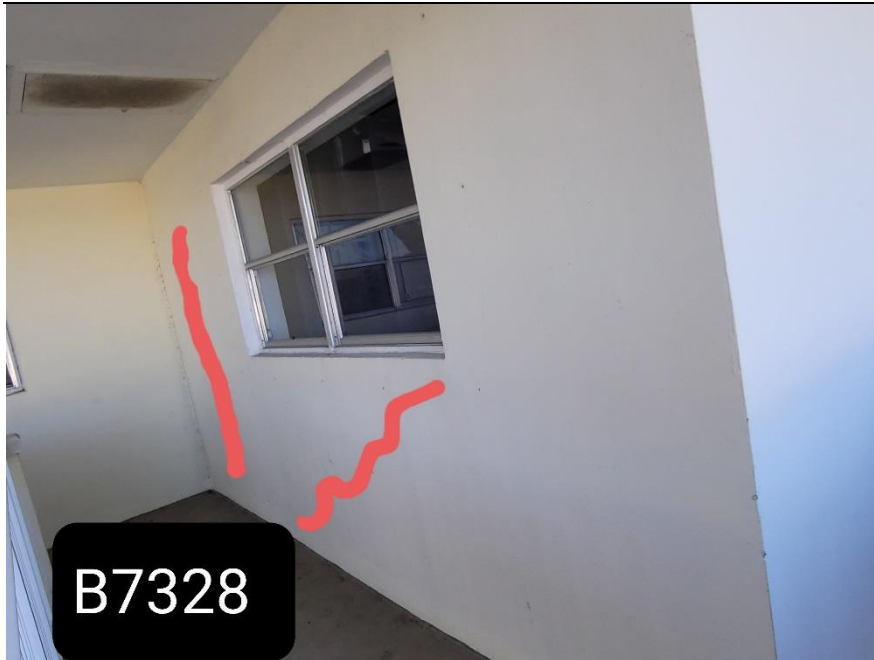
Photo #7:

Fine surfaces cracks observed on the stucco membrane. Areas were sounded and still considered to be sound.

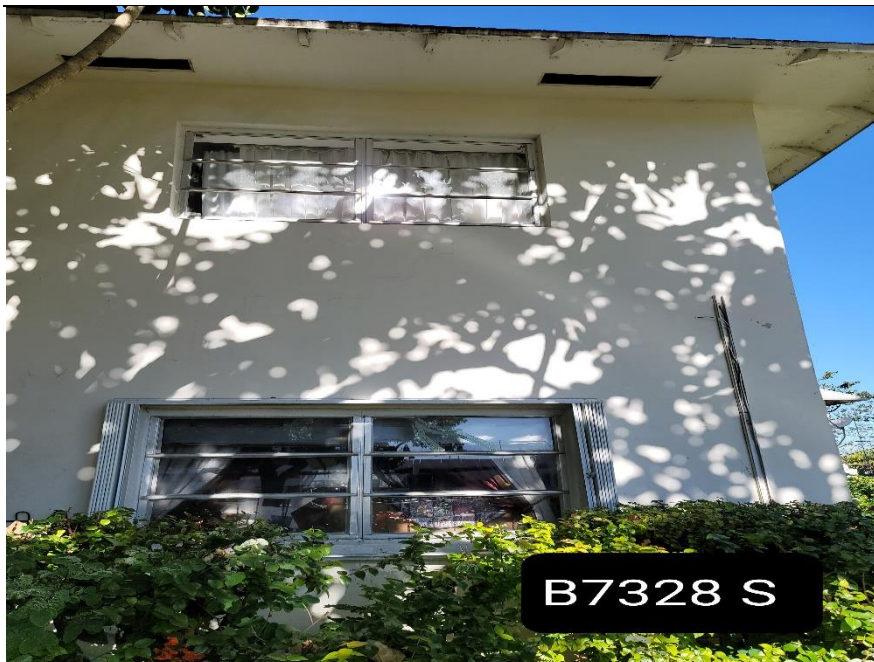
Photo #8:

Step cracks observed between the window lines at the south/east corner of the building.

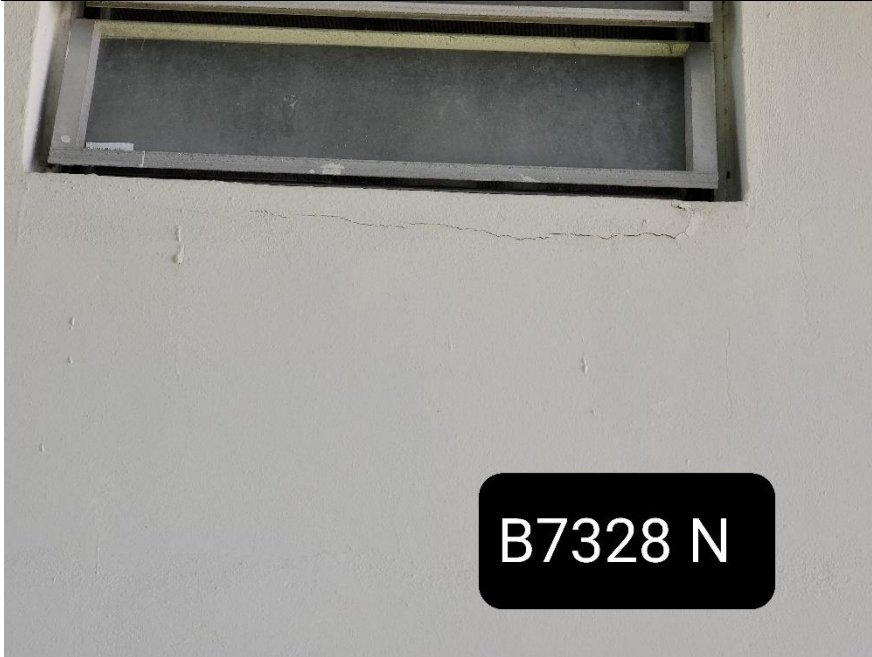
Photo #9:

A small spalled area
underneath the window
observed

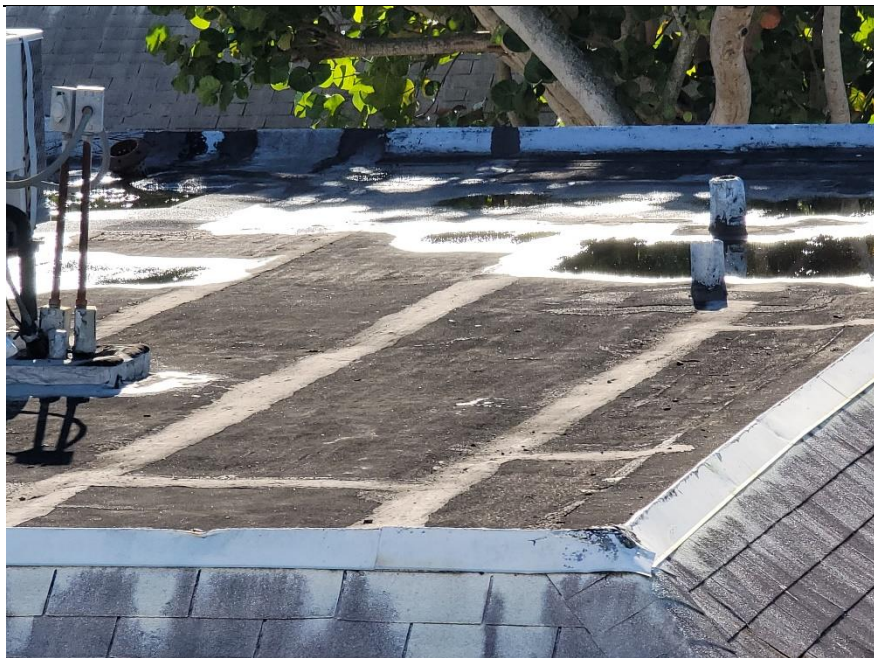
Photo #2:

Water ponding stains observed on the roof.

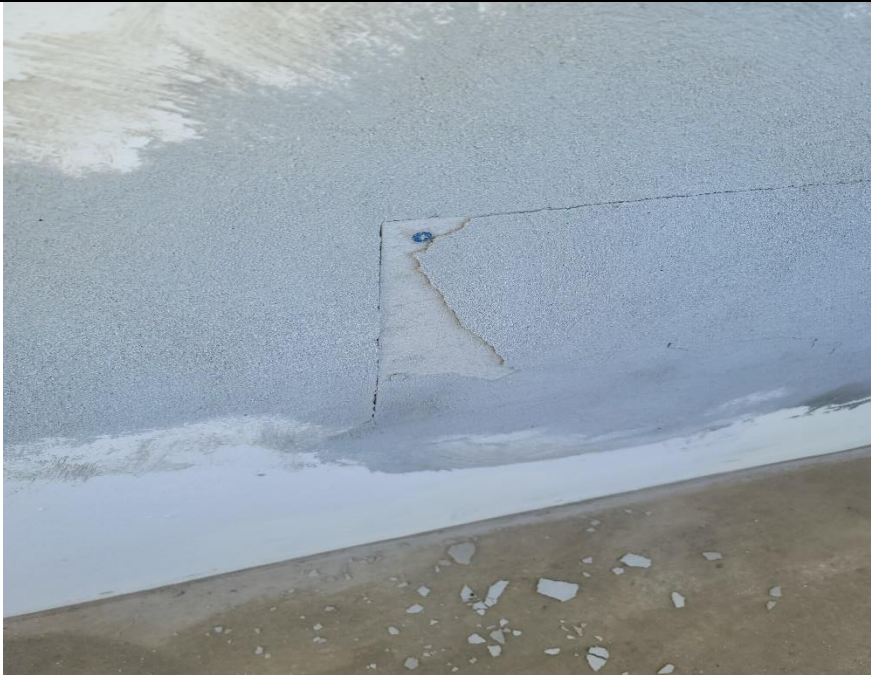
Photo #3:

Previous exterior wall repair/patches observed in the front elevation. The stucco has begun to fall off exposing the wood sheathing beneath. Areas need to be properly repaired to maintain water tightness of the exterior envelope.

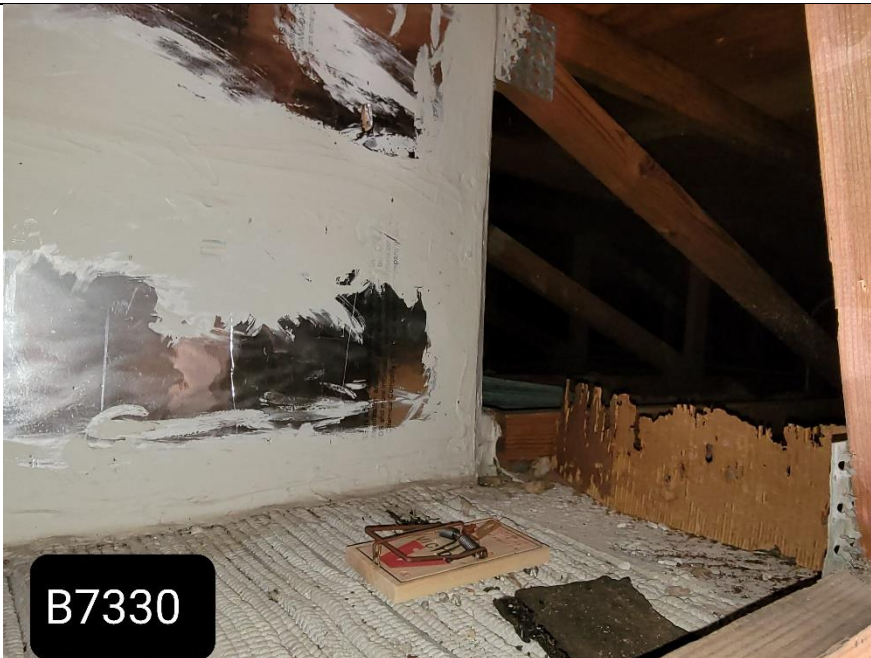
Photo #4:

Where accessible the roof structure was observed and found to be in fair condition.

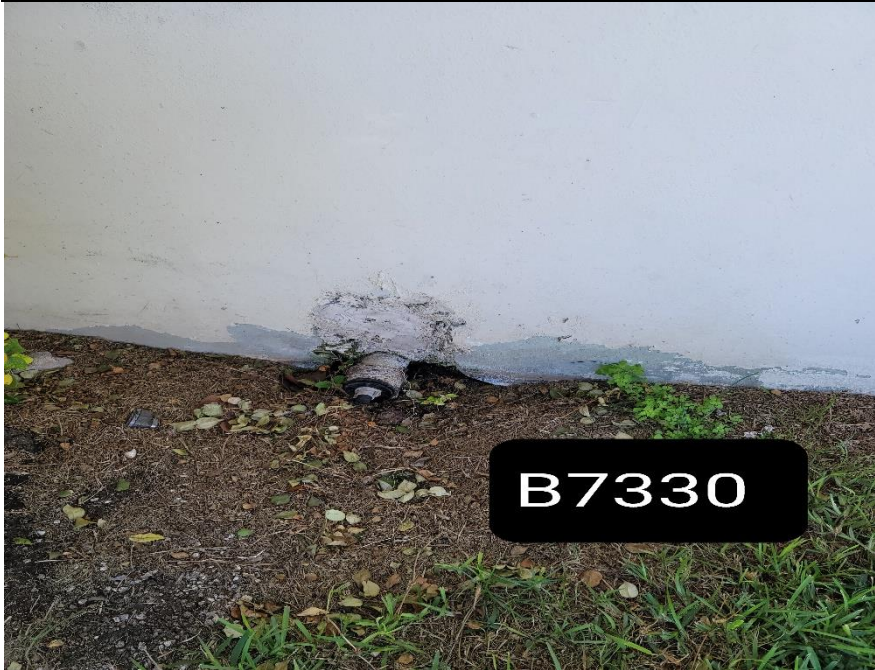
Photo #5:

Miscellaneous penetrations of the exterior walls should be properly sealed to prevent water infiltration into the building and/or surface decay of the stucco membrane in the vicinity of the penetration.

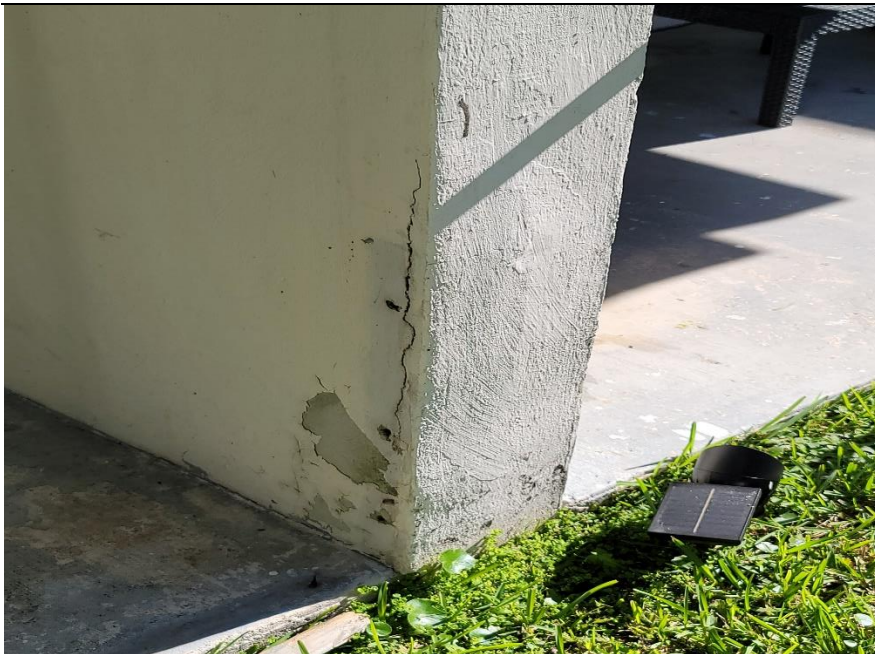
Photo #6:

Some decay/spalling observed at the base of the patio exterior walls.

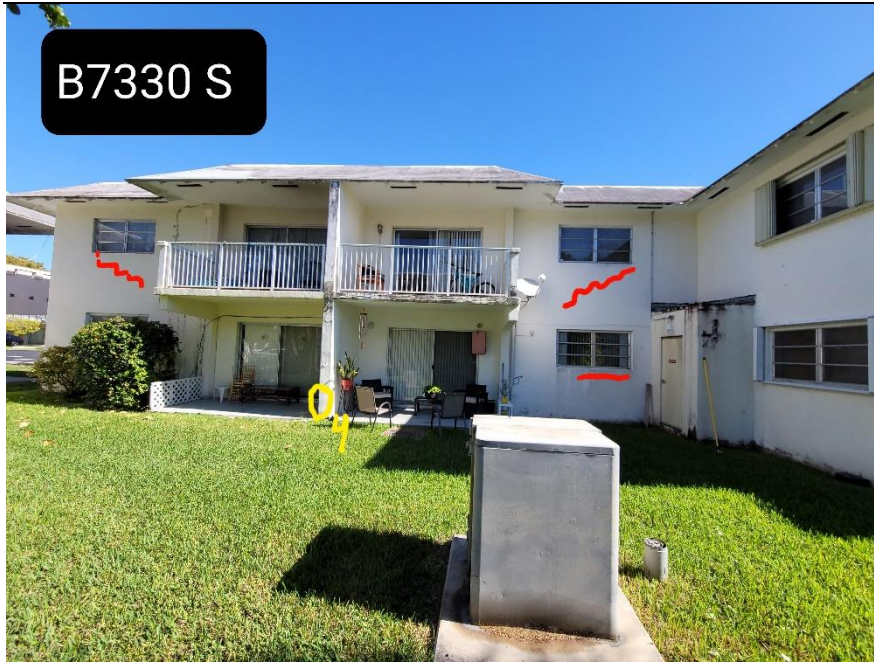
Photo #7:

Fine surfaces cracks observed on the stucco membrane. Areas were sounded and still considered to be sound.

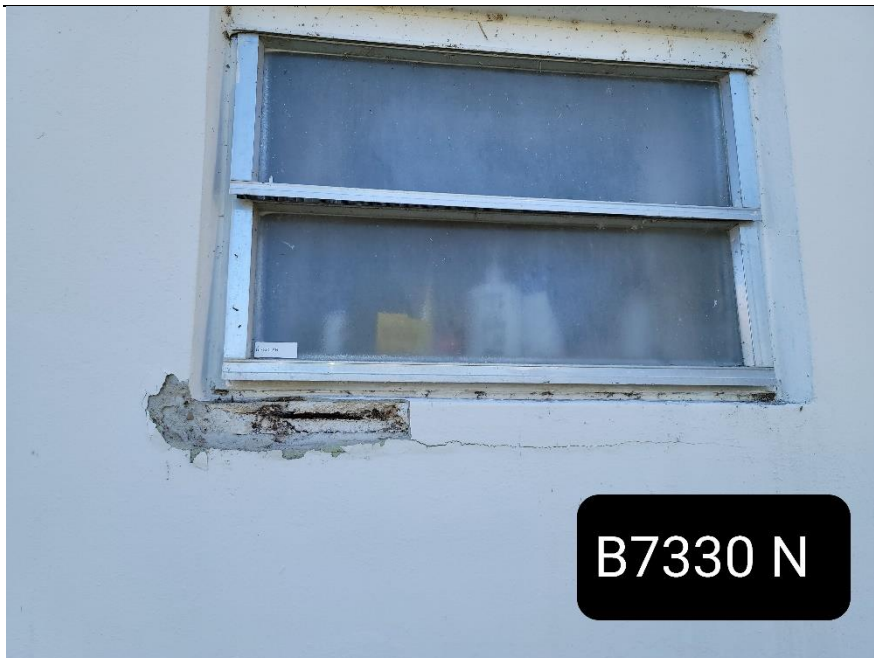
Photo #8:

A small spalled area underneath the window observed. The exposed rebar is heavily corroded
