CONEJOS RIVER

DIVERSION INFRASTRUCTURE INVENTORY

Structure Name: TROGILLIO D

Date: April 15, 2019

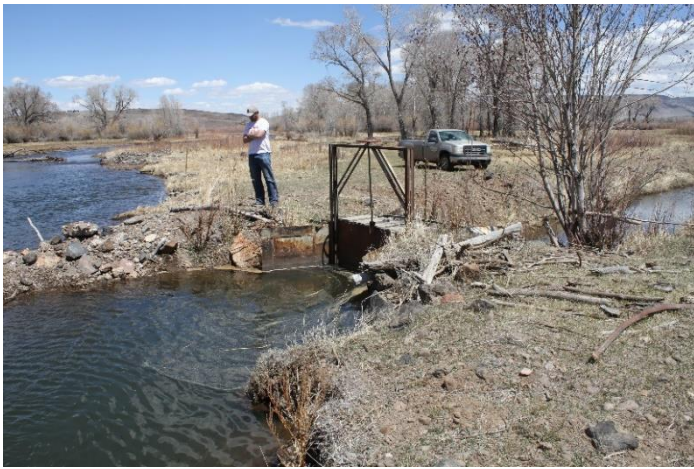
Headgate looking downstream

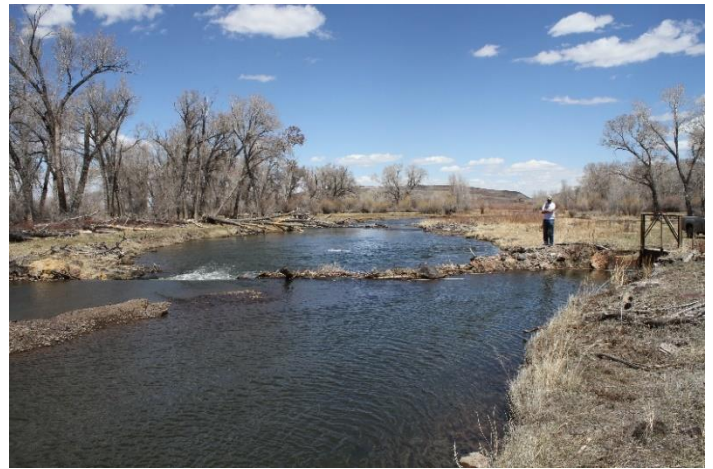
Headgate and diversion dam

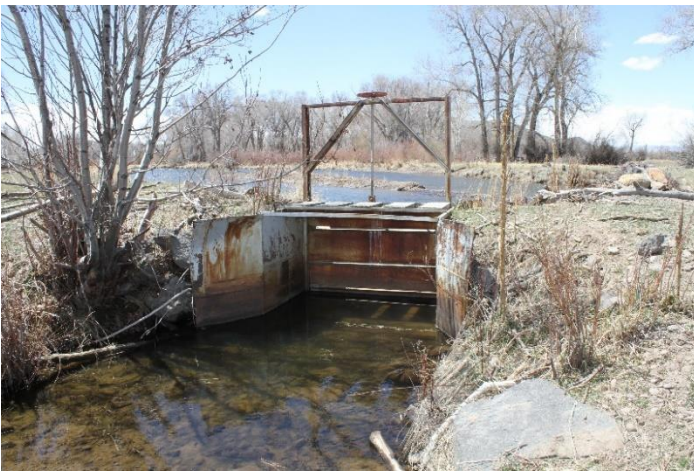
Headgate outlet

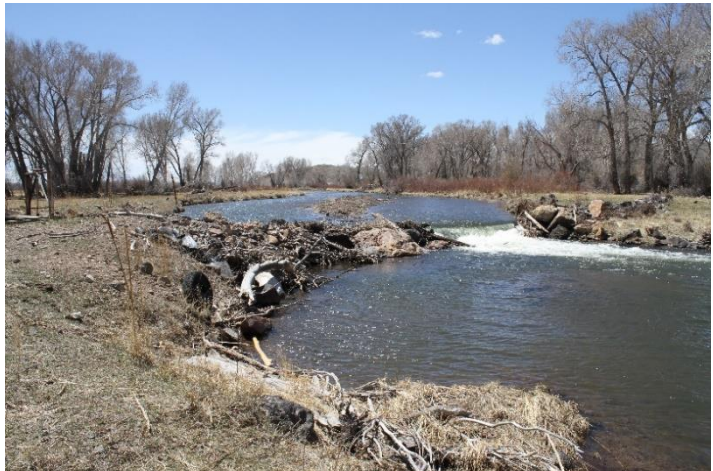
Diversion dam looking upstream

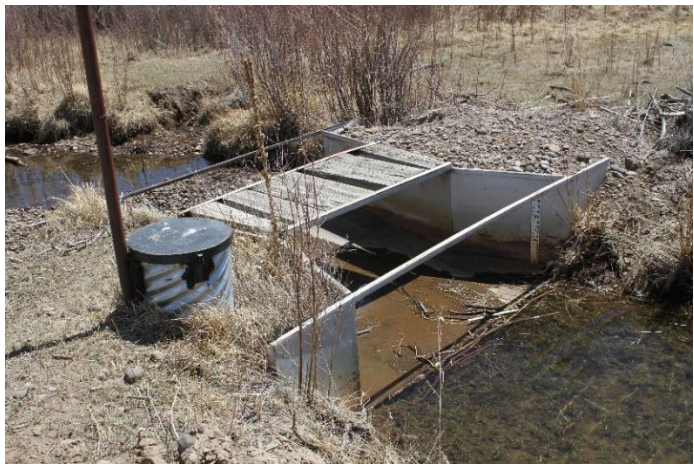
Flume looking downstream

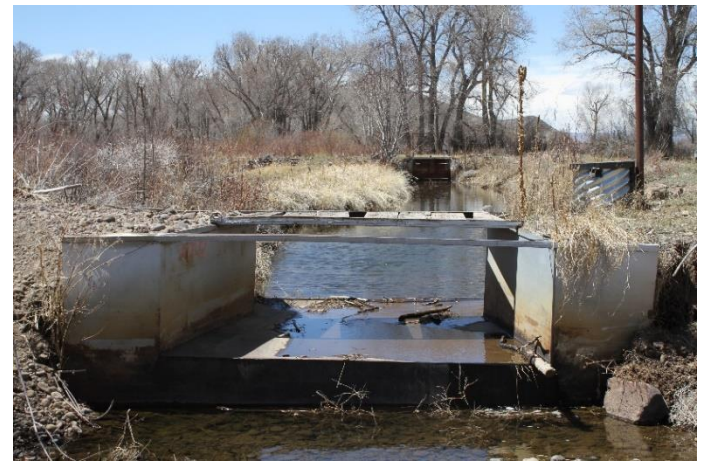
Flume looking upstream
