FULL RESERVE STUDY

3300 Park Avenue Condominium Association, Inc.

Bridgeport, Connecticut

June 7, 2016

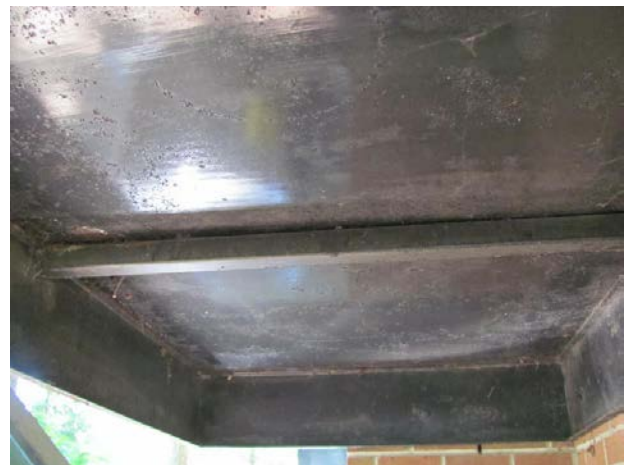
Balconies and Bridges, Metal - The Association is responsible for eight balconies at Building 1, two balconies at Building 2 and two bridges connecting Units 8 and 9 to the garage. The balconies and bridges comprise 510 square feet of decking and 190 linear feet of railings. The balconies and bridges are original and in fair condition. The finishes are in poor condition at an unknown age. We note rust throughout the balconies and isolated areas of significant corrosion.

Balcony underside, note rust at ends

Balconies and bridges of this type have an indeterminate useful life with the benefit of protective paint finishes and partial replacements of deteriorated metal every six- to eight-years. The Association should also anticipate the need for a more extensive restoration to include replacement of the metal decking and railings up to every 45 years. As mentioned previously, homeowners are responsible for paint finishes and repairs to the balconies and bridges. However at the request of Management, we include reserve expenditures for these activities.

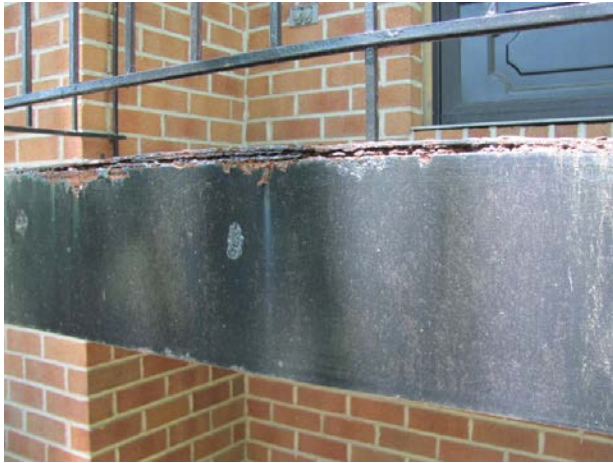
Typical rust

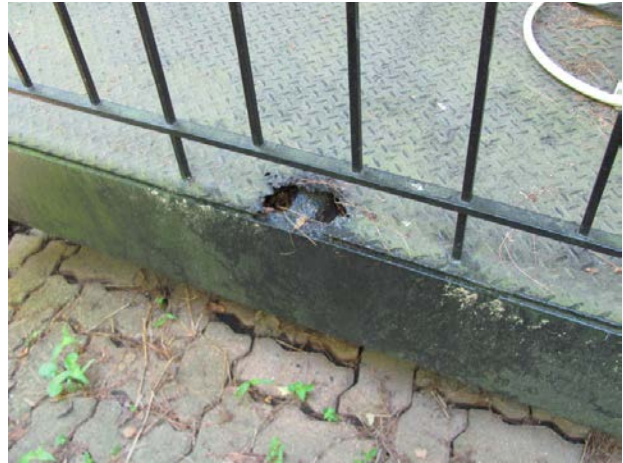
Corroded metal at Building 2

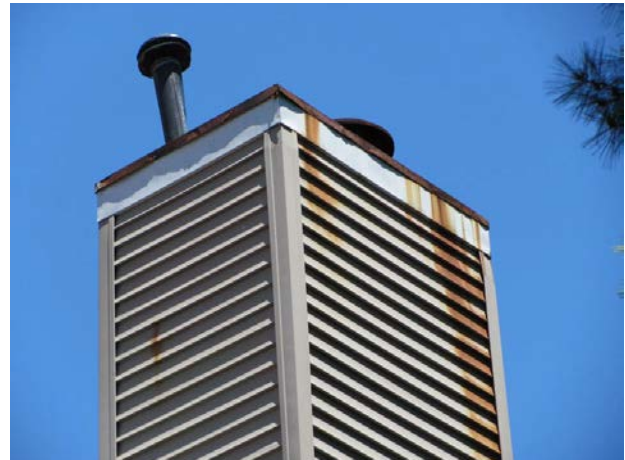
Chimney Caps, Aluminum - 3300 Park Avenue maintains nine aluminum chimney caps. The chimney caps were replaced in 2015 and 2016 and are in good overall condition based on our visual inspection from the ground. The exception is one chimney cap at Building 1 which is original and in poor condition.

Loose chimney cap and significant rust at Building 1

Chimney caps of this type have useful lives of up to 25 years. We recommend the Association anticipate replacement of the chimney caps and related flashing by 2040. We depict this information based on a historical cost provided by Management on Line Item 1.140 of *Reserve Expenditures*. The Association should budget for near term interim replacement of the remaining one chimney cap through the operating budget. We recommend the Association inspect the condition of the chimney caps concurrent with replacement of the roof systems.

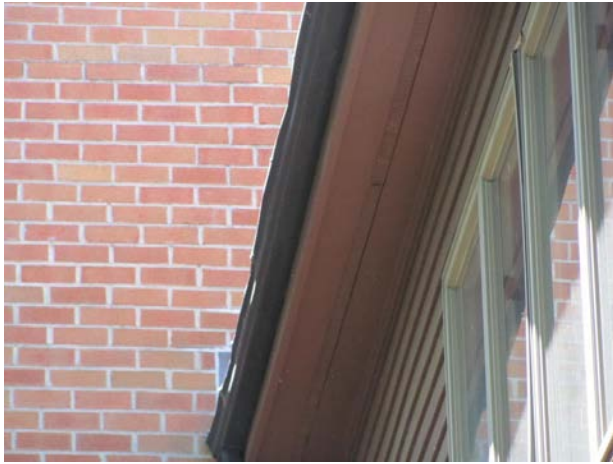
original and in fair to poor overall condition. The gutters and downspouts at Building 2 were replaced in 2008 and are in good to fair condition. The gutters and downspouts exhibit deflection and many locations of dented sections.

Dented aluminum gutter at Building 1

These gutters and downspouts have a useful life of 15- to 25-years. We include the following solutions and procedures for gutter and downspout maintenance and replacements for present and future board members.

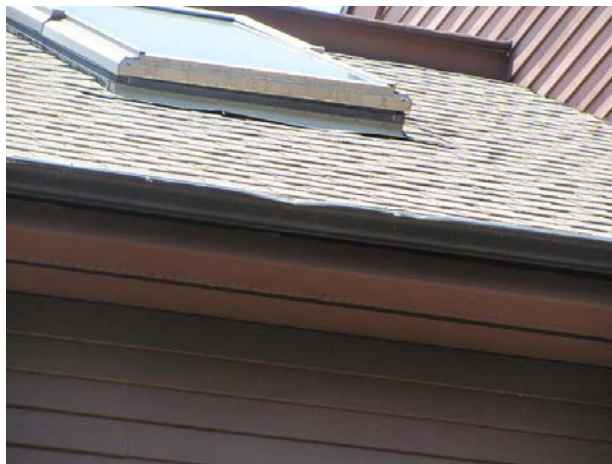
Dented gutter at Building 3

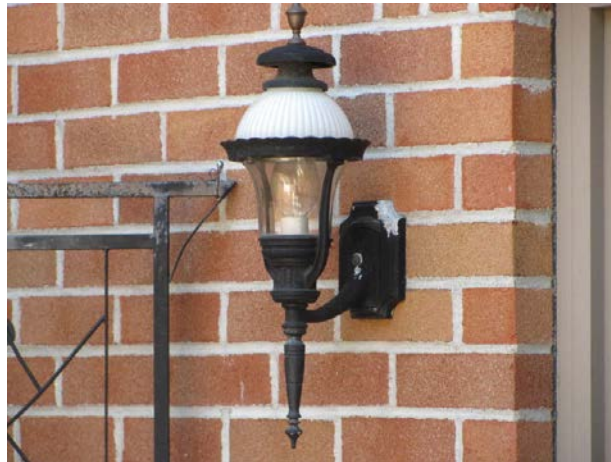
Light Fixtures - 3300 Park Avenue maintains approximately 80 exterior wall mounted aluminum light fixtures with incandescent bulbs to accent the garages, and the front and rear entries. Many light fixtures are original and in fair overall condition. However, the Association recently replaced a portion of the light fixtures. We note finish deterioration and loose components.

Finish deterioration

The useful life of exterior light fixtures of this type and quality is up to 25 years. We recommend the Association plan for a phased replacement of the light fixtures beginning by 2019 and concluding by 2034. A subsequent phased replacement is likely beginning by 2044. The Association should aggregate the replacement of the light fixtures to ensure their availability and to maintain aesthetic continuity throughout the community. We include this information on Line Item 1.260 of *Reserve Expenditures*. Our cost does not include an allowance for replacement of electrical wiring.

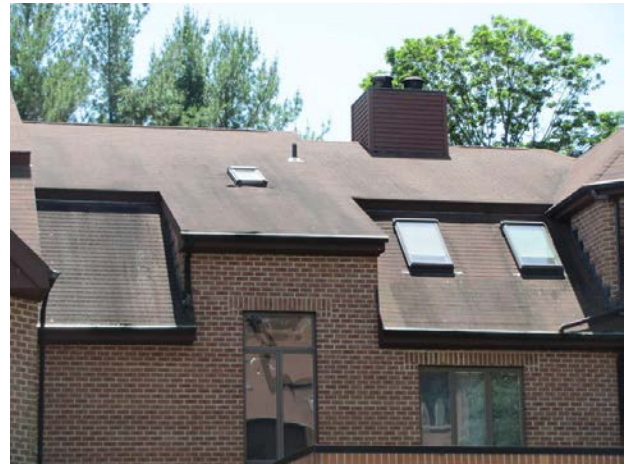
Our visual inspection from the ground notes granular loss at shingles, and lifted and weathered shingles.

Weathered shingles at older roofs at Building 1

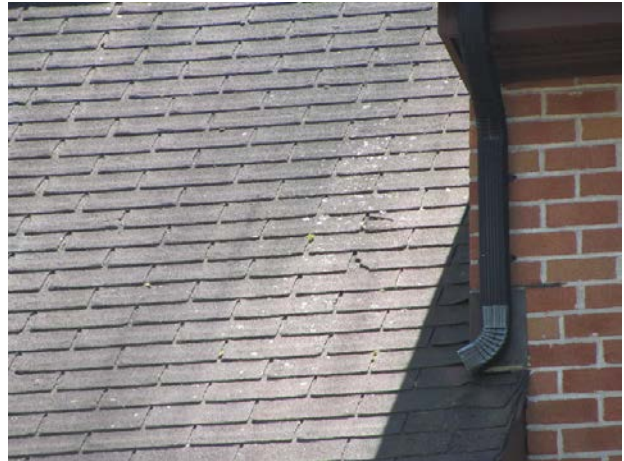
Granular loss and cracked shingles at Unit 2 at Building 1

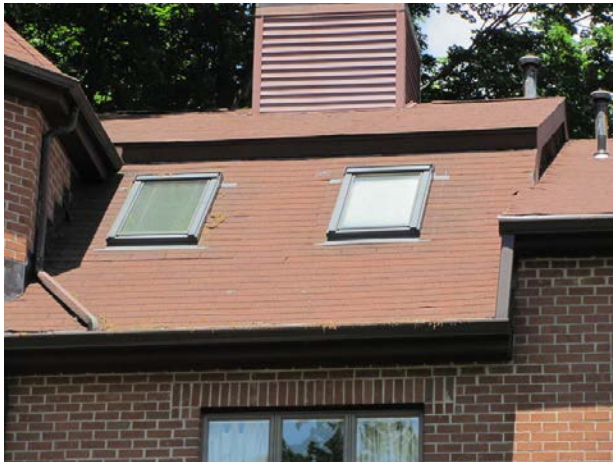
Partial shingle replacements and lifted shingles at Building 2

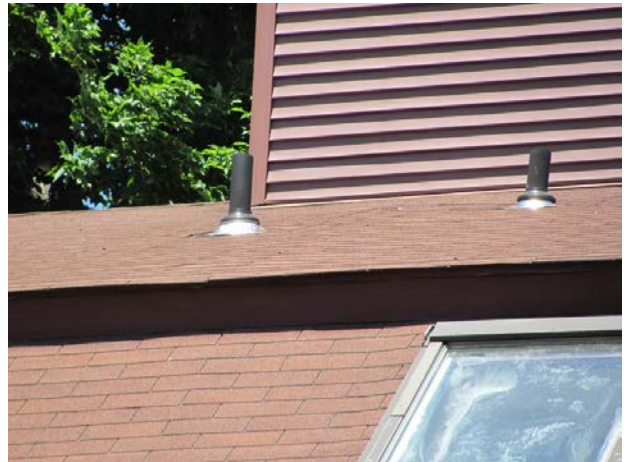
Sheathing deflection evident at Building 2

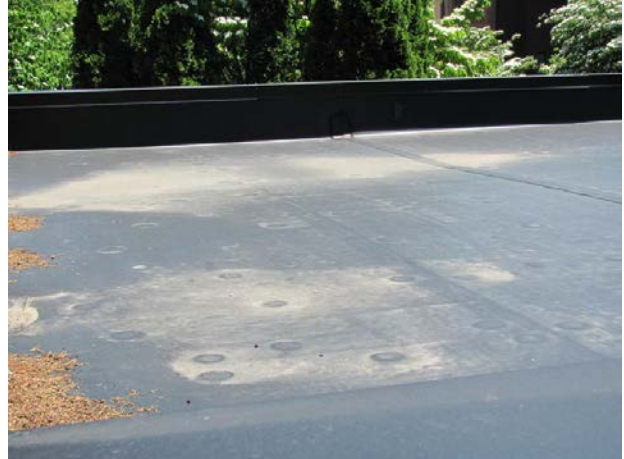
a history of leaks. Our visual inspection notes evidence of standing water. However, we were unable to visually inspect each roof at the time of our inspection.

Standing water evident at garage for Units 27 and 28

The time or need to replace the roofs becomes apparent with multiple or recurring leaks. The Association should determine whether the origin of the leaks is from the membrane or flashings. Repairs of the flashings may be more cost-effective than replacement of the entire roof. However, because of the difficulty in finding several or many breaks in a roof, replacement eventually becomes the more economical option rather than repair. We recommend 3300 Park Avenue prepare for a complete tear-off at the time of a phased replacement beginning by 2023 and concluding by 2033. A subsequent phased replacement is likely beginning by 2043. We depict this information on Line Item 1.380 of *Reserve Expenditures*. The Association should monitor outside vendors when they service any elements on the roofs to minimize unreported roof damage.

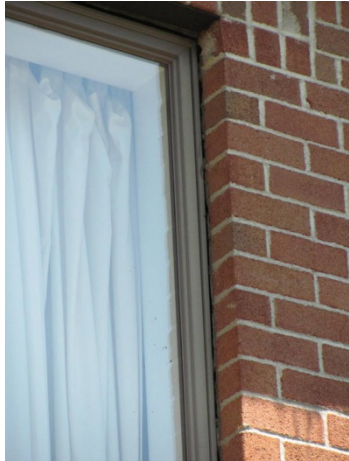
Sealants, Windows and Doors - The perimeters of the window and door frames use approximately 7,600 linear feet of exterior sealants or *caulk*.³ Sealants are flexible, allow for differential movement between dissimilar materials and prevent water infiltration into the building. The sealants vary in age and condition. We note sealant cracks and adhesion failure.

Adhesion failure at sealant

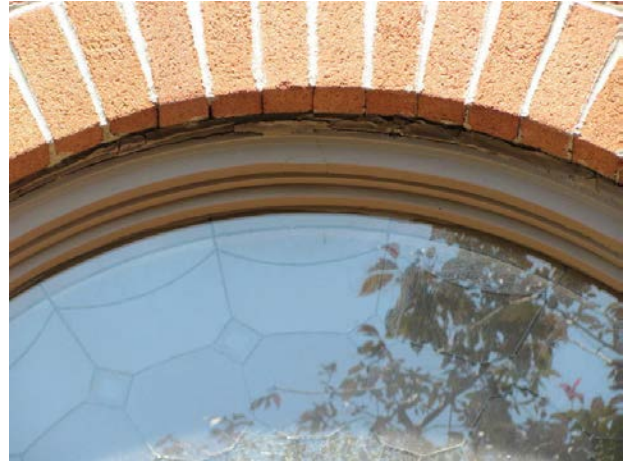
Sealant cracks

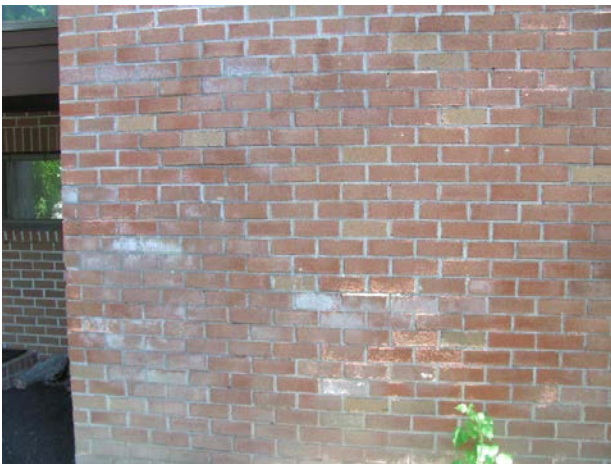
Efflorescence

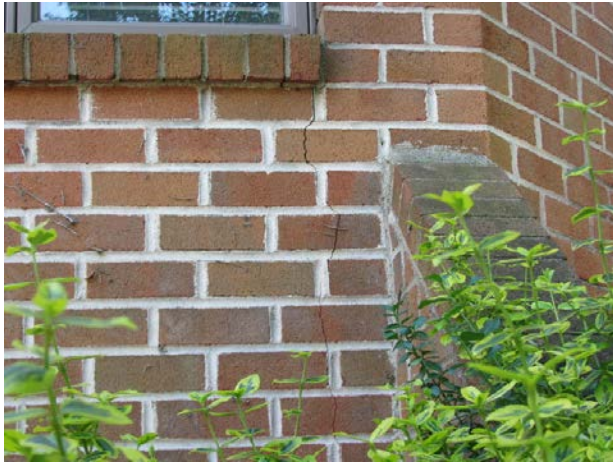
Masonry crack at Unit 1

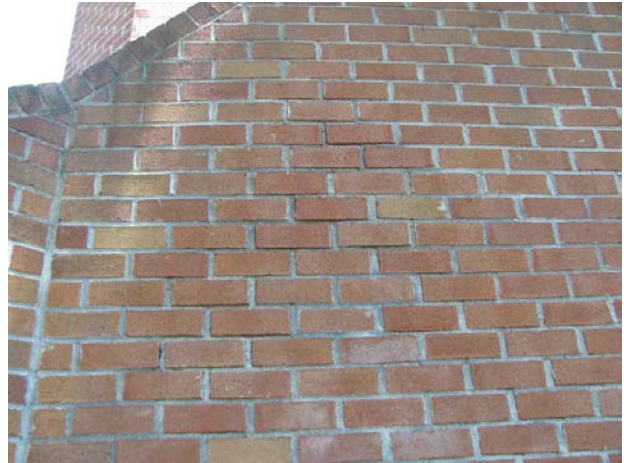
Mortar deterioration

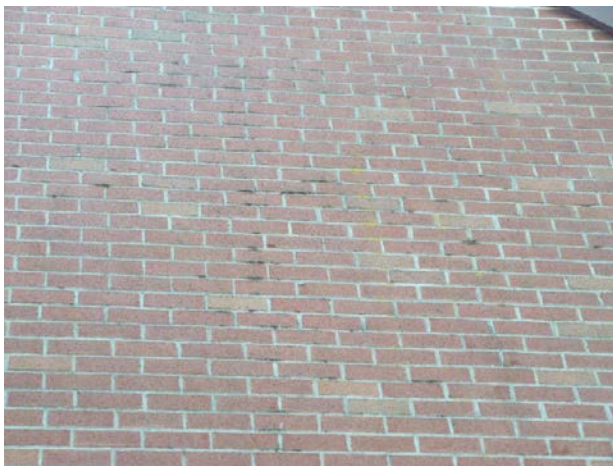
Mortar deterioration

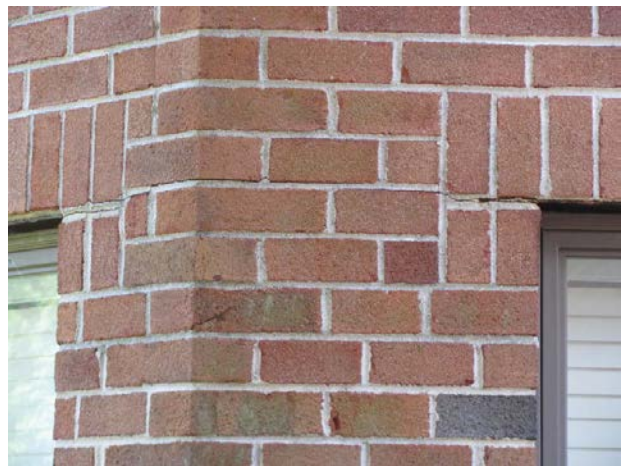
Mortar cracks

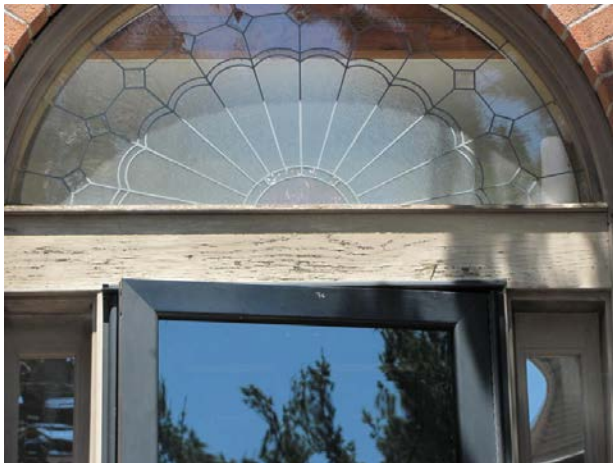
Walls, Wood Siding, Paint Finishes - The buildings include paint finish applications on the 17,100 square feet of wood siding, trim, soffit and fascia. Periodic application of a protective finish of paint or stain is an essential maintenance activity to maintain the physical appearance and integrity of these elements. The Association finish is in fair condition at an unknown age. We note peeling and faded paint finish, especially at south facing elevations.

Chipped paint at wood trim

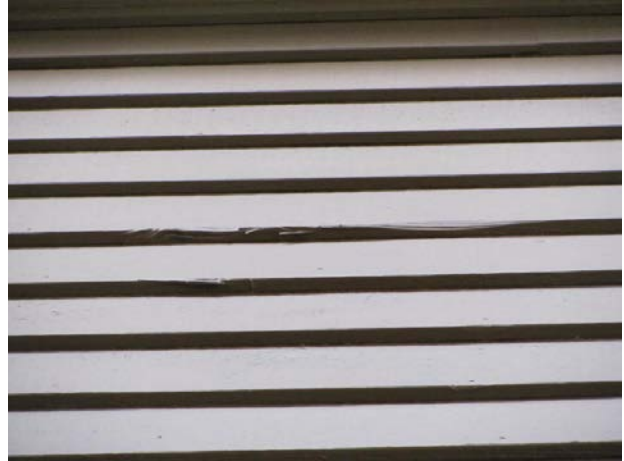
soffit and fascia. The siding is primarily original and in fair overall condition. The siding exhibits loose pieces, wood rot, and warped and weathered siding.

Wood rot

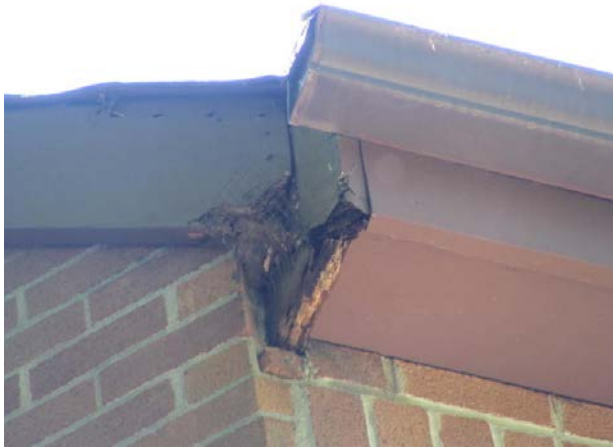
Wood rot at soffit and fascia

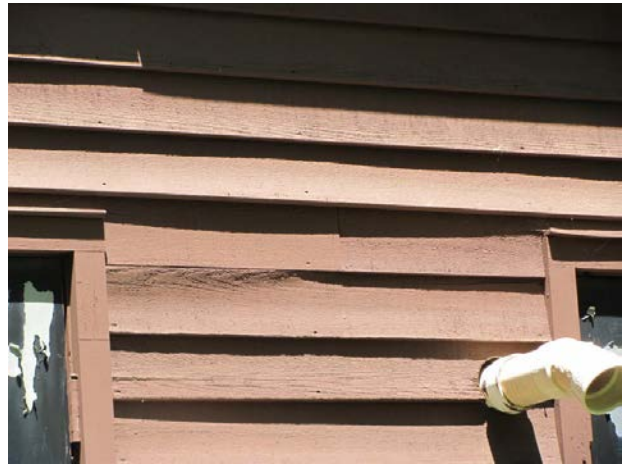
Warped wood siding

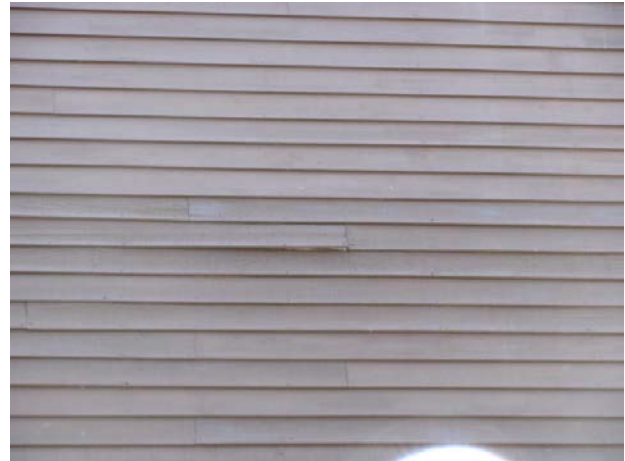
Loose siding

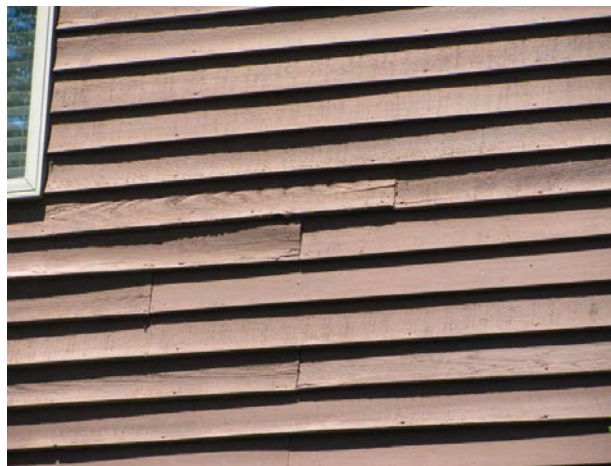
Weathering near joints/fasteners

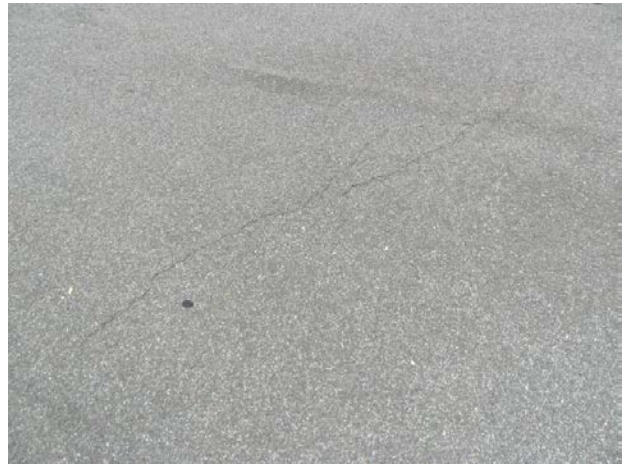
overall condition. We note isolated cracks and deterioration adjacent to catch basins and manholes.

Minor crack

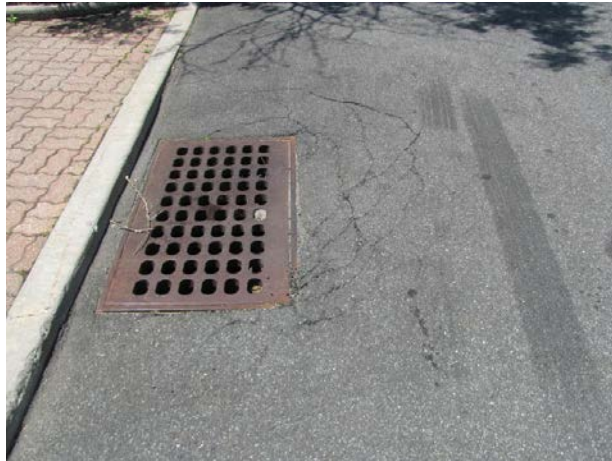
Alligator cracks adjacent to catch basin

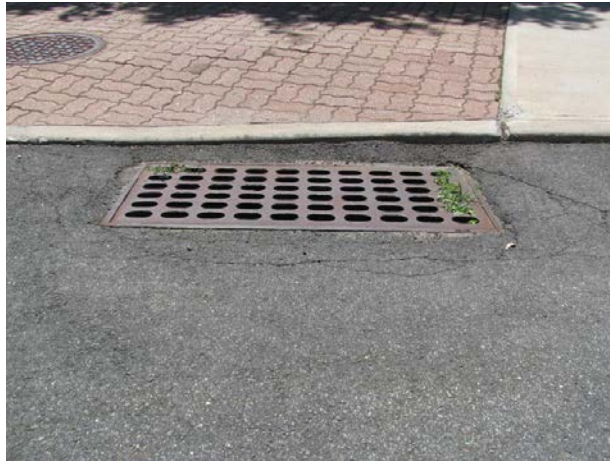
Catch Basins - The six catch basins collect storm water from the pavement and conduct it into the storm water system. The overall condition of the catch basins is good to fair with settlement visually apparent.

Settlement at catch basin

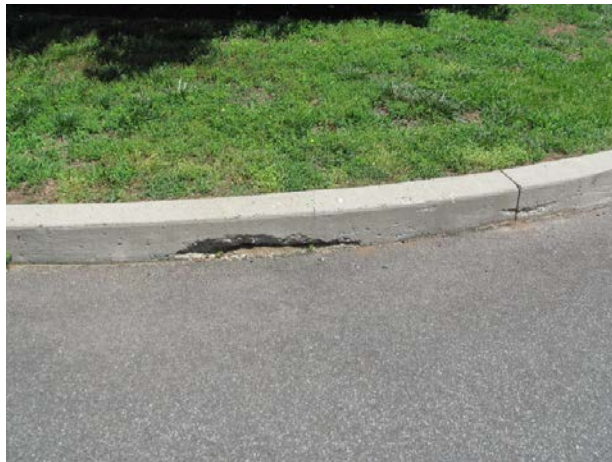
Concrete Curbs - Concrete curbs line the pavement of 3300 Park Avenue. These curbs comprise 1,400 linear feet and are in good condition overall. A majority of the curbs were replaced in conjunction with the asphalt pavement in approximately 2012 or 2013. We note isolated spalled concrete and damage.

Spalled concrete curb

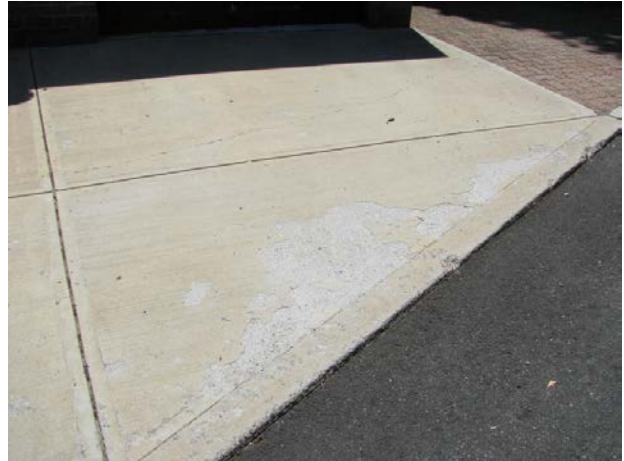
Concrete Driveways - Concrete driveways of varying sizes and configurations allow for access to the individual residences throughout the Association. The driveways were all replaced in approximately 2012 or 2013, are in good overall condition and comprise approximately 3,250 square feet. We note isolated cracks and spalled concrete.

Concrete spalls at Units 1 and 2

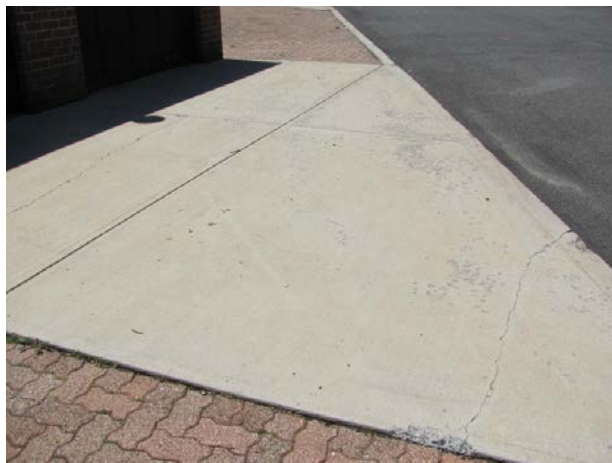
Cracks and spalls at Units 3 and 4

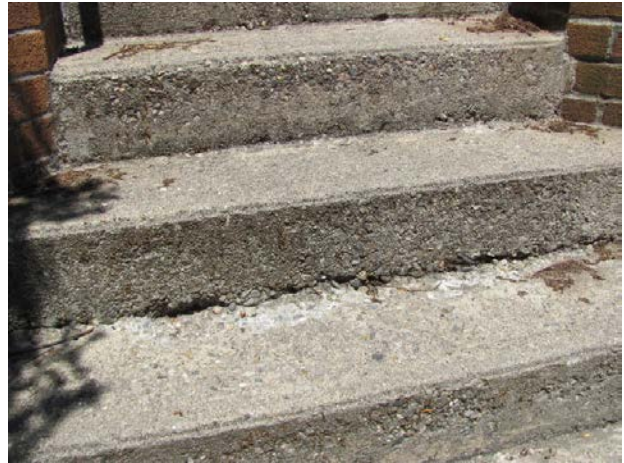
Concrete Stairs and Stoops - The units at the property are accessed either by cast on ground concrete stairs or concrete stoops. The 250 stairs comprise 1,500 linear feet of nose, and stoops and landings comprise 1,100 square feet. The stairs and stoops vary significantly from good to poor condition. We note significant concrete spalls and deterioration at a limited number of units.

Spalled concrete stairs at Unit 36

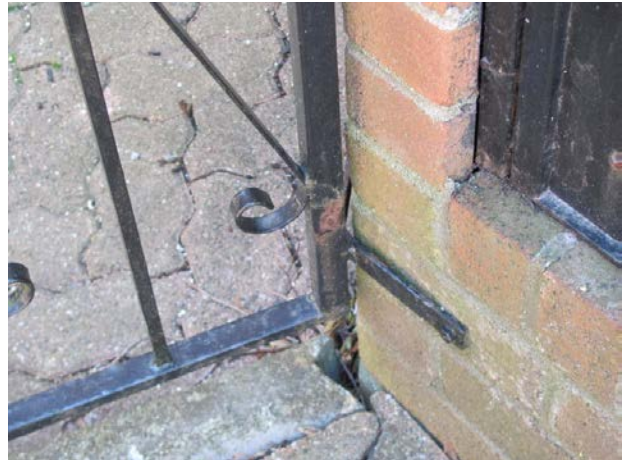
Fences and Handrails, Steel - Approximately 240 linear feet of steel fences and 280 linear feet of steels handrails are found at the front of the units. The fences and handrails are original and in fair condition. We note rust and corrosion, and loose connections.

Rust

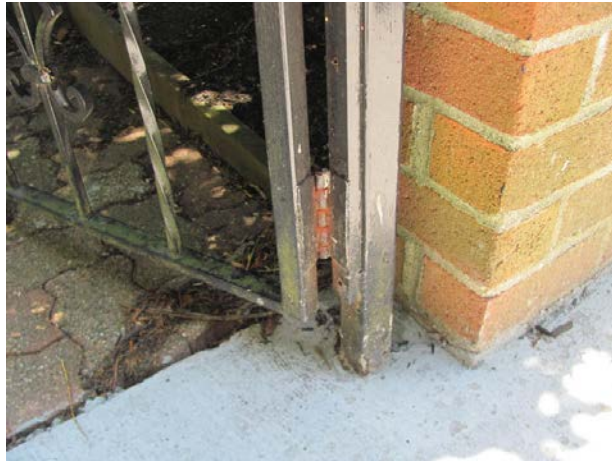
Rust at post and hinge

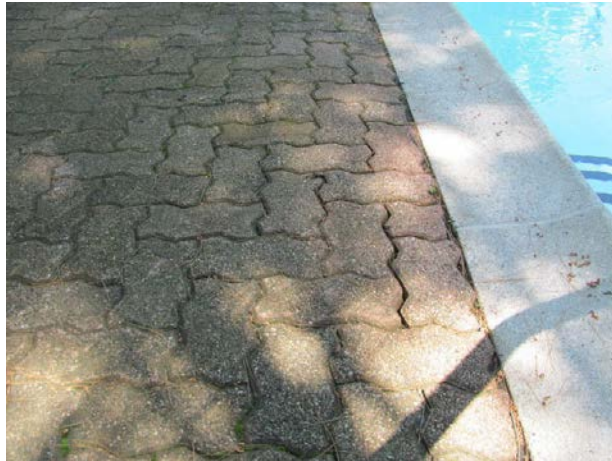
Deck, Pavers - Brick pavers surround the pool and comprise approximately 1,650 square feet. The deck is likely original and in fair condition. The Association completes partial resetting and replacements as needed, and most recently completed partial resetting of the pavers in 2015. We note organic growth and settlement.

Settlement evident

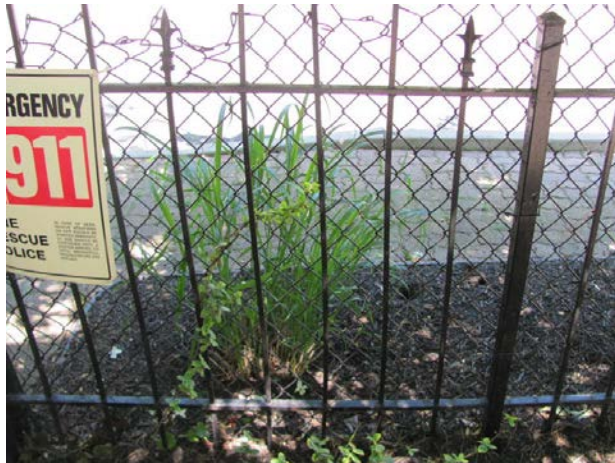
Fence, Steel - The Association maintains approximately 150 linear feet of steel fence at the pool deck. The fence is original and in fair overall condition. We note rust and isolated bent pickets.

Minor bend at picket

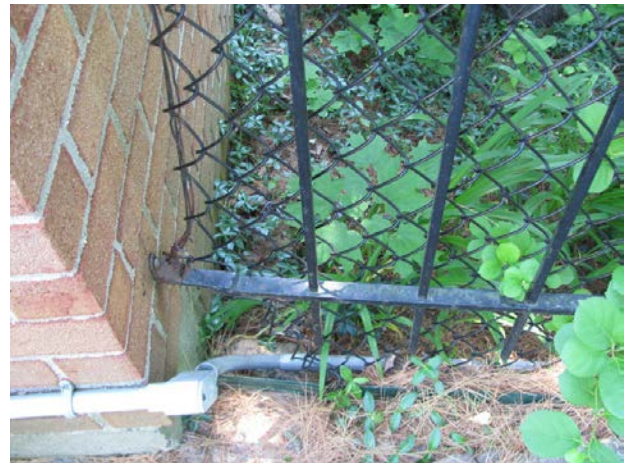
Rust at bottom fastener
