**GEOLOGIC HAZARD ASSESSMENT
PROPOSED GALLO CABINS
TRACT EX1 #637723
GALLO HILL ROAD
MARBLE, COLORADO**

PROJECT NO. 17-7-374

MAY 19, 2017

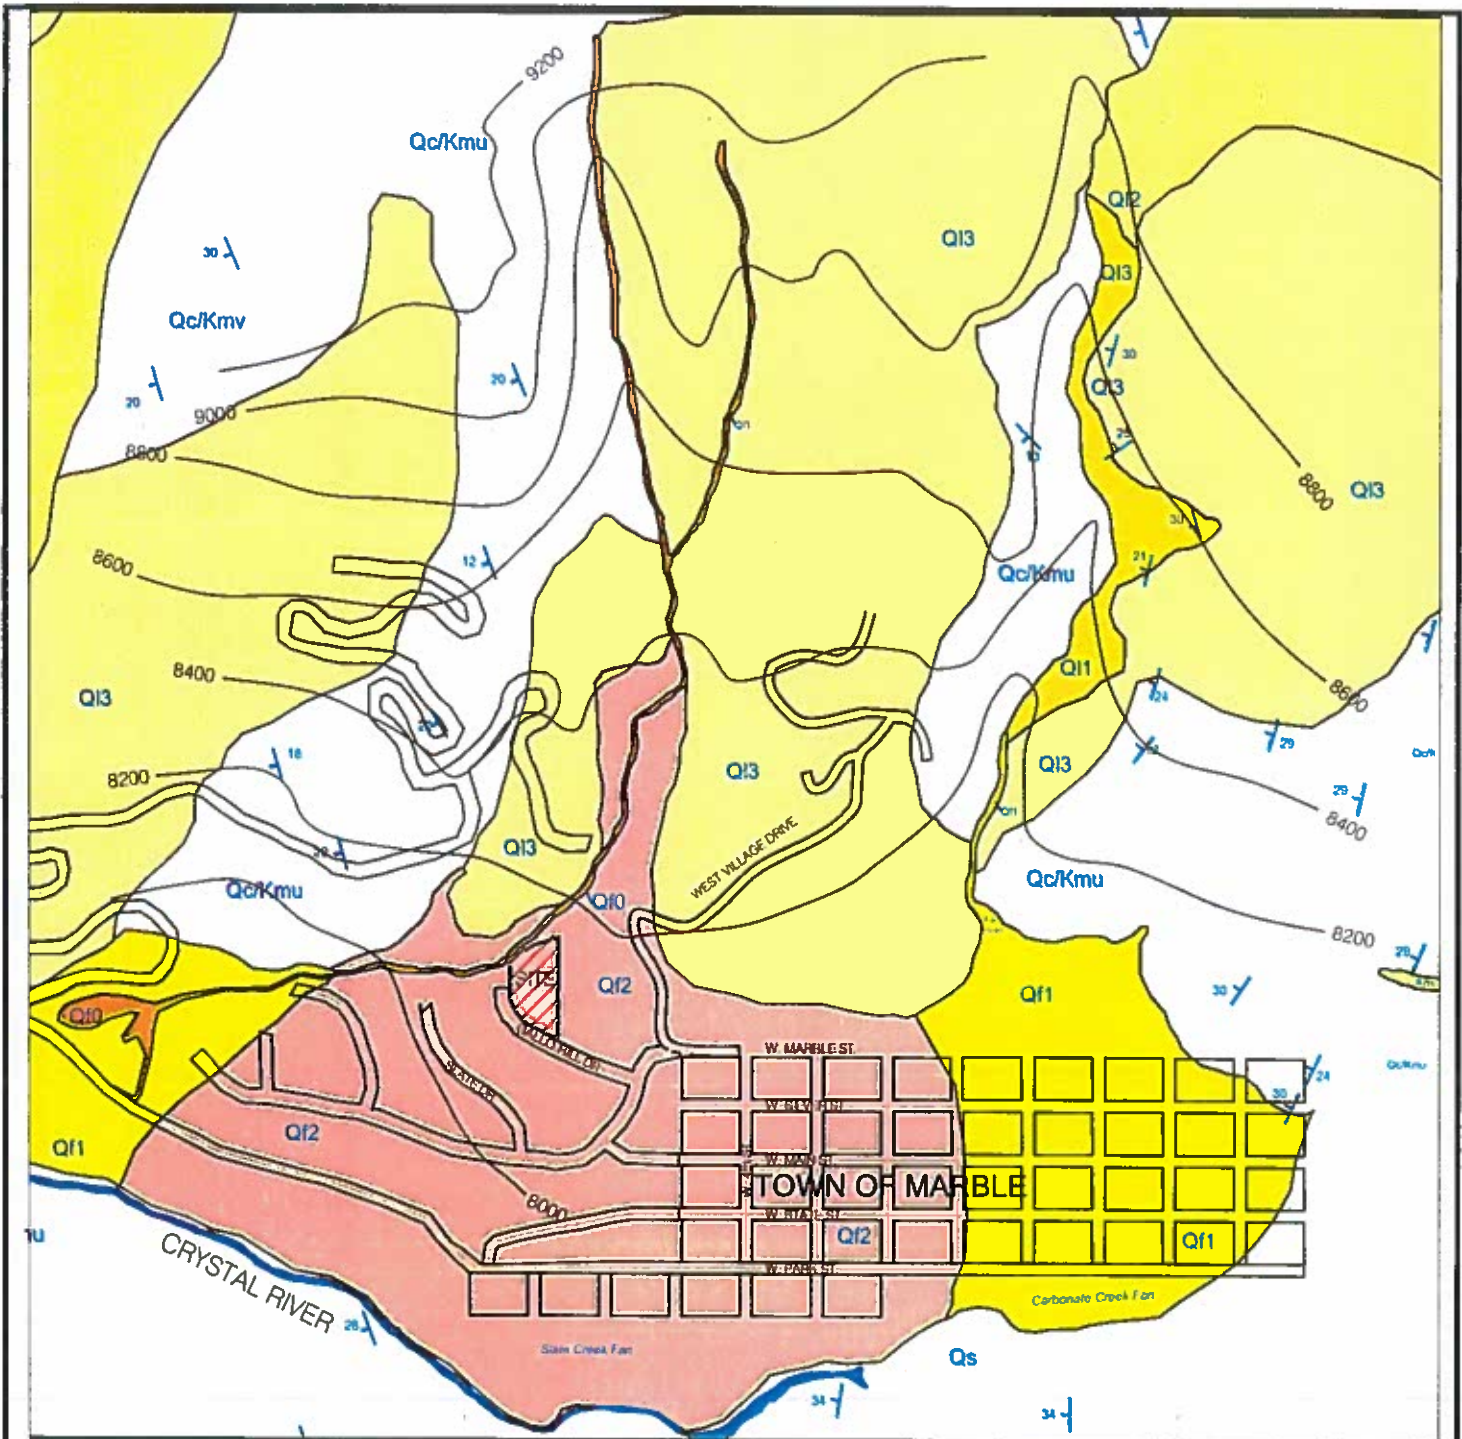
The site is located north of the town of Marble, on the eastern edge of Slate Creek and west of Carbonate Creek at an elevation of about 8,150 feet. The main geologic features in the project area are shown on Figure 1. This map is based on our field work and is a modification of published regional maps by Gaskill and Godwin (1966), Rodgers and Rold (1972) and Wright Water Engineers (1996).

Outcrops of upper Mancos Shale (kmu) are common along the Slate Creek canyon sides, the surrounding area and the lower portion of Gallo Bluff. The Cretaceous Mesaverde Formation is exposed in the upper portions of Gallo Bluff. The upper Mancos is a dark gray, silty to clayey shale with thick zones of sandy shale and siltstone and some lenticular sandstone beds. The bedding strikes to the northeast and typically dips between 12 and 30 degrees to the west-southwest in the project area. The site and building area are likely located on an old landslide complex (Q13) that involves surficial soils and underlying Mancos Shale. The complex developed in post-glacial time, during about the past 15,000 years. It appears to have been dormant with respect to large scale displacement or movement for a long time. It is described as an area of old landslides that shows no indication of large, fairly recent movements (Rodgers and Rold, 1972). The landslide complex is overlain by mud flow deposits at the site. The site is mapped within a dormant alluvial fan area (Qf2).

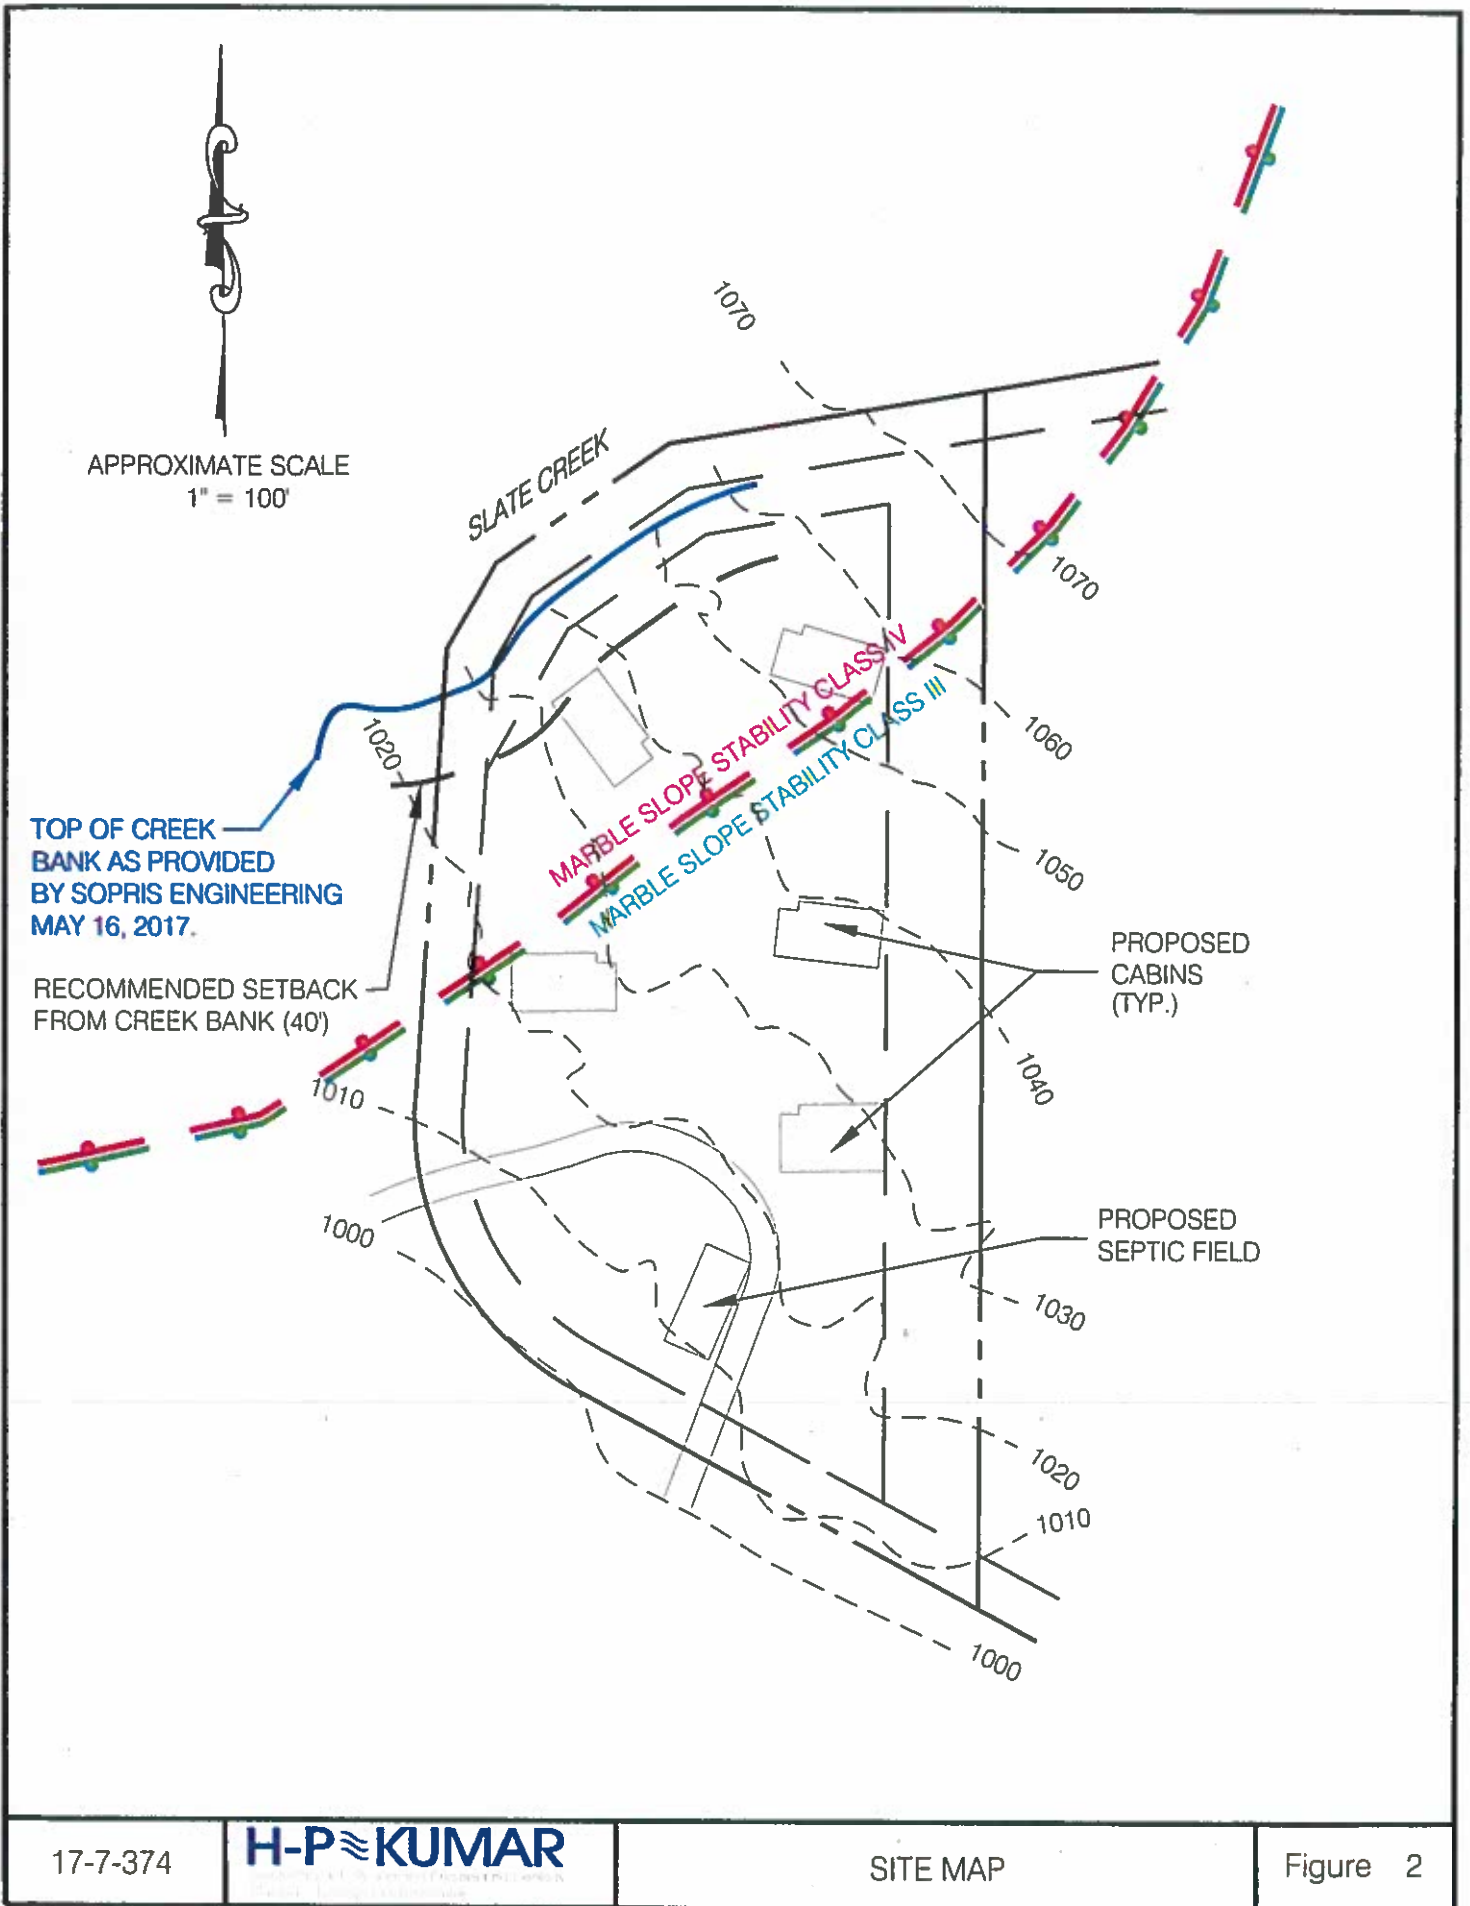
Robinson and Cochran evaluated the slope stability of the Marble Ski Area in 1973 and established five classifications of stability. The site is bisected by Slope Stability Class IV and Class III as shown on the (Wright Water Engineers, 1996) Gunnison County Geologic Hazard Maps. The boundary is shown on Figure 2. Slope instability problems in the project area include deep soil creep of old landslides which could easily be reactivated by construction activity and potential unstable slopes where new slides could be activated by construction activity. Active landslides are not located near the project site. Unstable Slopes Class III is defined as generally stable colluvial slopes subject to creep and stabilized landslides. Cuts and

fill should be minimal. Unstable Slopes Class IV is defined as steep slopes of surficial deposits subject to creep, slopes adjacent to stabilized landslides and unstable surficial deposits. Cuts, fill and excavations should be avoided. Surface and subsurface drainage control is important in both slope classes.

The risk of construction-induced slope instability at the site appears low provided the cabins are setback from the steep channel slope of Slate Creek and cut and fill depths are limited. We recommend a minimum setback of 40 feet from the top of the channel bank for the cabins. We assume the cut depths for the crawlspaces to about 3 to 4 feet. Fills should be limited, especially near the top of the channel bank where the slope steepens. Roadway, driveway and utility cuts should be kept shallow.

RECOMMENDED SETBACK FROM CREEK BANK (40')

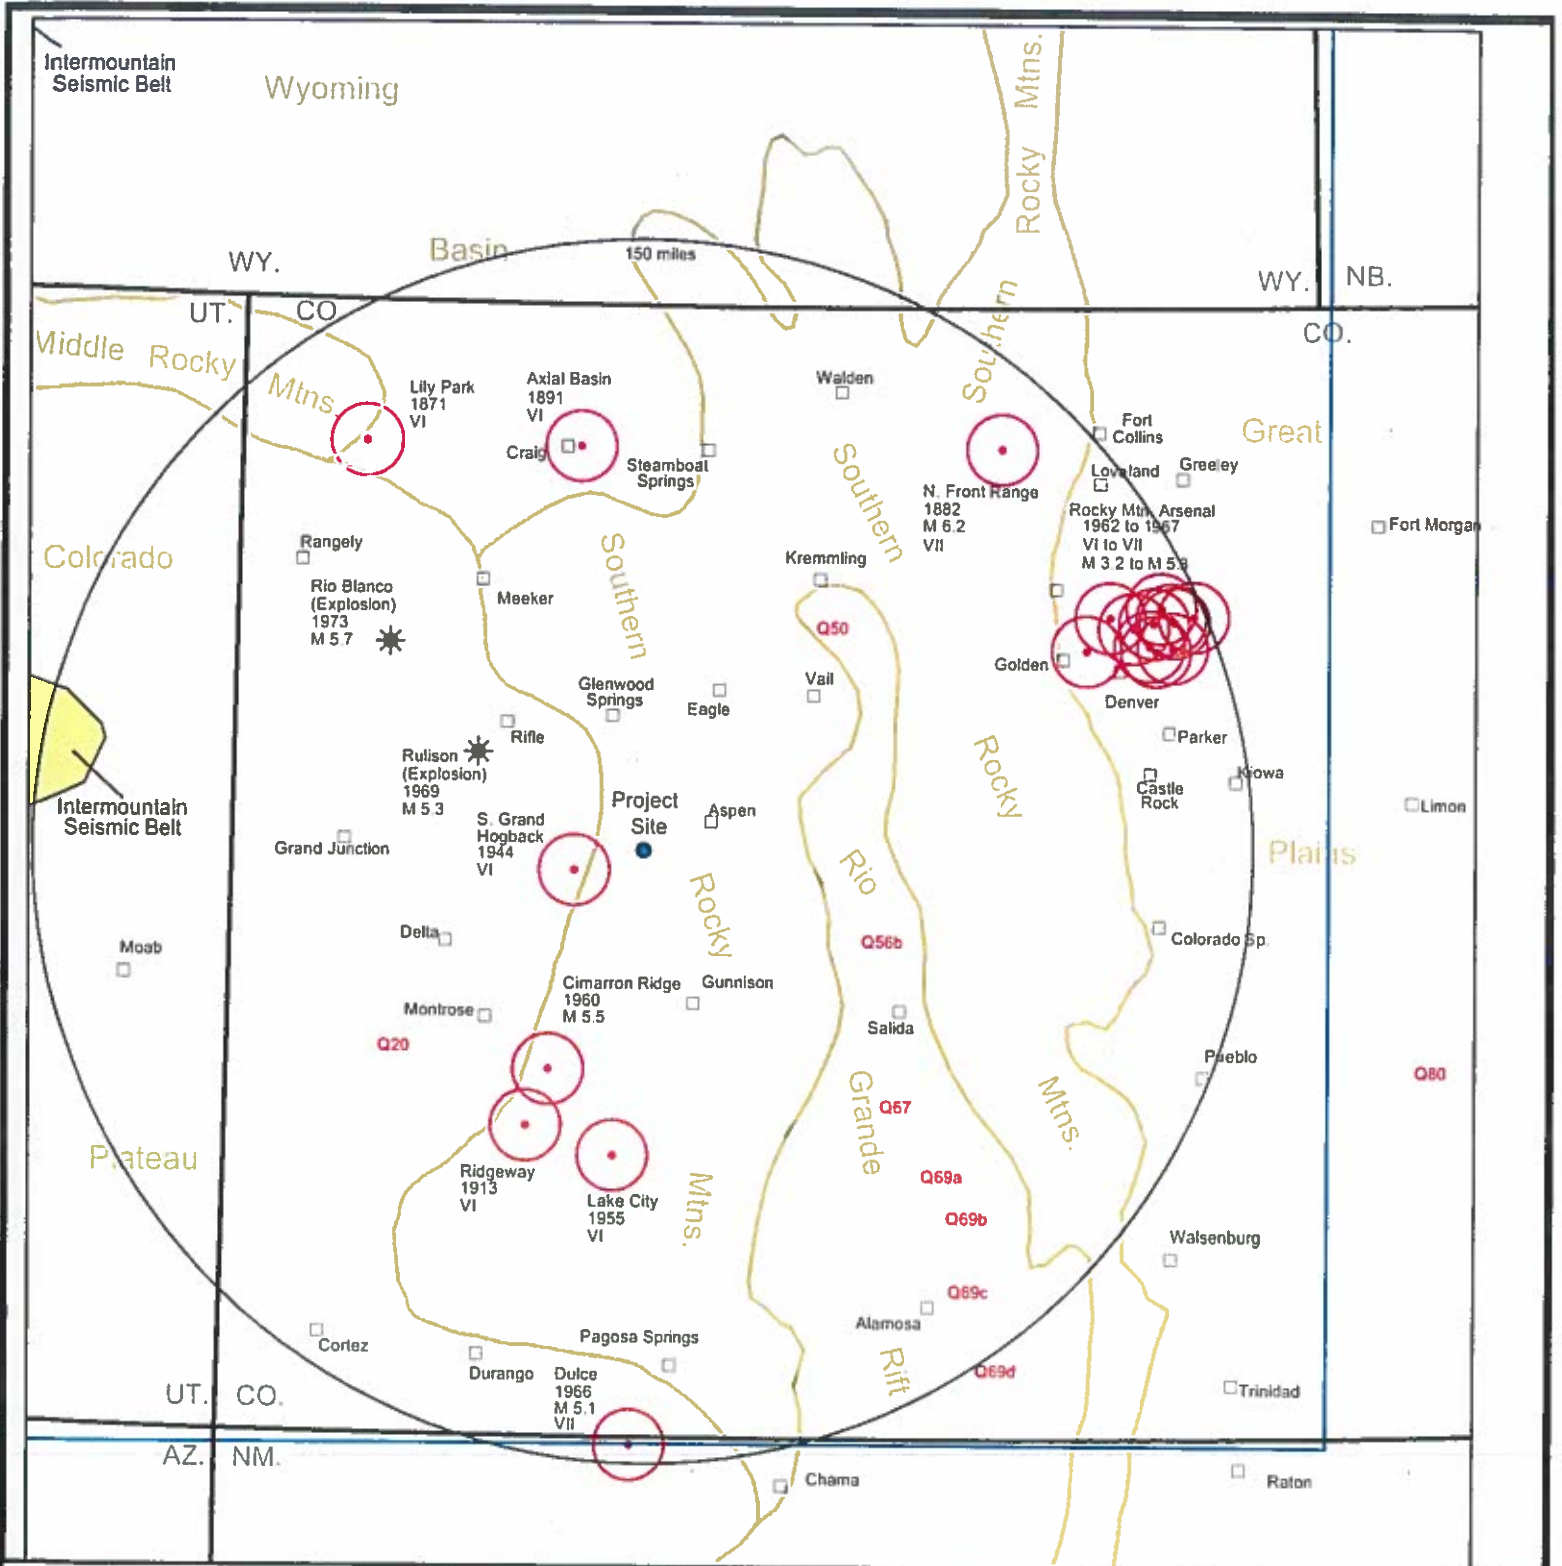
Geologically young faults are not present in the project vicinity. The closest geologically young faults that may be capable of producing large earthquakes, are in the southern section of the Sawatch fault zone in the Rio Grande Rift about 53 miles to the southeast, Fault Zone Q56b on Figure 3.

Historic earthquakes within 150 miles of the project site have been moderately strong with magnitudes less than M 5.5 and maximum Modified Mercalli Intensities less than VII, see Figure 3. Historic ground shaking at the project site does not appear to have exceeded Modified Mercalli Intensity VI (Kirkham and Rodgers 1985). Modified Mercalli Intensity VI ground shaking should be expected during a reasonable exposure time for the proposed cabins, but the probability of stronger ground shaking is low. Intensity VI ground shaking is felt by most people and causes general alarm, but results in negligible damage to structures of good design and construction.

The cabins should be designed to resist moderately strong ground shaking with little to no damage and to collapse under stronger ground shaking. The U.S. Geological Survey 2002 National Seismic Hazard Maps indicate a peak ground acceleration of 0.07g has a 10%
