WALDEN, ASHWORTH & ASSOCIATES, INC.  
**CONSULTING ENGINEERS**  
P.O. BOX 6462 • MARIETTA, GEORGIA 30065 • 770/956-7879

**RE: MIRROR LAKE DAM INSPECTION  
WA&A J.O. 4003000**

**WALDEN, ASHWORTH & ASSOCIATES, INC.**  
MIRROR LAKE VISUAL INSPECTION

**PHOTO LOG**

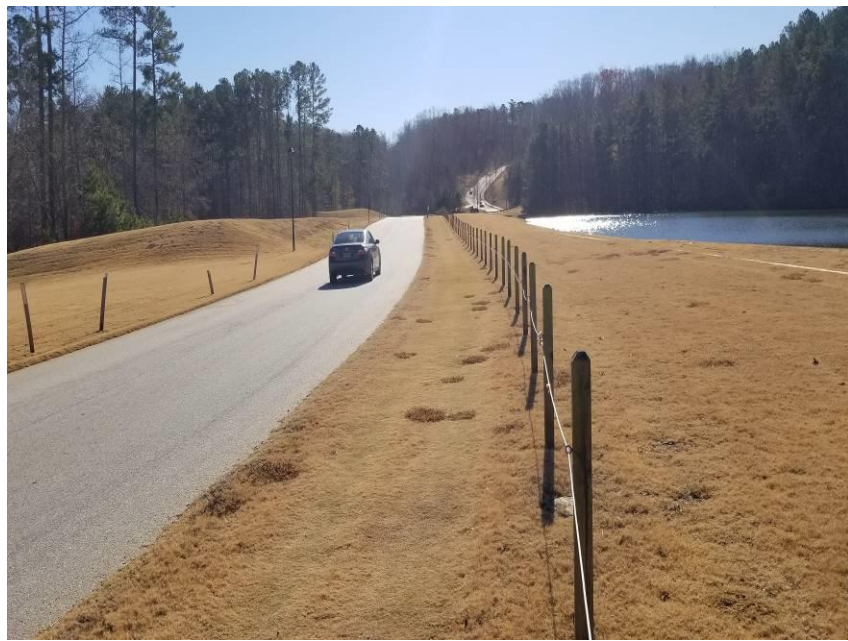
The crest of the dam has a paved road that appears to be in good condition with no cracking observed. There is minor rutting located parallel with the paved road across the crest due to golf cart travel. These ruts are grassed and should continue to be monitored to ensure the rutting does not worsen and remains grassed. The horizontal and vertical alignment of the earth embankment appears to be generally good. The crest is covered with a good stand of well-maintained grass. The abutment contacts were good.

Crest and upstream slope of dam with paved road. Note golf cart path on right side.

1. The downstream slope around the primary spillway needs some additional vegetation.
2. Monitor crest golf cart path along road and ensure grassing remains.
3. Monitor right side groin for any changes/erosion.
4. Monitor right side toe area for seepage.
5. Clear vegetation from toe of the dam and around the plunge pool area at the primary spillway outlet.
6. Provide key or remove lock on piezometer located in observation well 2 (OW2) at the saddle dam near the primary spillway.

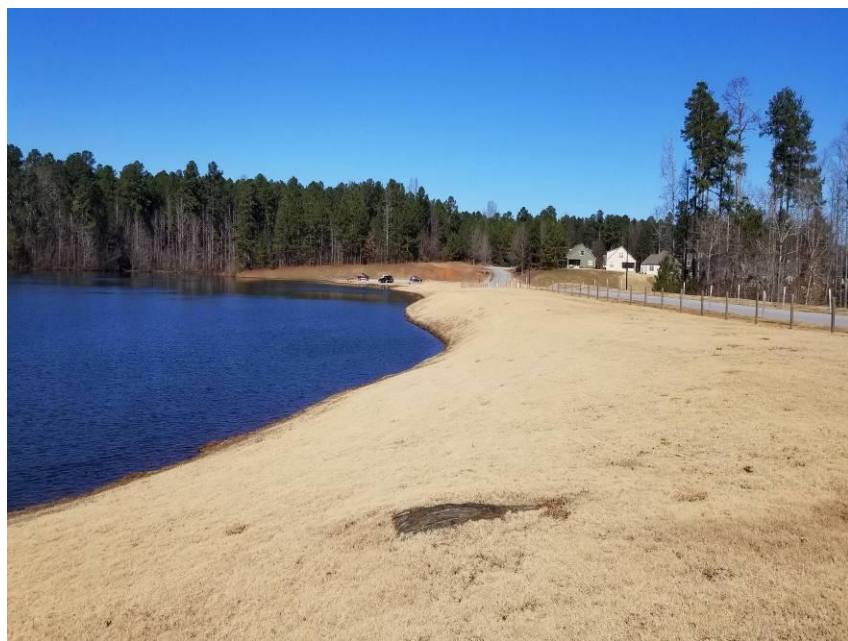
No changes were observed on the upstream slope, the crest of the dam, or along the shoreline. The portion of the slope that is visible above the water line is covered with bermuda sod that appears to be in good condition. No shoreline protection such as rip rap was observed. There were no signs of shore erosion visible. The slope is estimated to be a 3 horizontal to 1 vertical (3:1) and no unusual movement on the slope was observed. No slides or sloughs were observed and the abutment contacts looked good.

Upstream embankment and shore line.

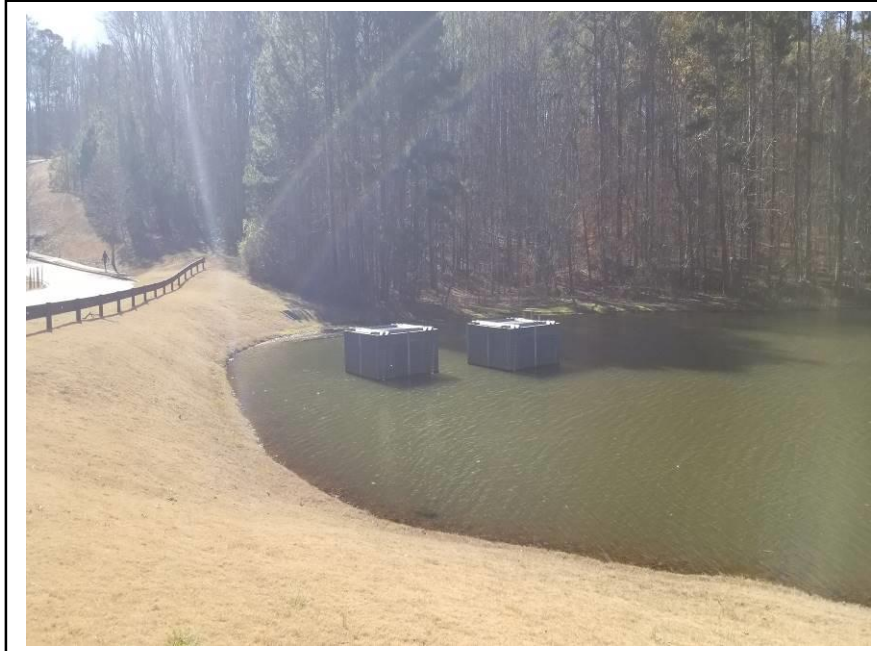
The water level of the lake is controlled by the primary spillway which consists of (2) reinforced concrete structures with 60-inch diameter low level discharge pipes. Observations from the upstream slope of the dam indicate that it appears to be generally in good shape. The structure appears to have an adequate functioning trash rack.

Primary spillway riser structures with trash rack.

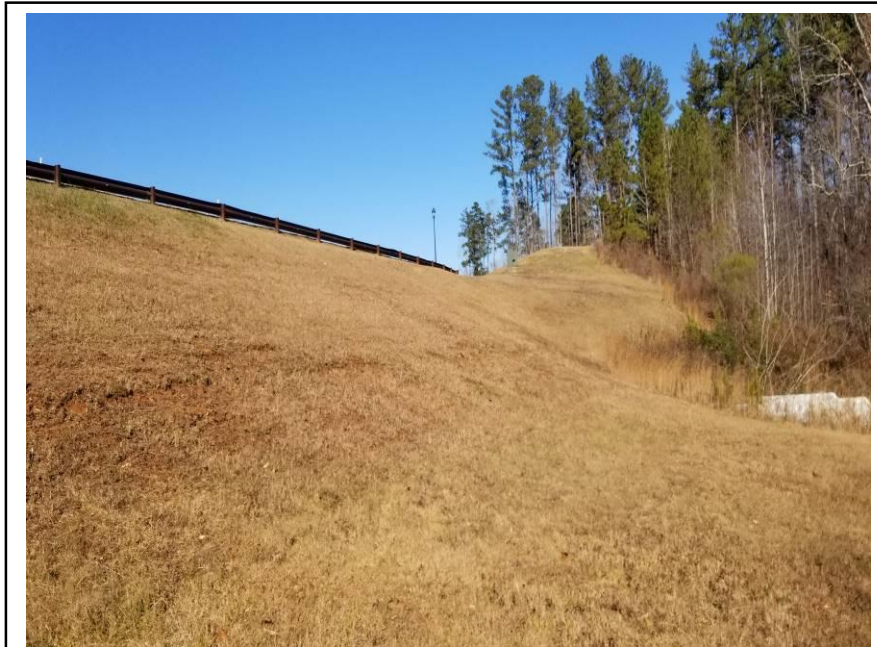
The downstream slope of the dam is covered with grass that appeared to have been mowed recently. The slope appears to be approximately 3 horizontal to 1 vertical (3:1). No signs of sloughing or sinkholes were observed. There were, however, some areas on the downstream slope near the primary spillway outlet pipes that were sparsely vegetated. These areas should be checked again in the spring and summer to ensure these areas are vegetated. There was also some minor erosion along the right downstream groin of the main dam. This area needs to be repaired and/or armored (grass, rip rap, concrete, etc.) or monitored to ensure erosion does not worsen. The wet/bubbling area at the right side toe of the dam as described by a Safe Dams inspection and inspected in April 2019 was dry during this inspection. Please refer to the Geotechnical Report dated November 2019 for additional information about this area. Currently there are rehabilitation designs being reviewed to help address this seepage.

Downstream slope at saddle dam with some sparsely vegetated areas. Area should have additional grassing. No change or erosion since last inspection.

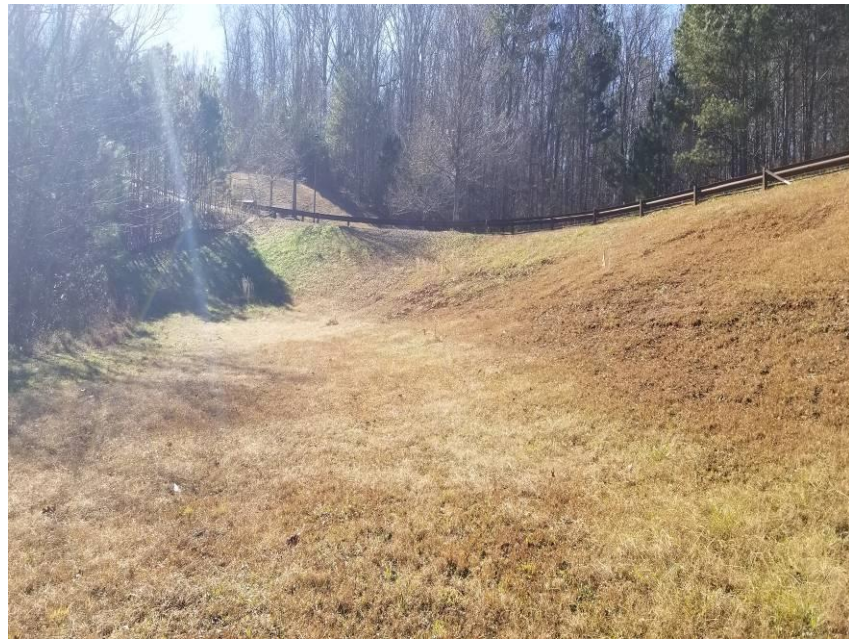
Seepage area at right abutment. Area was dry at time of inspection. Temporary observation wells installed by Geotechnical Engineer.

9. Other observations on the downstream slope/Corrective Action: previous area at toe on right side with observed seepage was dry

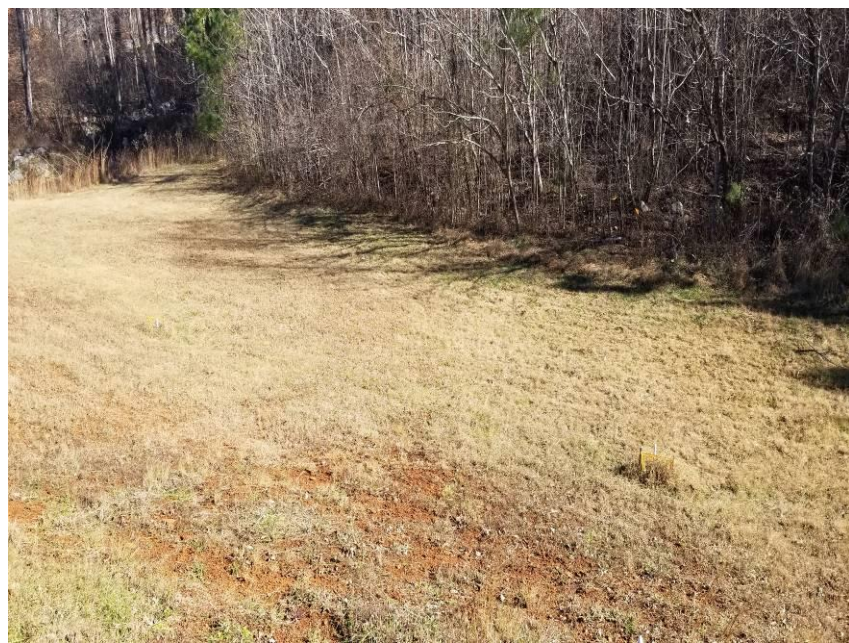
Temporary observation wells installed by Geotechnical Engineer at toe area.

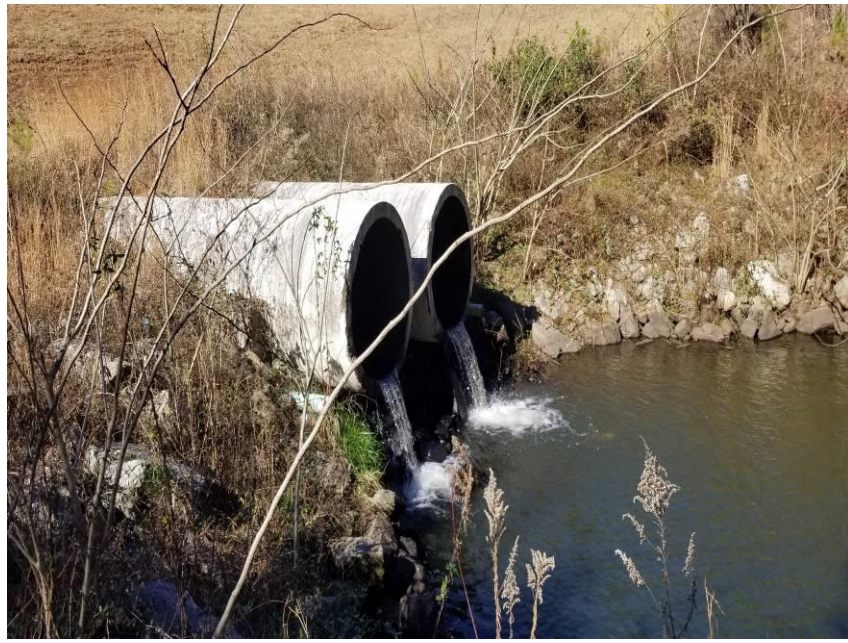
Seepage drains are located at the downstream end of the dam and on both sides of the primary spillway outlet. The right-side seepage drain located on the right side of the primary spillway outlet had a flow of approximately 5 gallons per minute (gpm) of clear water. The seepage drain on the left side of the primary spillway outlet only had a trickle of flow. The seepage drains located along the downstream toe of the dam were difficult to access due to heavy brush. This brush needs to be cleared from the area to allow access to the toe drains. The toe drains were partially submerged. This has been the case in all previous inspections due to the topography of the area downstream of the dam. This area should be drained if possible and continue to be monitored to ensure the condition does not worsen. Rust colored water was also observed in the wet swampy area in and around the toe drains. This area looked to remain unchanged from previous inspections. This should be monitored to make sure the situation does not worsen.

Outlet pipes for primary spillway and seepage drain outlet.

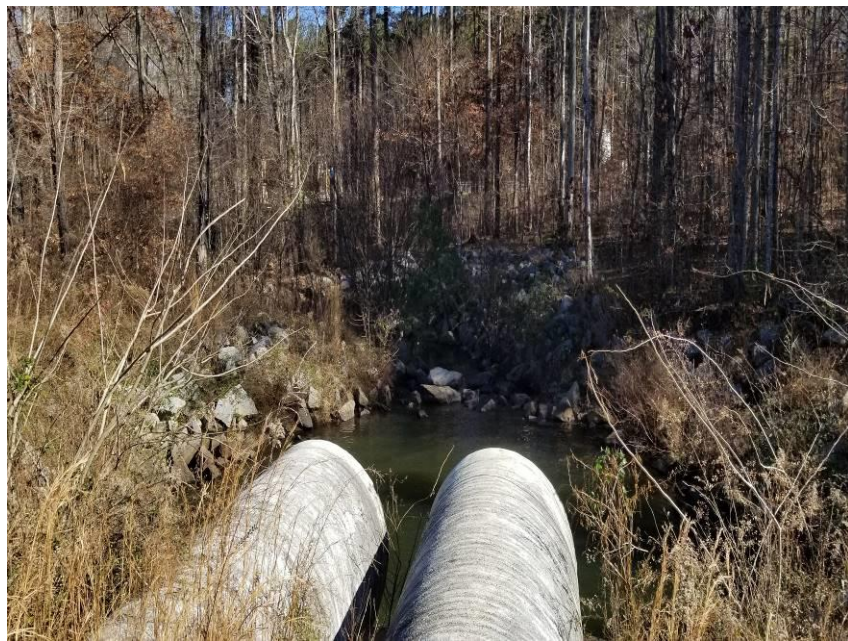
Two 60 in. diameter low level discharge pipes are located near the right abutment. The low-level outlet pipes terminate at the downstream toe of the dam with a cantilevered discharge into a rip-rap lined plunge pool. The plunge pool has encroaching vegetation. Access to this area was difficult due to the vegetation. The plunge pool area needs to be cleared of brush. The plunge pool continues to provide adequate dissipation of the energy from flows discharging through the pipe.

Plunge pool and outlet channel for primary spillway outlet.

1. Is there any type of erosion protection around the plunge pool (such as riprap)? Yes  No \_\_\_\_\_
- If yes, describe what type and its condition (for example, riprap - adequate, inadequate, obstructed by vegetation) /Corrective Action: rip rap adequate
2. Is there any erosion and or seeps around or going into the plunge pool? Yes \_\_\_\_\_ No
- If yes, describe (size of area, location, severity, etc.)/Corrective Action: \_\_\_\_\_
3. Other observations around the plunge pool/Corrective Action: area getting overgrown difficult access

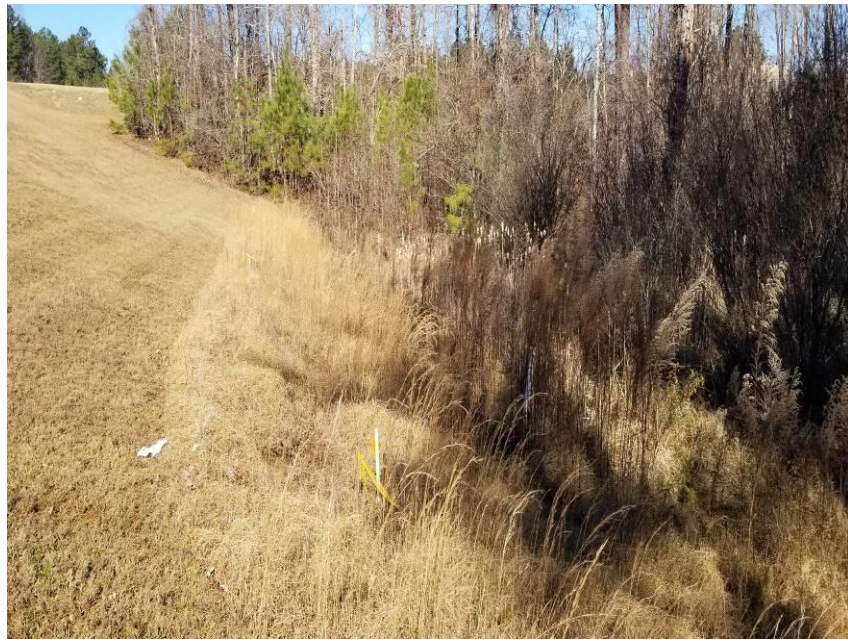
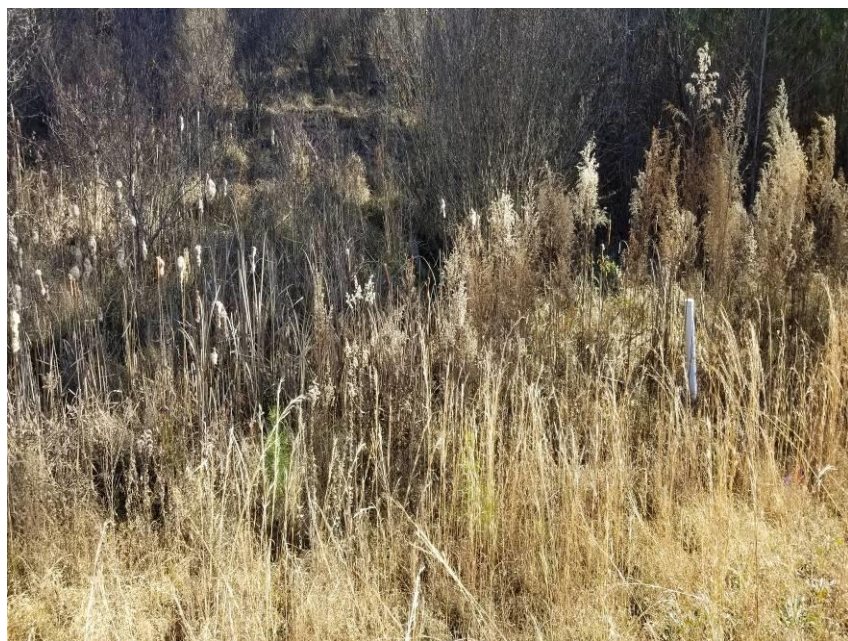
Swampy wet area at toe of dam. Toe drains inaccessible due to heavy brush.

6. Are there any wet areas or areas of hydrophilic (lush, water-loving) vegetation? Yes  No \_\_\_\_\_
- If yes, describe (size of area, location, etc.)/Corrective Action: along toe of Dam - low lying area is constantly wet

7. Do any wet areas indicate seepage through the dam (such as rust-colored, stained water)? Yes  No \_\_\_\_\_ N/A \_\_\_\_\_
- If yes, describe (for example, new area of seepage, no change from past observations, size of area, location) /Corrective Action: along toe no change from past, difficult access

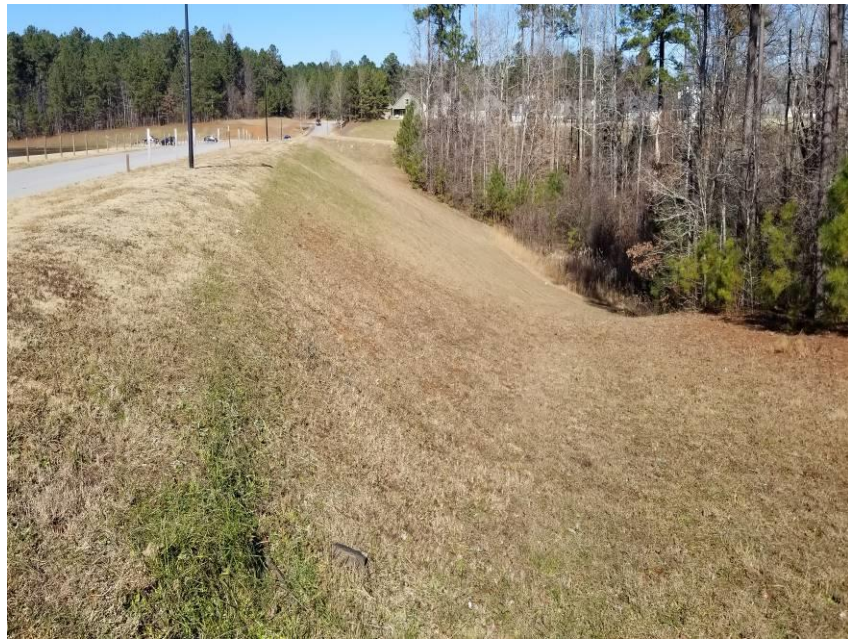
Downstream embankment and toe drain outlets at primary dam.

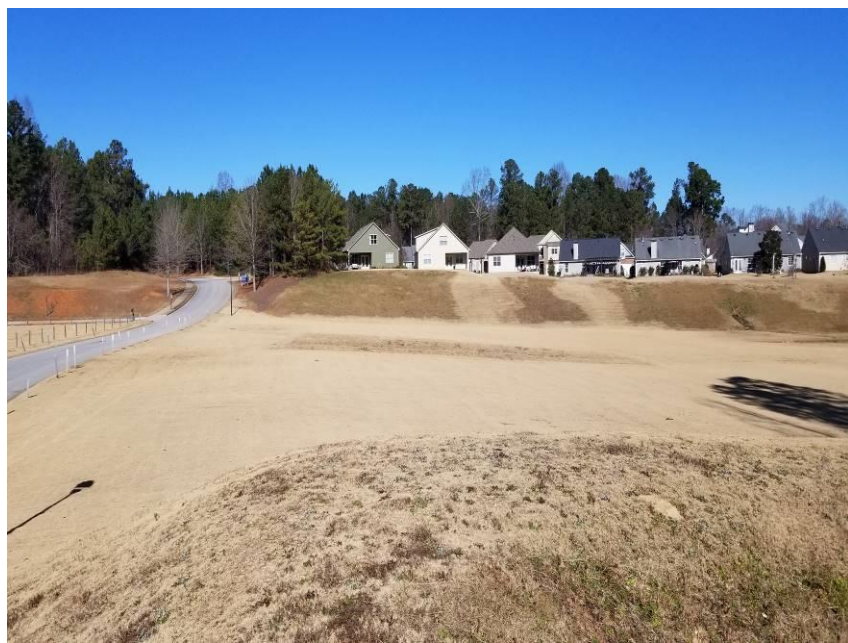
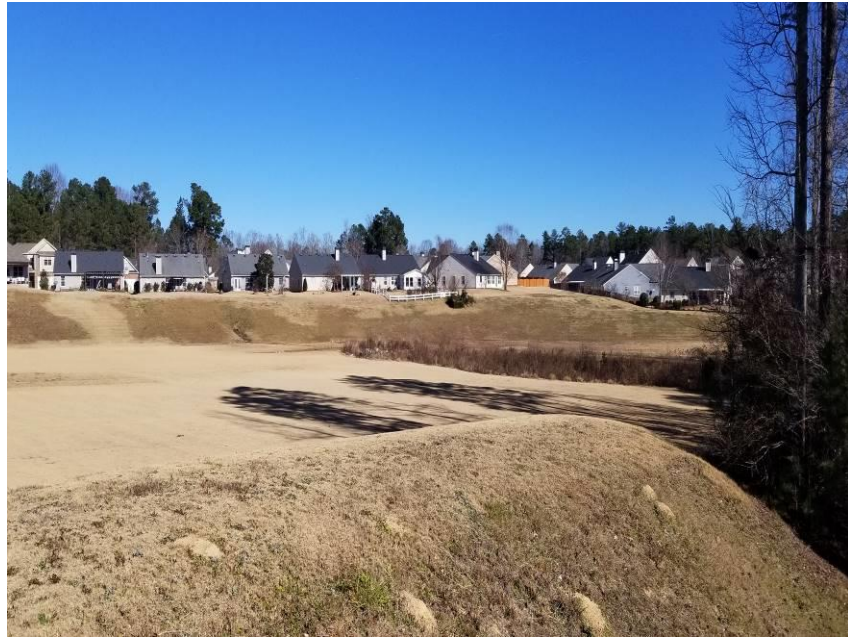
The 300-foot-wide grassed trapezoidal channel secondary or emergency spillway located in the left abutment appears to be generally in good condition. The approach channel is unobstructed and is covered with a good stand of grass. The discharge area also appears to be clear of debris. No evidence of frequent activation of this spillway was observed. Two rip rap lined drainage ditches remain at the downstream end of the emergency spillway. There appeared to be no erosion problems in the area, however these areas should continue to be monitored to ensure no erosion takes place. The exit channel is lined with rip rap along the spillway outlet running parallel to the dam. The downstream bank has some erosion damage. This area poses no threat to the dam as it would erode away from the dam into an open grassed field and did not appear to worsen any from the previous inspection.

Emergency spillway.  
Grassed trapezoidal channel.

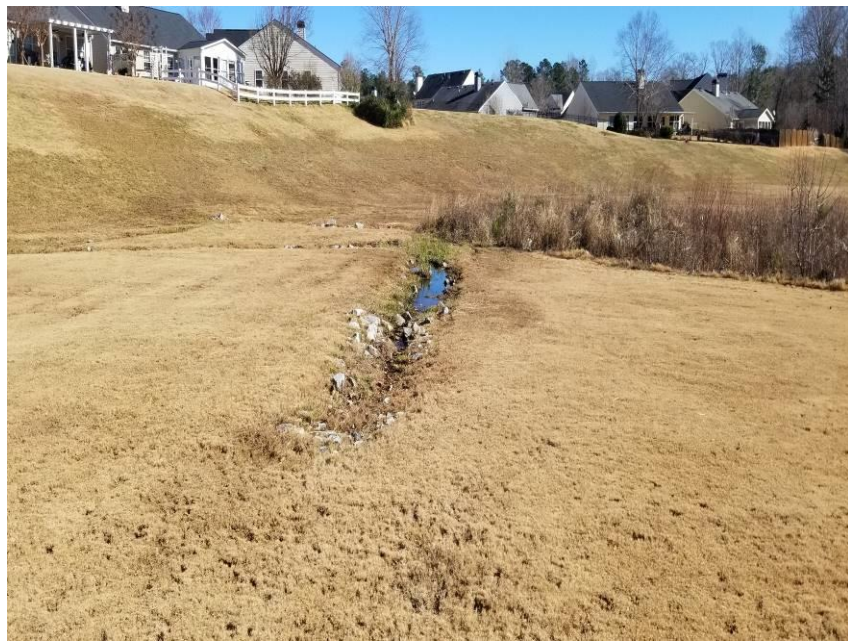
Exit of emergency  
spillway. Rip rap lined  
ditches located at the  
exit.

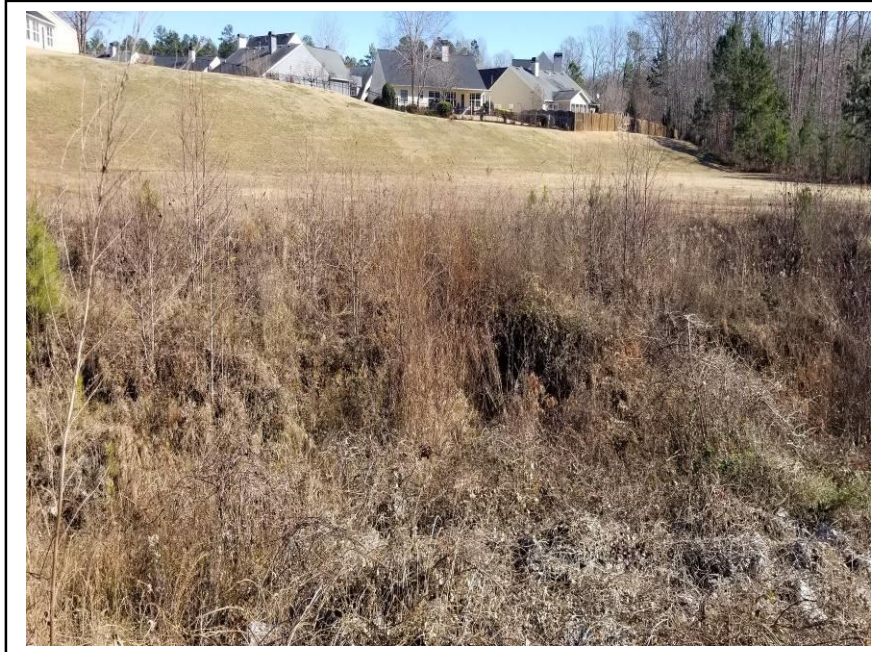
Erosion in the spillway exit channel on the downstream slope. No change since previous inspection.

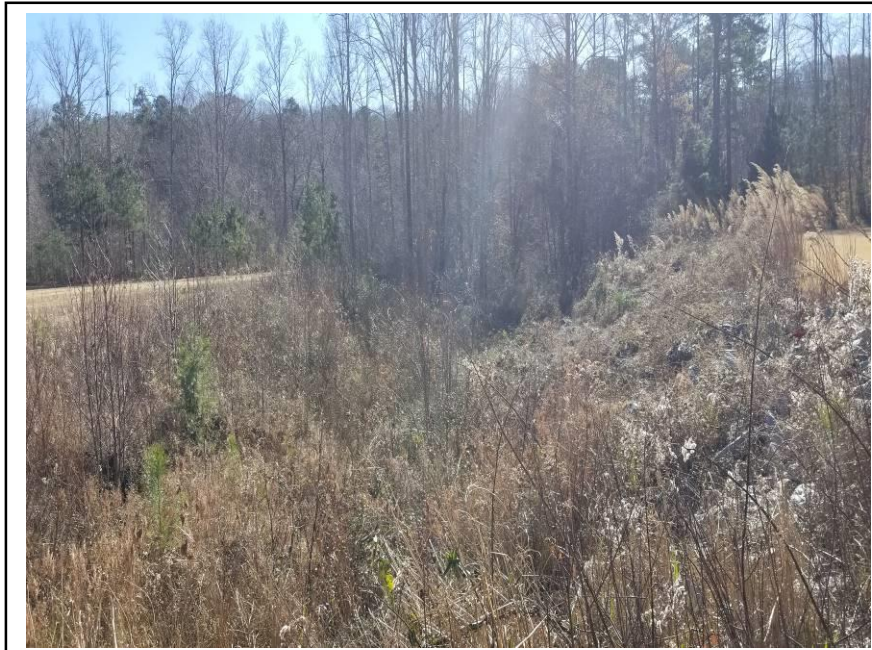
Spillway exit channel.  
Upstream slope armored with rip rap.

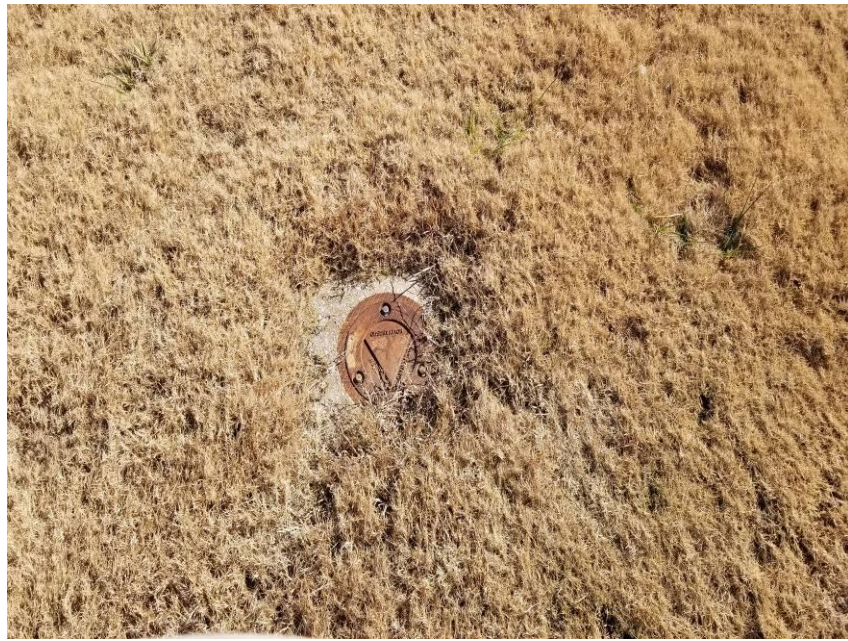
The piezometers are in good condition located along the upstream side of the crest of the dam. Observation well (OW) 1 is located at the upstream center of the dam and observation well (OW) 2 is located at the center of the saddle dam where the primary spillway is located. Both wells were accessible and OW1 measured approximately 14 ft of water depth. OW2 had a locked cap on the piezometer inside and was not able to be measured.

Observation well 1 on upstream side of main dam.

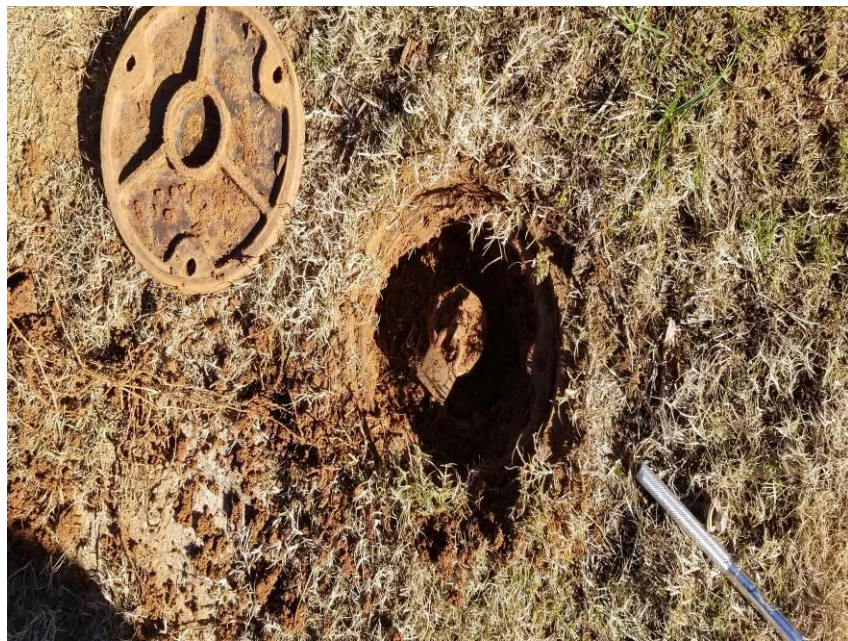
Observation well 2 on upstream side of saddle dam. Note locked cap on piezometer inside well.

8. Other observations on instrumentation/Corrective Action: OW1 - 14 ft  
OW2 - cap was locked
