CONEJOS RIVER DIVERSION INFRASTRUCTURE INVENTORY

Structure Name: LOPEZ D

Date: April 15, 2019

Conejos River Stream Management Plan

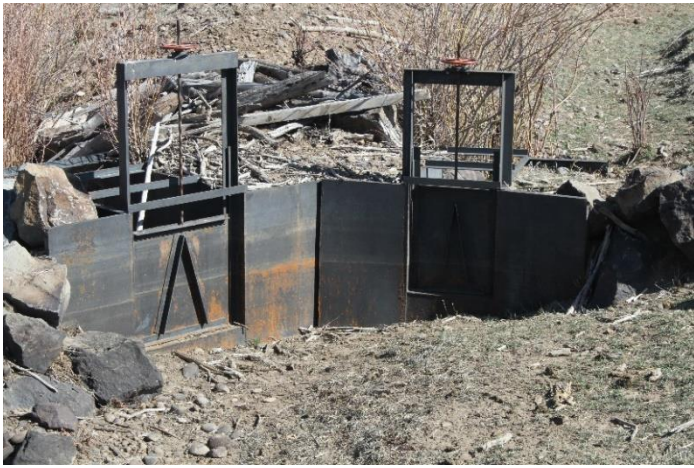
Headgate looking downstream

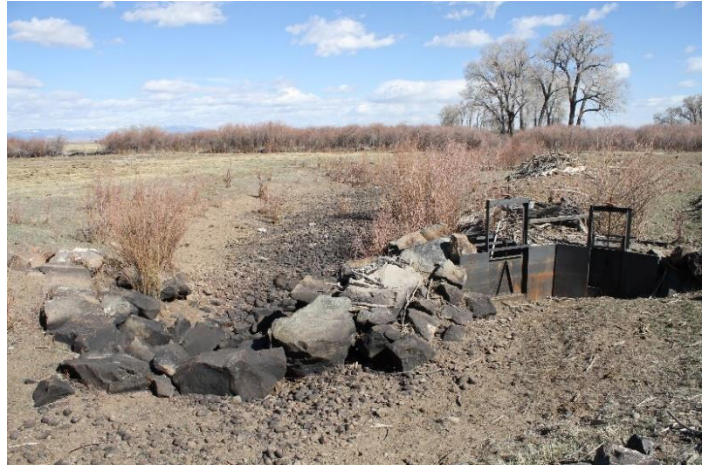
Headgate and diversion dam

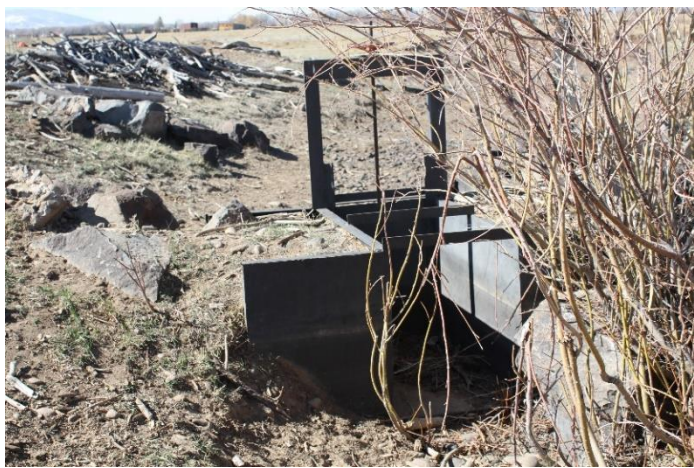
Headgate outlet

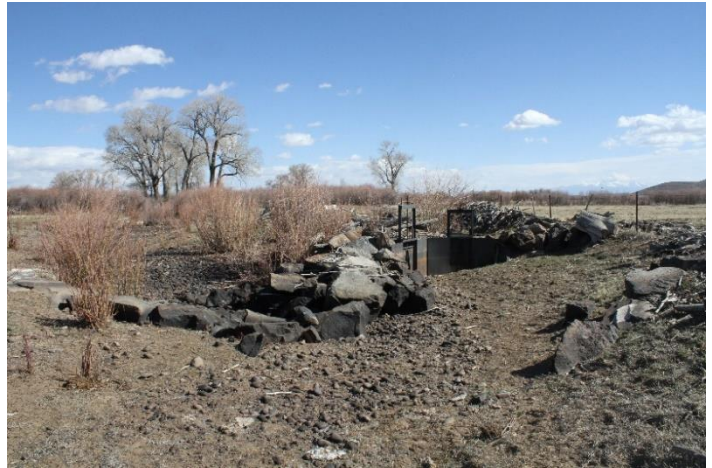
Diversion dam looking downstream

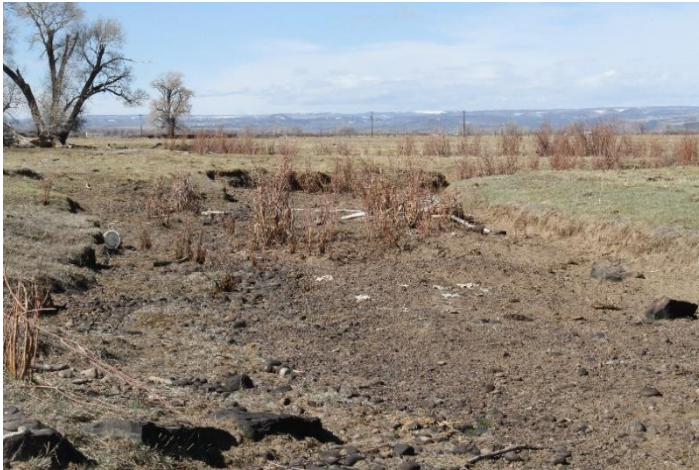
North branch Conejos River looking upstream

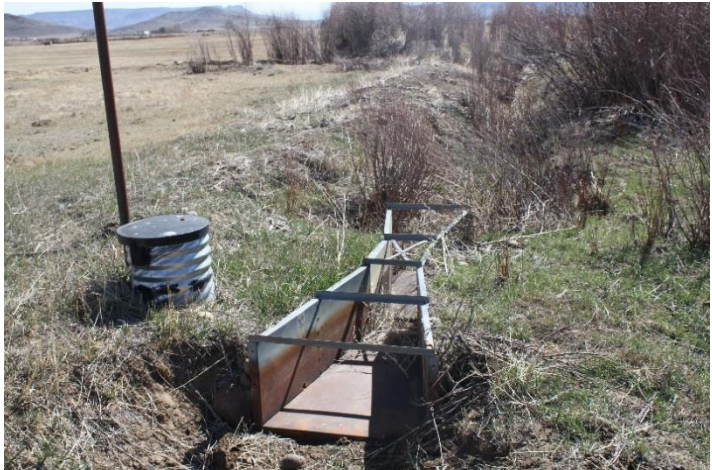
Flume looking downstream
