# Property Inspection Report

XXXX Xxxx Street, San Diego 92XXX

Report Number: 15XXXX0319A Xxxx 1881sf 1985 Slab Pool

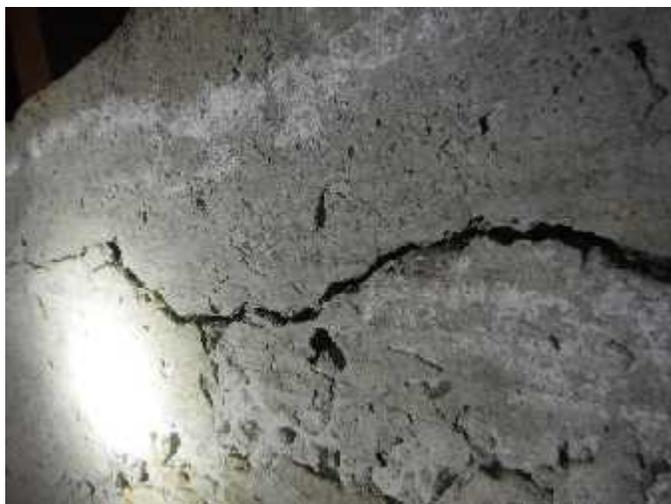
The south foundation stemwall east of the subarea crawlspace entry contains a horizontal crack that was not previously patched or repaired but is now cracked.

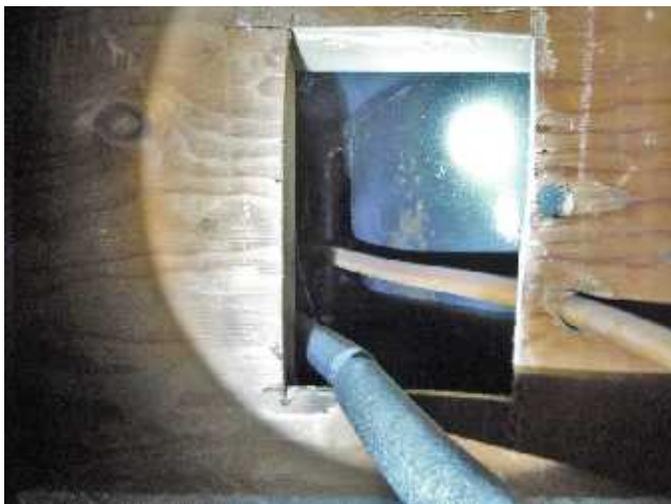
\* The lack of a protective covering over the opening to restrict access to the interior wall adjacent to the bathtub can allow rodents and other vermin into the interior of the bathroom walls and does not meet minimum building standards and is a **NOT FUNCTIONING PROPERLY CONDITION**.

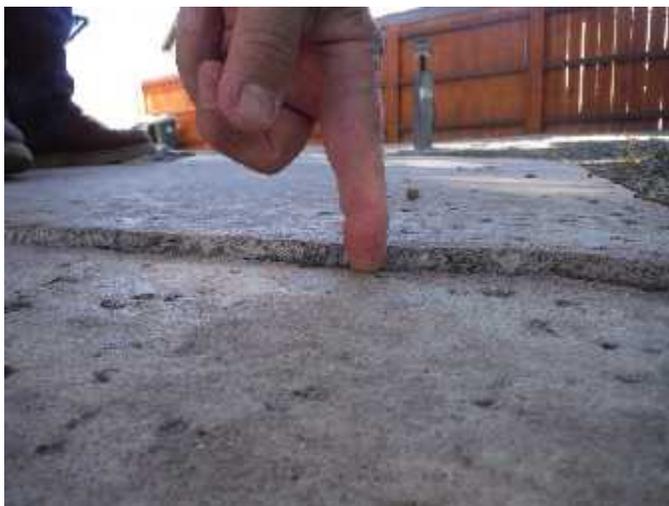
\* The broken walkway with height differential that is a possible trip hazard is a **SAFETY HAZARD CONDITION**.

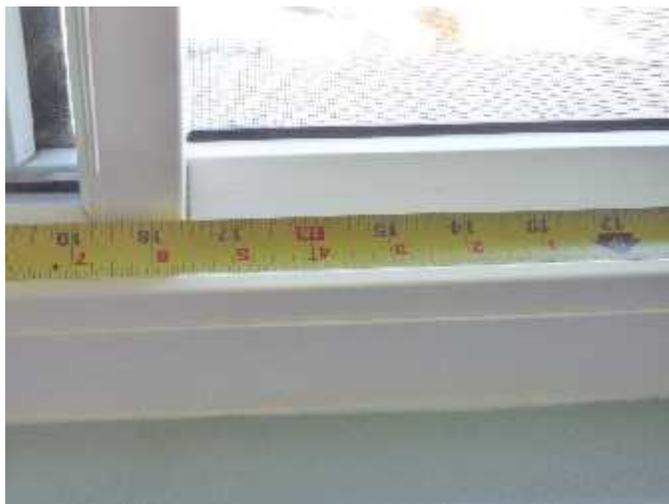
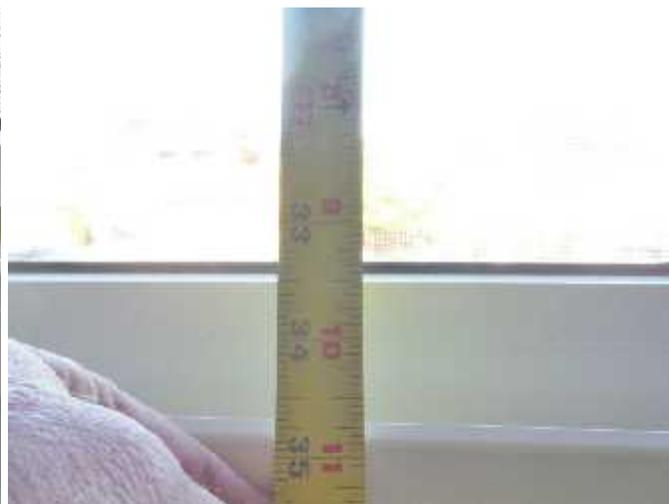
\* The inability to escape through a bedroom window as well as the inability of rescue personnel (with a tank on their back) to be able to enter an egress bedroom window is an **EXTREME HAZARD!!!!** The less than minimum opening dimension of 5.7 square-feet required for second-floor bedroom egress replacement window that opens to less than the minimum opening dimension is an **EXTREME HAZARD**. The replaced bedroom egress window that opens over a second-floor with less than 5.7 square feet opening and less than 20-inch wide opening does not meet minimum safety standards and is a patent **SAFETY HAZARD CONDITION**.

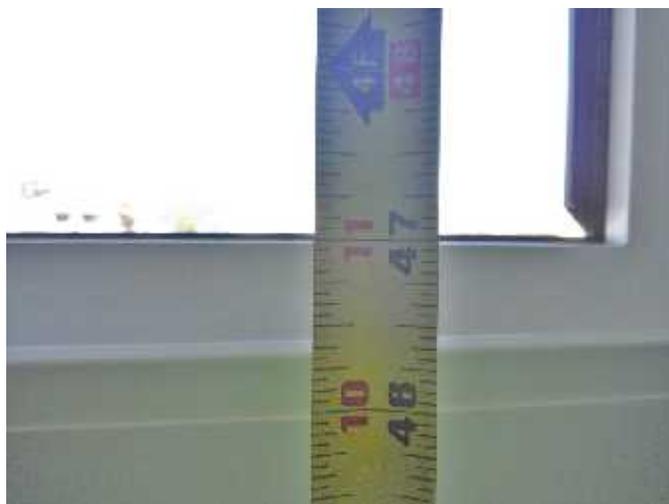
\* The replacement window in the two bedroom is too high for emergency egress and rescue, is a patent **SAFETY HAZARD CONDITION**.

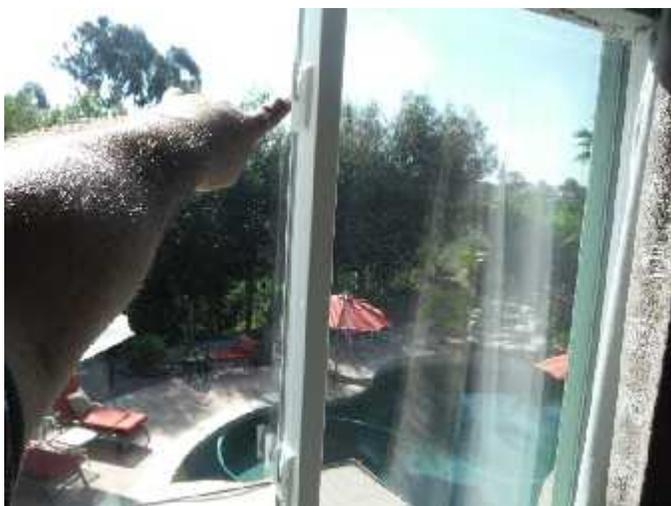
\* Although the configuration does not pose a problem for typical window applications, it does create a potential safety issue when utilized at an egress window installation (bedrooms). Children, height challenged individuals, someone with a disability, the elderly, and someone in distress in an emergency situation may be unable to open the upper security latch due to the distance above the finished floor and the multiple actions needed to open the escape window. The upper latch on the bedroom sliding egress windows are a **SAFETY HAZARD CONDITION**.

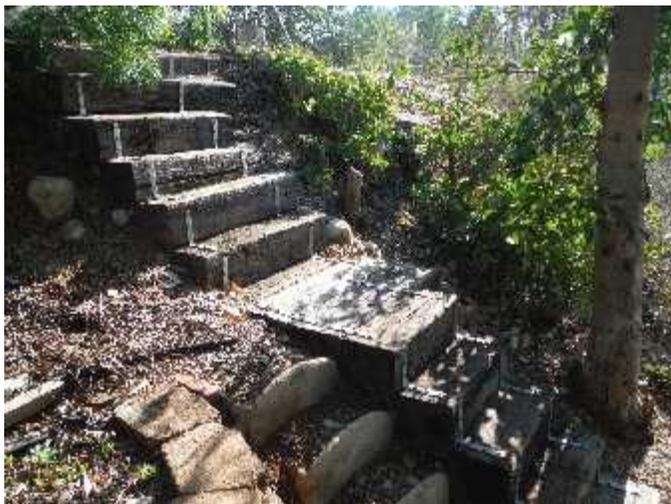
\* Exterior stairway without handrail protection does not meet minimum safety and building standards and presents a potential fall hazard for a user of the stairs out of balance while descending the stairway. The lack of handrail for a stairway with 4 or more risers is a patent **SAFETY HAZARD CONDITION**.

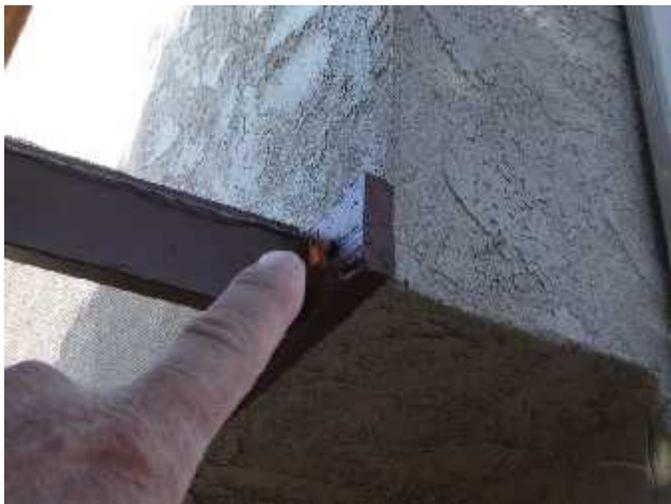
\* The lack of flashing over the top edge of the ledger board does not meet minimum building standards and can eventually allow moisture into the building interior through the bolting penetrating the exterior wall cladding of the building. The lack of adequate flashing of the attached patio cover ledger board is a patent **NOT FUNCTIONING PROPERLY CONDITION**.

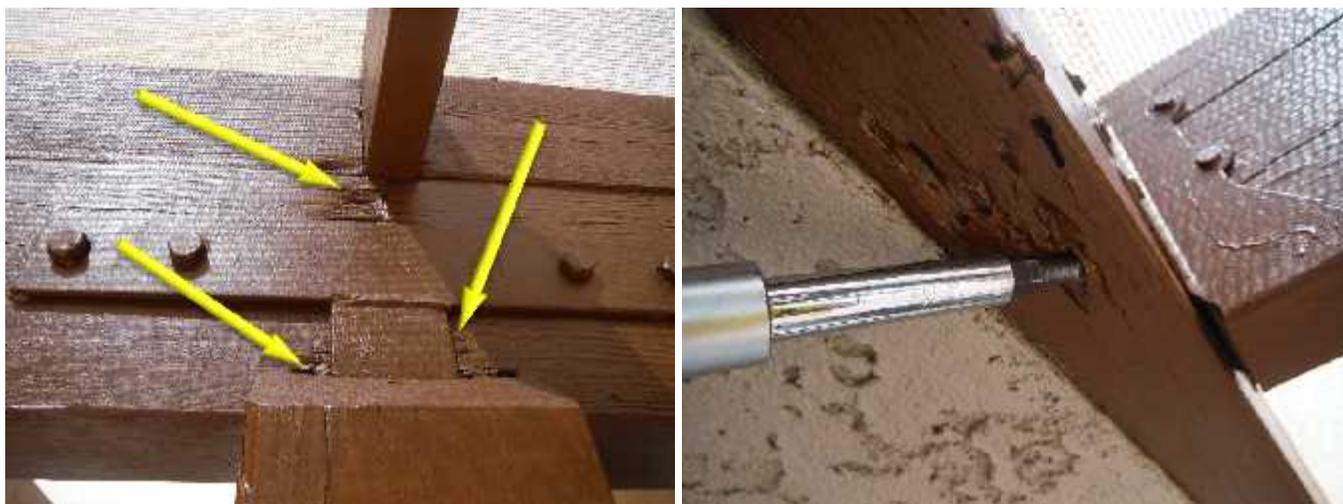
\* The damaged dimensional wood open design patio cover will continue to deteriorate and is a **NOT FUNCTIONING PROPERLY CONDITION**.

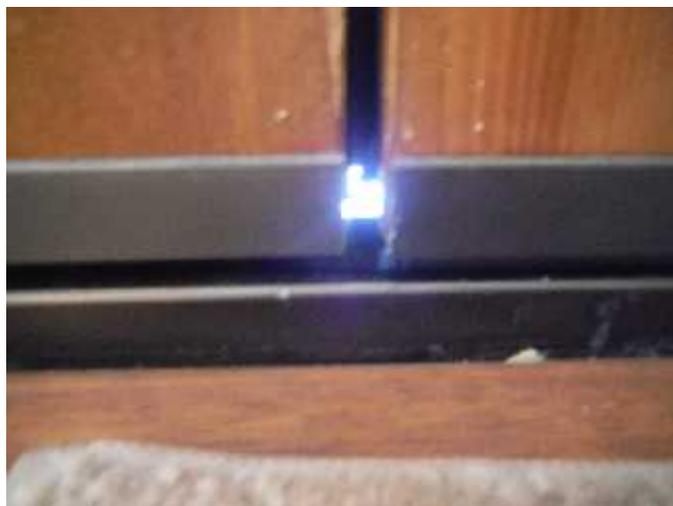
\* The missing weather-stripping will allow unheated air through the gap between the two doors and is a **MAINTENANCE DEFICIENCY CONDITION**.

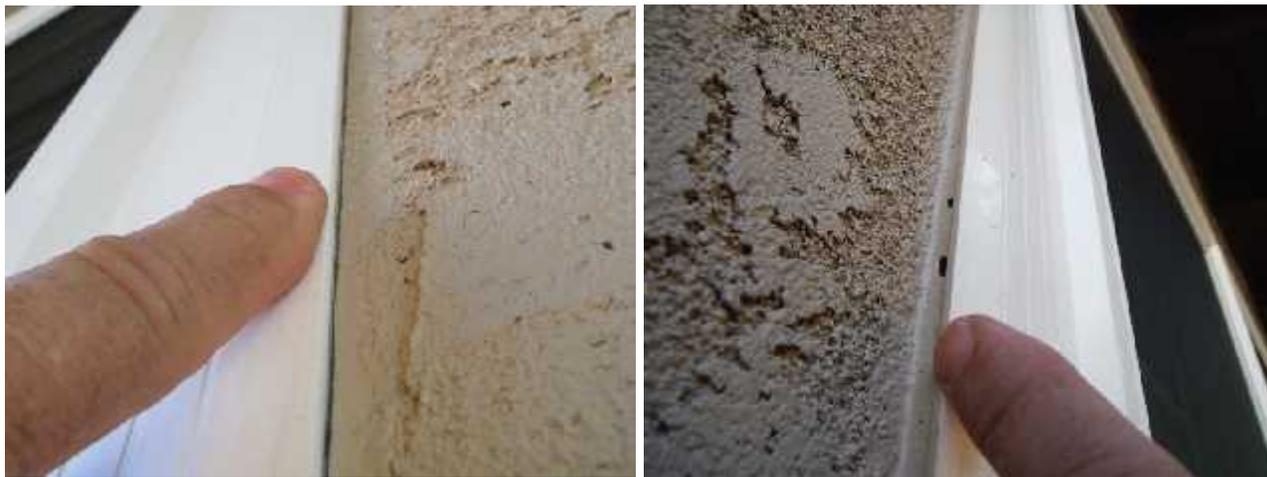
\* The 'Easy-Framed' windows on the exposed exterior walls will need periodic sealant applied to the top and two sides (not the bottom) to control moisture from entering behind the exterior window phalange. is a **MAINTENANCE DEFICIENCY CONDITION**.

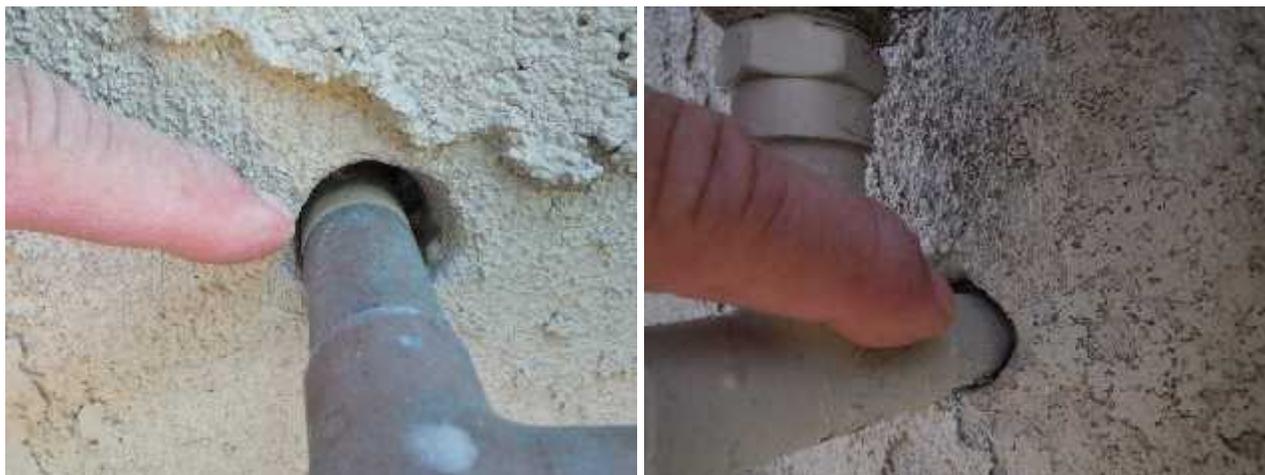
\* The open annular gaps around penetrations and small cracks through the exterior wall covering can allow moisture through the exterior wall covering and are a **MAINTENANCE DEFICIENCY CONDITION**.

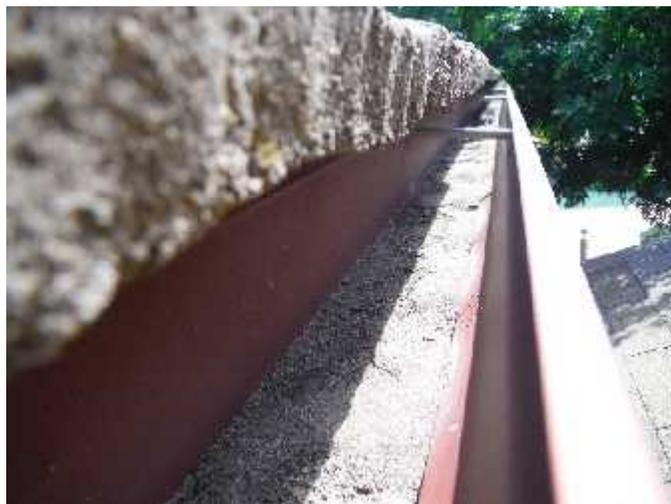
\* The height of the upper roof rain gutters precludes someone cleaning them without adequate training and the proper equipment. The debris filled roof rain gutters are a **NOT FUNCTIONING PROPERLY CONDITION**.

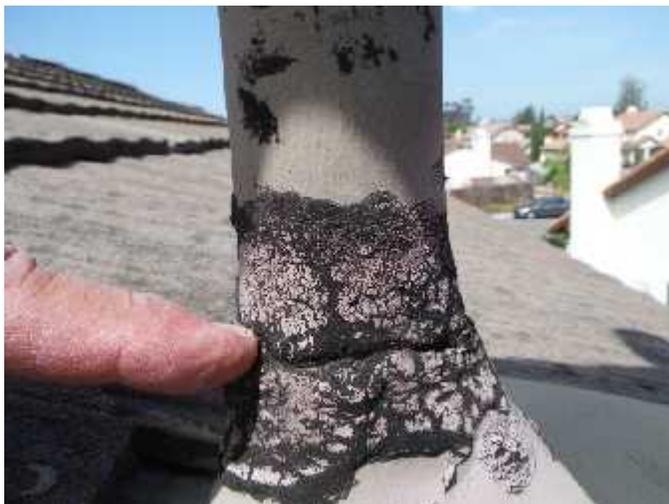
\* An open gap will allow moisture through the separation, below the roof penetration flashing, and into the roof deck assembly. The open separation gaps around the roof penetrations piping and the roof sheet-metal penetration flashings are an **END OF SERVICE LIFE CONDITION**.

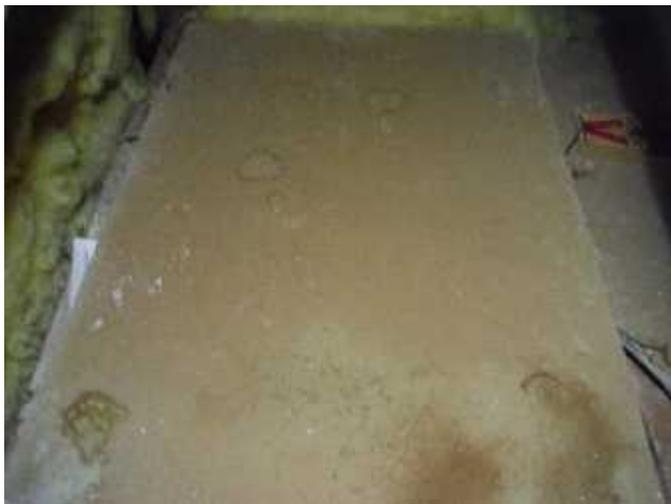
\* Installing insulation to meet modern attic space insulation requirements (R30) is an inexpensive upgrade that leads to the direct comfort of the inhabitants below the attic spaces. The lack of adhered attic insulation to the top surface of the attic access panel cover creates a hot or cold spot (dependent on the season) on the ceiling where the access hatch is located. The lack of weather-stripping around the perimeter of the attic hatch opening will allow heat and cold to transfer into the interior of the dwelling reflecting the temperature and pressures in the attic spaces. The missing areas of ceiling insulation will create ceiling areas with temperatures reflecting the temperate in the attic spaces. The missing sections of insulation, with the lack of an adequate seal around the

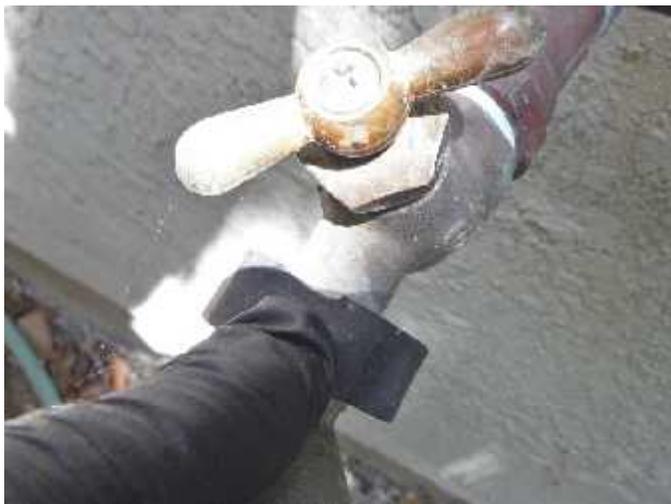
\* Modern safety standards require anti-siphon protection to be installed on all hose bib faucets to prevent cross-contamination of the potable water supply with water from attached hoses, and the lack of exterior hose bib faucet anti-siphon protection for the hose bib faucets does not meet minimum building standards, and is a potential **SAFETY HAZARD CONDITION**.

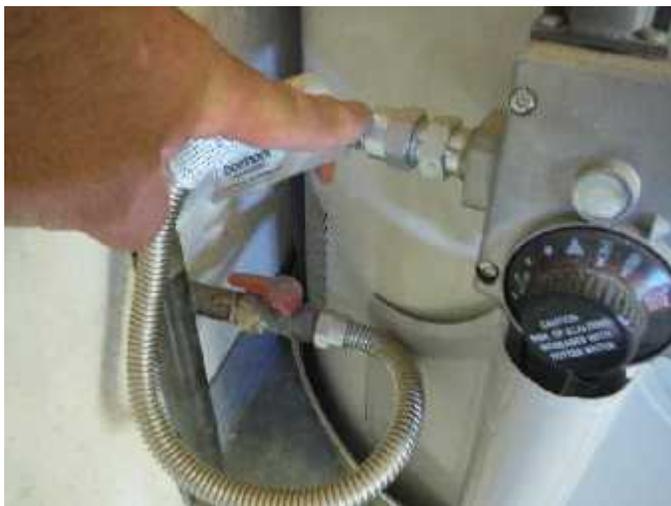
\* The absence of a sediment trap on the gas piping for the water heater does not meet Manufacturer's installation requirements thus potentially voiding warranty coverage, the building standards applicable when the manufacturing of the appliance occurred, and is a patent **SAFETY HAZARD CONDITION**.

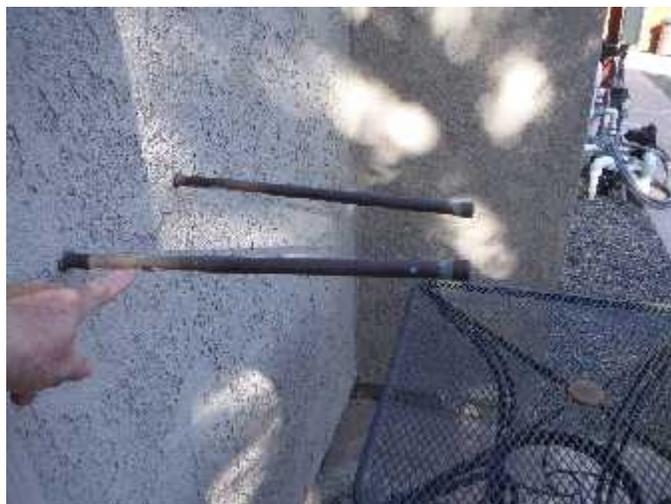
\* The protruding copper piping appears to have been in place for the addition of an exterior shower to rinse off pool water. The excessive protruding pipes are a potential impact hazard for some who does not see the piping when running around the corner of the building. The piping could rupture on impact or hurt someone from impact and is a **NOT FUNCTIONING PROPERLY CONDITION**.

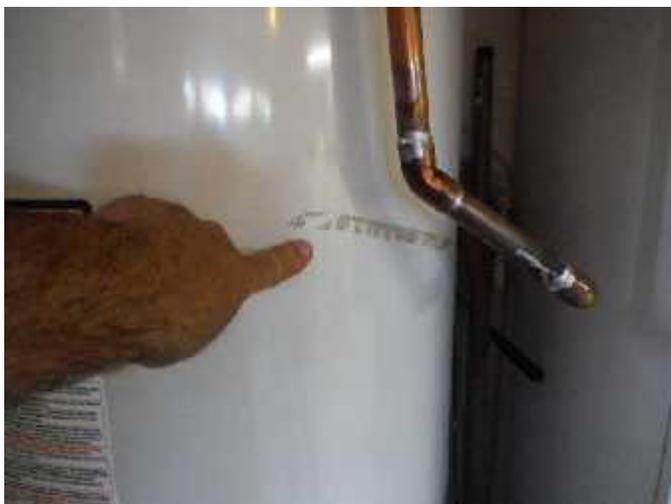
\* The missing manufacturer installation and operation instructions that are not attached to the water heater tank are a **NOT FUNCTIONING PROPERLY CONDITION**.

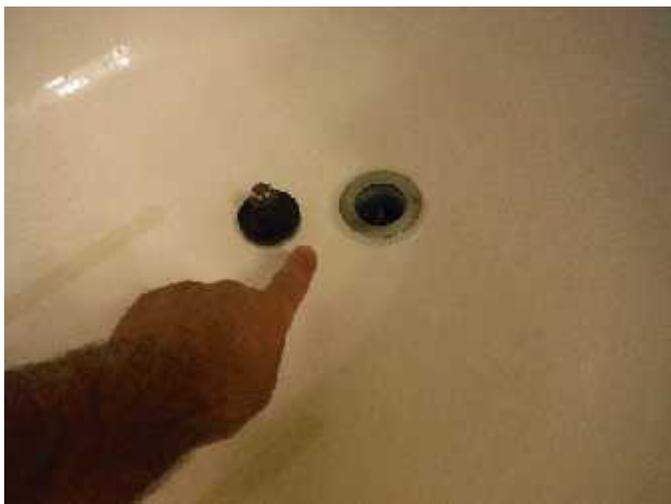
\* The damaged bathtub drain screw-in drain stopper assembly can no longer be relied upon to function as intended and is an **END OF SERVICE LIFE CONDITION**.

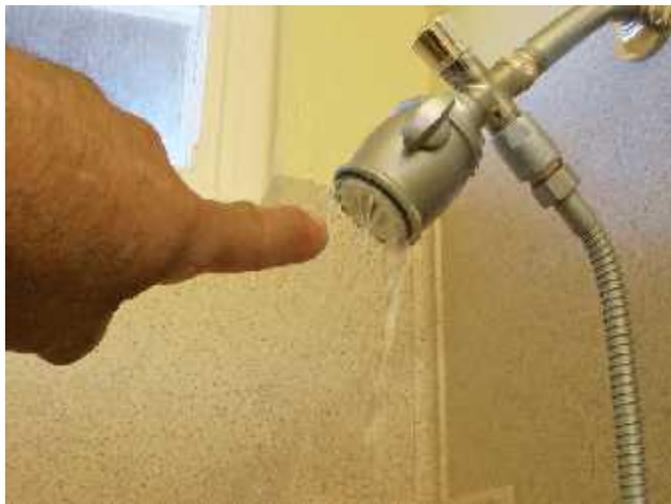
\* The water supply volume reduction with multiple faucets on, and the water pressure drop with only one faucet turned on indicates that the pressure regulator is not opening adequately when there is a demand for more volume as the regulator is designed to function. With the water volume drop with multiple fixtures on and the significant water pressure drop in the pressure regulator when one faucet is turned on is the pressure regulator device nearing an **END OF SERVICE LIFE CONDITION**.

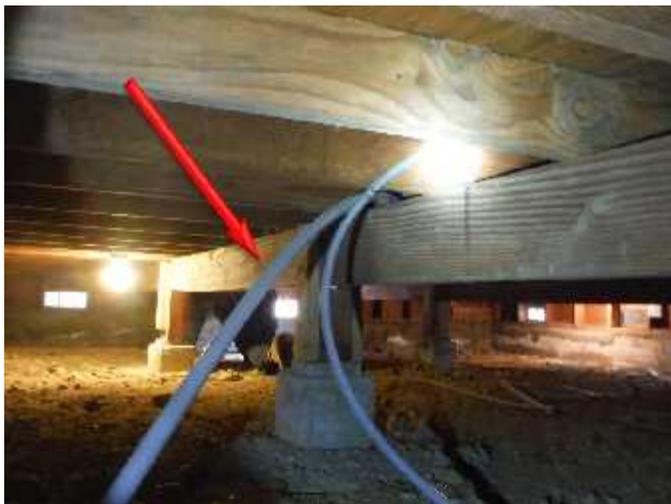
\* The abandon water supply piping not cut back to the point where the plastic piping penetrates the floor construction and then removed is an unfinished installation of the re-piping installation and is a **MAINTENANCE DEFICIENCY CONDITION**.

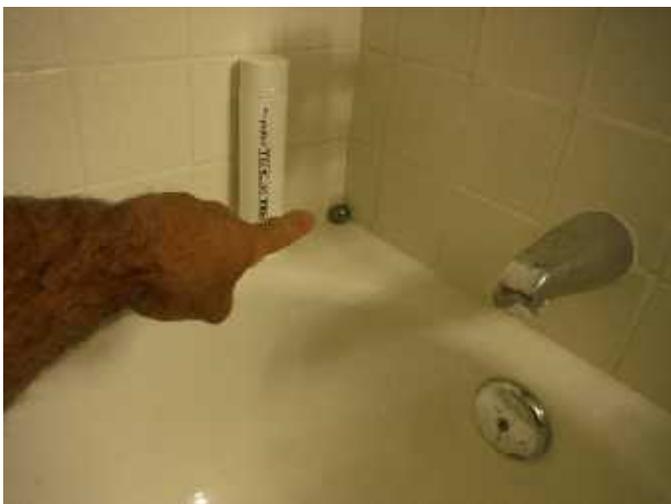
\* With water sitting on the bathtub rim there is potential for moisture to migrate under the shower enclosure walls and come in contact with the wall materials behind the shower enclosure walls. The improperly sloped bathtub rim does not meet minimum installation requirements for draining all shower spray to the bathtub vessel drain and is a **MAINTENANCE DEFICIENCY CONDITION**.

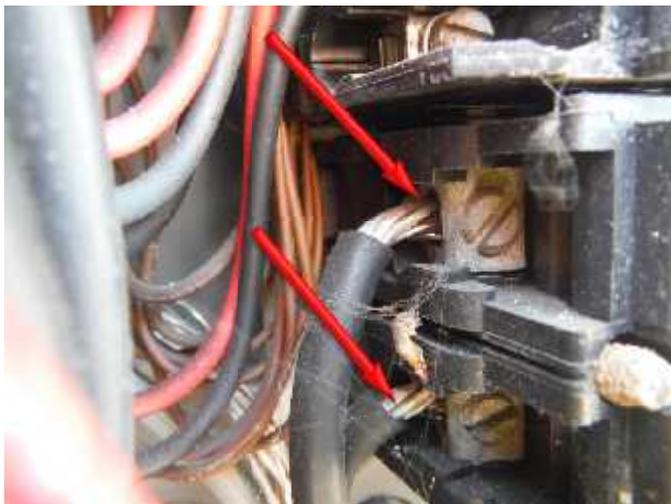
\* The lack of antioxidant paste on strand-aluminum connections does not meet the requirements of the manufacturer or building standards, could allow a separation between the stranded aluminum wiring and the breaker connection that can cause overheating of the connection, and is a patent **SAFETY HAZARD CONDITION**.

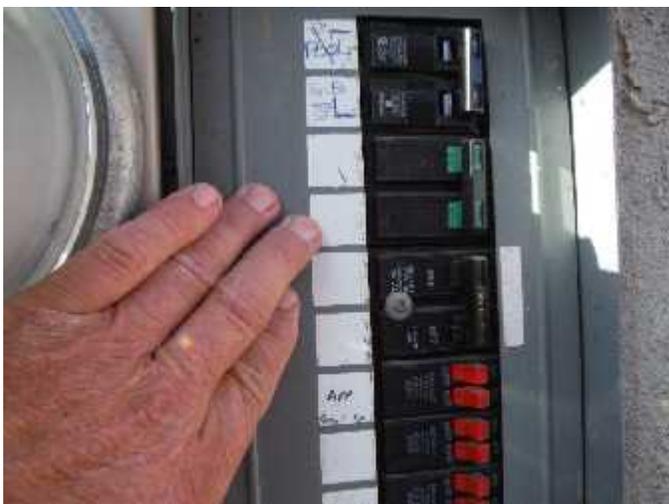
\* The lack of labeling for each circuit's use will inhibit repair and emergency access when shutting off a specific electrical circuit. The lack of labeling for each electrical circuit's use does not meet minimum modern building and safety standards, and is a patent **SAFETY HAZARD CONDITION**.

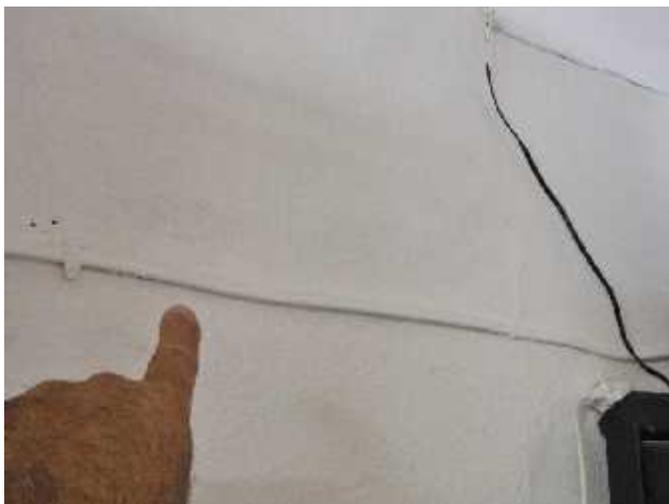
\* Accessible exposed horizontal wiring in garages is prohibited by building standards to protection children from being in contact with damaged electrical wiring while pulling or climbing on the exposed wiring. The lack of adequate protection for the Nonmetallic Sheathed Cable (Romex) does not meet minimum building and safety standards and is a **SAFETY HAZARD CONDITION**.

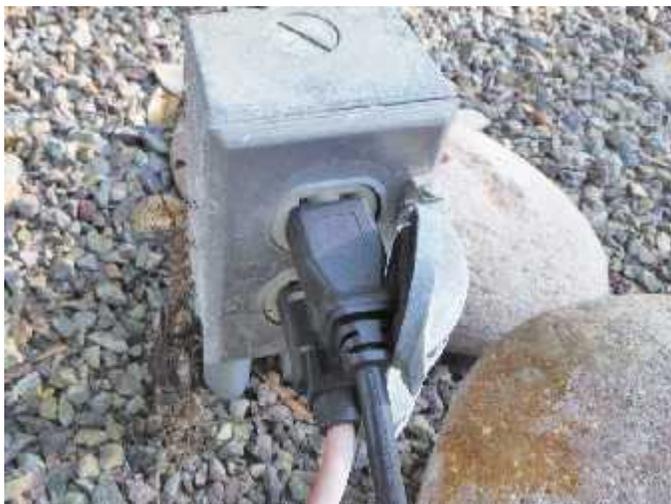
\* The lack of a bubbled exterior cover-plate will allow rainwater into the outlet interior, does not meet minimum building standards, and is a **SAFETY HAZARD CONDITION**.

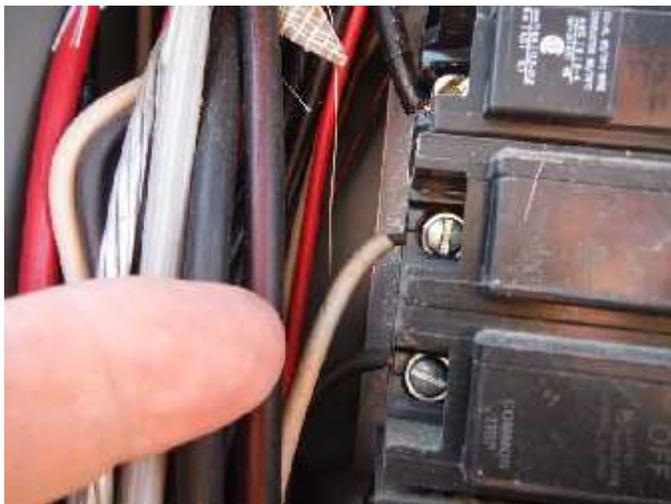
\* The use of a white wire is prohibited by minimum building standards in order to reduce the risk of someone contacting the white wire assuming it is as still neutral conductor. The white wire being used as a hot conductor and no properly coded as no longer a neutral and is a **NOT FUNCTIONING PROPERLY CONDITION**.

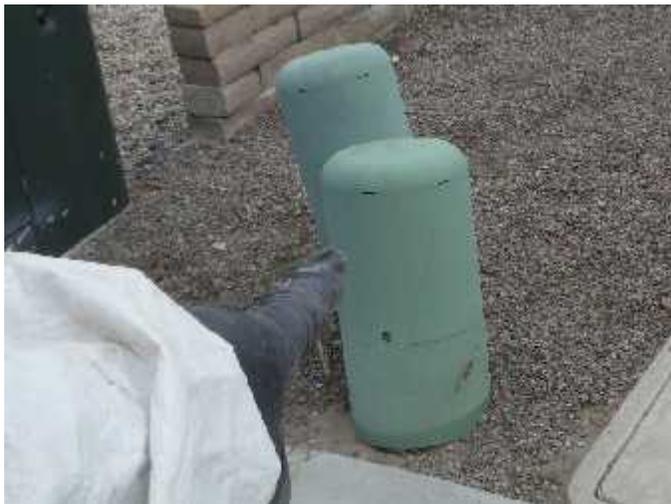
\* The front yard Utility boxes are an **UNKNOWN CONDITION AND DEFERRED.**

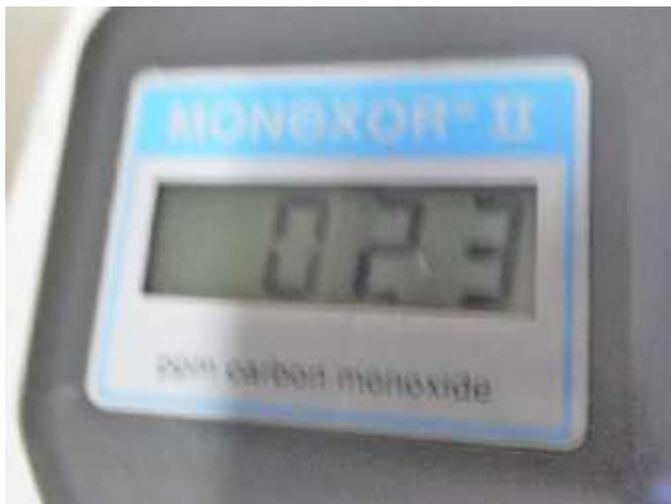
\* Consistent with the year the furnace was built the furnace is very inefficient allowing a large percentage of the Btu consumption to escape out the furnace flue. Consistent with the year the furnace was built the furnace appliance components, heat exchanger, gas valve, and limit safety switch, are all past their service life and cannot be relied upon to function safely. The older central forced-air furnace is an **END OF SERVICE LIFE - MATERIAL DEFECT CONDITION**.

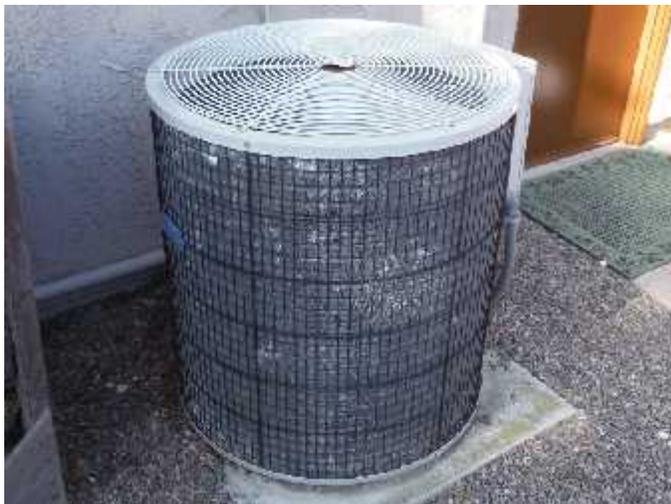
\* The split-system air-conditioner condensing unit and evaporator coil are older, have exceeded the expected service life, and even if serviced and repaired cannot be relied upon to continue to operate as intended. The older split-system air-conditioner equipment is an **END OF SERVICE LIFE - MATERIAL DEFECT CONDITION**.

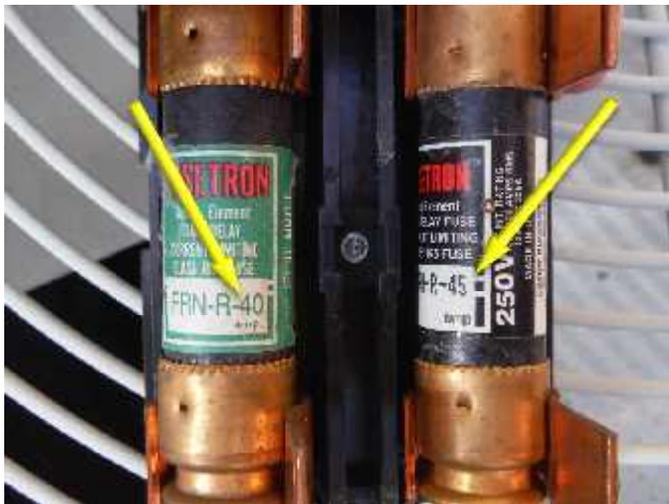
\* The different amperage fuses for the exterior condensing unit does not meet the minimum manufacturer requirements, could void the manufacturer warrant coverage for the condensing unit equipment, could damage the condensing unit electrical components by not supplying the needed amperage the condensing unit needs to operate properly, and is a patent **NOT FUNCTIONING PROPERLY CONDITION**.

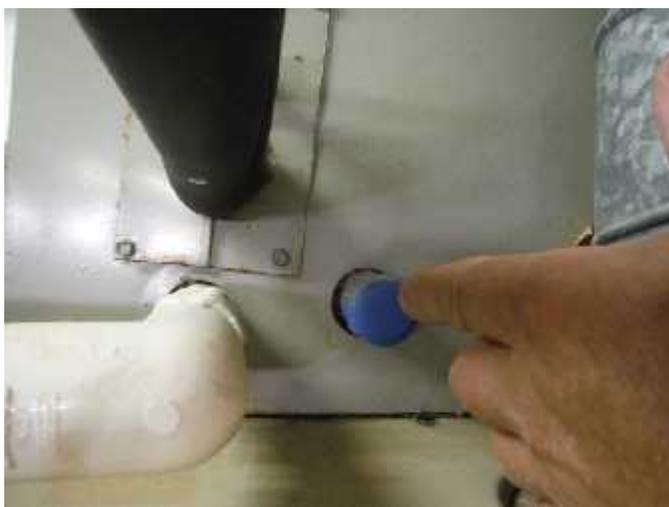
\* The lack of a secondary condensate drain piping or any moisture activated emergency shutoff switch will allow spilled condensate water to saturate and potentially damage building components under the garage installed air-conditioning evaporator coil. The lack of secondary condensate drain piping or a moisture activated emergency shutoff switch with an closet installed air conditioning evaporator coil does not meet minimum building standards and is a **NOT FUNCTIONING PROPERLY CONDITION**.

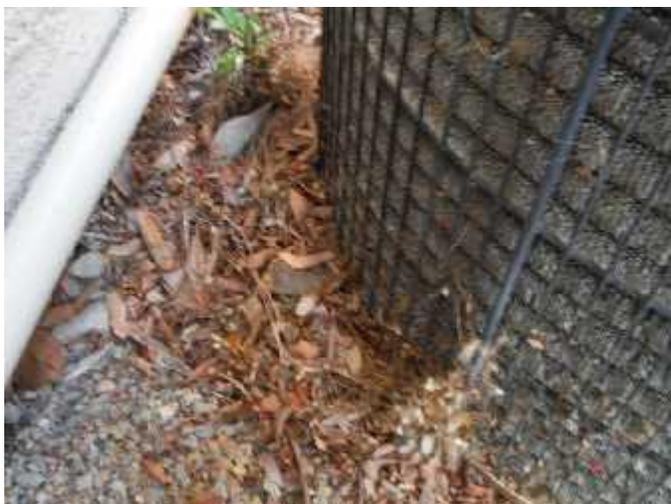
\* **Vegetation debris in contact with the air-conditioning condensing unit will not allow the condensing unit to release heat and cool the refrigerant returning to the interior evaporator coil. Vegetation debris in contact with the air-conditioning condensing unit allows moisture to be in contact with and eventually deteriorate the exterior air-conditioning condensing unit and is a **MAINTENANCE DEFICIENCY CONDITION.****

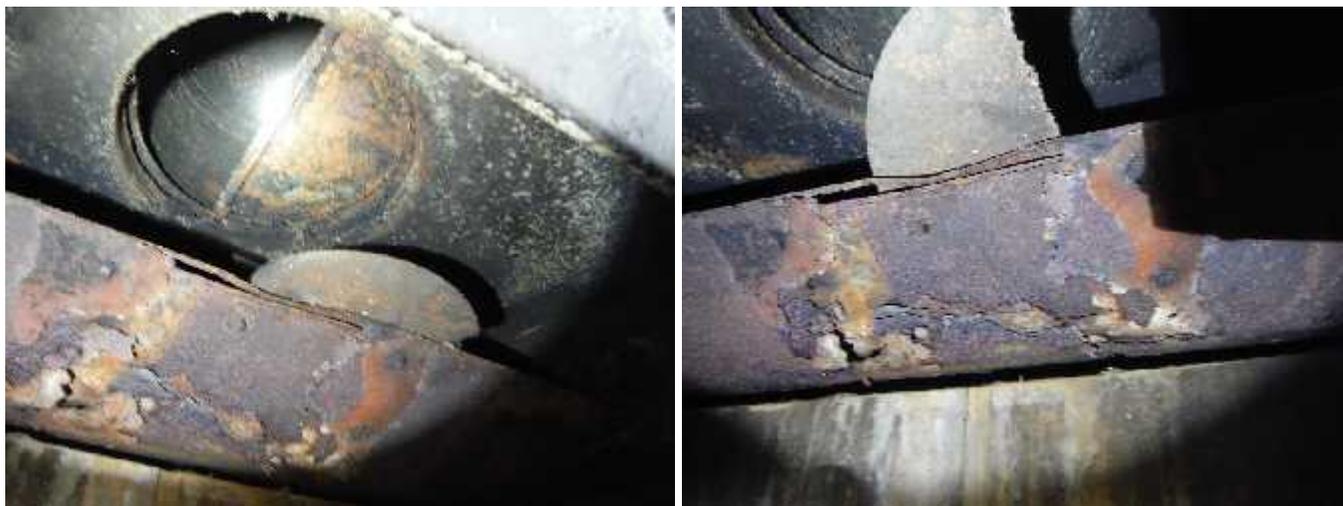
\* The extensive damage to the metal firebox throat area is a patent **SAFETY HAZARD – MATERIAL DEFECT CONDITION**.

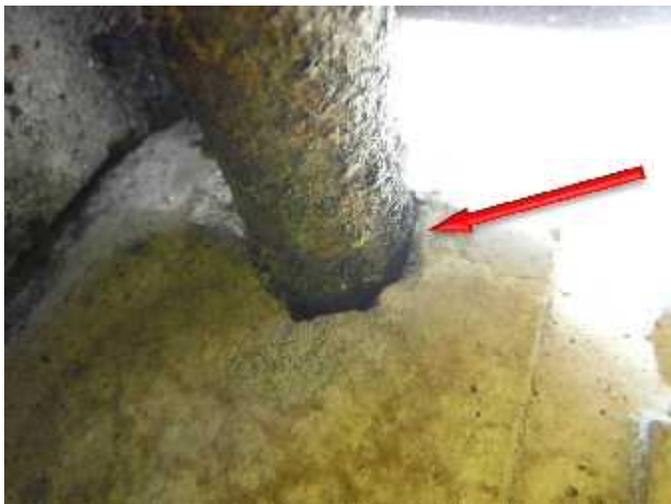
\* The open gap around the gas piping could allow heat to draft through the annular opening and into the components behind the firebox side refractory plate wall. The annular separation around the gas piping does not meet Manufacturer requirements and is a **SAFETY HAZARD CONDITION**.

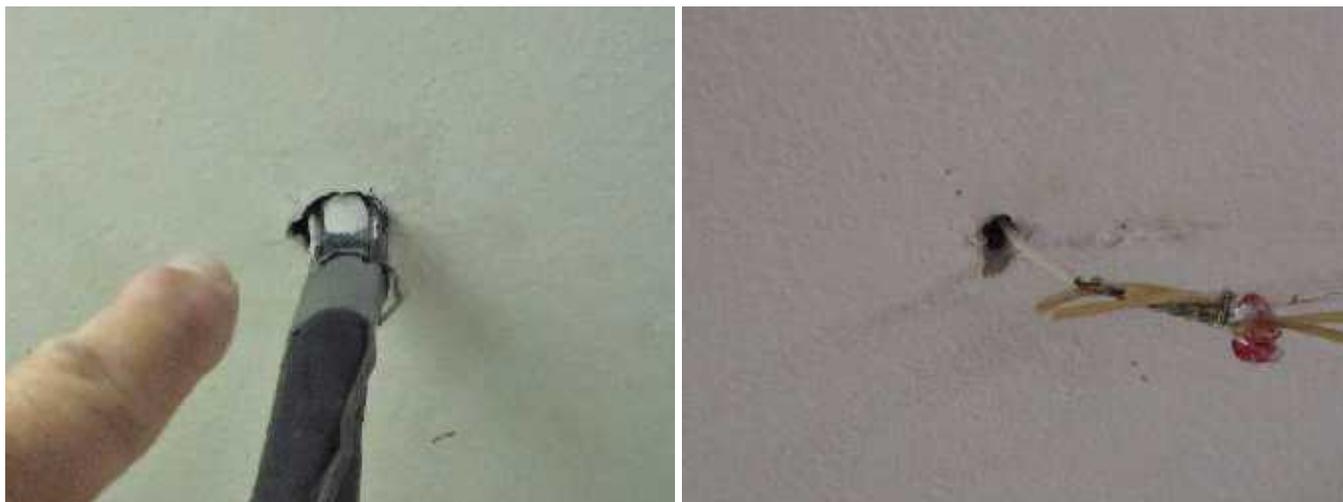
\* The annular gaps around the line-set and piping penetrations could allow a garage fire to seek oxygen through the open holes and spread into the dwelling attic structure. The openings through the garage fire-separation ceiling are a **SAFETY HAZARD CONDITION**.

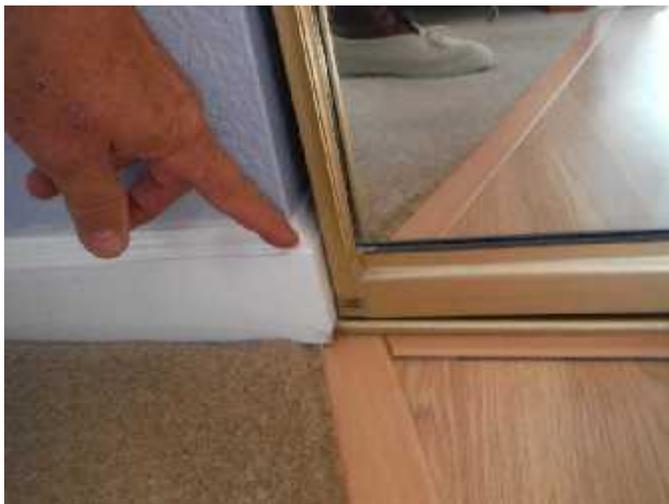
\* The constant hitting of the interior sliding mirrored closet doors to their running baseboard molding can eventually cause the mirrored glass to shatter. The missing door bumpers are a **SAFETY HAZARD CONDITION**.

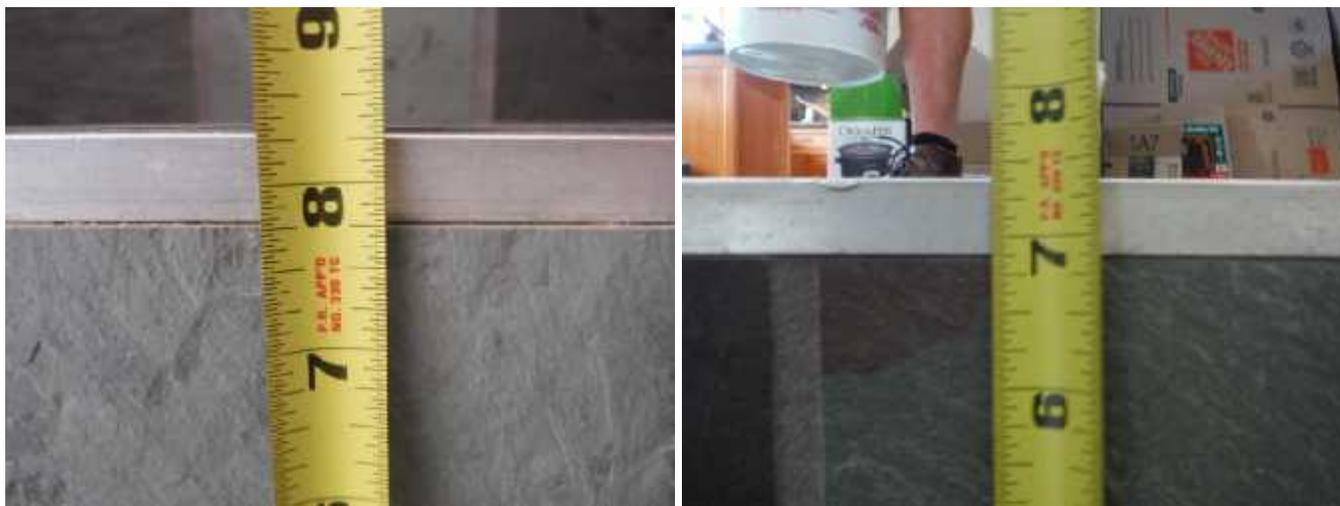
\* The excessive height of the bottom step does not meet minimum building standards, is a potential trip hazard, and is a **SAFETY HAZARD CONDITION**.

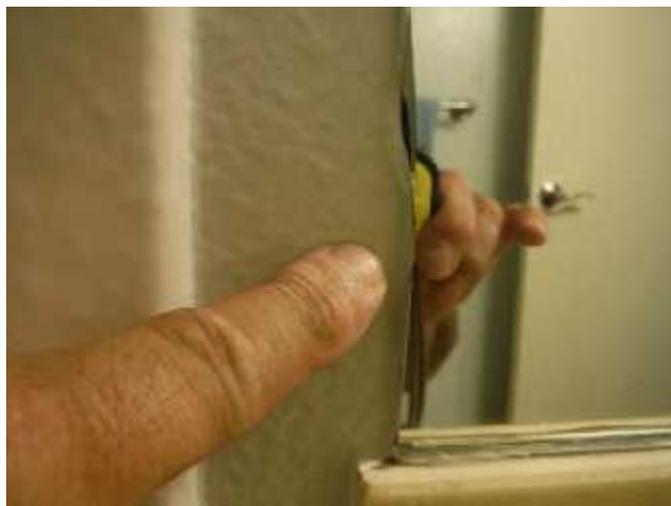
\* The broken glass in the wall mirror cannot be relied upon to continue to hold together and is a patent **SAFETY HAZARD CONDITION**.

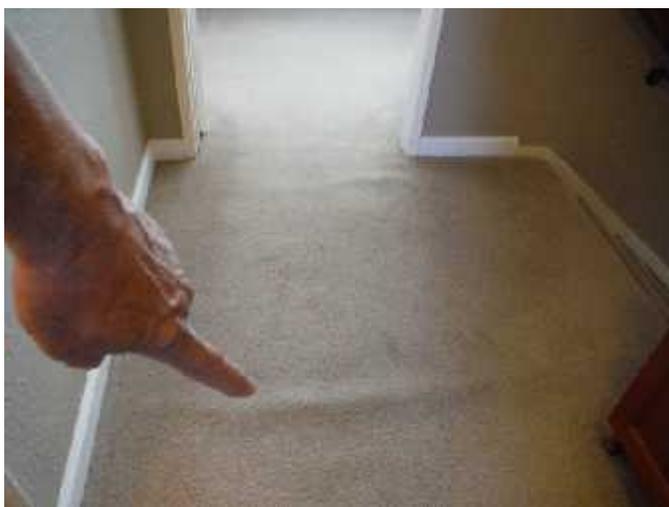
\* The buckling carpeting will continue to buckle until damaged or it becomes a trip hazard. The buckling carpeting is a **NOT FUNCTIONING PROPERLY CONDITION**.

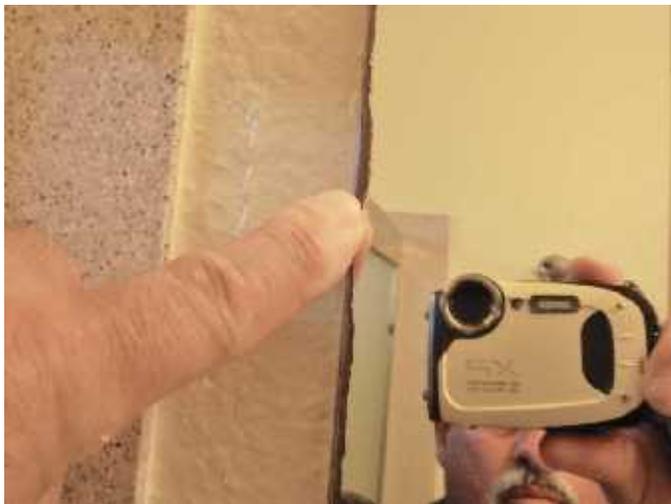
\* The damaged reflective backing will continue to corrode until replacement is warranted and is an **END OF SERVICE LIFE CONDITION**.

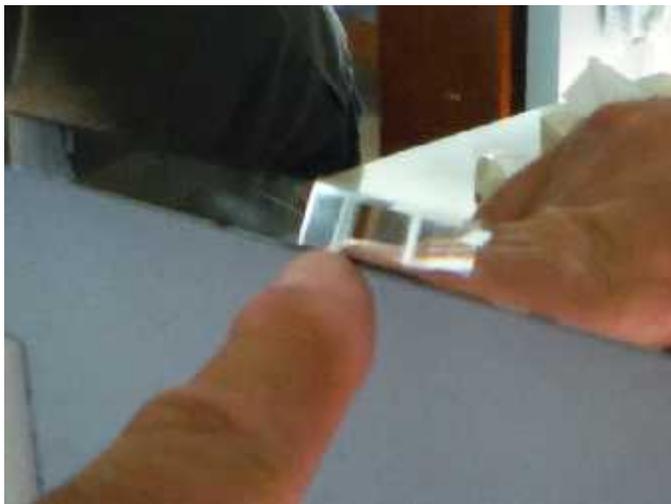
\* The deterioration of the bathroom mirrors will continue until the bathroom mirror looks so unsightly that it is time to replace the damage medicine cabinet. The unsightly bathroom medicine cabinet mirror is an **END OF SERVICE LIFE CONDITION**.

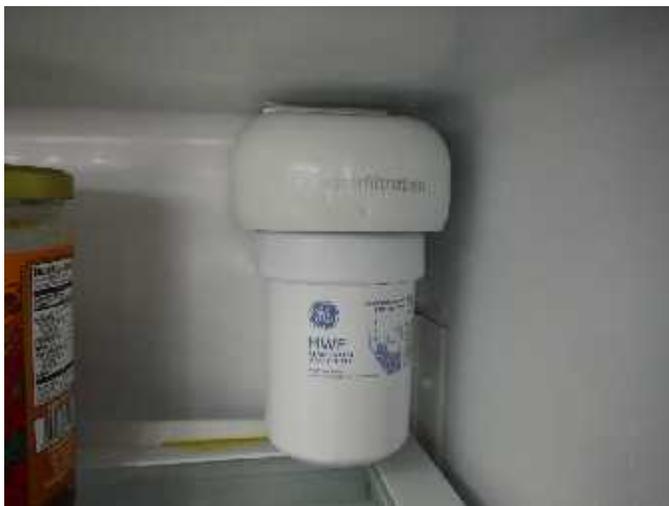
\* When the refrigerator water dispenser water-filter was last replaced is not known and should be changed at the change of ownership of the property. The operation and function of the water dispenser is beyond the understanding of Asset Inspection & Consulting Services to discover defects associated with those components. The refrigerator water-filter and water dispenser are an **UNKNOWN CONDITION AND DEFERRED**.

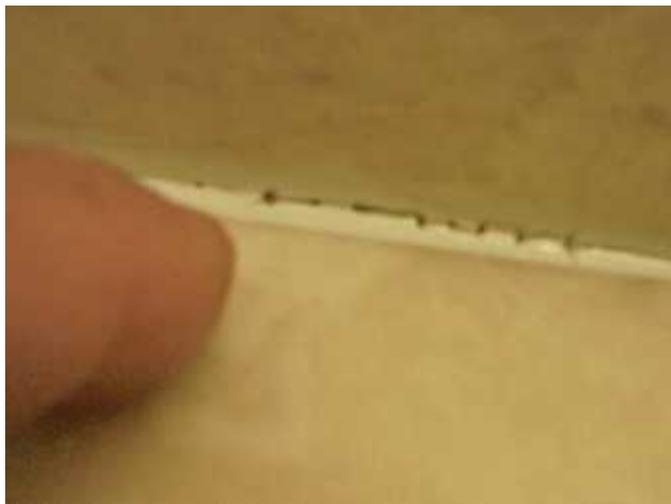
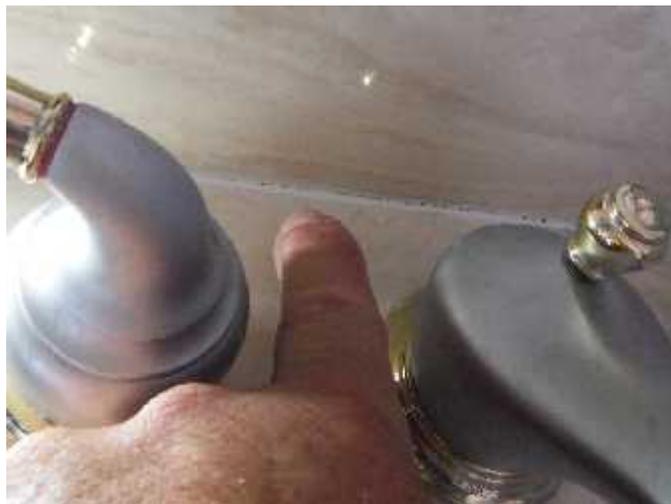
\* The open gap can allow moisture behind the countertop surface material into the cabinet / wall substrate which can swell from moisture saturation. The open separation between the bathroom countertop and backsplash material is a **MAINTENANCE DEFICIENCY CONDITION**.

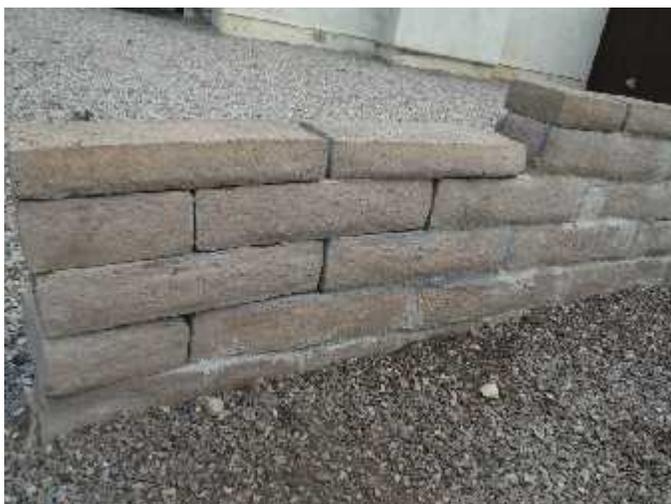
\* The masonry short wall was obviously damaged and was not repaired with mortar so the masonry blocks are just stacked upon each other and can easily fall. The substandard repair to the damaged masonry short wall is a **NOT FUNCTIONING PROPERLY CONDITION**.

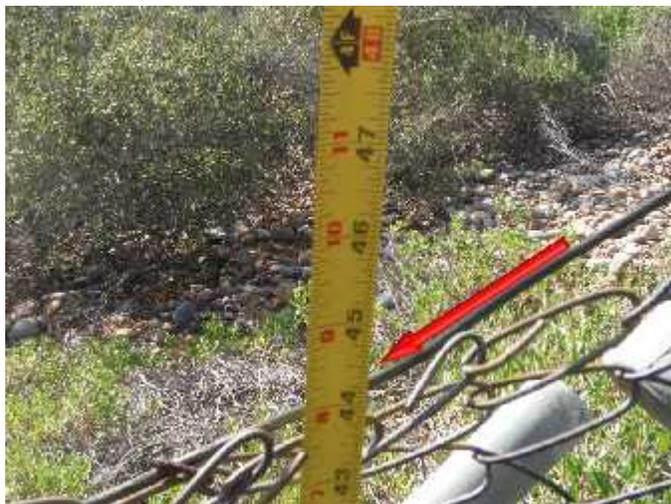
\* The minimum California safety building code requires safety barrier fencing for pools with spas to be a minimum of 60-inch high from grade level (on both sides of the fencing) and completely around the yard with the pool with spa in order to control unsupervised access to the pool or spa waters, which, historically have had horrific consequences. The less than minimum 60-inch high safety barrier fencing is a **SAFETY HAZARD CONDITION**.

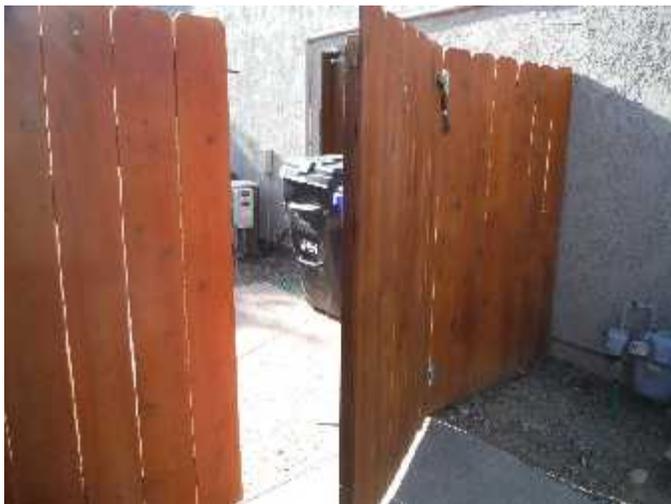
\* City of San Diego minimum health and safety requirements for protective barriers to prevent drowning requires that all gates accessing yards with pools be self-latching to prevent unattended access to a yard containing a pool. The lack of self-latching barrier gates for the pool / spa area does not meet minimum safety standards to prevent child drowning. The improperly not self-latching gate is a patent **SAFETY HAZARD CONDITION**.
