# Property Inspection Report

XXXX Xxxx Street, San Diego 92XXX

Report Number: 15XXXX0319A Xxxx 1881sf 1985 Slab Pool

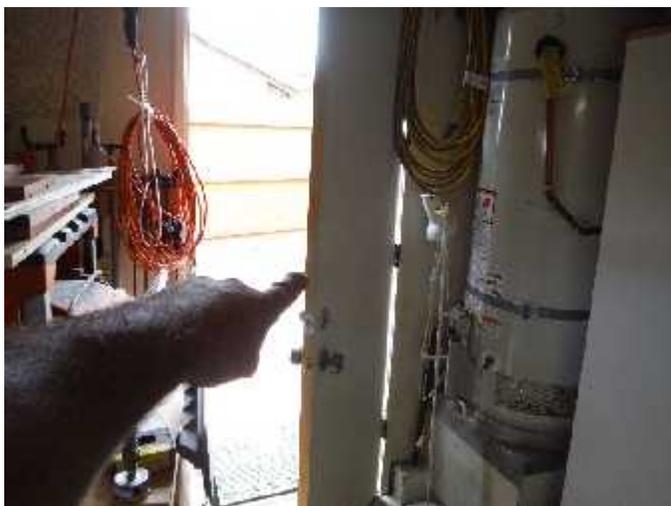
\* Doors accessing yards with pools and spa vessels through the interior must be self-closing and self-latching or contain alarms to prevent unattended access to a yard containing a pool or spa and potential drowning. The lack of an operating self-closing and self-latching mechanisms or alarms for the pool barrier-doors is a patent **SAFETY HAZARD CONDITION**.

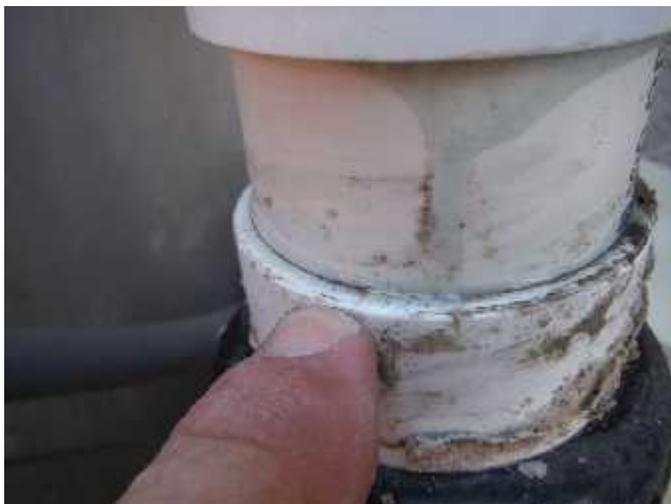
\* The leaking return piping will continue to leak wasting water until repaired. The leaking return piping is a **NOT FUNCTIONING PROPERLY CONDITION**.

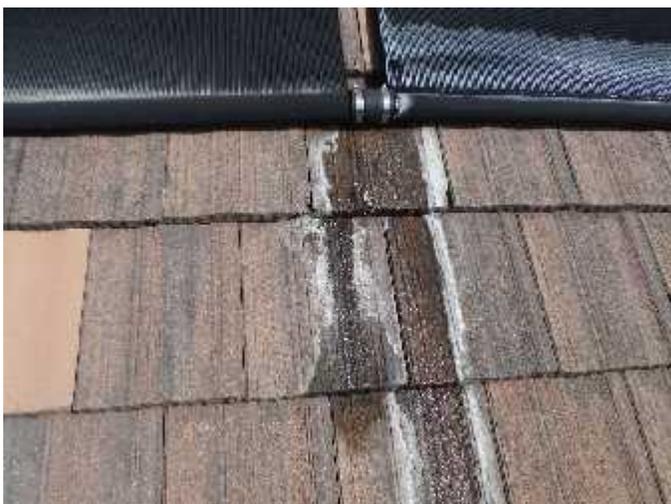
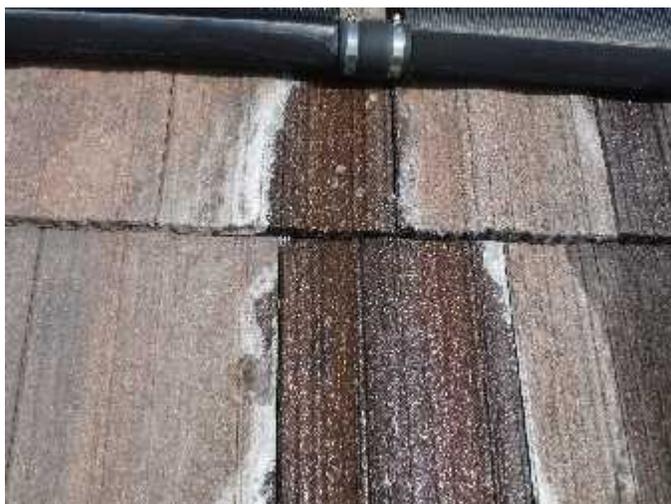
\* The leaking solar manifold piping will continue to leak until fixed and is a **NOT FUNCTIONING PROPERLY CONDITION**.
