Treasure State Acres Road Maintenance Plan

DRAFT 2015 REPORT

**Lewis & Clark County
Public Works Department
and
Treasure State Acres Homeowners Assoc.**

Robert Peccia & Associates
Helena & Kalispell, Montana
RPA Project: 14513.000

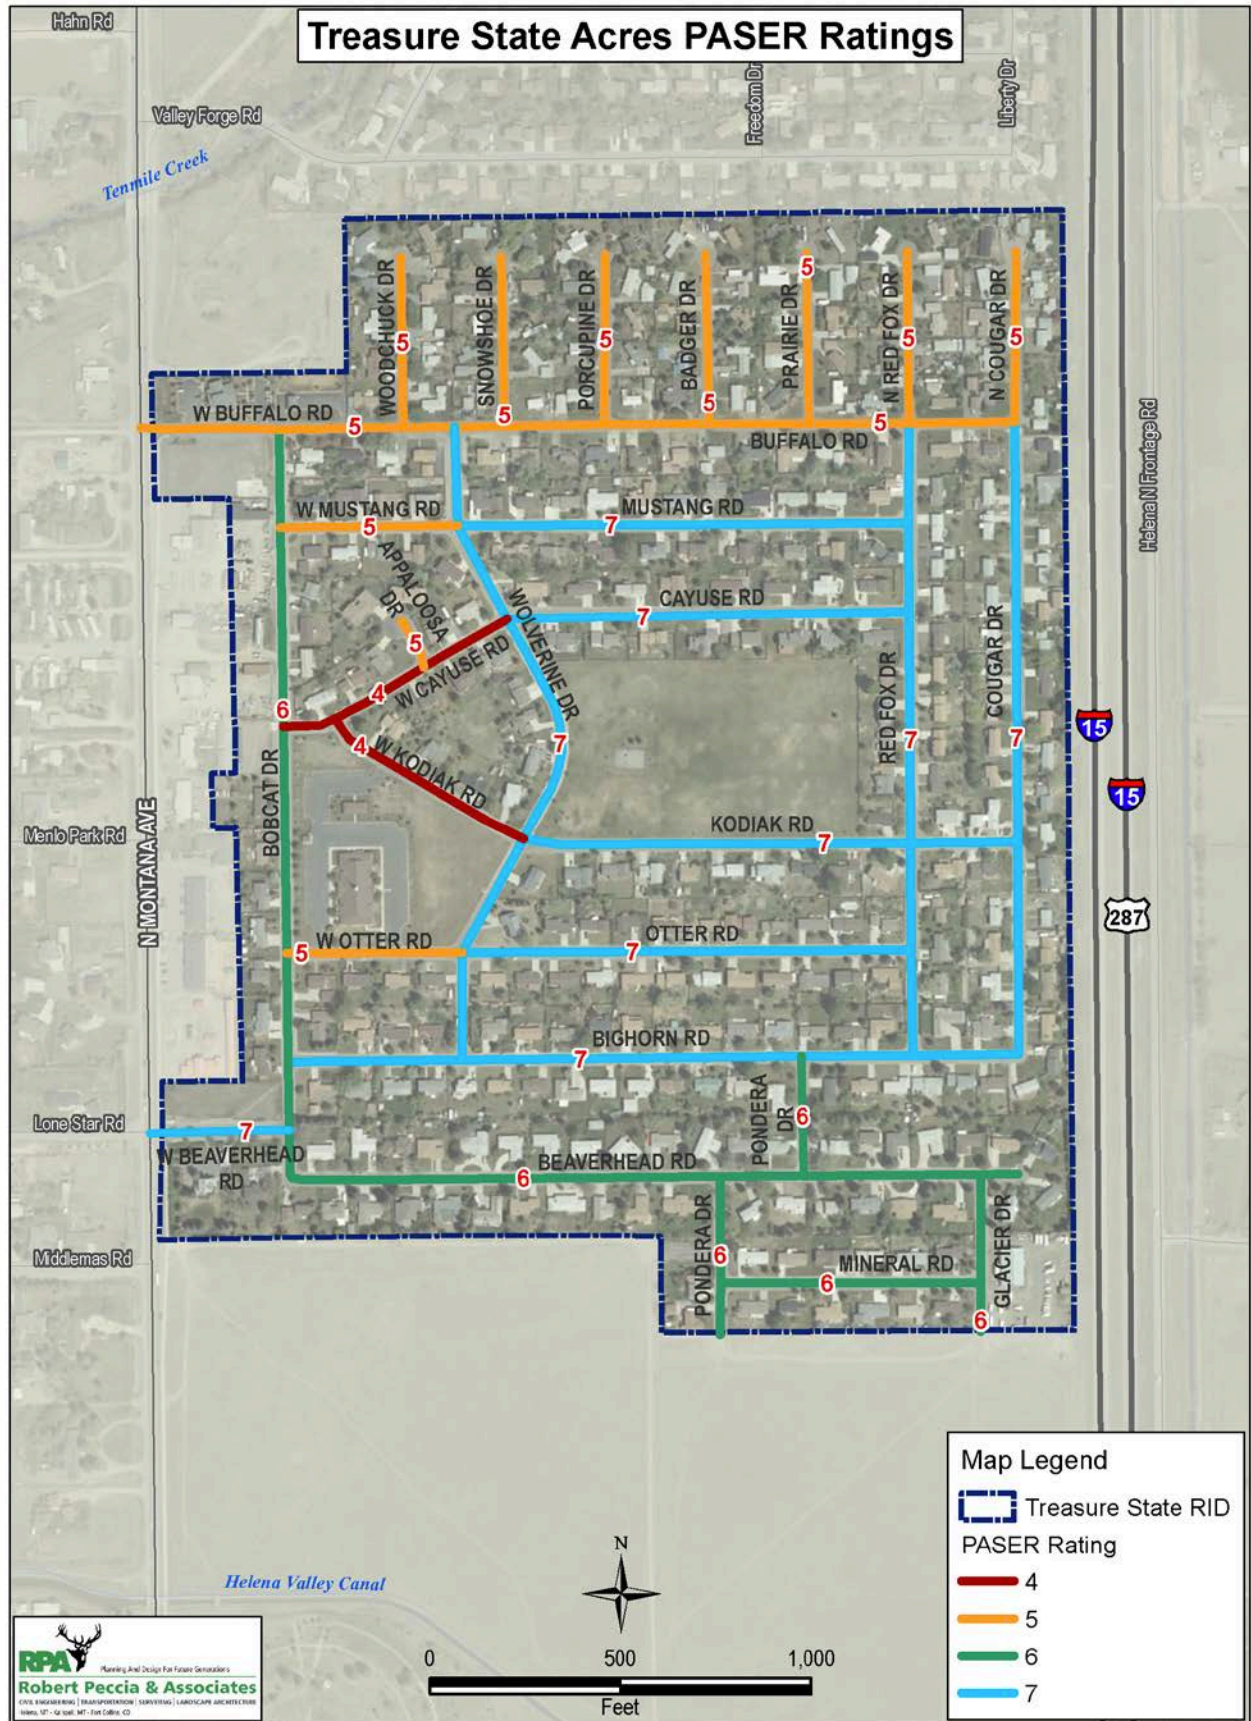
Figure 2-2: 2015 PASER Ratings of Paved Roads Assessed

Roadway ratings are summarized in **Table 2-7**. The paved roads were rated on a scale of 1 to 10, with 1 being “failed” and 10 being “excellent” per the PASER rating process (appendices). See **Appendix C** for more information on each TSA road rating.

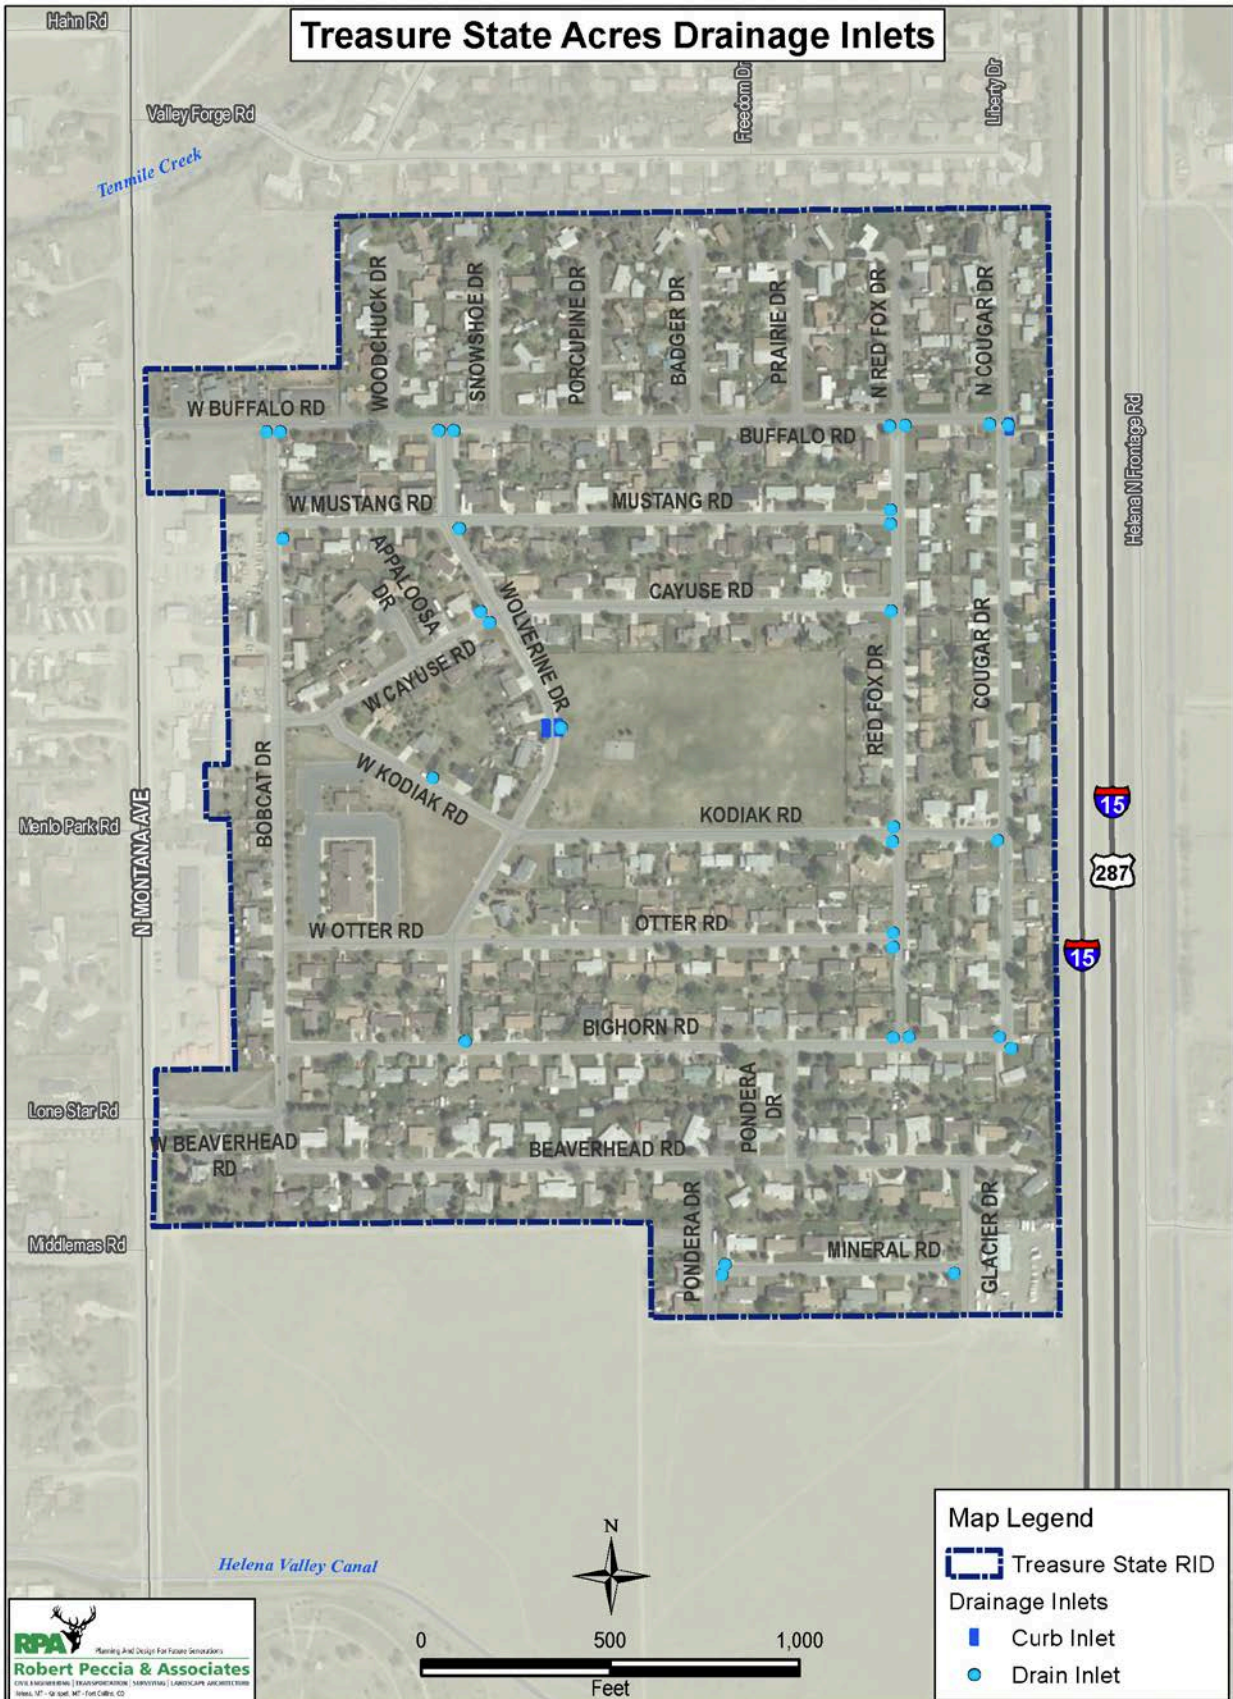
Figure 3-1: Treasure State Acres Drainage Inlets

Many of the infiltration inlets pond during spring snow melt and/or significant precipitation events. This is likely caused because the inlets are undersized to handle the flows and the infiltration capacity of the inlets has diminished over time due to sedimentation and clogging.

There are many ways to improve the drainage system for TSA. More traditional, and costly improvements, would include a collection system of inlets, manholes and pipes that would collect storm runoff and convey it to a centralized infiltration facility or discharge point. These types of systems are effective, but costly due to the amount of inlets, manholes, pipes, deep excavations, and roadway reconstruction. Presently TSA does not have surface areas available for storm drainage outfall discharges.
