RE: SCEAP Grant EPG-104-16

Please find enclosed the Facility Plan for wastewater treatment and collection system improvements serving the City of Fair Grove, Missouri, for your review.

Gregory S. Perkins, P.E.
Senior Consultant/Project Manager
TREKK Design Group, LLC

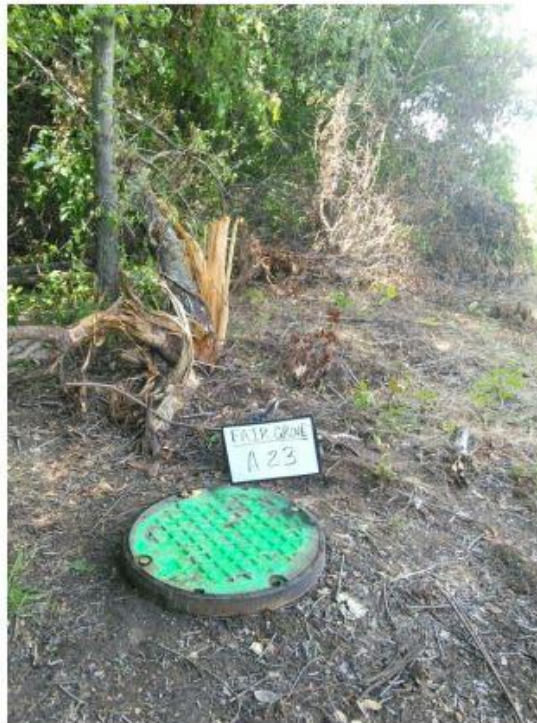
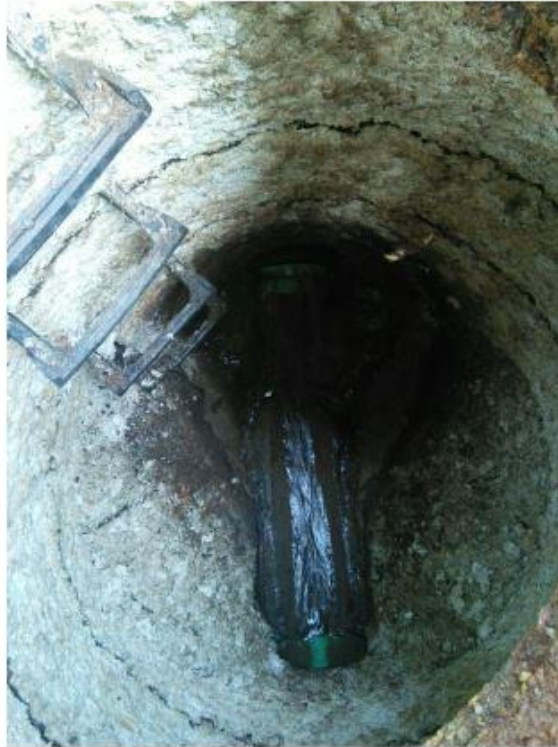
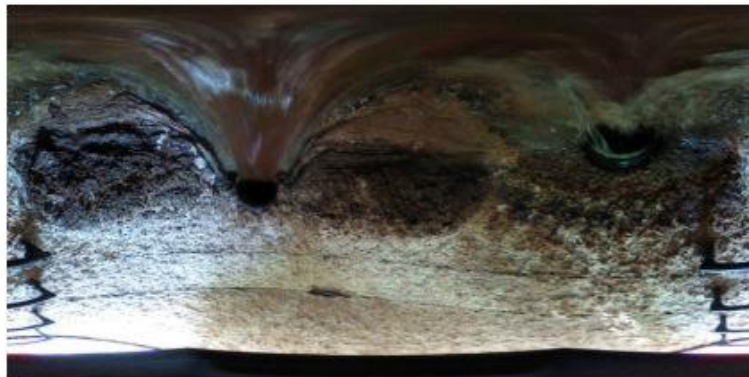
NE-092, Surface Inspection, Manhole

Manhole Depth	6.68
Manhole Material	Precast
Manhole Use	Sanitary
Frame Condition	Corroded
Cover Condition	Corroded
Surcharge	Yes
Infiltration and Inflow	Yes
Hydrogen Sulfide	Yes
Emergency Situation	No
Overflow	No
Location Details	Treeline

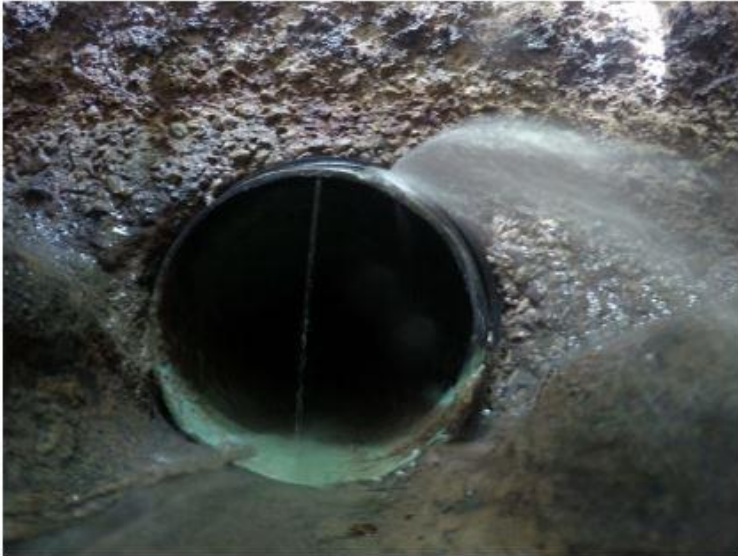
Additional Information	Moderate to severe Hydrogen Sulfide throughout manhole, 8-12 inches of manhole wall material sitting on bench from Hydrogen Sulfide, stream of Infiltration and Inflow above out pipe has worn 4x4 area in bench/trough, 4 inches flow at 5.25 feet per second
1, 10, Polyvinyl Chloride, Out, NE-091	
Pipe Number	1
Clock Position	12
Direction	Out
Connecting Manhole ID Number	NE-091
Invert Depth (Feet)	7.05
Pipe Size	10
Pipe Material	Polyvinyl Chloride
Pipe Photo

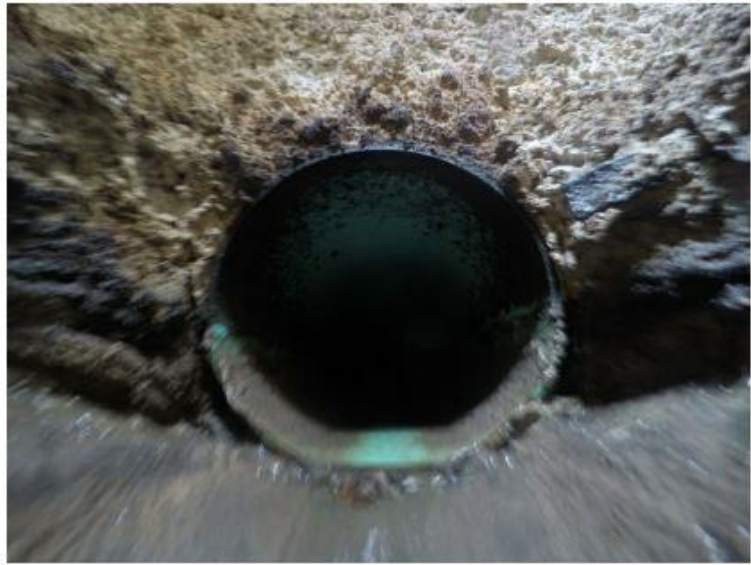
Acoustic Sounding Complete	Yes
Acoustic Sounding Test Number	2240
Acoustic Sounding Score	9
Acoustic Sounding Date	2016-11-22
Comments	I&I stream above pipe and around pipe seal.
CCTV Complete	No
2, 10, Polyvinyl Chloride, In, NE-093	
Pipe Number	2
Clock Position	6
Direction	In
Connecting Manhole ID Number	NE-093
Invert Depth (Feet)	6.3
Pipe Size	10
Pipe Material	Polyvinyl Chloride

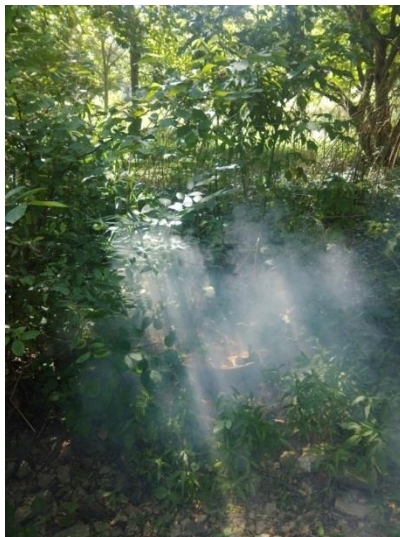
Figure 2-15: Smoke Testing Defect Examples

The photo to the left shows a manhole defect smoking in a creek bed identified during smoke testing in Fair Grove, MO. This is an example of a smoke testing defect found on the public side.

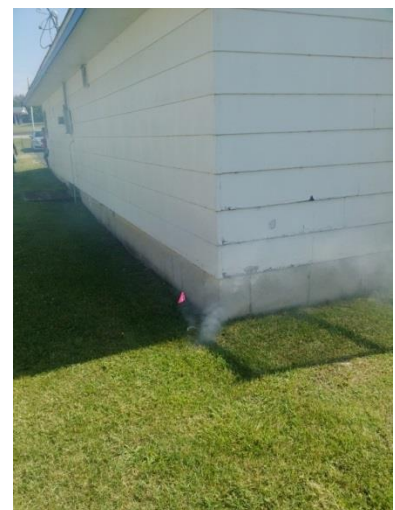
The photo to the right shows a cleanout defect identified during smoke testing in Fair Grove, MO. This defect is an example of a private side defect.

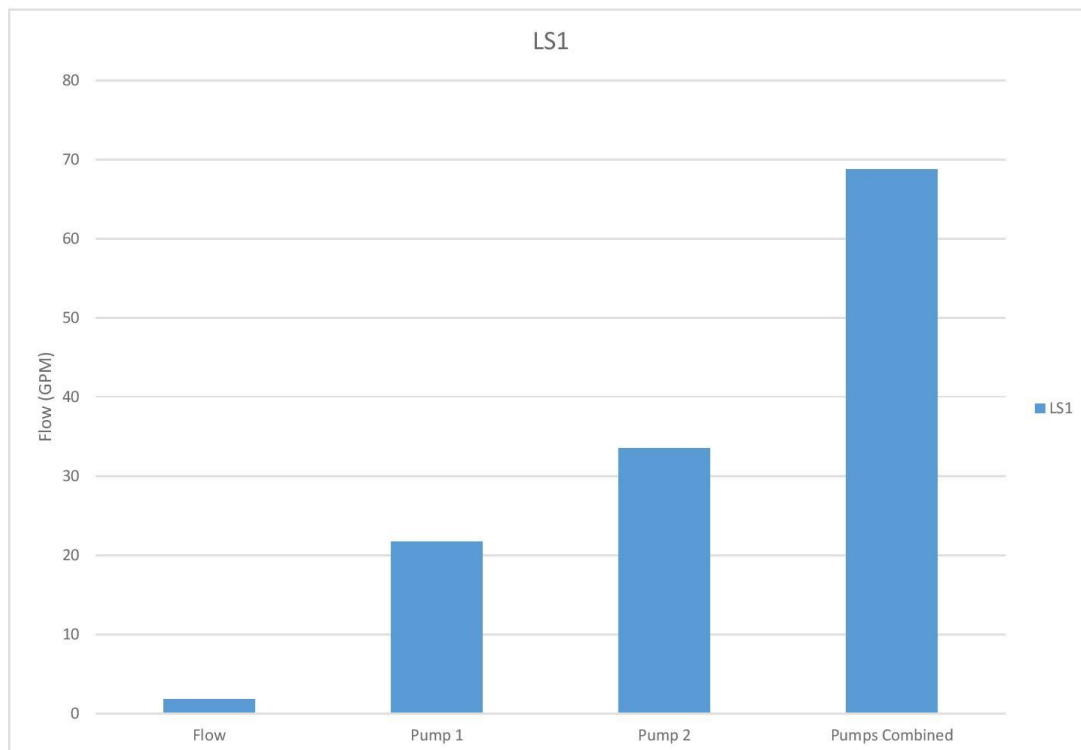
Figure 2-17: LS1 Lift Station Inspection

This lift station is located on the southeast side of Fair Grove. The lift station services a small number of houses along South Grove Road. A visual inspection was performed in February of 2017. Both pumps were found to be in working order and no defects were recorded.

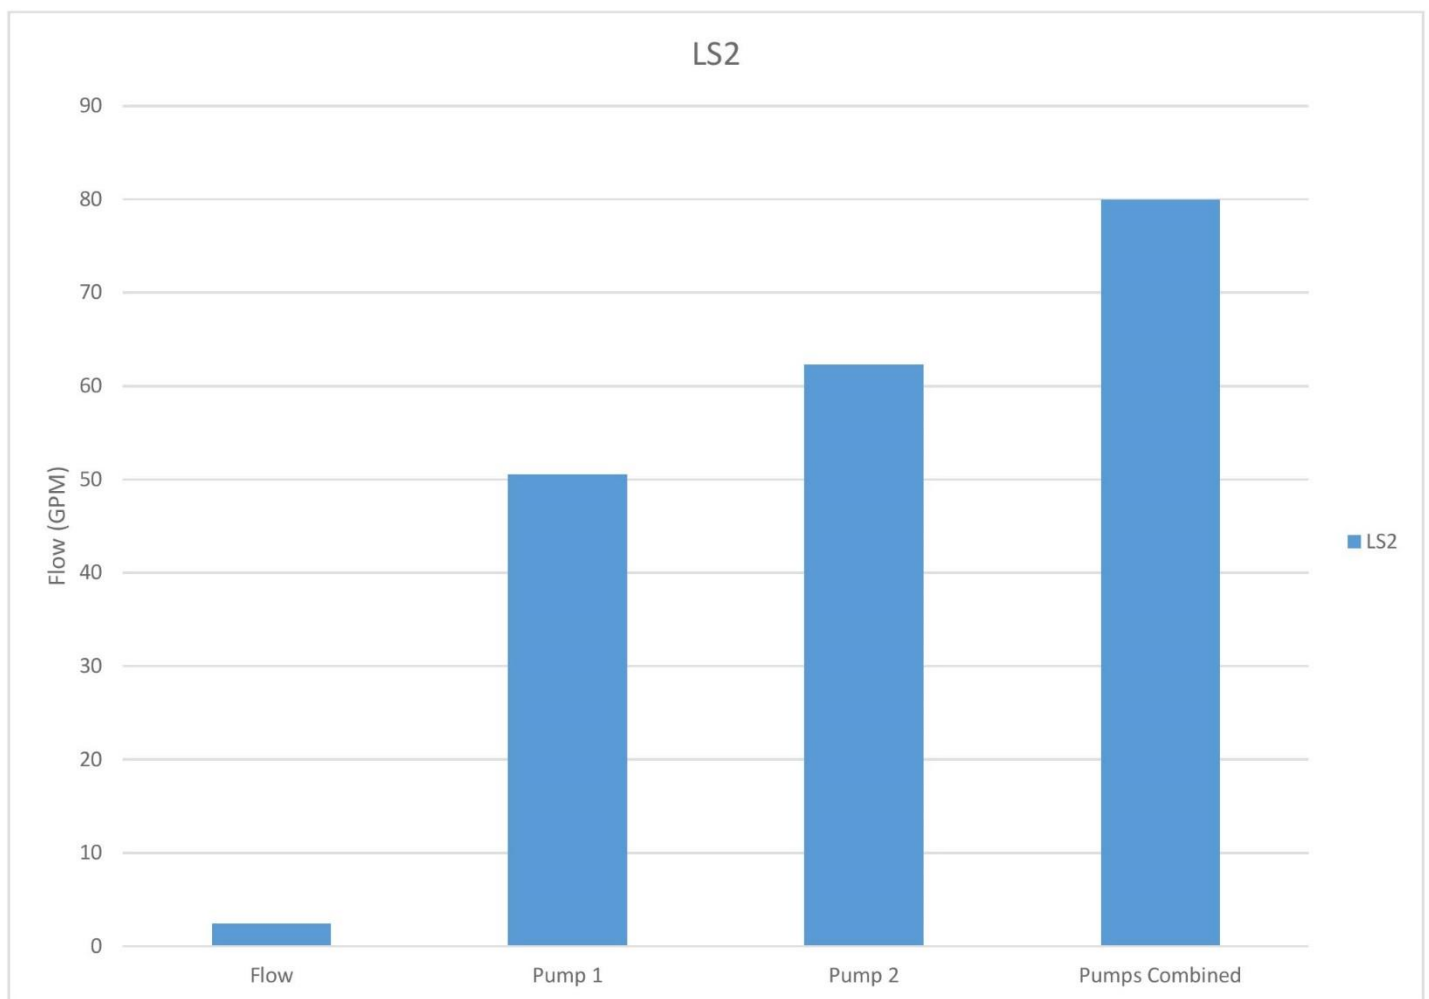
Figure 2-18: LS2 Lift Station Inspection

This lift station is located on the west side of the City. The lift station services the majority of flow from the town and pumps it back east towards the treatment plant and discharges into manhole NE-099. A visual inspection was performed in February of 2017. Both pumps were found to be in working order and no defects were recorded. Manholes located downstream from the discharge of this lift station were found to have severe hydrogen sulfide damage during manhole inspections. These manholes have since been replaced. It is recommended to consider a chemical addition of a calcium nitrate solution such as Bioxide to be added to the main lift station to control the formation of hydrogen sulfide for corrosion protection.

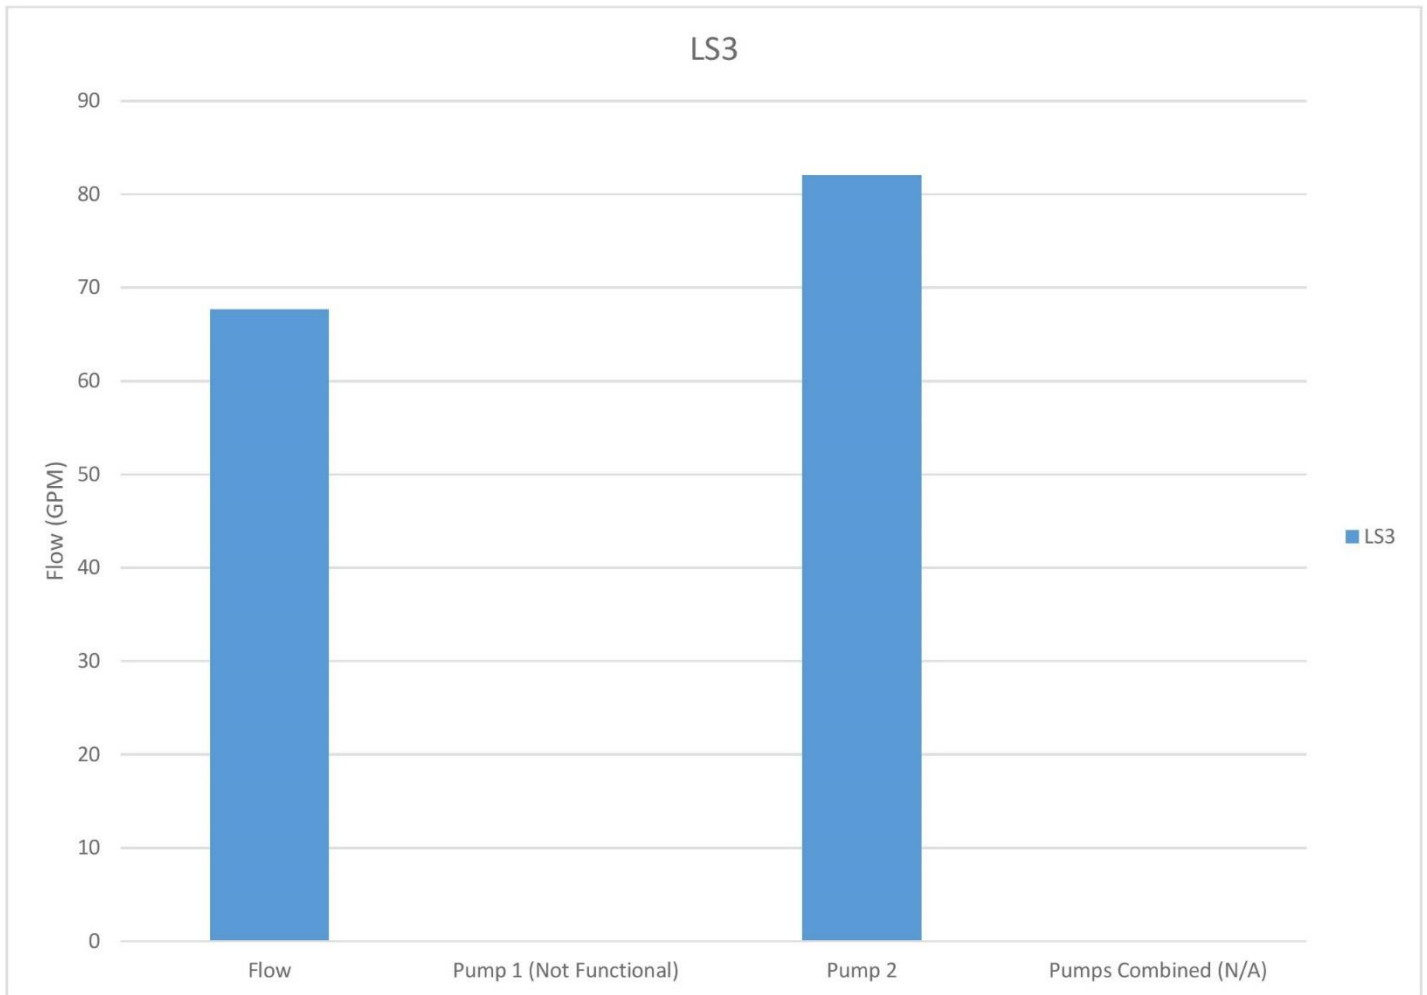
Figure 2-19: LS3 Lift Station Inspections

- All 3 of the City lift stations were inspected. Each lift station has 2 pumps and pump 1 at lift station 3 is not functional and needs to be repaired/replaced .

This lift station is located on the northwest side of the City. The lift station services a small number of residences along East Northview Circle. A visual inspection was performed in February of 2017. One pump was found to be not functioning and the City was notified. This pump is to be repaired.

Inspections were performed on all three lift stations within the study area. All pumps were operational except for pump 1 in lift station 3. It is recommended that this pump be replaced or repaired to bring back to working order. It is also recommended the City consider a chemical addition of a calcium nitrate solution such as BIOXIDE to be added to the main lift station to help control the formation of hydrogen sulfate gas for corrosion control.
