SAGUACHE CREEK DIVERSION INFRASTRUCTURE INVENTORY

Structure Name: HODDING D 5

Date: April 12, 2019

Saguache Creek Stream Management Plan

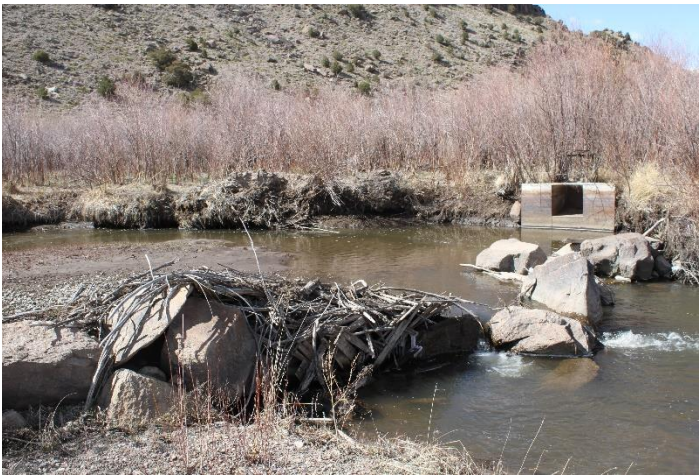
Diversion dam and headgate

Structure Description: This ditch is located on the outside of a meander. A boulder diversion dam directs flow to the headgate, which is located on the north bank of the river. Upstream of the diversion, the channel is very wide and shallow. The diversion has created a small island in its middle that forms two stream channels, one leading to the headgate and the other continuing downstream. Similar to Monk Ditch 3, a scour pool and island have formed downstream of the diversion dam. The meander downstream of the diversion is eroding.

Repair(s) or Improvement(s) Currently Needed: The flume does not measure accurately and should be reset or replaced. The diversion dam could be improved to more effectively divert water at low flows and have a lesser impact on the stream's function. Fish passage and riparian restoration should also be considered as part of any future repairs or improvements.
