CONEJOS RIVER DIVERSION INFRASTRUCTURE INVENTORY

Structure Name: BRANCH D

Date: April 15, 2019

Conejos River Stream
Management Plan

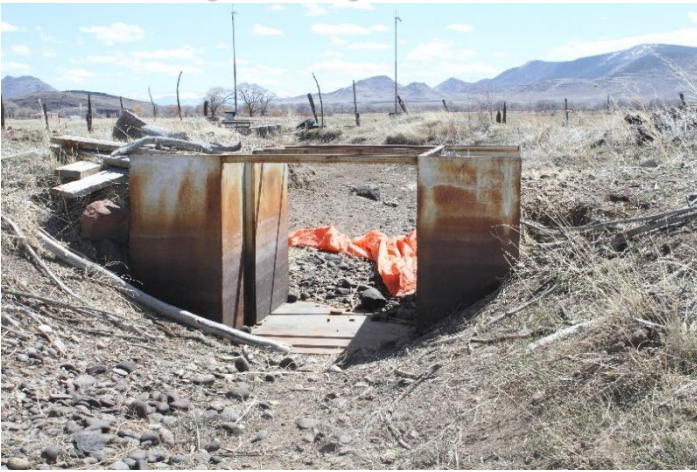
Structure Description: Located on the North Branch of the Conejos River. The channel is unstable in this location and prone to migration and avulsion. A checkboard diversion dam supported on either side by large tires created head pressure and directs water to the headgate. The soil supporting the headgate wing walls is eroding. The flume's wing walls are also eroding.

Headgate looking downstream

Repair(s) or Improvement(s) Currently Needed: Erosion affecting the headgate and flume needs to be addressed. The diversion dam could be improved with a more easily adjustable structure. Fish passage should be considered as part of any future repairs or improvements to the diversion. Riparian vegetation restoration should also be considered to reduce erosion and provide stream shading.

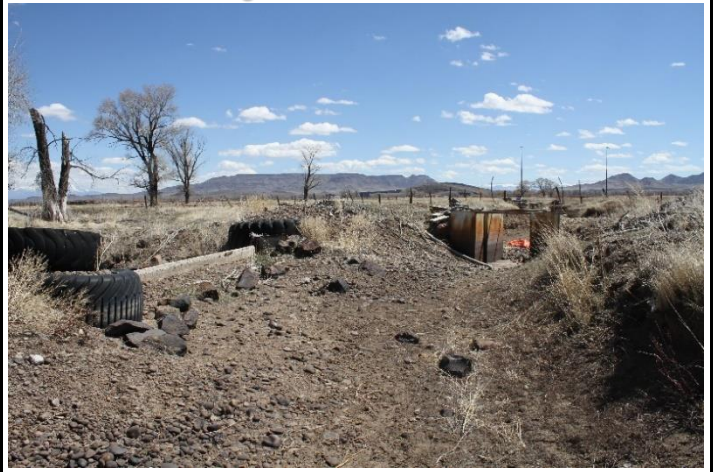
Headgate and diversion dam

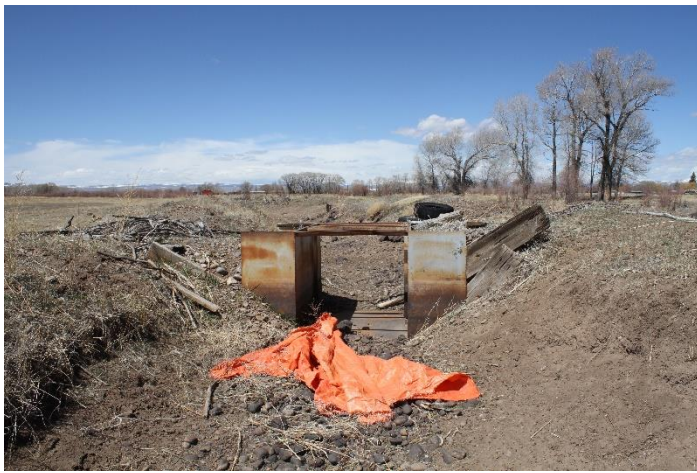
Headgate outlet

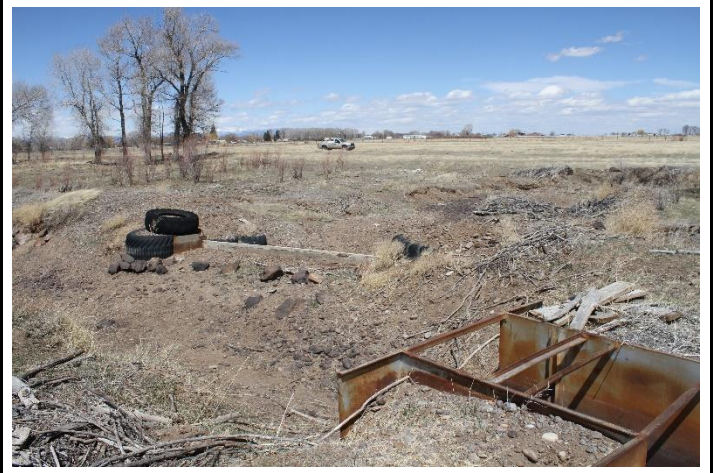
Diversion dam looking upstream

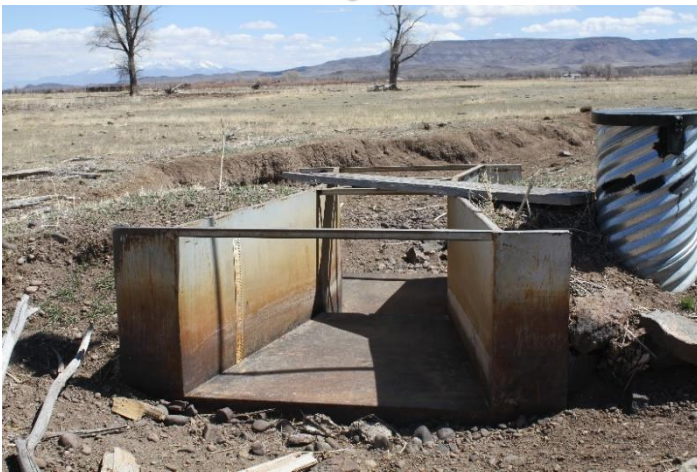
Flume looking downstream

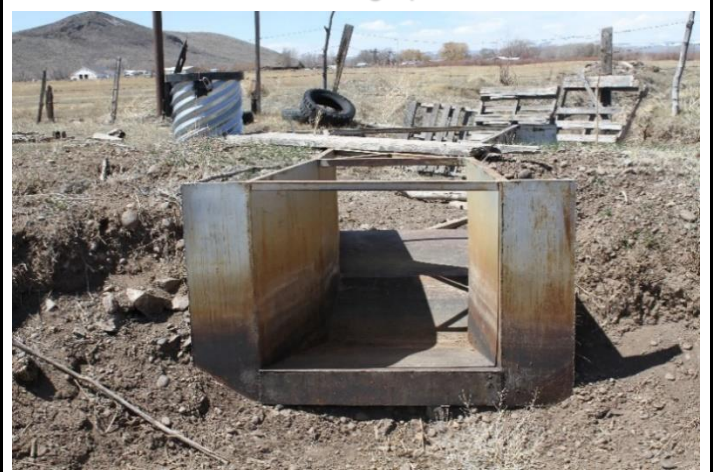
Flume looking upstream
