PB92-917004
NTSB/SIR-92/04

SPECIAL INVESTIGATION REPORT

MEDIUM/HEAVY TRUCK WHEEL SEPARATIONS

ADOPTED: SEPTEMBER 15, 1992

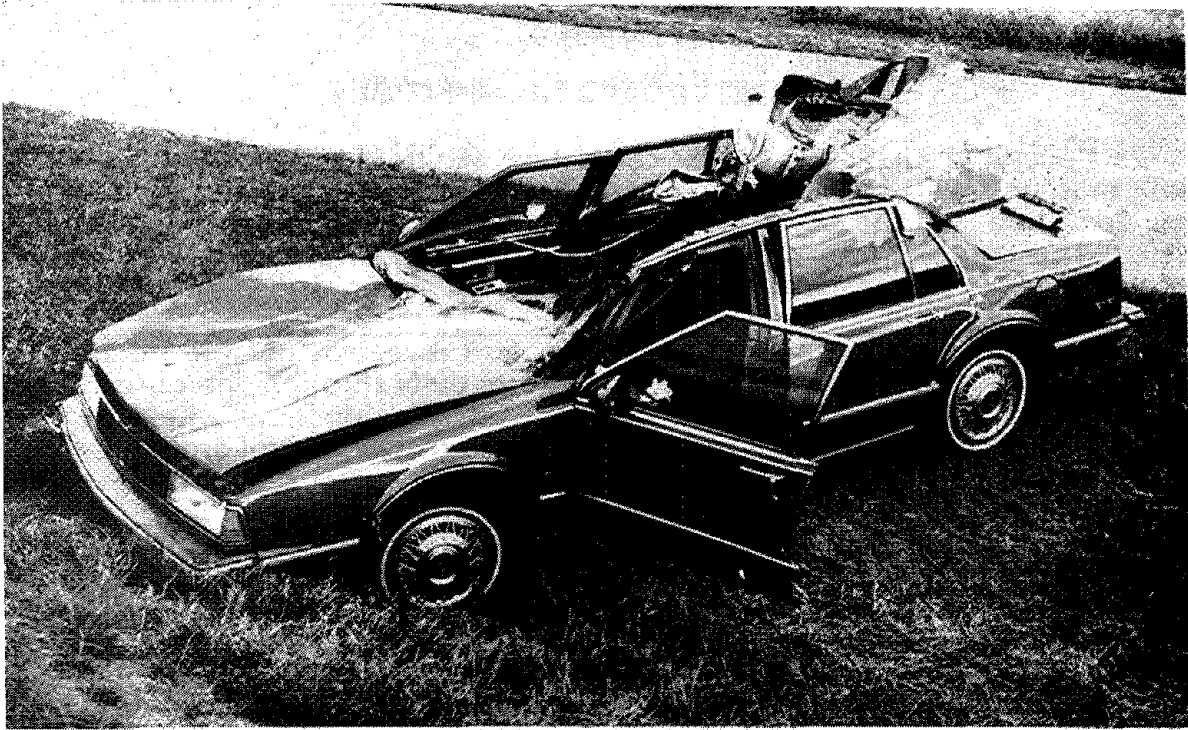
Warrior, Alabama -- On September 19, 1991, a 1986 tractor in combination with a loaded 1985 two-axle Great Dane 40-foot van semitrailer was traveling southbound on Interstate 65 and descending a grade when the left front dual wheels disengaged from the trailer. The loose wheels crossed the highway median and struck an oncoming 1989 Oldsmobile passenger car, killing the passenger and seriously injuring the driver. (See figure 3.)

Figure 3.--Damage to a 1989 Oldsmobile struck by a left front dual wheel in Warrior, Alabama.

Warrior, Alabama -- In the postcrash examination of the tractor/semitrailer, the Alabama Department of Public Safety investigators reported rust streaks near the stud bolts and nuts of the vehicle's third axle leftside, fourth axle rightside, and fifth axle rightside. Figure 7 shows the sheared bolts on the hub assembly of the accident vehicle.

Examination of four bolts from the wheel that separated from the trailer disclosed surface markings indicative of fatigue cracking. Most of the fractures were representative of rotating bending fatigue. If a nut is loose on a stud, when the wheel turns, the stud will bend and become subject to fatigue from all directions. Analysis showed that fatigue markings extended completely through the fractured cross section of three of the four studs examined. The full extent of cracking in the fourth stud could not readily be determined.

The Safety Board concluded that such fatigue would occur if the studs were not properly tightened. Inadequate clamping forces between the wheel and hub allow relative movement between these members. When this occurs, studs are subjected to rotating bending stress when the wheel rotates.

The investigators who examined the Accuride Corporation wheel and the Webb Wheel Product, Inc., hub determined in independent examinations that the dual wheels were contaminated with rust and old paint, that the stud holes were elongated, and that the raised metal from the elongations caused by the loose nuts precluded the full development of clamping force.

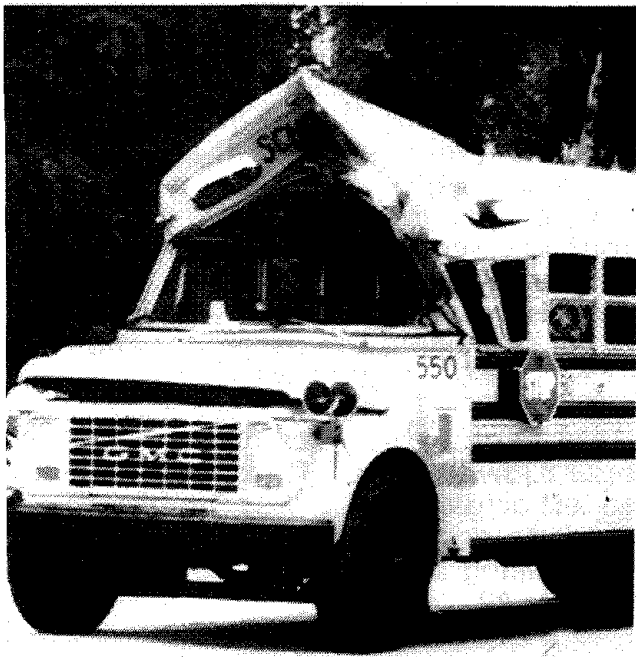
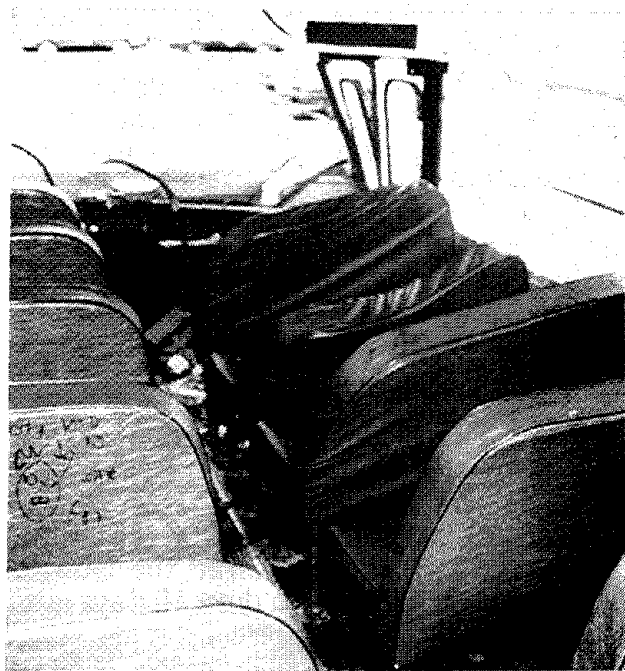
Miami, Florida -- On October 14, 1991, a 1986 Mack two-axle cargo van was traveling eastbound in heavy traffic on State Route 836 when the left front wheel, hub intact, disengaged. The loose wheel angled left across the highway, bounced over the 32-inch-high concrete center barrier, and struck an oncoming, occupied schoolbus. The wheel entered the front of the bus, killing two children and fatally injuring a chaperon, who died 10 days later. (See figure 4.)

Figure 4.--Left photograph shows damage to Miami, Florida, schoolbus. Right photograph shows interior damage caused when the truck wheel penetrated the front windshield of the bus.

Miami, Florida--At the postaccident inspection, Safety Board investigators were assisted by two engineers from Mack Trucks, Inc., the manufacturer of the accident vehicle. Investigators found a cotter pin fragment embedded in "cooked," or overheated, grease on the inside surface of the cap (see figure 10). The heat had fused the nut, lockwasher, and inner race of the outer bearing (see figure 11). A portion of the fused pieces had considerable accumulated rust. The excessive heat had also burned up the bearing and destroyed the bearing cage.

The investigators found the roller bearings had some flat spots, "galling," and "pitting" (see figure 12). According to engineers, these deficiencies are characteristic of "long-time" wear resulting from a lack of grease, improper grease, or the presence of water. When they checked the hub cavity, investigators found that the amount of grease was "almost unmeasurable," as opposed to 9 ounces specified by the manufacturer.

On-scene investigators concluded that lack of maintenance, specifically, proper lubrication, caused the wheel bearing to seize. They determined that the lack of grease on the wheel bearing, together with accumulated rust on the spindle and outside bearing, resulted in the following scenario:

1. The bearing progressively seized and overheated.
2. The bearing fused with the retaining washer and retaining castellated nut.
3. This "fused assembly" started to rotate according to the forward wheel motion.
4. The lock tab on the retaining washer broke.
5. The cotter pin sheared off.
6. The fused assembly started to unscrew progressively until the complete wheel assembly became loose.

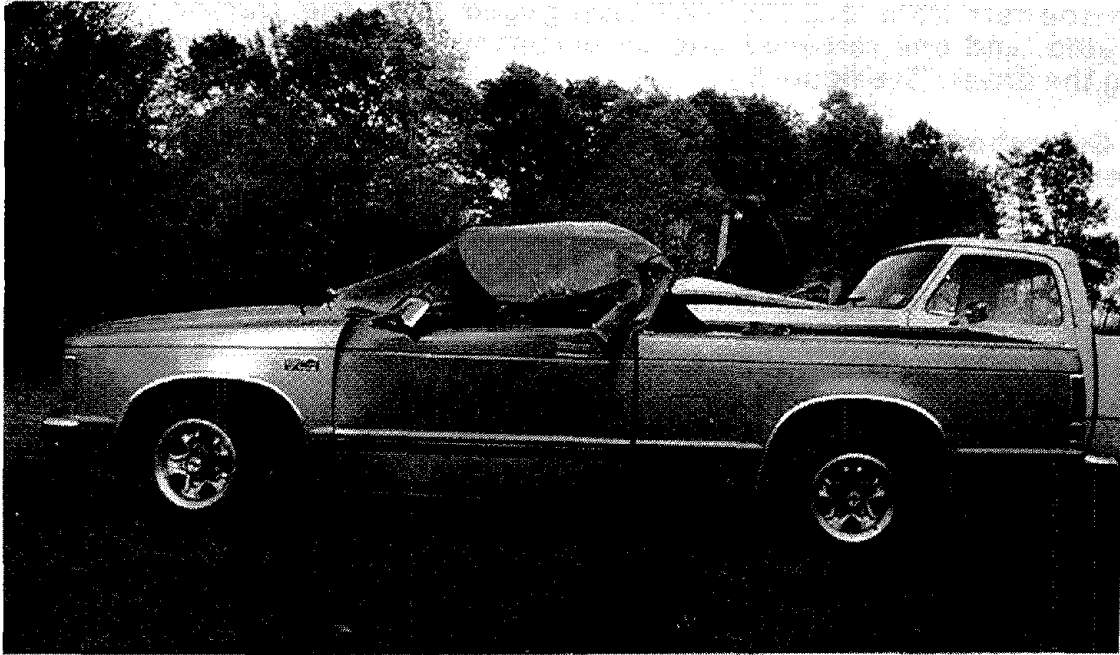
Marion, North Carolina -- On October 16, 1991, a 1989 Freightliner tractor in combination with a 40-foot semitrailer was traveling northbound on U.S. Route 221 when the left front drive wheels disengaged from the tractor. The wheels separated, and one careened into an oncoming pickup in the southbound lane, killing the driver. (See figure 5.)

Figure 5.--Damage sustained by pickup truck near Marion, North Carolina.

Marion, North Carolina.--In its investigation of this accident, the Safety Board found that the wheel assemblies on this vehicle were painted steel rims that had been stripped and repainted. The wheels had been installed on the tractor 58,000 miles before the separation accident. The carrier contracted an independent consulting firm to examine the vehicle's wheels after the accident. In the postcrash examination, investigators found paint build-up on the wheels. Laboratory analysis performed by the carrier's consulting firm showed that paint deterioration had caused a loss of clamping force, which in turn allowed the articulated cone washer lock nuts to loosen.

Motor Wheel, Inc., manufactured the hub system on the tractor. Motor Wheel's system has a hub pilot that consists of four machined flats situated between every other wheel mounting stud. The consulting firm's examiner found that the bearing surfaces supplied by these four pilots were heavily worn. He also found the corresponding rim areas heavily worn, "...apparently from relative movement at the contact surface." In his report of findings, he stated

...the most probable scenario for the loss of torque on the mounting nuts appears to be...[due to the wear] of the paint coats on the mating surfaces of the rims under the initial clamping force.... The movement of the paint coat from under the mounting nut would allow some loss of the elastic elongation present in the cone washer and the wheel mounting bolt. The...[loss of] the paint coat on the rims can be observed in the photographs [see figures 8 and 9] of the wheel assemblies....

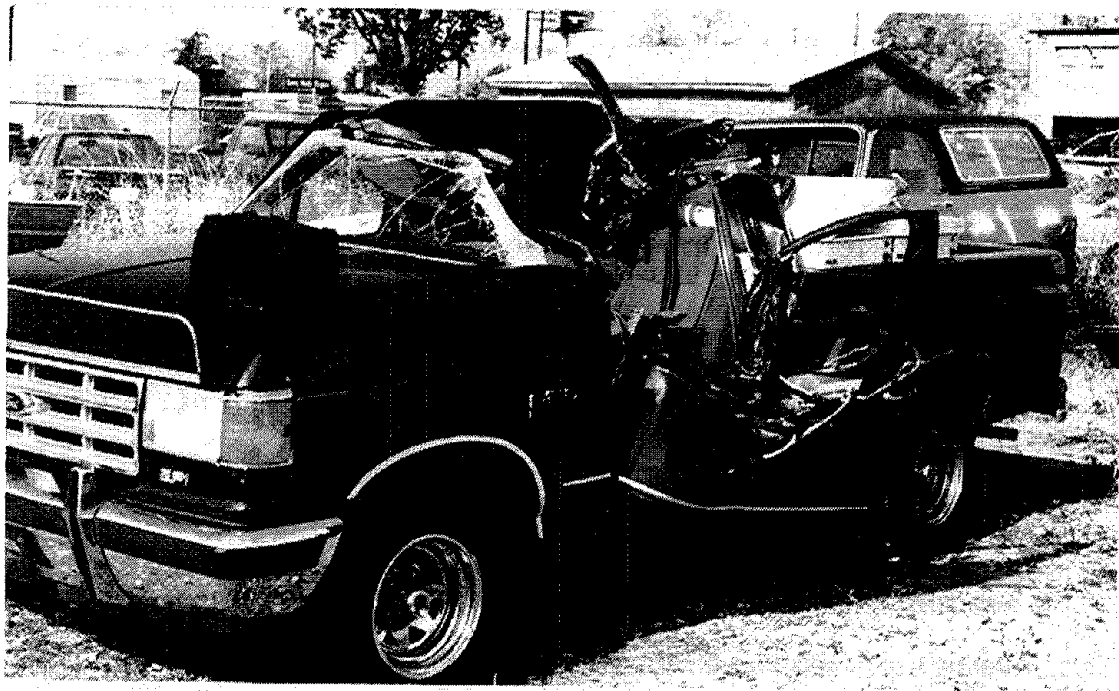
Figure 6.--Damage sustained by pickup near Greensboro, North Carolina.

Greensboro, North Carolina--At the postaccident field examination, investigating officials found metal deposits on the race of the outer wheel bearing. Inside the hub, examiners found cotter pin pieces, one of which appeared "blue from heat." The bearing cone of the outer wheel bearing had "deep grooving." The outer wheel bearing roller cage had been destroyed; a portion of it was found on the spindle between the inner wheel bearing and the cone of the outer wheel bearing. From the outer wheel bearing, investigators recovered three rollers, each of which had flat spots and "scoring and wear." They noted a bluish color on a portion of the spindle and also on the grease-free cone of the outer wheel bearing.

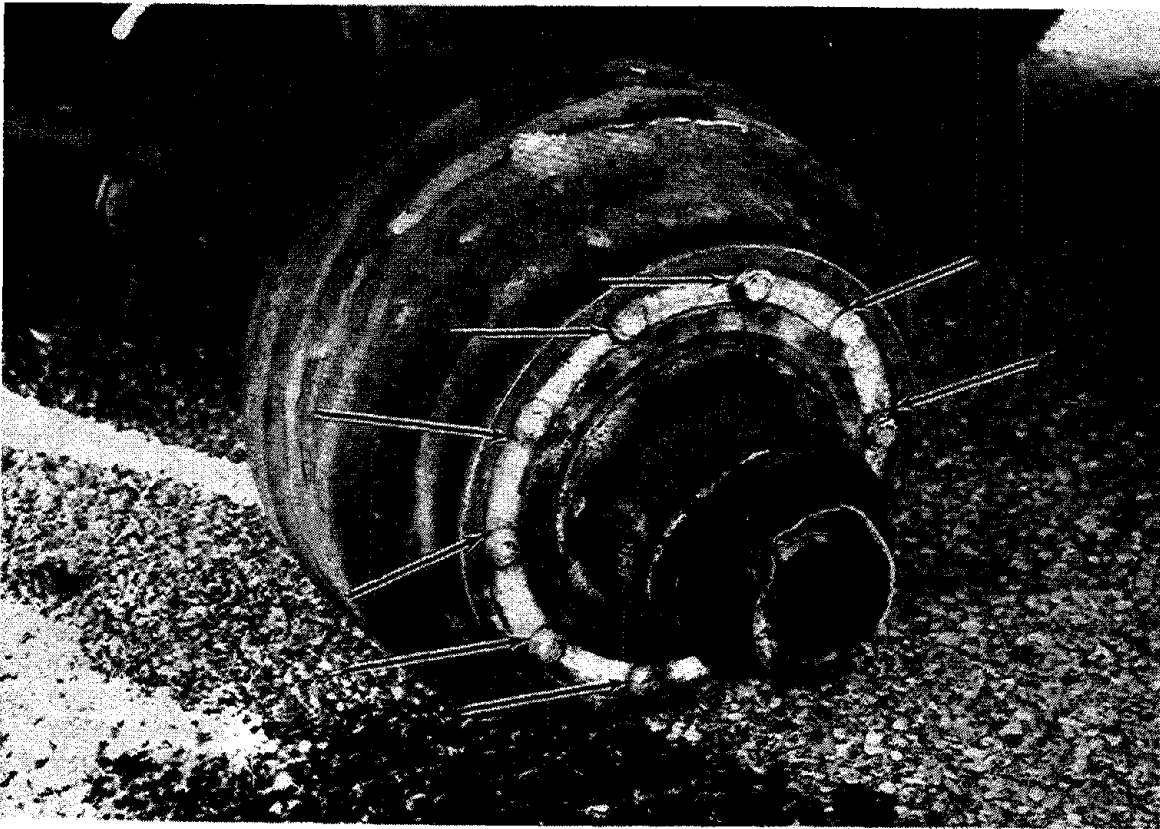
Figure 7.--Hub assembly showing fractured bolts. Arrows point to rust build-up.

Rust, metal burrs, and paint build-up between the wheel and hub can prevent the surfaces from fully contacting each other during tightening of the nuts. During service, rust, paint, and metal burrs can flatten or wear, causing a loss of clamping force and reduced torque on the nuts. The loss of force would allow the nuts to back off. The loose nuts cause excessive rotating bending stress in the stud that eventually results in stud failure.

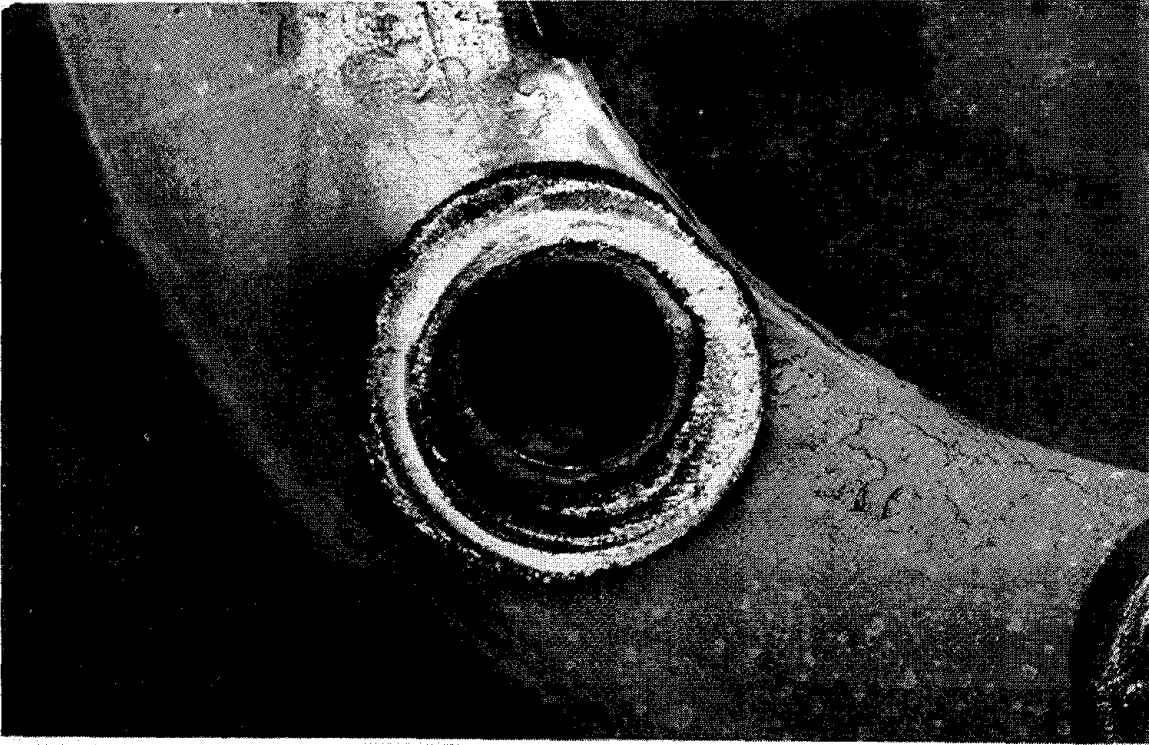
Figure 8.--Mounting face wear on outboard wheel assembly.

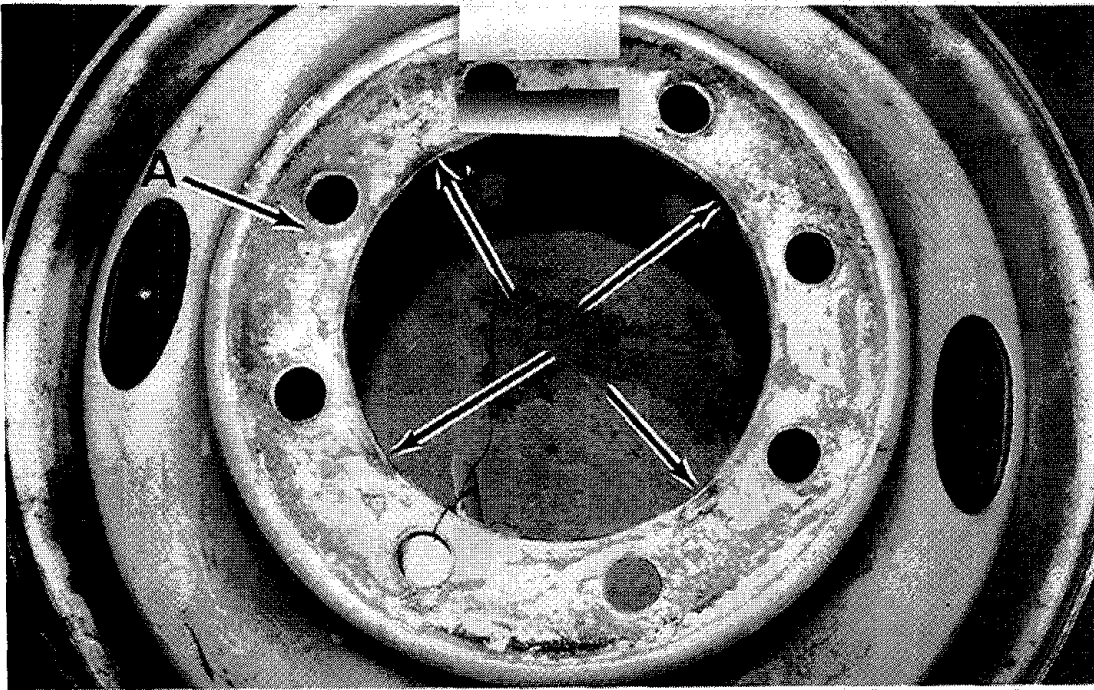
Figure 9.--Mounting face of inboard wheel assembly. Area at A shows a loss of paint from the mounting face. The inside rim between the bolt holes shows wear from the pilots.

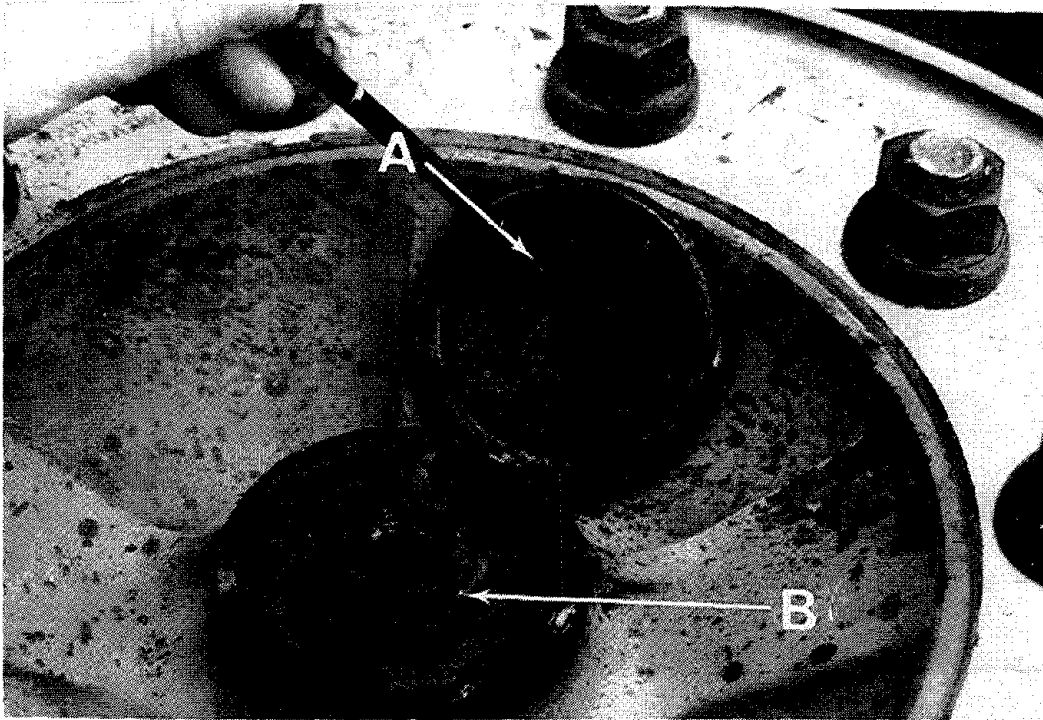
Figure 10.--View of overheated grease from the left front wheel assembly. (Arrows A and B point to the hub cap and lock nut, respectively.)

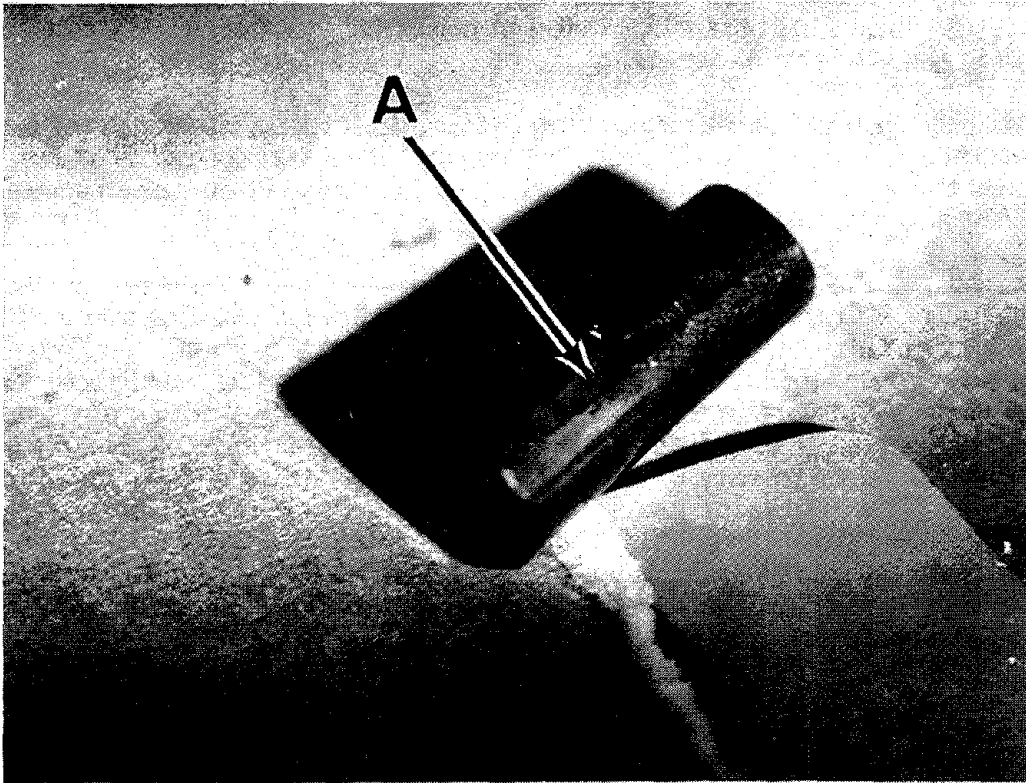
Figure 12.--Roller bearing with flat spots (A) and pitting.

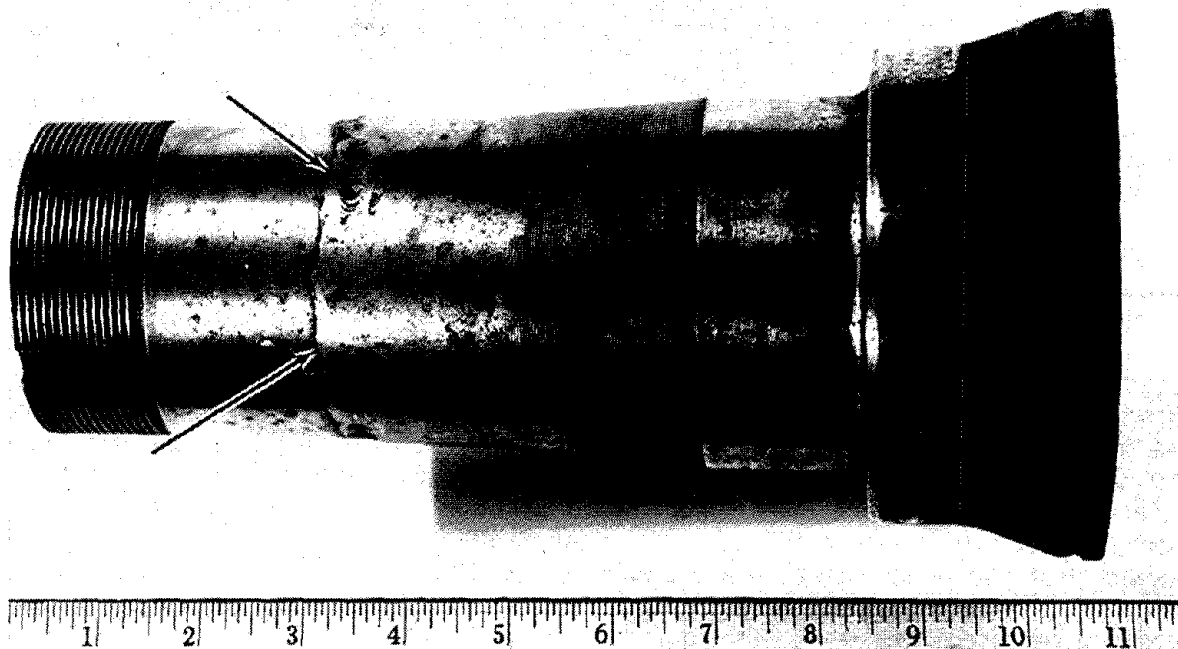
Maintenance officials must discourage maintenance practices that could create bearing problems. During the Safety Board truck-wheel separation investigation, NHTSA officials were shown a wheel assembly that had worn out two sets of bearings and could have resulted in a wheel separation (see figure 18). NHTSA is

Figure 18.--An improper spindle repair. Arrow highlights the weld.

examining a remanufacturer's process to restore a spindle that was damaged due to bearing failure. The process involves cutting off the damaged part of the spindle and placing part of a manufactured spindle repair kit on the end between the bearing races, using a jig, and welding the new part on. If the welds are not correct, eccentricity or offset can be introduced that wear bearings out prematurely. When put in a lathe, the spindle appeared to be out of plumb by as much as 0.25 inch. The ATA has put out warnings against using this practice.
