## **RESERVE STUDY**

### **SPYGLASS LANDING CONDOMINIUM**

### **MARSHFIELD, MASSACHUSETTS**

| DATE: | November 2016 |

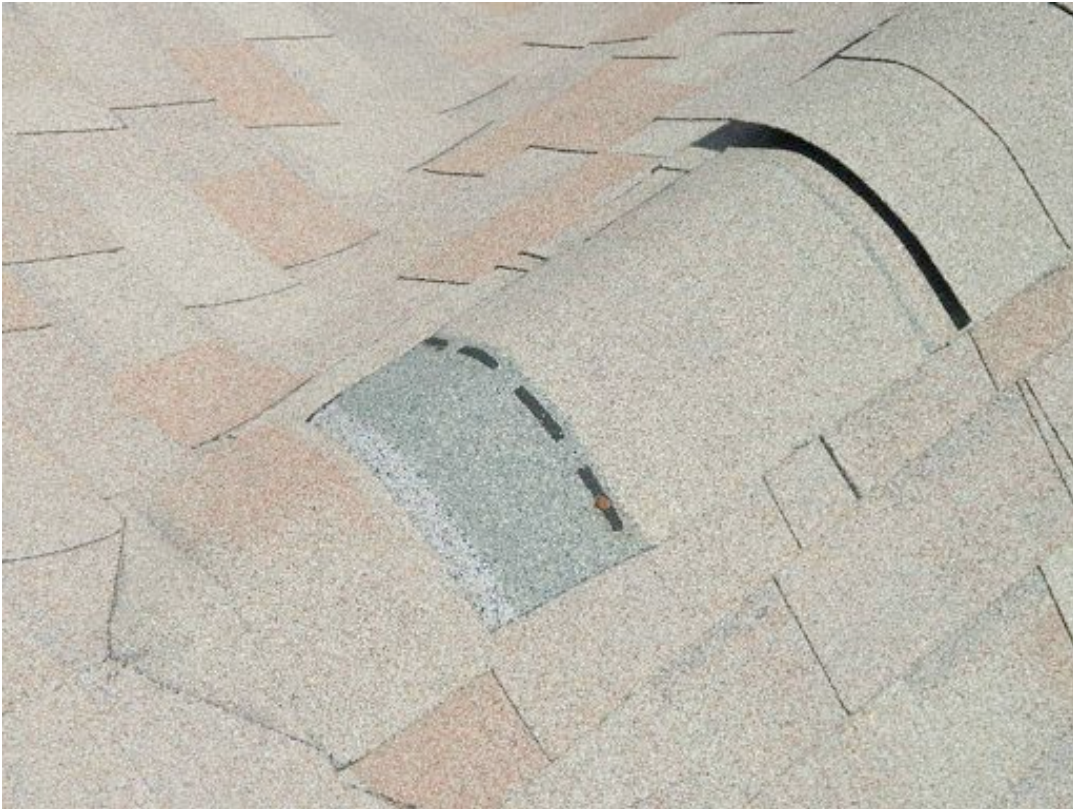
A FEW MISSING RIDGE CAP SHINGLES WERE NOTED (NOT WIDESPREAD)

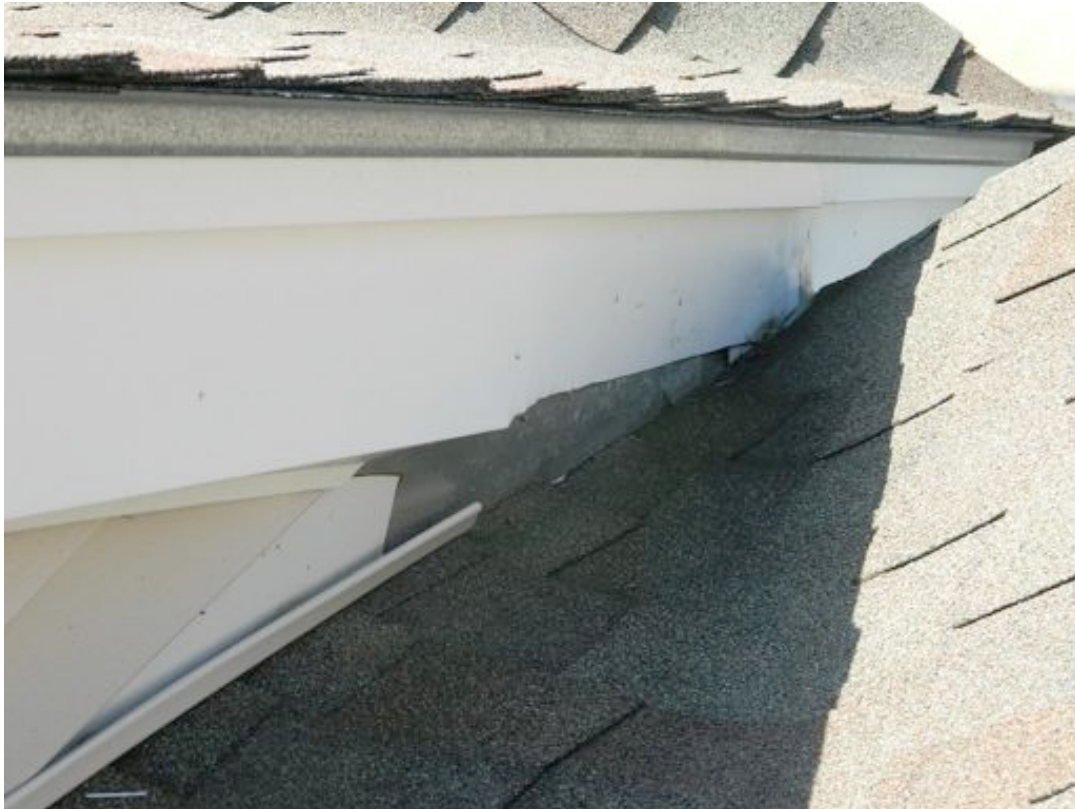
We did note some locations where the units merge that appear potentially vulnerable to leakage. In many cases, the units merge at a step-flashed cheek wall, some of which end against adjacent roofing systems, and appear vulnerable to trapping water, snow or ice (see photos). Without a complete re-design, little can be done about this now, but if any leakage were to occur in the general area, we would suspect a flashing/underlayment deficiency where the units meet.

QUESTIONABLE FLASHING DETAILS WERE FOUND WHERE SOME UNITS MERGE

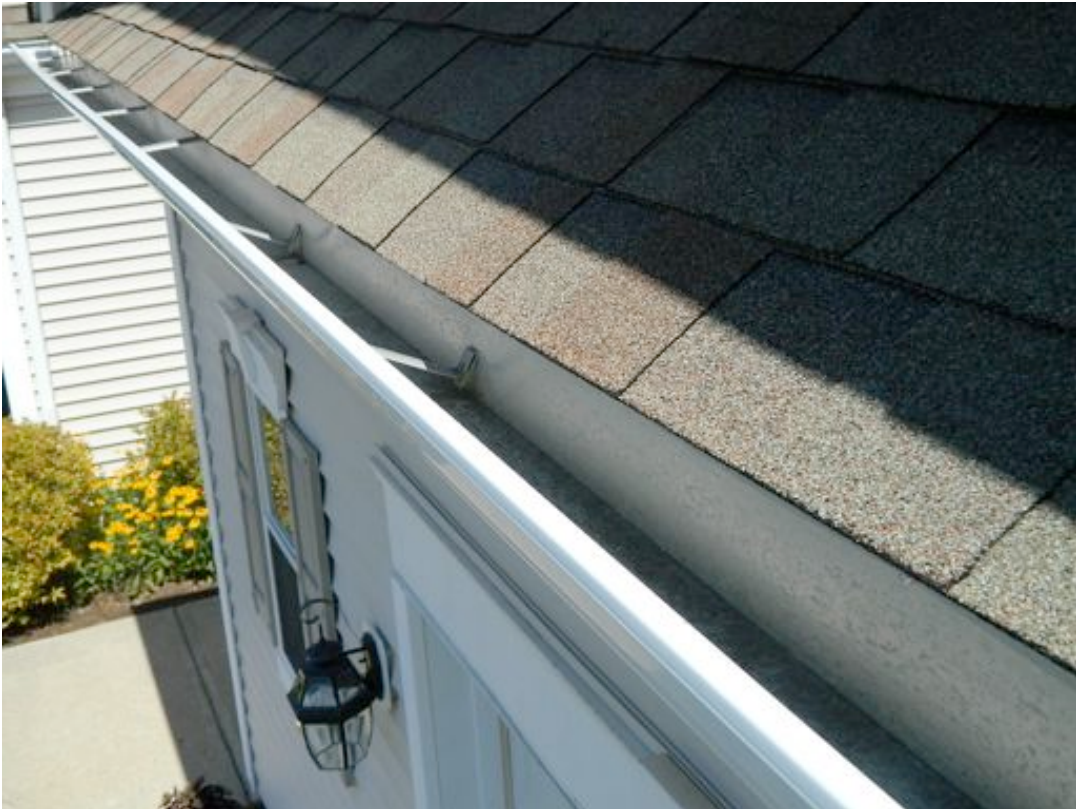
THE GUTTERS ARE ATTACHED WITH A BAR-HANGER SYSTEM (NOTE DETACHED HANGERS)

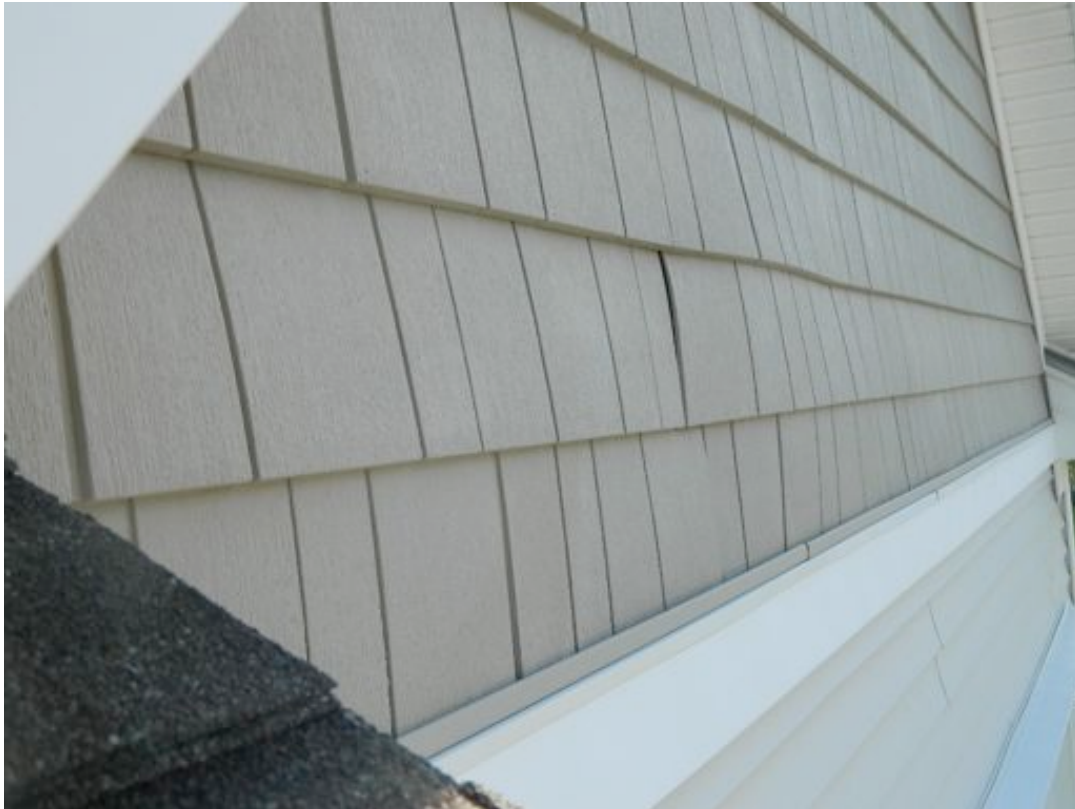
THE SHINGLE SIDING IS A POLYPROPYLENE PRODUCT (NOTE RIPPLING PANELS)

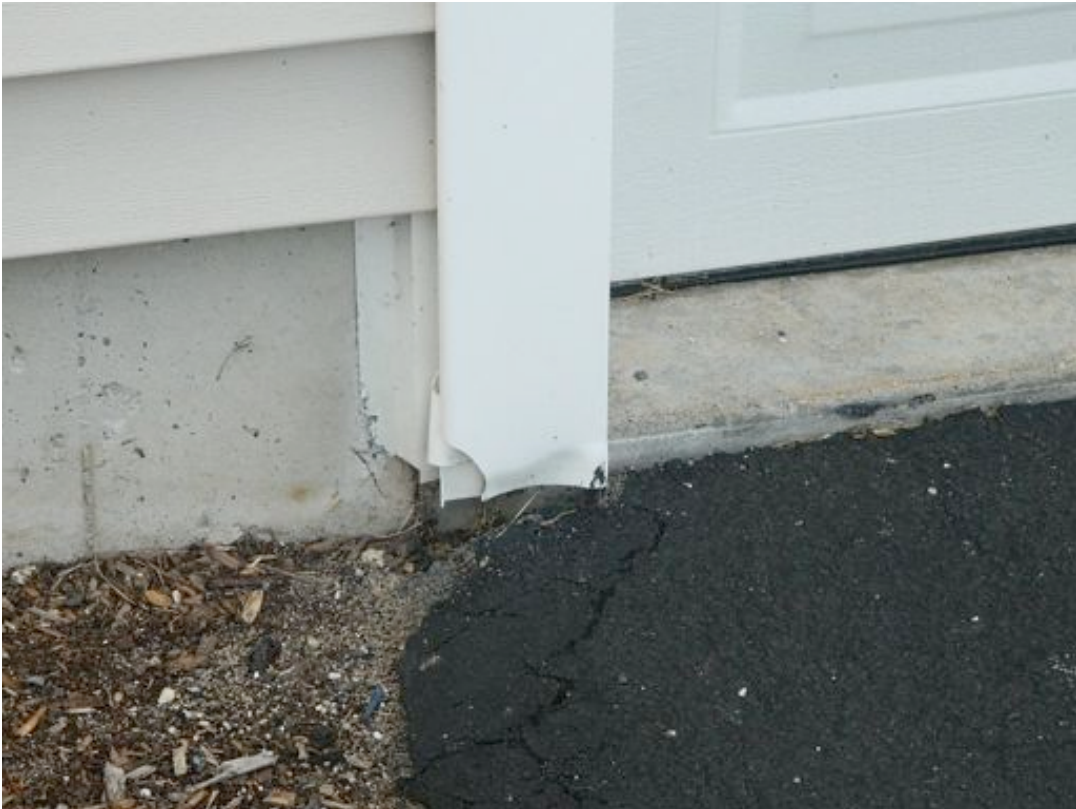
Some minor damage was noted at the base of the walls, again likely caused by landscaping activities. In some instances, the siding is less than 6” from surrounding grade. Although Code allows vinyl siding to be close to grade, the

underlying framing members are required to be at least 8" above grade. The vast majority of the buildings have adequate clearance from grade. The damage at the base of walls is largely an aesthetic issue which will not significantly impact the performance of the siding.

SOME DAMAGED SIDING/TRIM WAS FOUND AT THE BASE OF WALLS (NOT WIDESPREAD)

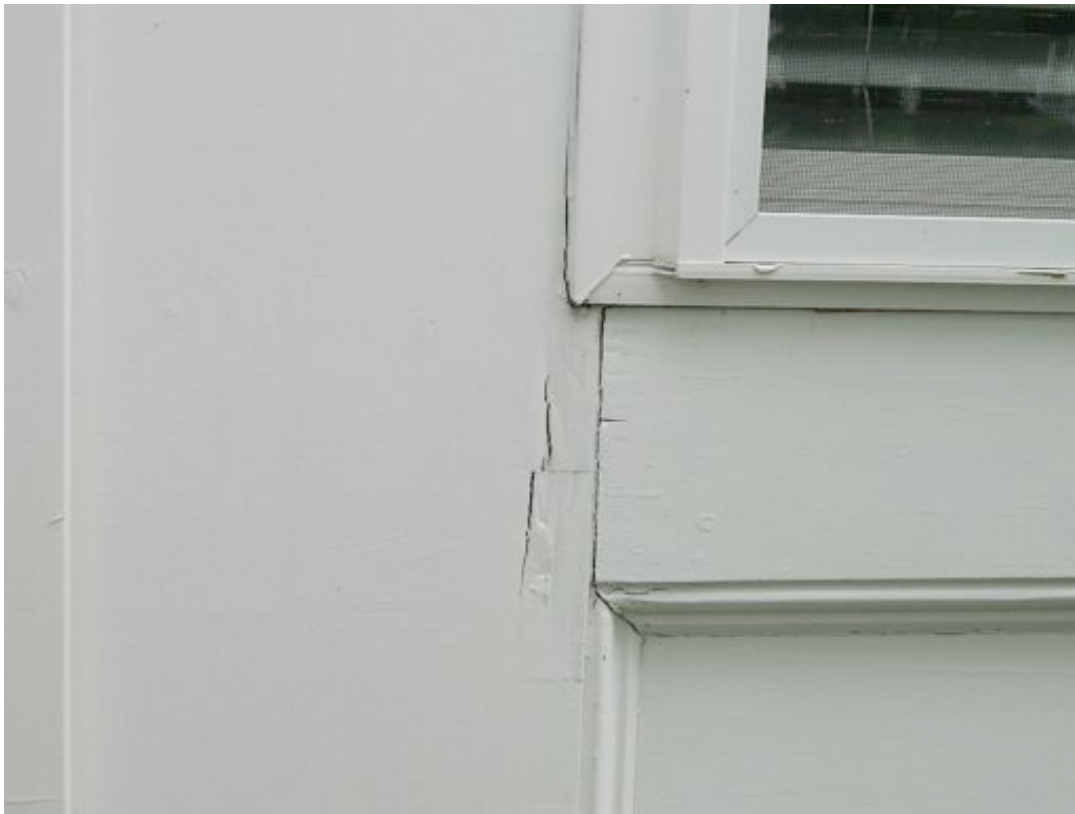
Each building includes areas where there are what appear to be MDO (medium density overlay) panels around windows. We noted several of them have begun to rot (see photos), likely as a result of the failure to properly coat the cut ends prior to installation. This office would advise that any such rot be addressed by removing the deteriorated pieces, and replacing them with new cellular PVC trim. This issue is not widespread at this time, but is expected to accelerate as the property ages.

THE PANELS AROUND SOME WINDOWS ARE BEGINNING TO FAIL

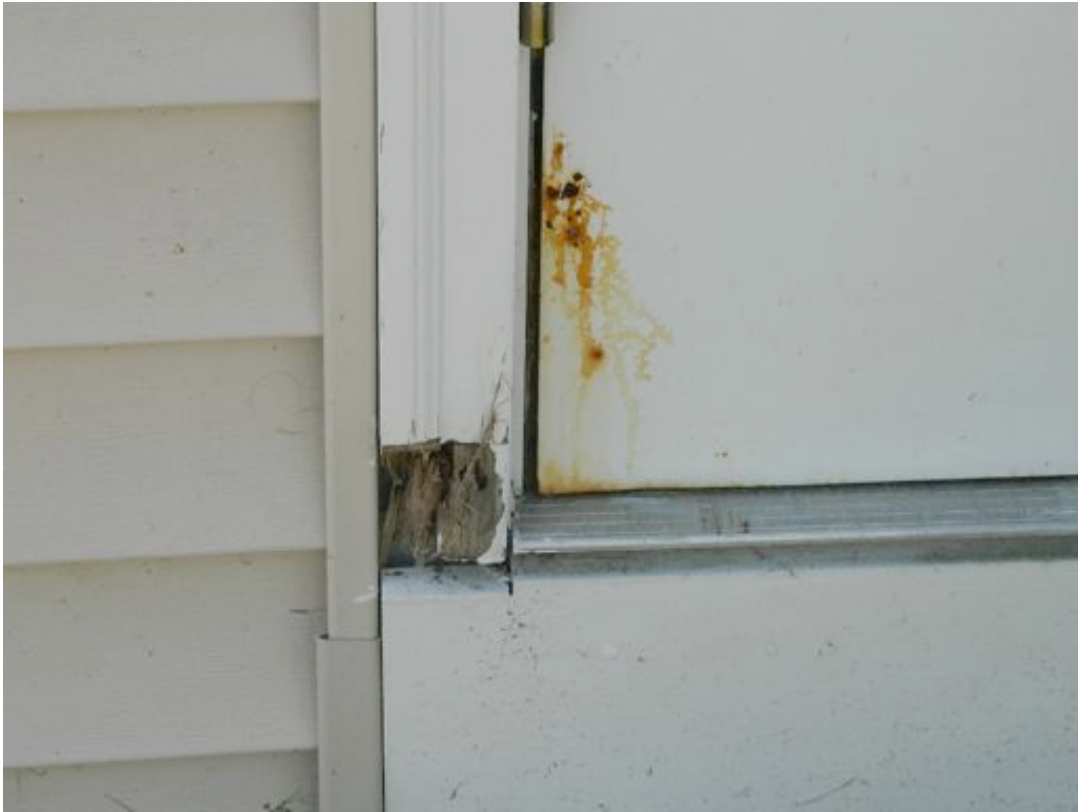
We noted some accelerating trim rot at the exterior doors on the utility rooms (see photos). The doors themselves are pressed-metal units, some of which have also begun to suffer from surface rust. These doors would appear to fall outside of the unit boundaries, and we have included their replacement in approximately 9 more years on the Reserve Schedule (Item #4). The estimated replacement cost reflects removal and replacement with a new equal.

SOME SIDE UTILITY DOORS ARE RUSTING, AND SUFFERING FROM TRIM ROT

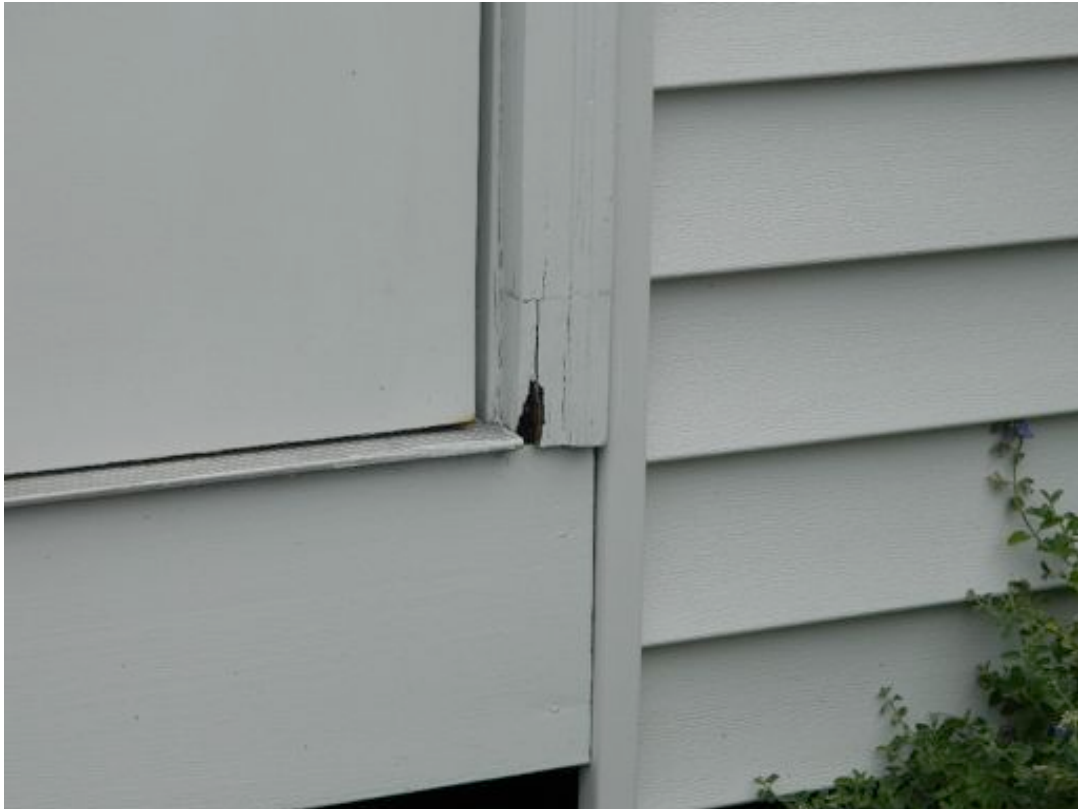
FURTHER EXAMPLE OF TRIM ROT ON A UTILITY ROOM DOOR

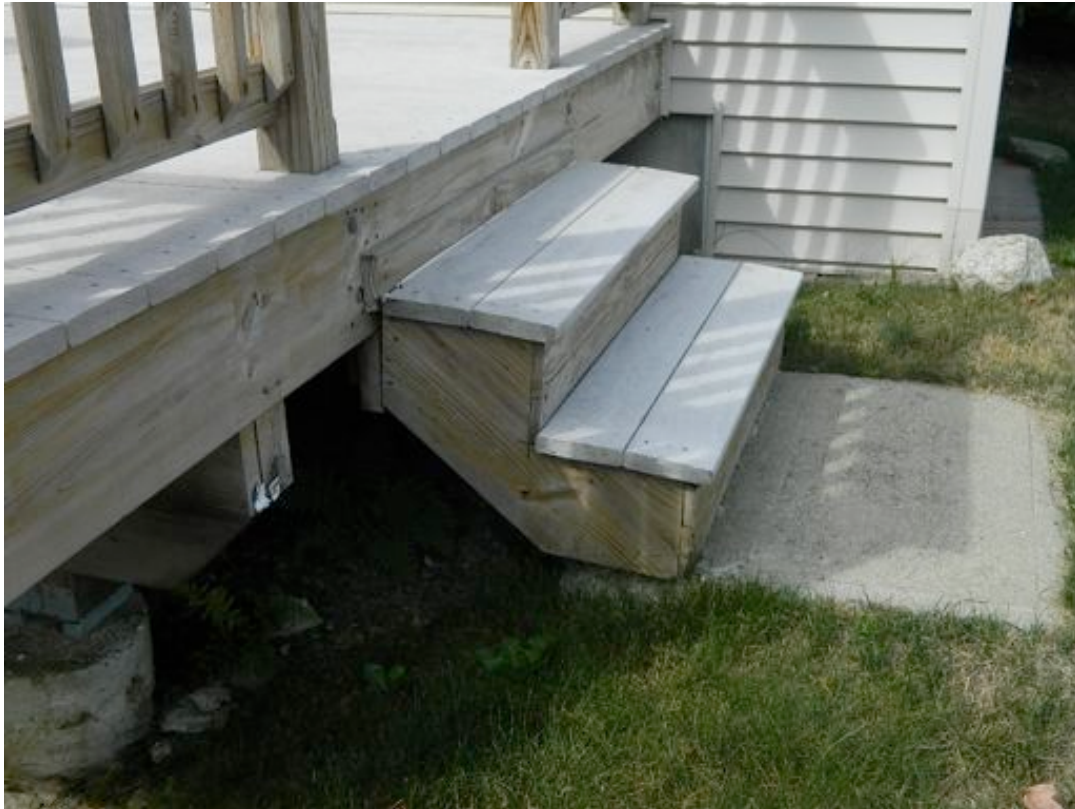
We also noted a few stair stringers that appear to have settled. The most severe such location was found at the rear deck of 22 Schooner, where the steps appear to have settled over 1" (see photos). This appears to be the result of inadequate (or omitted) stringer footings. It seems that many of the steps rest only on the concrete pads at the bottom of the steps.

SOME OF THE STEPS HAVE SETTLED

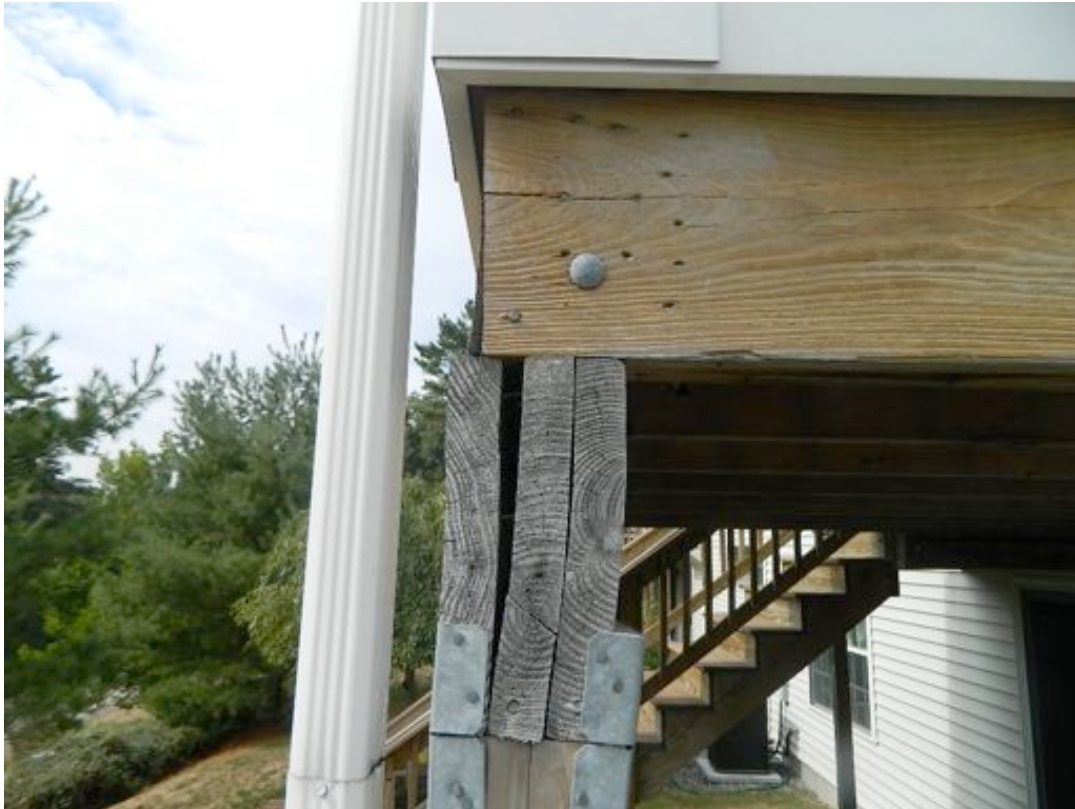
The decks utilize synthetic decking and top railing caps. The railings themselves are also of preservative-treated lumber, with 2 x 4 top and bottom rails, and 2 x 2 balusters installed with nails. Many of the nailed components were found to be suffering from cracking, splitting or other damage (see photos). It appears that some of the nailed connections have been augmented with lag or carriage

bolts. It's unclear if the bolts were a part of original construction, or if they were added after the fact. We suspect that many of the decks will require remedial repairs, in the form of augmenting nailed connections that are failing, in order to achieve the anticipated remaining life of 14 years.

POOR ATTACHMENT AND FASTENER CHOICES HAS COMPROMISED SOME DECK FRAMING

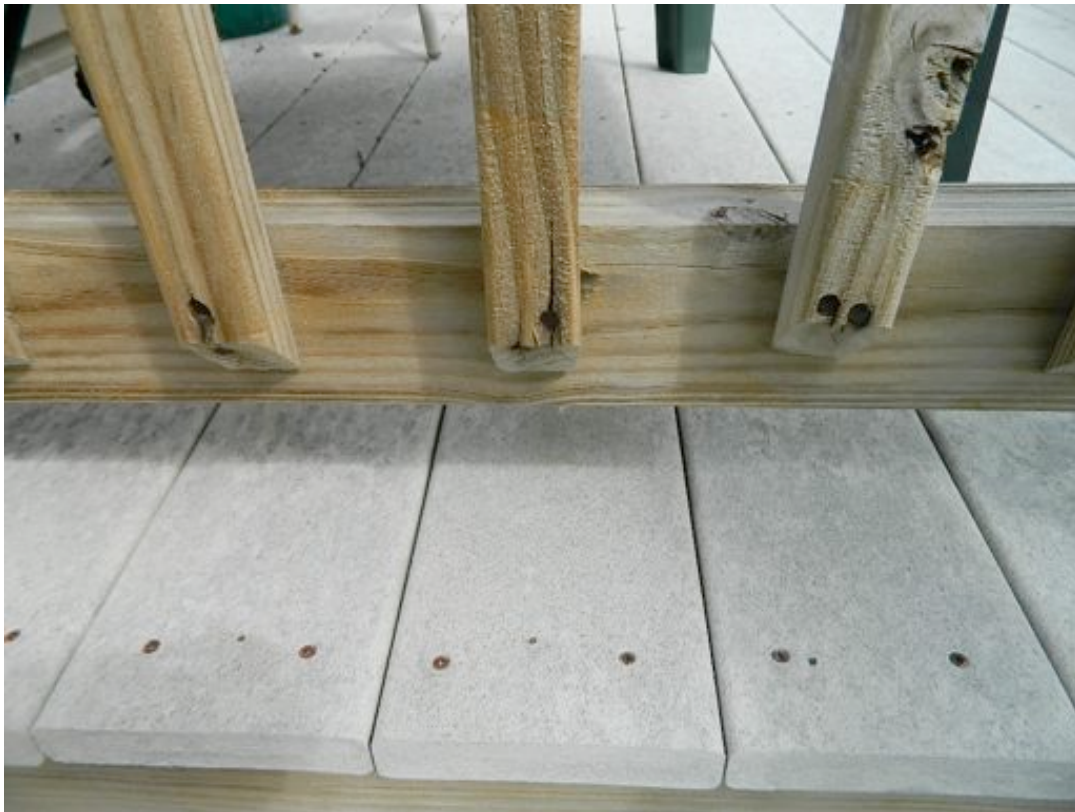
THE SYNTHETIC DECKING IS ATTACHED WITH SCREWS THAT HAVE RUSTED

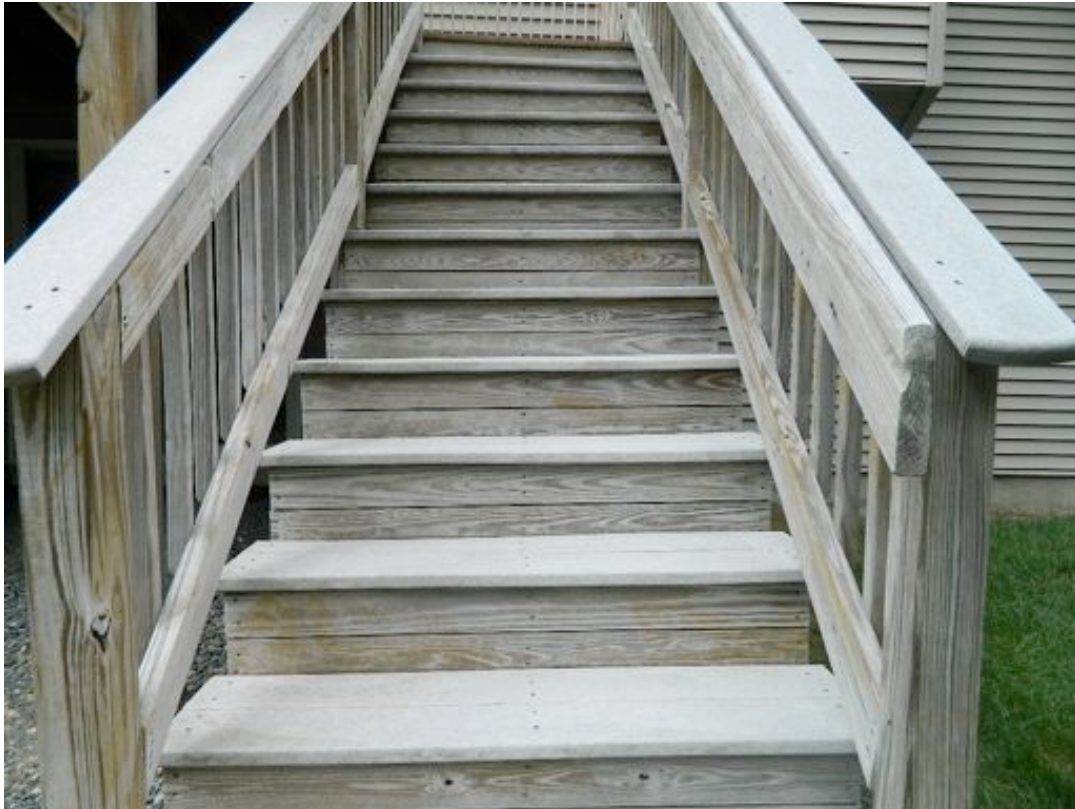
SETTLING DECK STEPS AT THE REAR DECK OF 22 SCHOONER

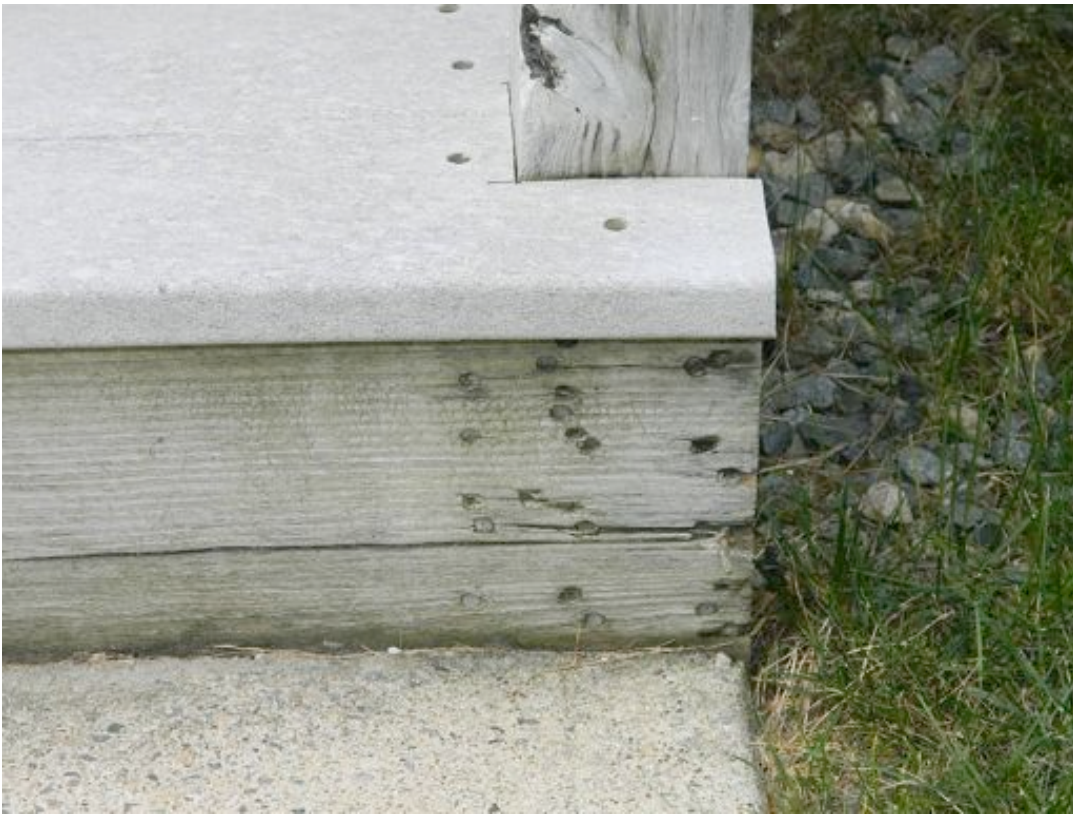
MANY OF THE DECKS ARE “OVERNAILED” WITH INAPPROPRIATE FASTENERS

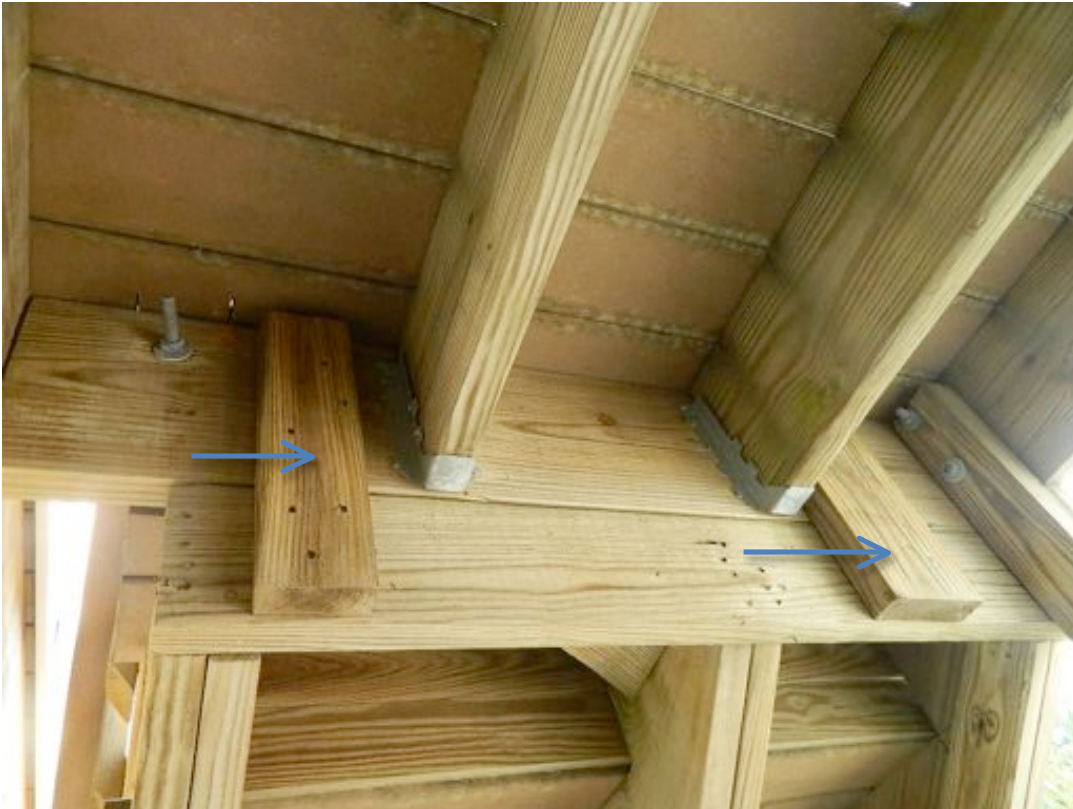
This office has some concern with the way the stair stringers are attached to the main decks. In some of the locations that were directly examined, they are fastened with 2 x 4's nailed to both the deck frame and stringer ledger (see photo). A much better attachment detail would utilize either lag or carriage bolts, or as a minimum, rated screws. We noted some locations where the stringers appear to be pulling away as a result of poor attachment (see photo). This issue is not widespread, but monitoring of the deck stringers should be a regular part of site maintenance/inspection.

OPTIMALLY THE STRINGER BRACKETS SHOULD BE BOLTED (FASTENED WITH NAILS ONLY)

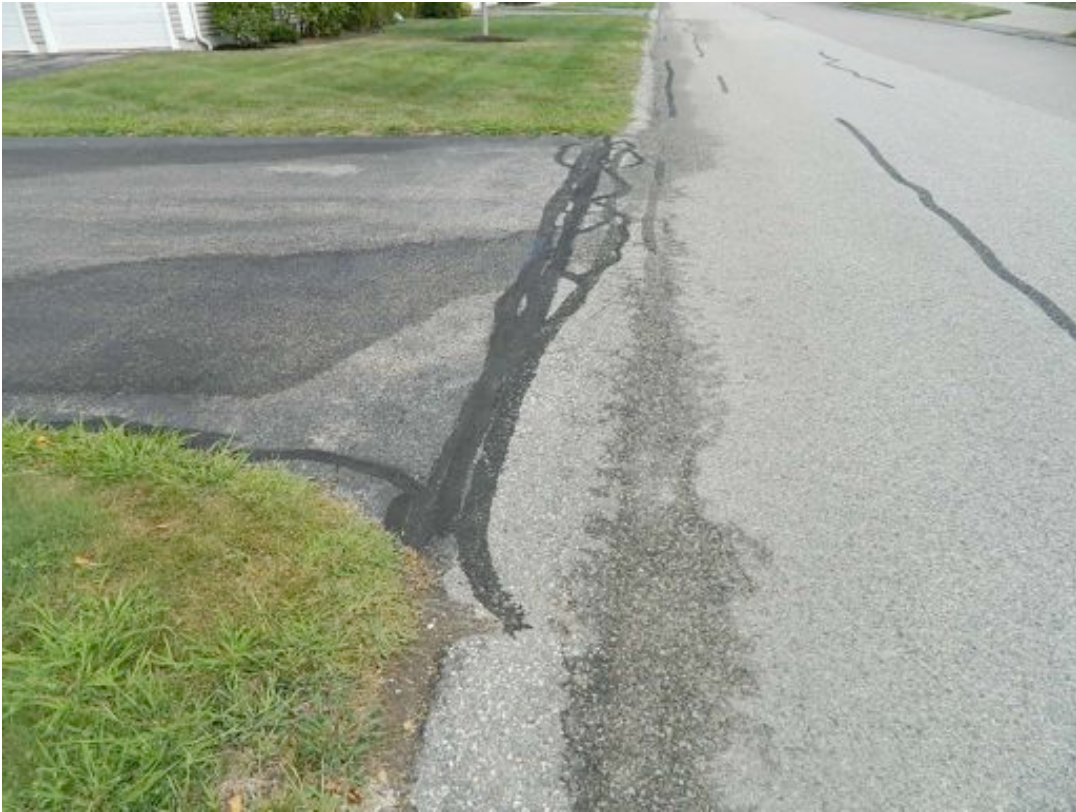
We did note cracking throughout the property, but the vast majority of the cracks have been sealed (see photos). We also noted some apparent “settlement cracks” around catch basin grates and man holes, but not anything excessive.

SEALED CRACKS WERE FOUND AT THE END OF MOST DRIVEWAYS

Crack sealing must be a regular part of pavement maintenance, and should be an ongoing process. It is critically important to seal pavement cracks on an annual basis, preferably before every Winter. The cracks most commonly occur at course lines, driveway transitions in the pavement, or at penetrations. When water gets below the pavement, it can cause frost heaves or wash-out of the substrate, which will lead to settlement.

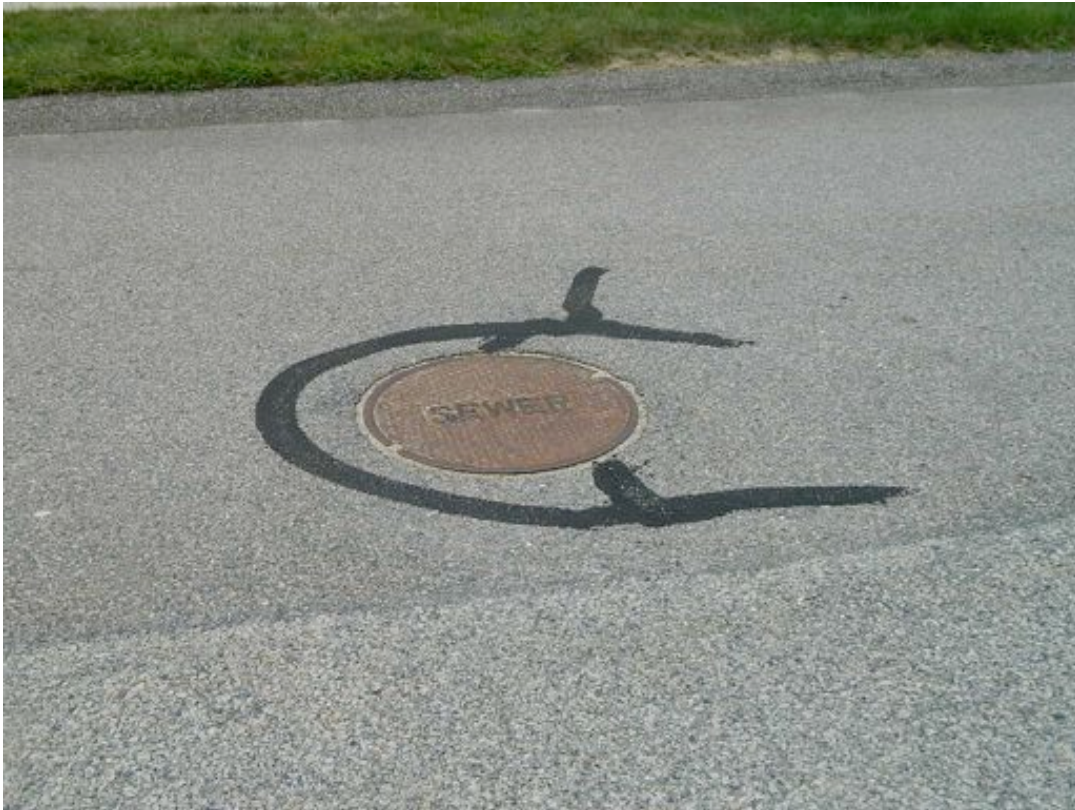
SOME SEALED CRACKING WAS NOTED AROUND ROADWAYS STRUCTURES

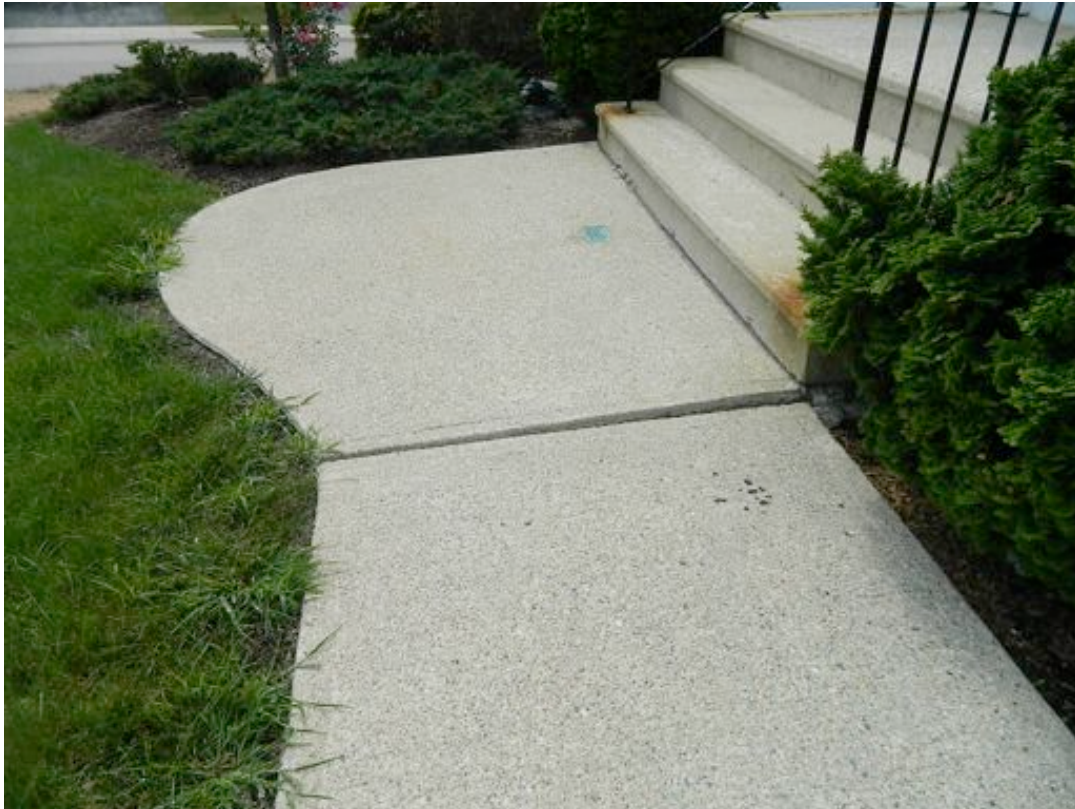
We noticed differential settlement in several areas that have created tripping hazards (see photos). When tripping hazards arise, if the concrete itself remains in good condition, grinding the lifted portion down flat is an option. From a planning standpoint, we feel that with aggressive maintenance, and replacement/grinding as the need arises, the walks in general can likely remain in safe condition for another 19 years, at which point they will be 30 years old.

A FEW TRIPPING HAZARDS WERE NOTED (NOT WIDESPREAD)
