Pfeifer Home Inspection  
Indianapolis, IN 46236  
317-340-1734  
pfeiferhomeinspect@gmail.com  
License #HI01700103

# Home Inspection Report

Jane Doe  
123 fake street  
Indianapolis, Indiana 46562

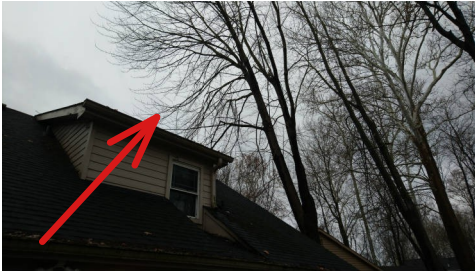
1. Vegetation: Trees - A few tree limbs are hanging over the roof and causing unnecessary debris to build up. We recommend having the limbs trimmed back by a qualified contractor.

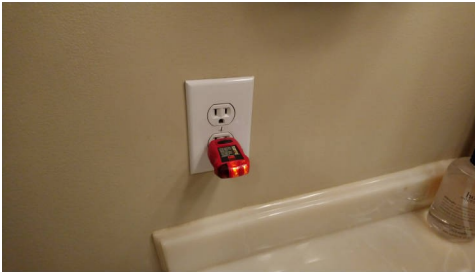
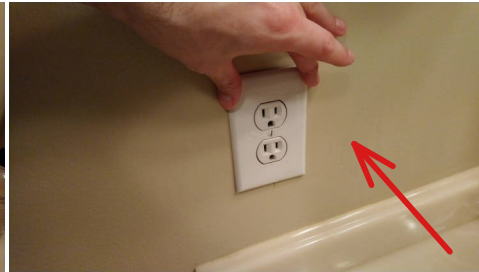
2. 1st Floor - Main Bathroom Bathroom Electrical: 110 VAC - The pictured outlet was tested and functioning correctly. We did notice this outlet was loose and will need to be secured to the wall by a qualified contractor.

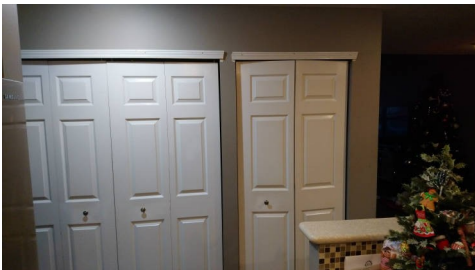
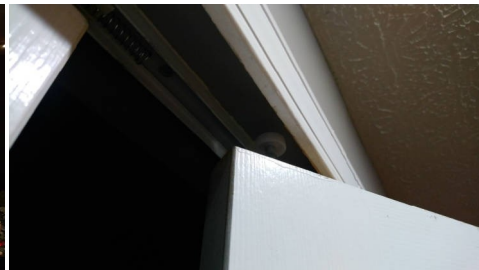
3. 1st Floor Kitchen Pantry Doors: The pantry doors will need to be adjusted as they are not currently sliding on the track. Additionally, we noticed the trim around the top of the pantry was recently replaced and a poor job was done.

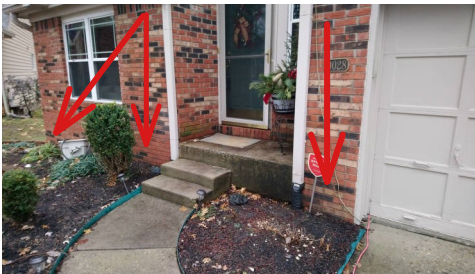
1. 1st Floor Exterior Surface Type: Brick veneer - As we walked the perimeter of the property we did not observe any "weeping wells" in the brick veneer. Weeping wells are drainage holes left in the face of a brick veneer wall in order to allow water that has penetrated the wall to escape downwards through the wall cavity and out to the exterior of the wall surface through the weep openings. A qualified contractor will need to drill out these openings around the home.

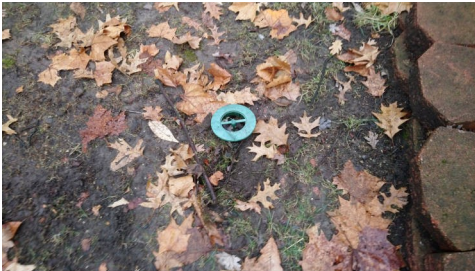
2. Drainage Lines: The buried drainage lines connected to the downspouts in the front yard will need to be reviewed by a qualified contractor. The pictured pop-up emitter will need replaced and it appears the drainage line is clogged as well.

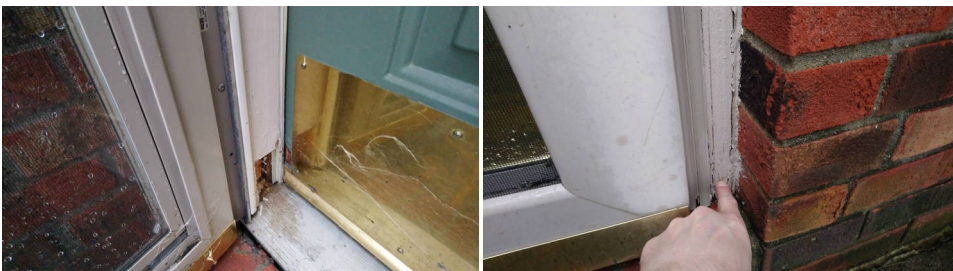
3. Entry Doors: Wood - The door jamb for the front door will need to be replaced as it is rotten at the bottom. Additional, damage was observed on the left side of the jamb. A qualified contractor will need to replace the jamb on the front door.

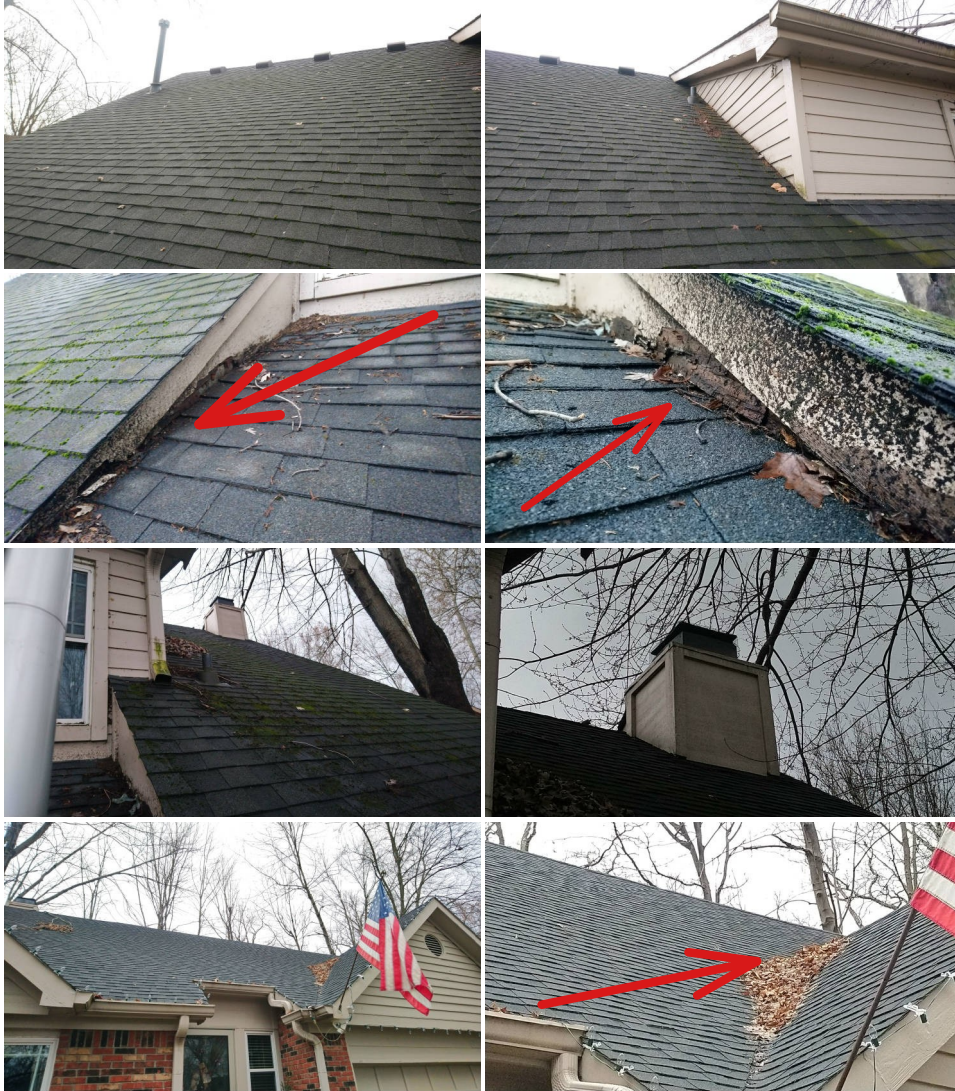
4. Main Roof Surface Material: Asphalt shingle - We were unable to walk the roof as it very steep and wet from the rain. With that said, we were able to review it from our ladder. In pictures 3 & 4 you can the rotting trim in front of and surrounding the dormer. All of the trim will need to be reviewed by a qualified contractor to insure the wood is not compromised. The rest of the shingles appear to be in good condition. No active or previous leaks were noticed.

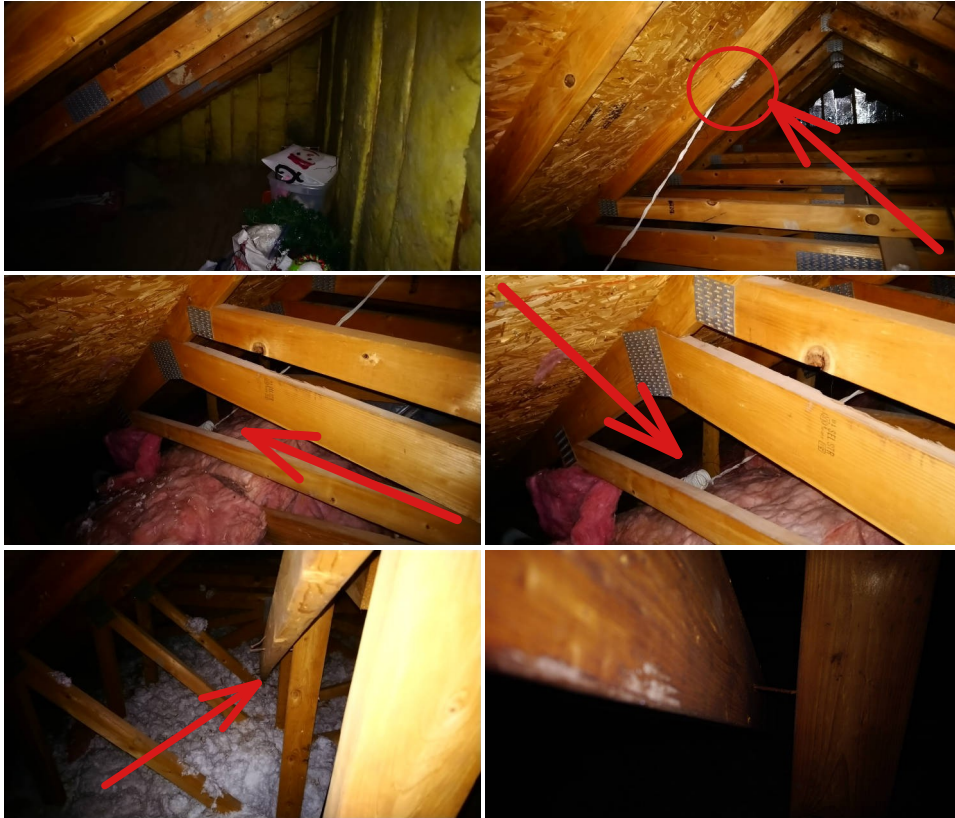
5. Main Attic Roof Framing: 2x6 Truss - Structurally speaking we do not see any issues with the 2x6 truss system in place. All gusset plates were firmly attached and no "sagging/settling" was observed in any of the trusses. A satisfactory amount of insulation was discovered in the attic as well. No water stains or wood rot were found on any of the webbing. In pictures two and three we found a exhaust vent that has almost separated in two. Furthermore, we observed a 2x4 used a lateral bracing that has come loose and needs reattached. A qualified contractor will need to address these two issues.

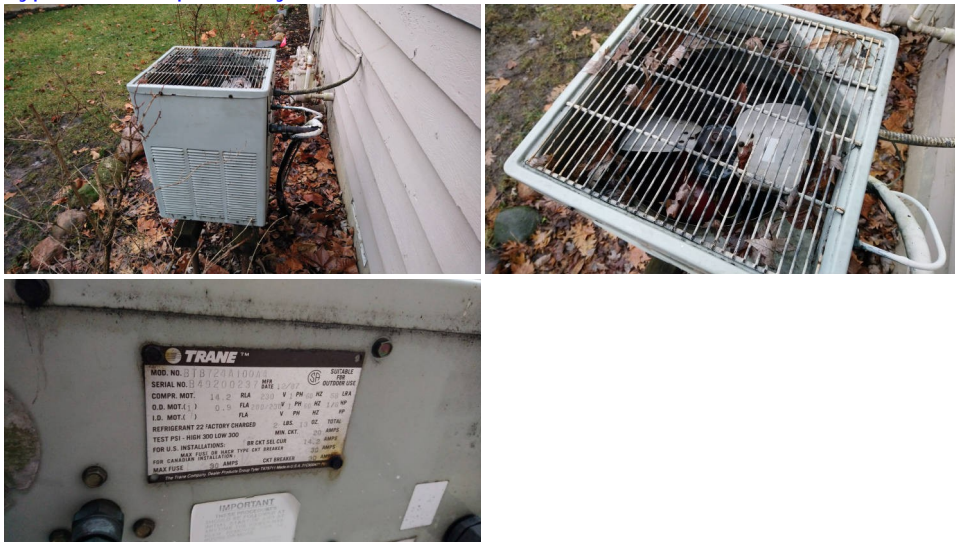
6. Main AC System A/C System Operation: Due to the temperature outside the AC unit was not tested, however were able to review the exterior of the unit. The suction line was correctly insulated from the home to the unit. We did observe leaves inside of the unit needing cleaned out. With that said, the unit is from 1987 and at end of the typical life expectancy.

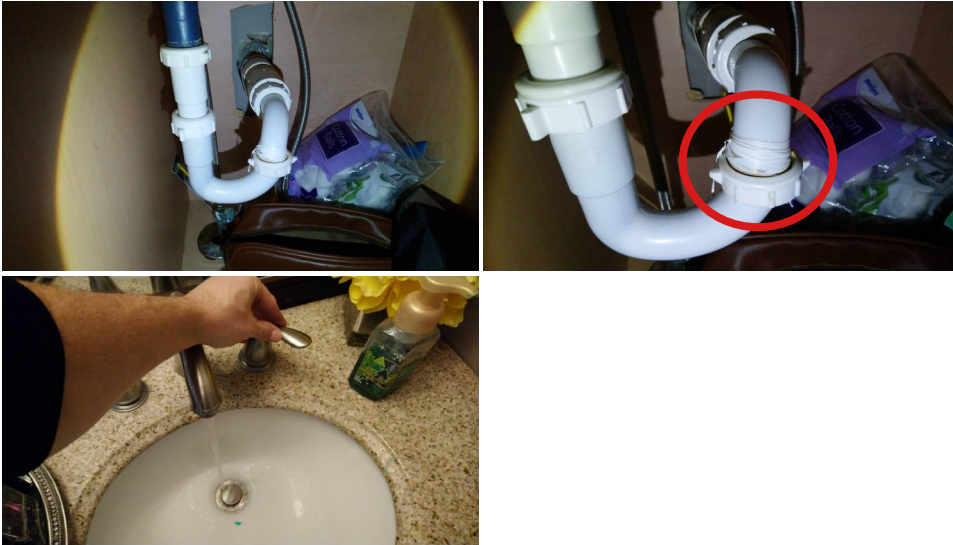
7. Master Bathroom Sink/Basin: The drainage line in this bathroom will need to be reviewed by a qualified contractor. The P trap on the pictured line is not installed correctly. We did not notice any leaks, however the slip nut was not properly attached to the P trap. A qualified contractor will need to correct this issue.

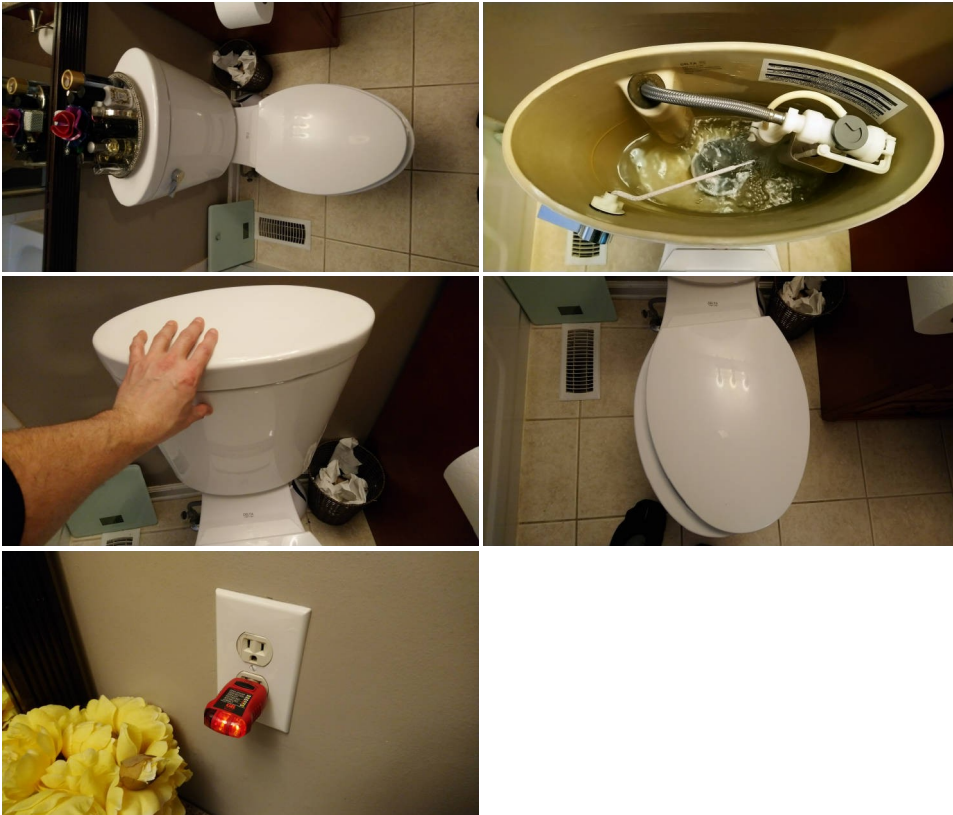
8. Master Bathroom Toilets: 1 1/2 Gallon Tank - The toilet tank in this particular toilet is loose and needs to be tightened. Typically, the tank of the toilet should be tight when installed correctly. Additionally, the seat is really loose as well. A qualified contractor will need to tightened the toilet and seat properly.

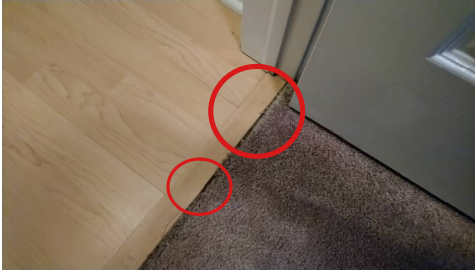
9. 2nd Floor - Right Bedroom Floor: Carpet - Several rips and imperfections were noticed in carpeting throughout the home. As these rips are permanent the carpet will need to be replaced to be properly fixed.

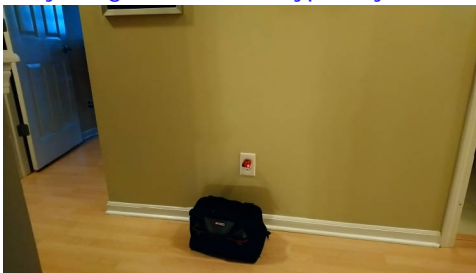
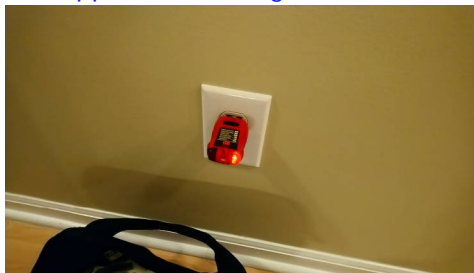
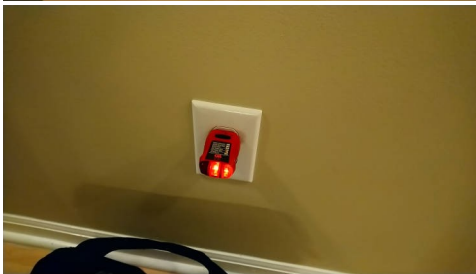
10. 2nd floor loft Living Space Electrical: 110 VAC - The outlet in the 2nd floor hallway appears to be loose. As we inserted our electrical tester we received an indication of loose wiring. Upon inserting the tester all the way everything tested fine. Typically when this happens the wiring is loose and needs to be tightened.

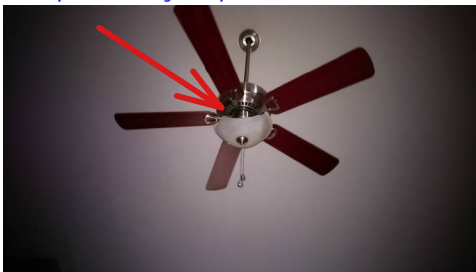
11. Family Room Living Space Electrical: 110 VAC - The cover attached to the pictured fan is broke and will need to be replaced by a qualified contractor.

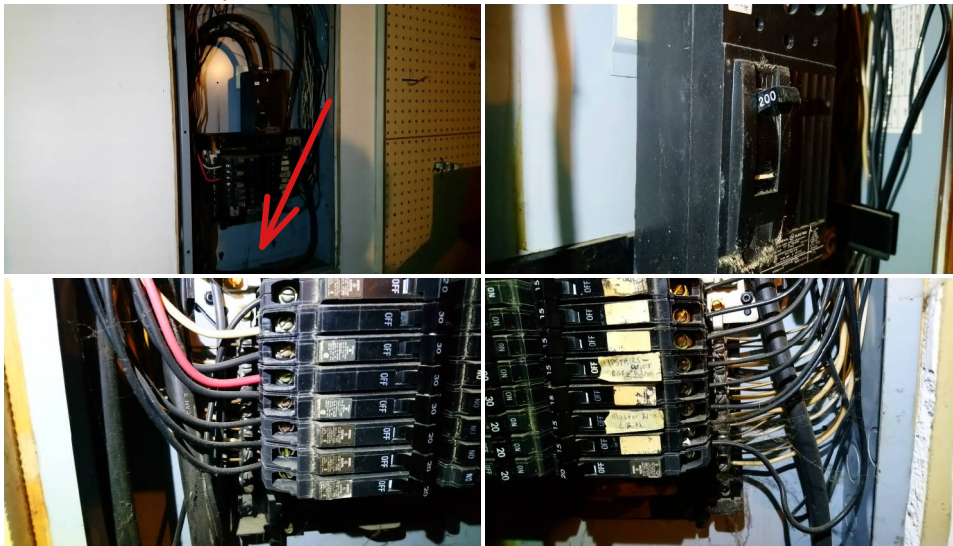
- Garage Electric Panel Manufacturer: Per code, all knockouts need to be properly covered if removed from the panel. If not, it presents a shock hazard as someone could accidentally stick a finger in the panel. We found one open knockout in the panel needing addressed. The rest of the panel is up to code. All neutral wires were isolated on both bus bars. All wiring is the right size for the attached breaker. A qualified contractor will need to evaluate for the correct repairs.

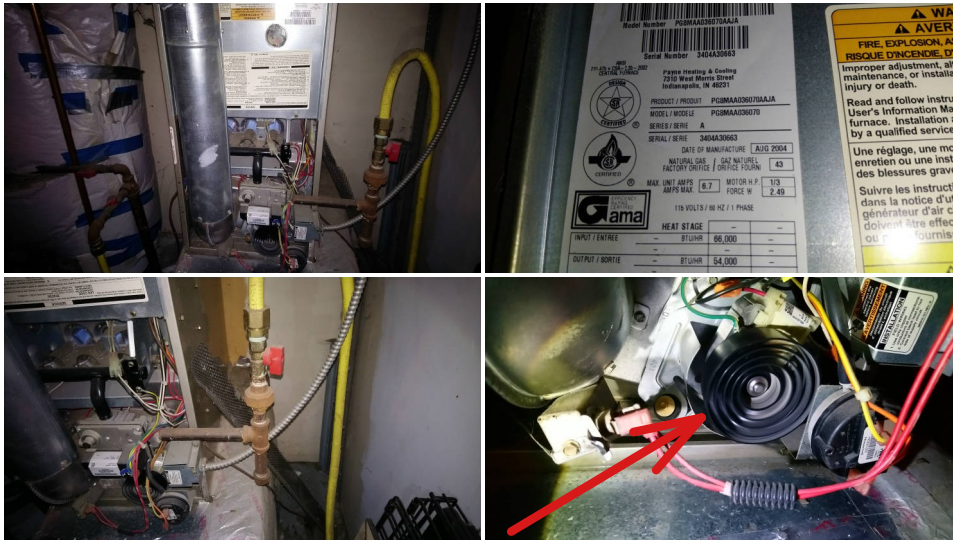
- Garage Heating System Heating System Operation: Inadequate - Immediately as we entered the garage we heard a noise coming from the furnace. We removed the covers and it appears the draft inducer assembly was responsible for the rattling. A qualified contractor will need to maintenance and clean the furnace. The rest of the unit is up to code and operating normally.

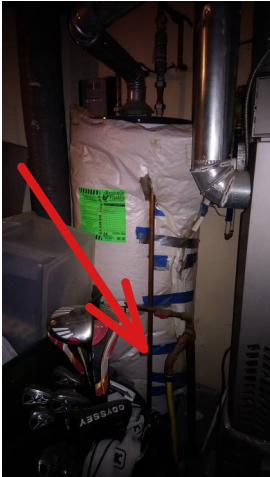
3. Garage Water Heater Water Heater Operation: Adequate - This particular hot water heater was functioning properly during our inspection. Hot water was getting delivered to the appropriate places as expected. Per code, all gas lines need a sediment trap or a "drip leg." A drip leg is a capped off section of the gas line, which is installed in such a way that any debris or moisture in the line would be caught in the trap where it can be cleaned out easily. A qualified contractor will need to install a drip leg. We recommend draining ten gallons from the tank to clean out and wash any built up sediment.

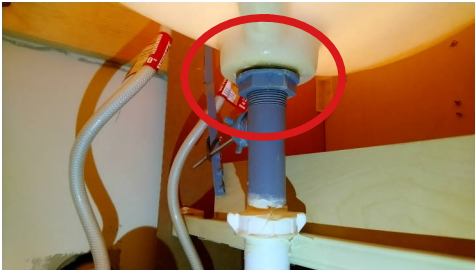
4. 1st Floor - Main Bathroom Bathroom Sink/Basin: Molded single bowl - We found an active leak where the sink connects to the PVC drainage line. A qualified contractor will need to evaluate for repairs.

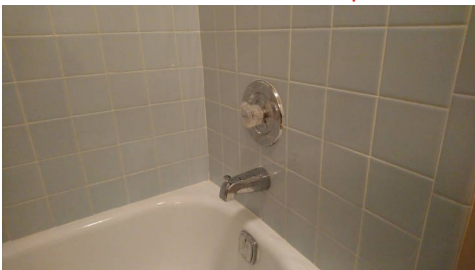
5. 1st Floor - Main Bathroom Bathroom Shower/Surround: Fiberglass pan and ceramic tile surround - We turned on the shower handle and water came out slowly for a few minutes. We attempted to turn the water on minutes later and no water came out. A qualified contractor will need to evaluate for the proper repairs.

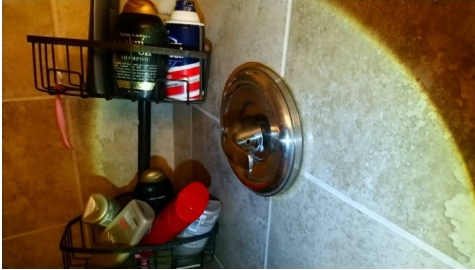
6. Master Bathroom Shower/Surround: We attempted to test the shower surround however no water came out when the handle was turned. It's possible a shut off valve was engaged at the time of our inspection. A qualified contractor will need to evaluate the shower to determine the correct repair.

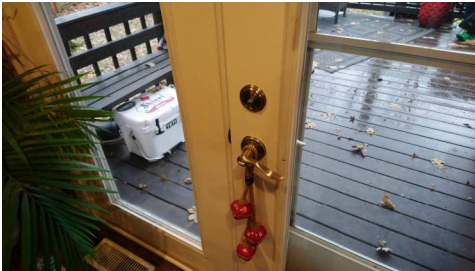
7. 1st Floor Kitchen Doors: Metal - The deadbolt on the back door will need to be replaced by a qualified contractor. The inside lever to open/lock the deadbolt is missing. The rest of the hardware on the back door was functioning as expected. We opened and closed the door without any issues.

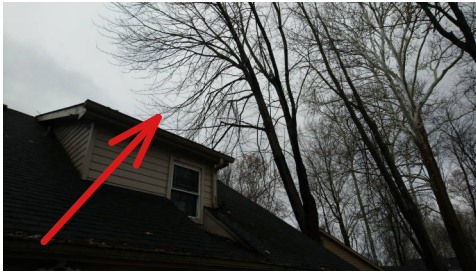
1. Maintenance Vegetation: Trees - A few tree limbs are hanging over the roof and causing unnecessary debris to build up. We recommend having the limbs trimmed back by a qualified contractor.

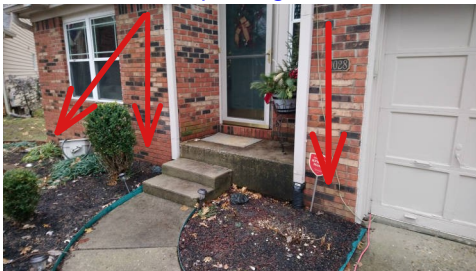
1. Marginal Type: Brick veneer - As we walked the perimeter of the property we did not observe any "weeping wells" in the brick veneer. Weeping wells are drainage holes left in the face of a brick veneer wall in order to allow water that has penetrated the wall to escape downwards through the wall cavity and out to the exterior of the wall surface through the weep openings. A qualified contractor will need to drill out these openings around the home.

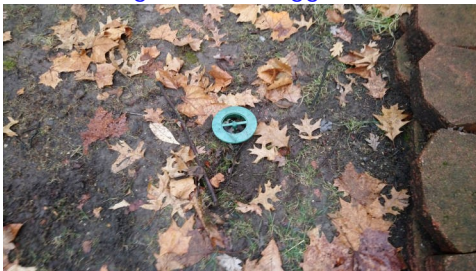
2. Marginal Drainage Lines: The buried drainage lines connected to the downspouts in the front yard will need to be reviewed by a qualified contractor. The pictured pop-up emitter will need replaced and it appears the drainage line is clogged as well.

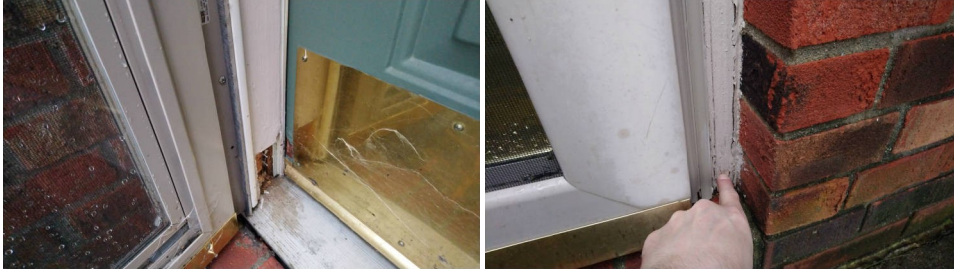
Entry Doors: Wood - The door jamb for the front door will need to be replaced as it is rotten at the bottom. Additional, damage was observed on the left side of the jamb. A qualified contractor will need to replace the jamb on the front door.

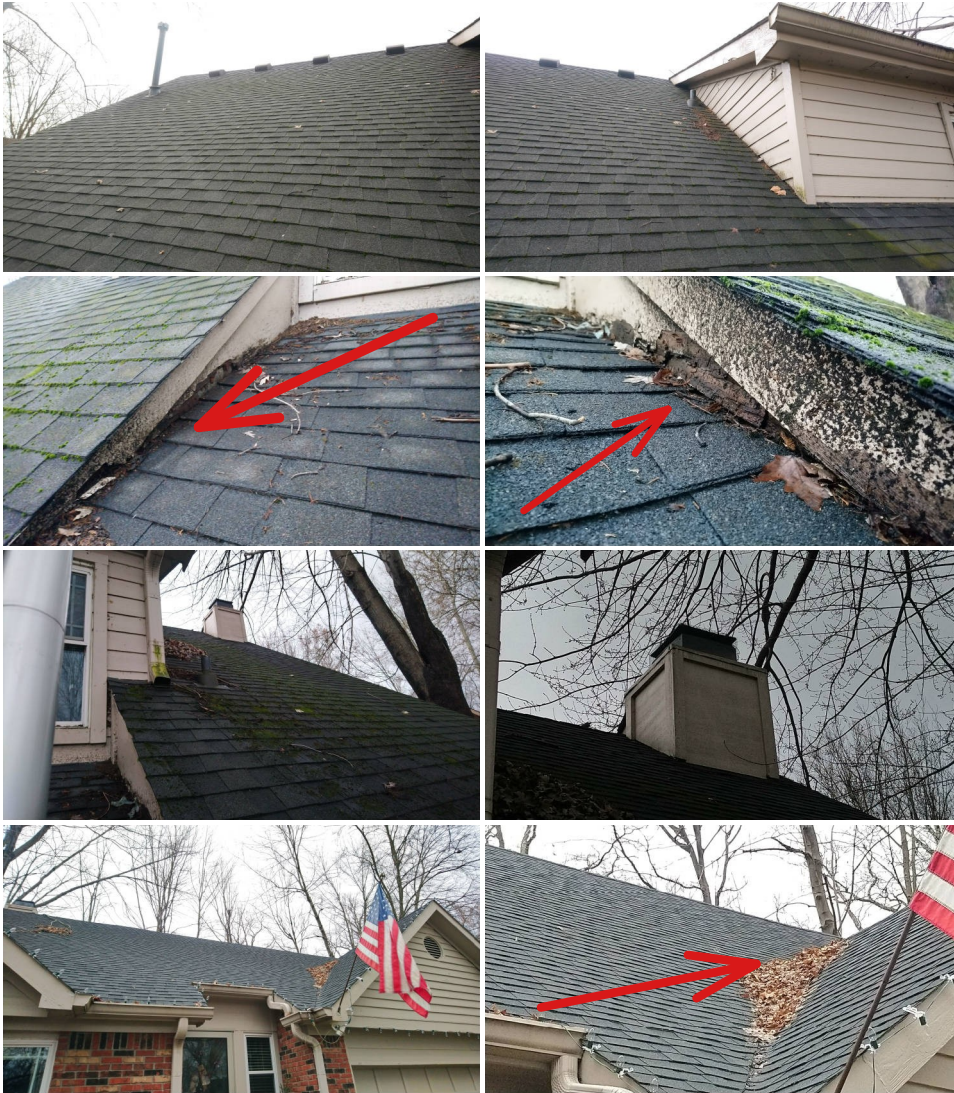
2. Marginal Material: Asphalt shingle - We were unable to walk the roof as it very steep and wet from the rain. With that said, we were able to review it from our ladder. In pictures 3 & 4 you can the rotting trim in front of and surrounding the dormer. All of the trim will need to be reviewed by a qualified contractor to insure the wood is not compromised. The rest of the shingles appear to be in good condition. No active or previous leaks were noticed.

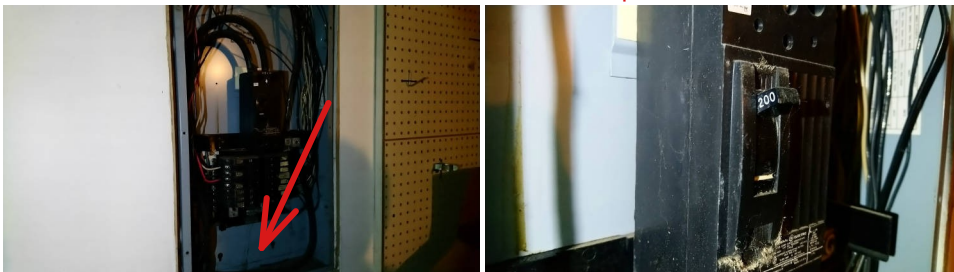
3. Defective Manufacturer: Per code, all knockouts need to be properly covered if removed from the panel. If not, it presents a shock hazard as someone could accidentally stick a finger in the panel. We found one open knockout in the panel needing addressed. The rest of the panel is up to code. All neutral wires were isolated on both bus bars. All wiring is the right size for the attached breaker. A qualified contractor will need to evaluate for the correct repairs.

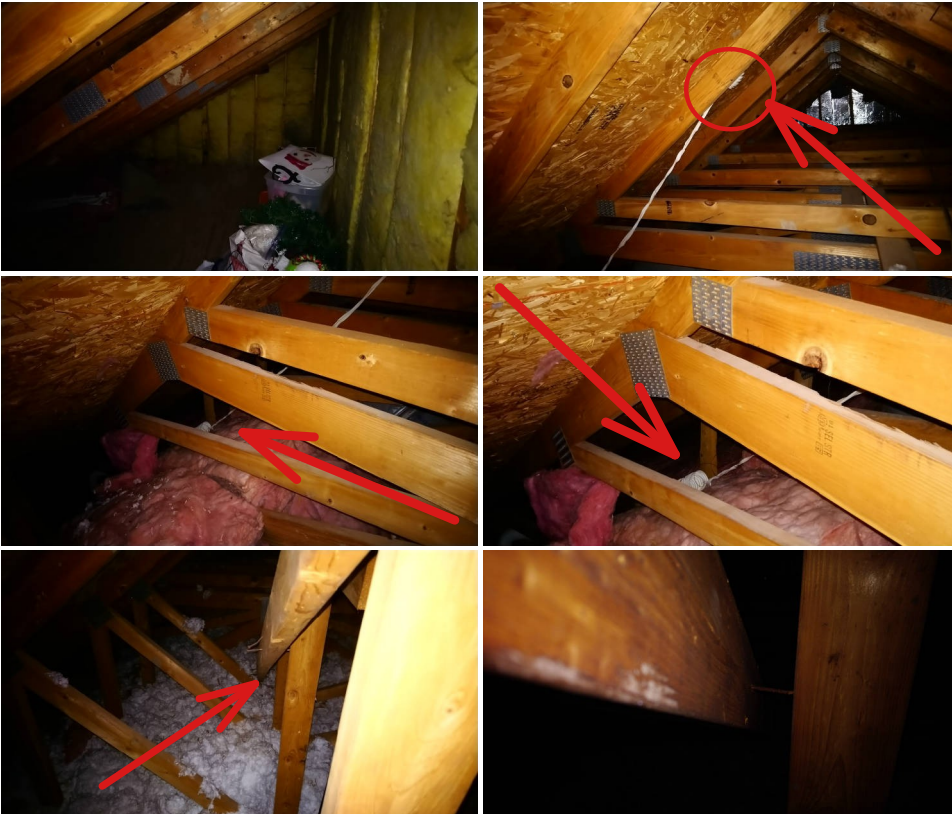
- 1. Method of Inspection: In the attic
- 2. Marginal      Roof Framing: 2x6 Truss - Structurally speaking we do not see any issues with the 2x6 truss system in place. All gusset plates were firmly attached and no "sagging/settling" was observed in any of the trusses. A satisfactory amount of insulation was discovered in the attic as well. No water stains or wood rot were found on any of the webbing. In pictures two and three we found a exhaust vent that has almost separated in two. Furthermore, we observed a 2x4 used a lateral bracing that has come loose and needs reattached. A qualified contractor will need to address these two issues.

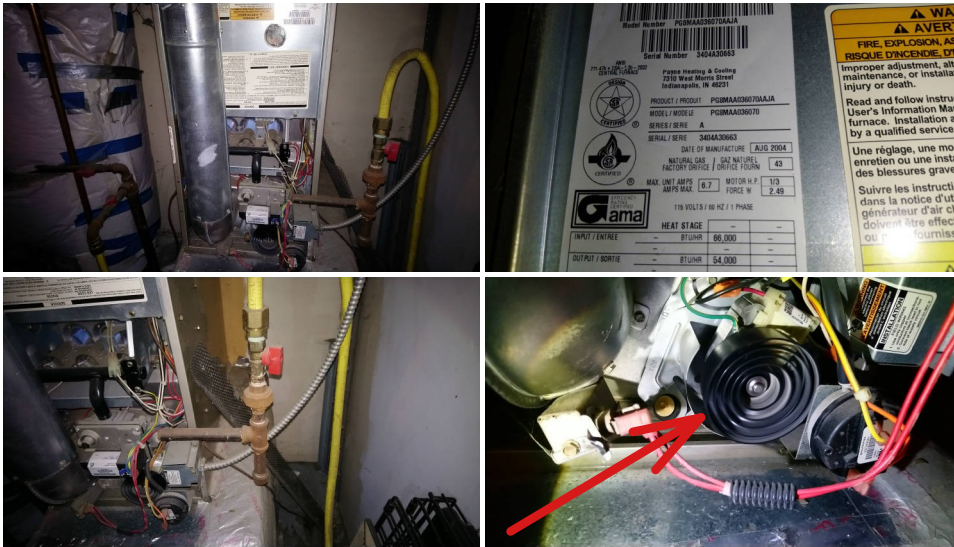
1. Defective Heating System Operation: Inadequate - Immediately as we entered the garage we heard a noise coming from the furnace. We removed the covers and it appears the draft inducer assembly was responsible for the rattling. A qualified contractor will need to maintain and clean the furnace. The rest of the unit is up to code and operating normally.

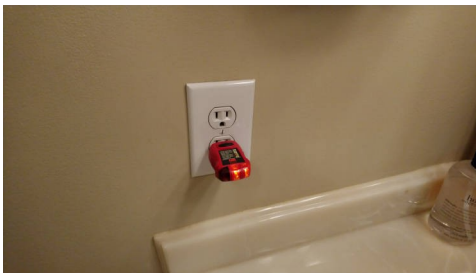
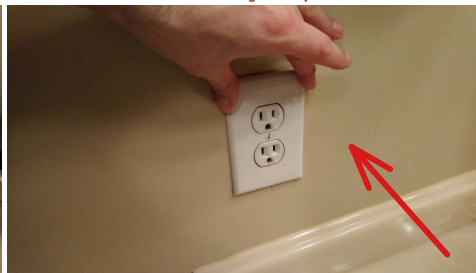
1. Acceptable Walls: Paint - All of the walls are in good condition in this room. No large holes or imperfections were noticed.
2. Maintenance Electrical: 110 VAC - The pictured outlet was tested and functioning correctly. We did notice this outlet was loose and will need to be secured to the wall by a qualified contractor.

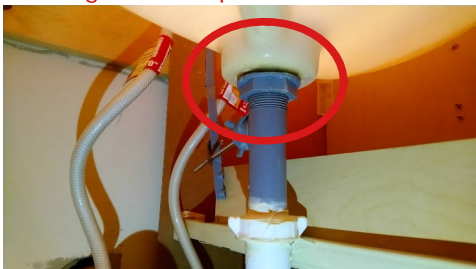
3. Defective Sink/Basin: Molded single bowl - We found an active leak where the sink connects to the PVC drainage line. A qualified contractor will need to evaluate for repairs.

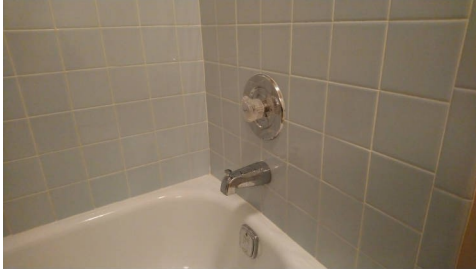
4. Defective Shower/Surround: Fiberglass pan and ceramic tile surround - We turned on the shower handle and water came out slowly for a few minutes. We attempted to turn the water on minutes later and no water came out. A qualified contractor will need to evaluate for the proper repairs.

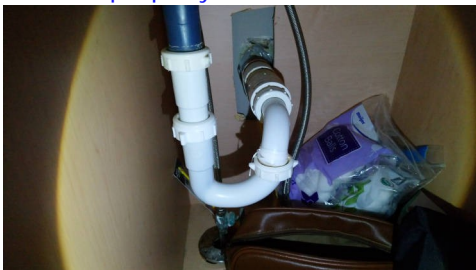
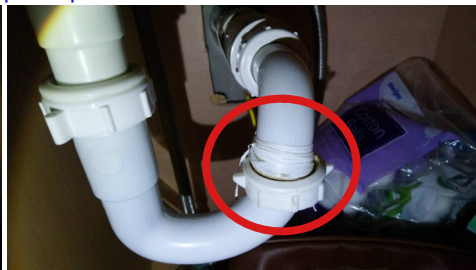
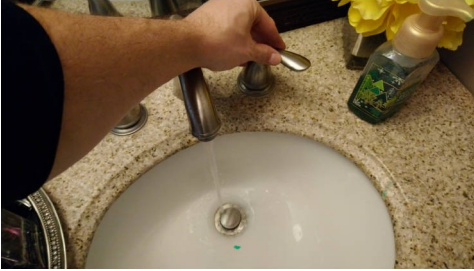
8. Marginal Sink/Basin: The drainage line in this bathroom will need to be reviewed by a qualified contractor. The P trap on the pictured line is not installed correctly. We did not notice any leaks, however the slip nut was not properly attached to the P trap. A qualified contractor will need to correct this issue.

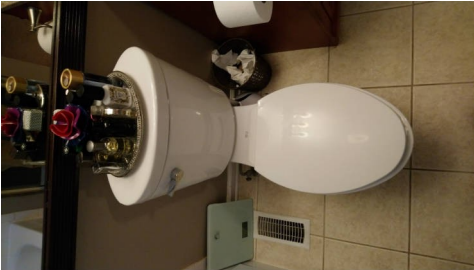
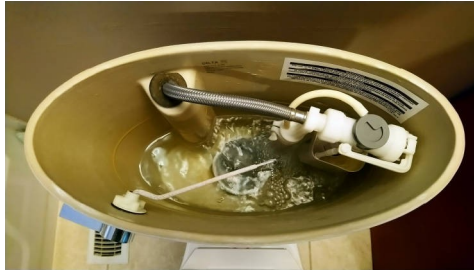
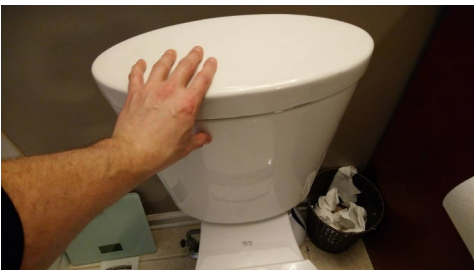
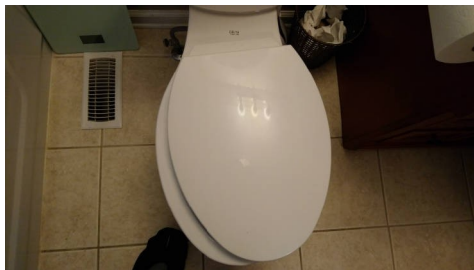
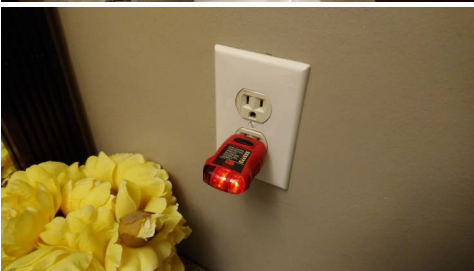
Toilets: 1 1/2 Gallon Tank - The toilet tank in this particular toilet is loose and needs to be tightened. Typically, the tank of the toilet should be tight when installed correctly. Additionally, the seat is really loose as well. A qualified contractor will need to tightened the toilet and seat properly.

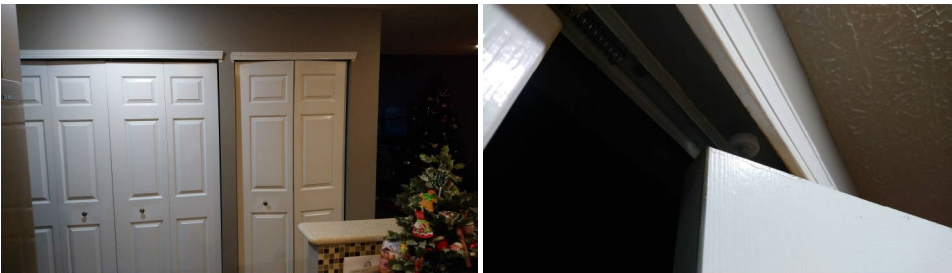
2. Maintenance Pantry Doors: The pantry doors will need to be adjusted as they are not currently sliding on the track. Additionally, we noticed the trim around the top of the pantry was recently replaced and a poor job was done.

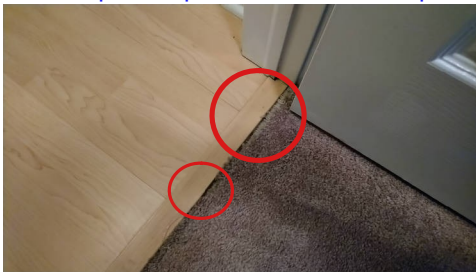
2. Marginal Floor: Carpet - Several rips and imperfections were noticed in carpeting throughout the home. As these rips are permanent the carpet will need to be replaced to be properly fixed.

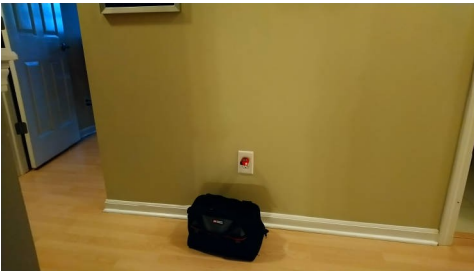
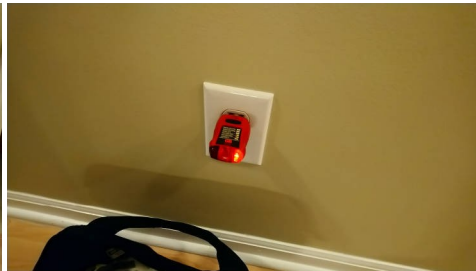
3. Marginal Electrical: 110 VAC - The outlet in the 2nd floor hallway appears to be loose. As we inserted our electrical tester we received an indication of loose wiring. Upon inserting the tester all the way everything tested fine. Typically when this happens the wiring is loose and needs to be tightened.

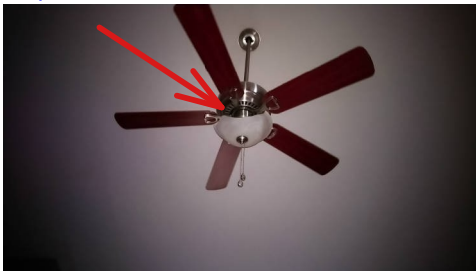
Electrical: 110 VAC - The cover attached to the pictured fan is broke and will need to be replaced by a qualified contractor.
