**Precision 20/20  
Full Reserve Study  
for  
3300 Park Avenue  
Condominium Association, Inc.  
Bridgeport, Connecticut  
March 24, 2011**

April 22, 2011

**3300 Park Avenue Condominium Association, Inc.  
Bridgeport, Connecticut**

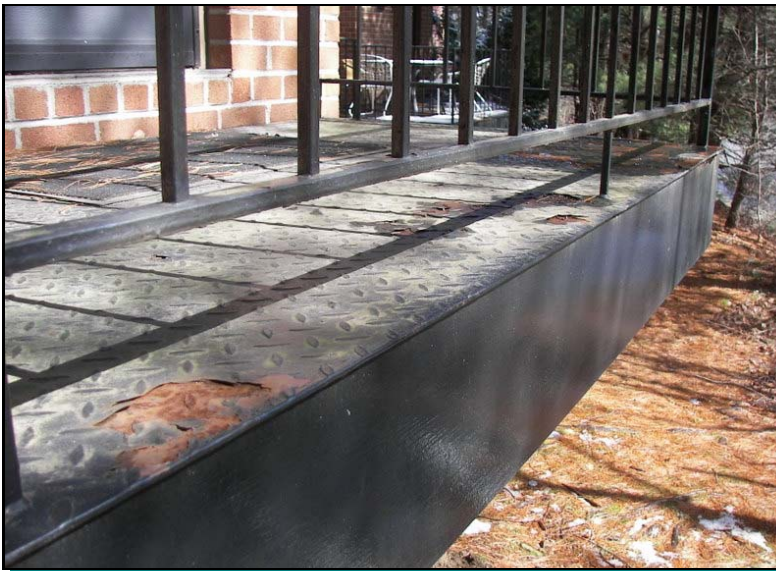
**Balconies and Bridges, Metal** - The buildings at 3300 Park Avenue utilize ten metal balconies and two metal bridges that comprise 510 square feet of decking and 190 linear feet of railings. The balconies and bridges exhibit areas of rust, pitting and metal deterioration. Page 1 of **Exhibit A Photographs** depicts these conditions. Balcony and bridge assemblies of this type have a long useful life of up to 45 years with inspections, paint finish applications and repairs

Rust, pitting and paint deterioration evident at metal balcony assembly

*(note Homeowners are responsible for periodic paint finish applications and repairs)*

every six- to eight-years. The Board informs us that homeowners are responsible for periodic paint finish applications, maintenance and repairs to the balconies and bridges. We suggest the homeowners apply paint finishes, inspect all anchor attachments to the buildings and conduct repairs to the metal balcony and bridge assemblies in order to extend the remaining useful life of the balconies and bridges. We recommend the Association anticipate replacement of the balconies and bridges by 2024. We include this information on Line Item 1.081 of **Exhibit B Reserve Expenditures**.

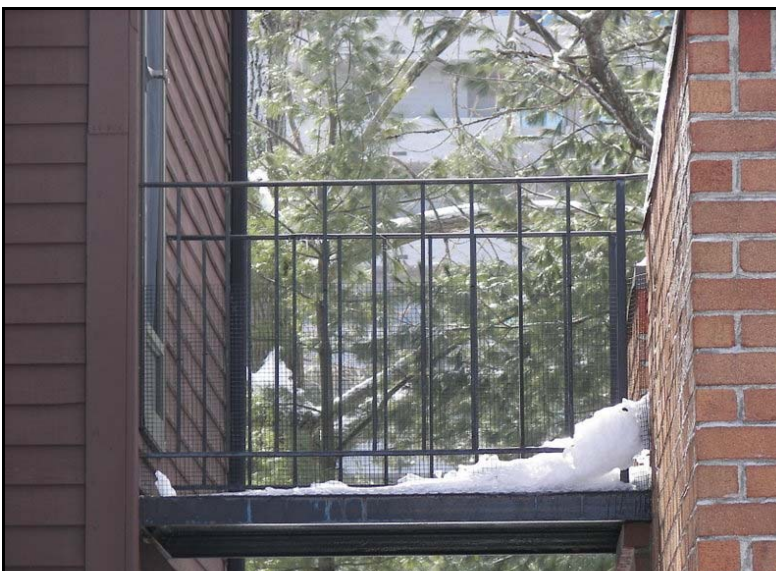
Metal bridge assembly

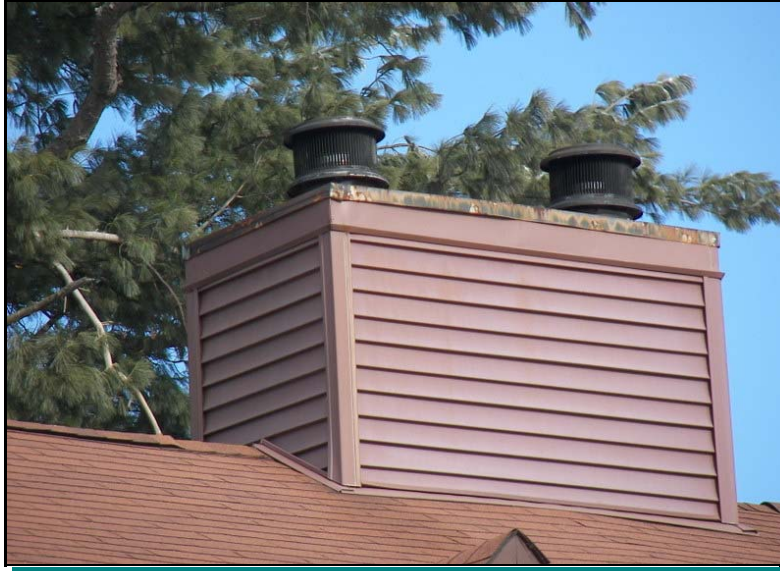
**Chimney Caps, Metal** - 3300 Park Avenue maintains 16 metal chimney caps atop the chimney chases. The Board apprises us that the Association replaced siding at several chimney chases. However, the chimney caps appear original and in fair to poor overall condition. We observe areas of rust and deterioration at the chimney caps, as depicted on Page 2 of **Exhibit A Photographs**. Chimney caps of this type have useful lives of up to 25 years. We recommend the Association anticipate phased replacement of the chimney caps and related flashing beginning in 2012 and concluding by 2013. A subsequent phased replacement is likely beginning by 2037 and concluding by 2038. We depict this information on Line Item 1.140 of **Exhibit B Reserve Expenditures**.

Rust and deterioration visible at metal chimney cap

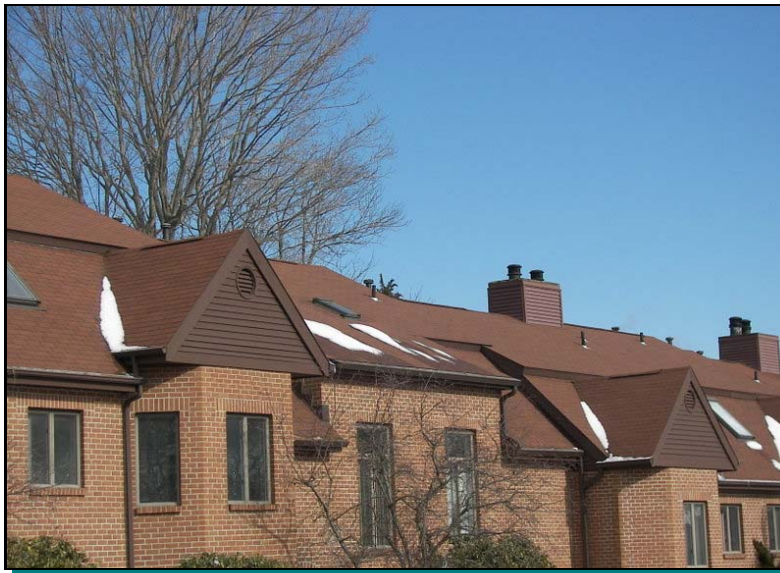
Asphalt shingle roof overview

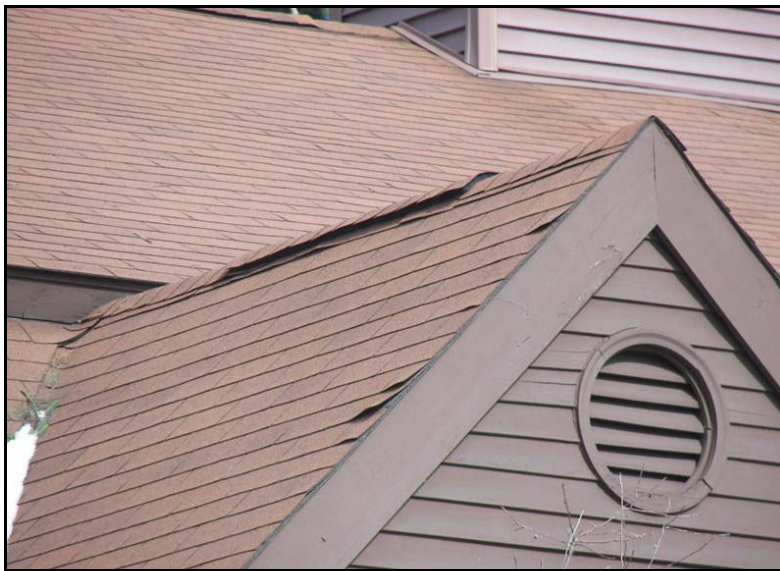
- Building 1: two units, or 22 squares, replaced in 2010 and three units, or 32 squares, will be replaced in 2011 by means of a special assessment or loan; good condition
- Building 3: eight units, or 87 squares, replaced in 2005, good condition
- Pool House Building: four squares replaced in 2003, good to fair condition
- Remaining Roofs: 140 squares over 13 units at Buildings 1 and 2 are at ages of 27- and 29-years; fair to poor condition with considerable shingle lift and sheathing deflection evident, as depicted on Pages 2 and 3 of **Exhibit A Photographs**

Shingle lift evident at roof

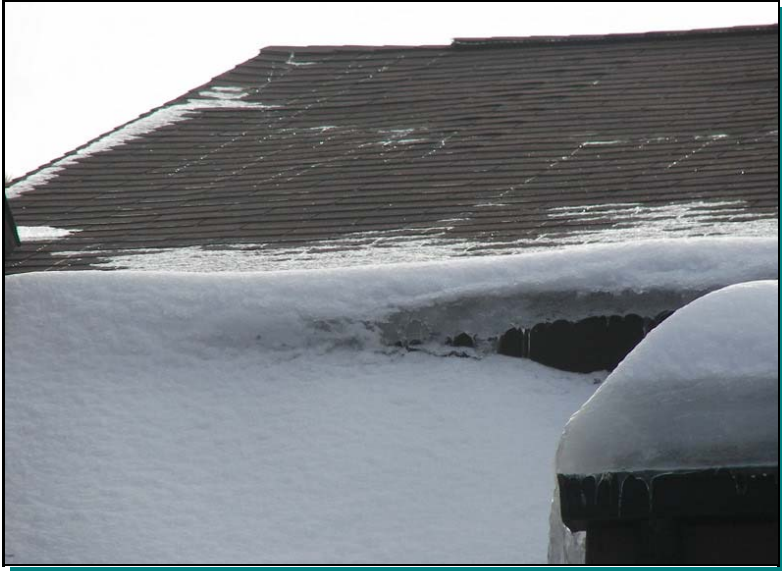
Roof exhibits shingle lift and sheathing deflection

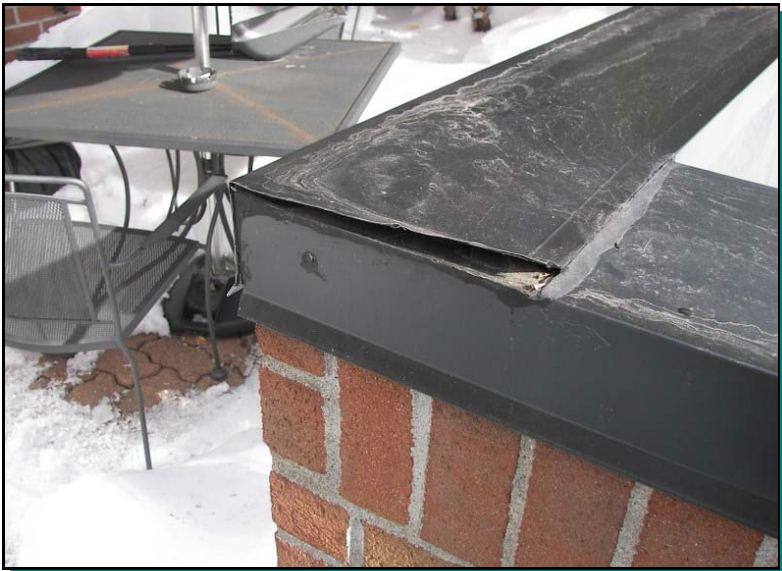
EDPM roof deterioration

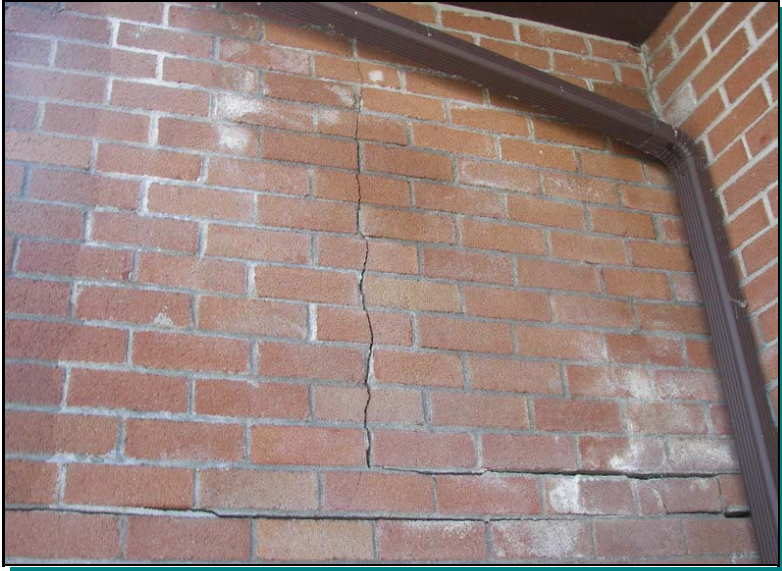
Severe cracks at brick masonry

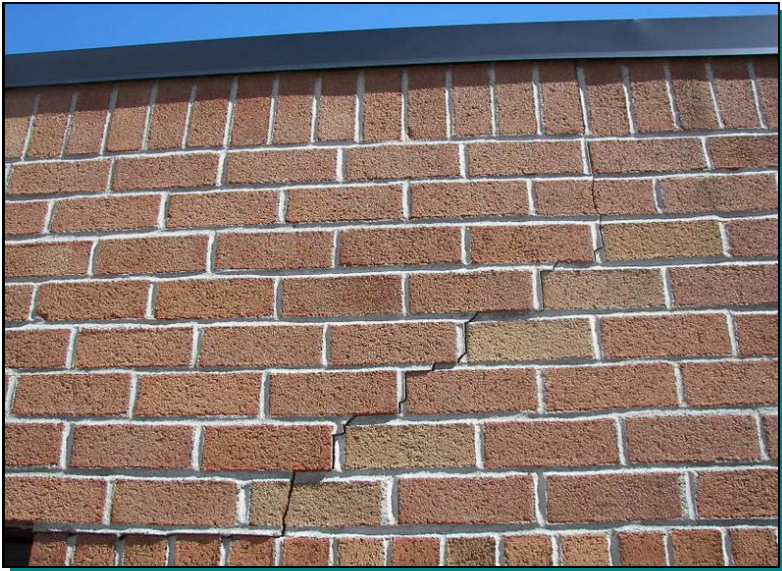
Step cracks at brick masonry

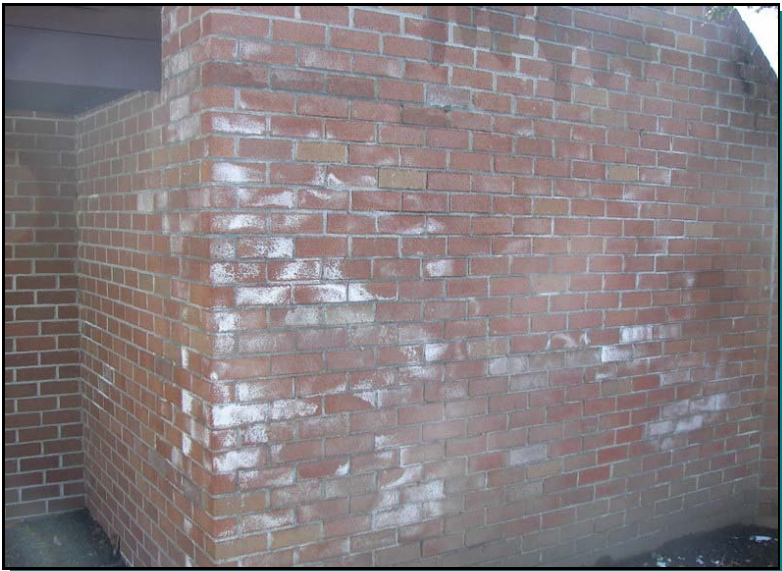
Efflorescence at brick masonry

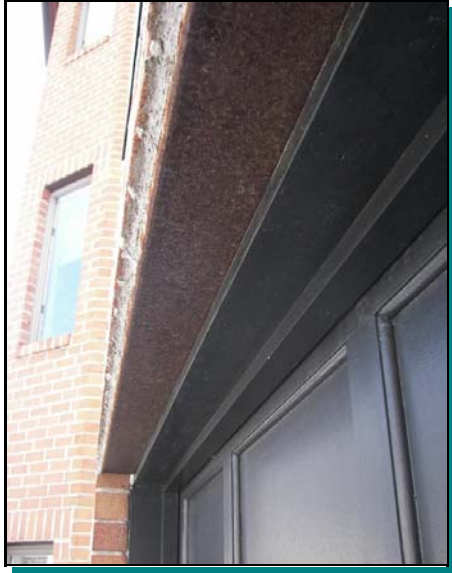
Rust and pitting visible at metal lintel

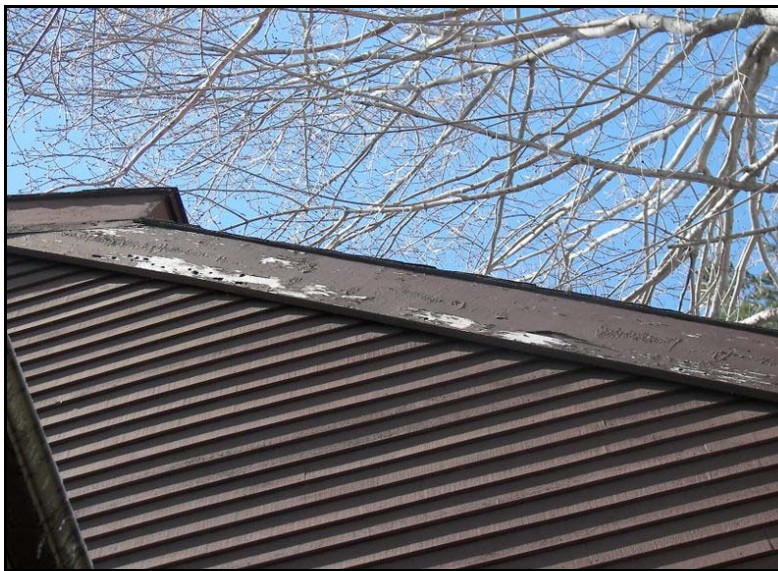
Chipped and blistered paint finish  
at wood fascia board

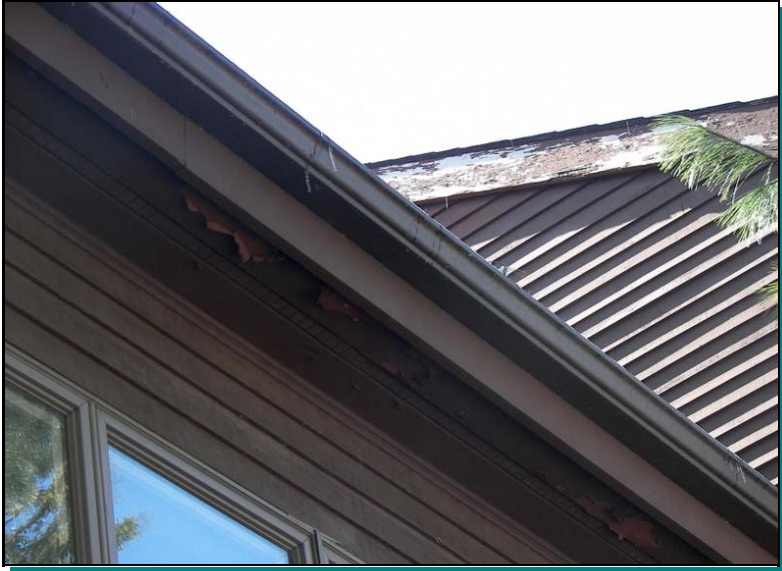
Chipped and blistered paint finish at wood soffit and fascia

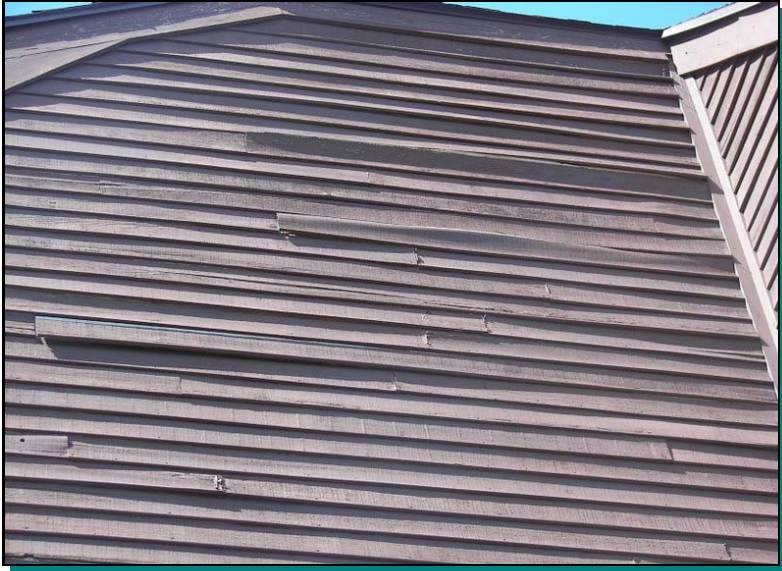
Loose, warped and bowed wood siding

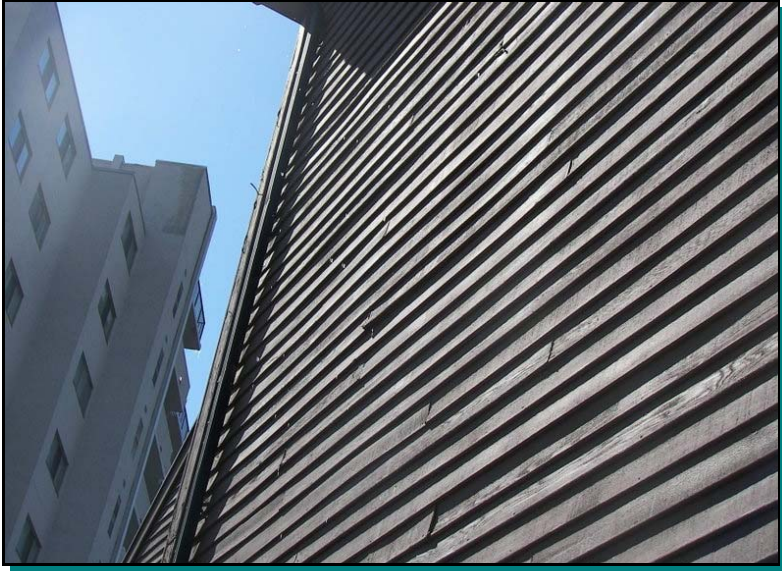
Loose and warped wood siding

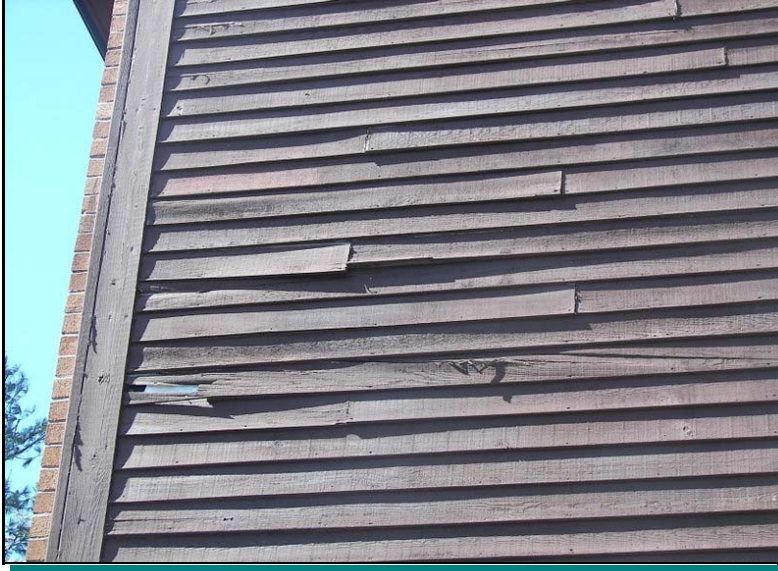
Cracked, rotted and bowed wood siding

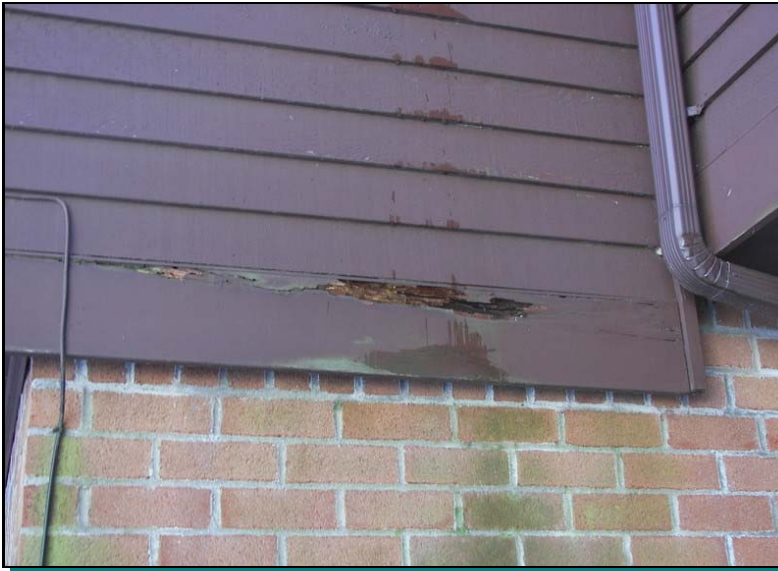
Wood rot evident at wood siding

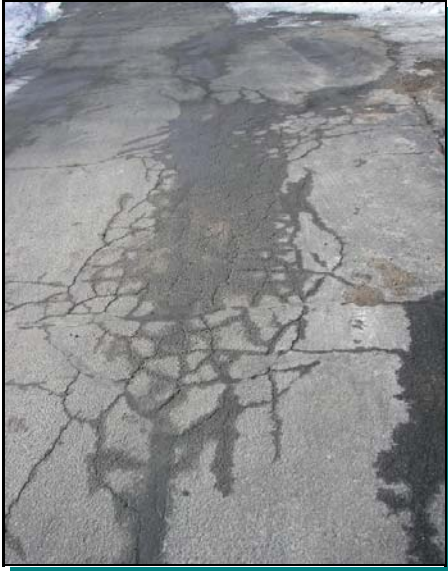
along with alligator, surface and lateral cracks. Pages 8 and 9 of **Exhibit A Photographs** depict these conditions. The Board informs us that the Association intends to conduct a mill and overlay of the existing pavement and expand the asphalt parking area in 2011 by means of a special assessment or loan. We estimate the proposed parking area will consist of 300 additional square yards of asphalt pavement. The useful life of pavement in Bridgeport is from 15- to 20-years. We include the following solutions and procedures pertaining to *components* of the pavement, the *manner of repaving*, *time* of repaving and *coordination* of other possible replacements with the repaving for the benefit of the present and future board members.

Alligator and surface cracks at asphalt pavement

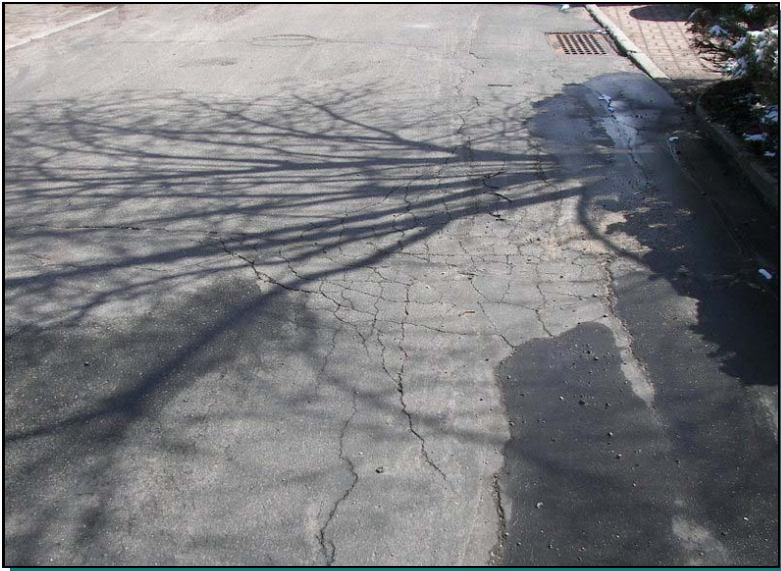
Alligator and surface cracks at asphalt pavement

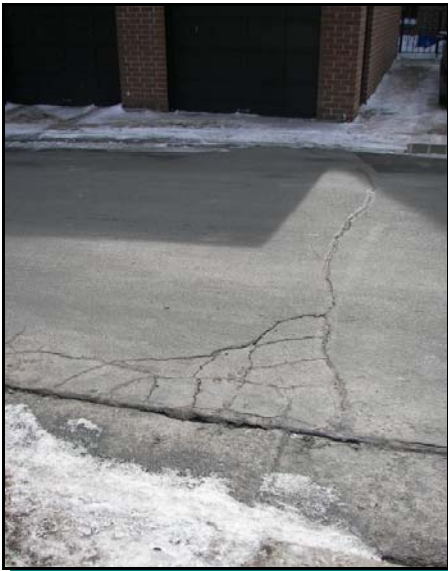
Surface and lateral cracks at asphalt pavement

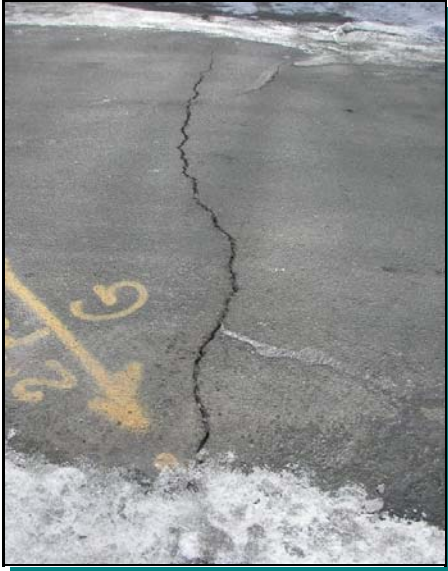
Lateral crack at asphalt pavement

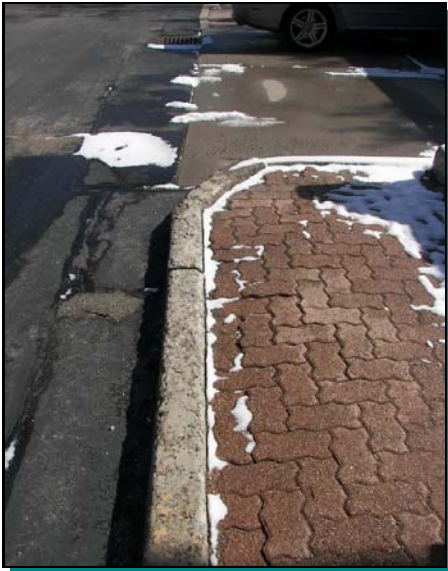
Spalled concrete curb  
*(note brick paver settlement)*

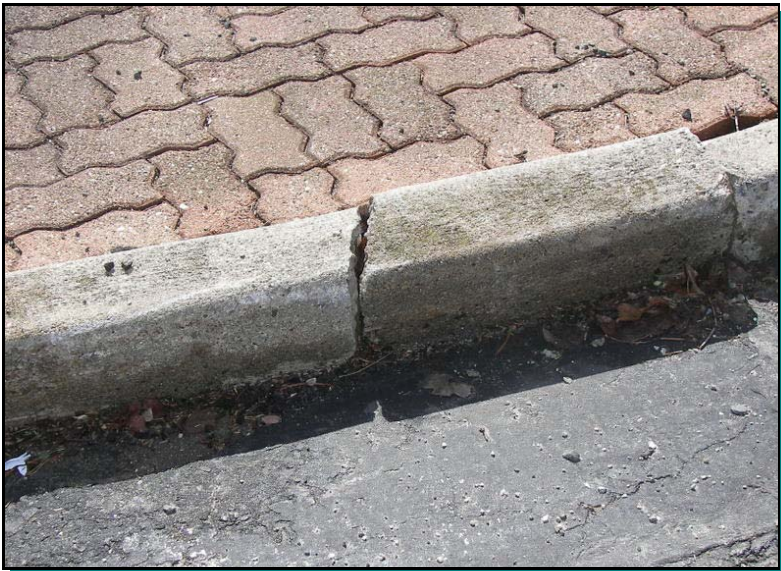
Cracked concrete curb

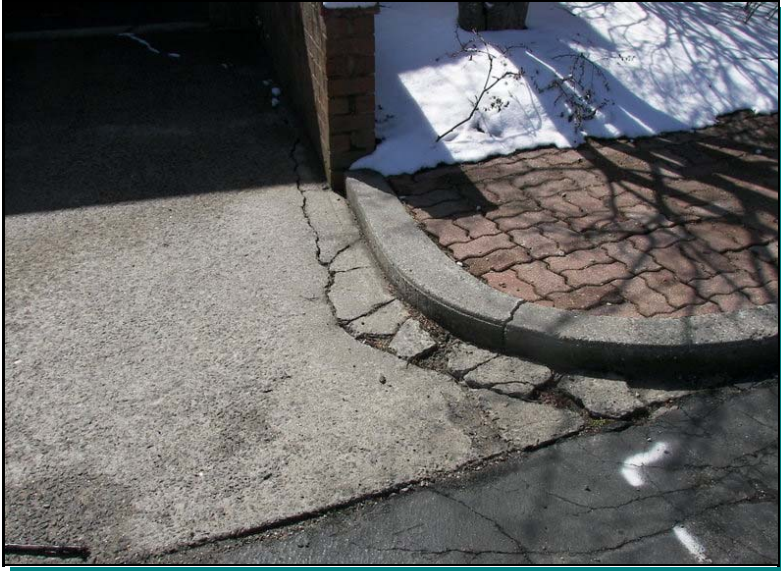
Cracks at concrete driveway

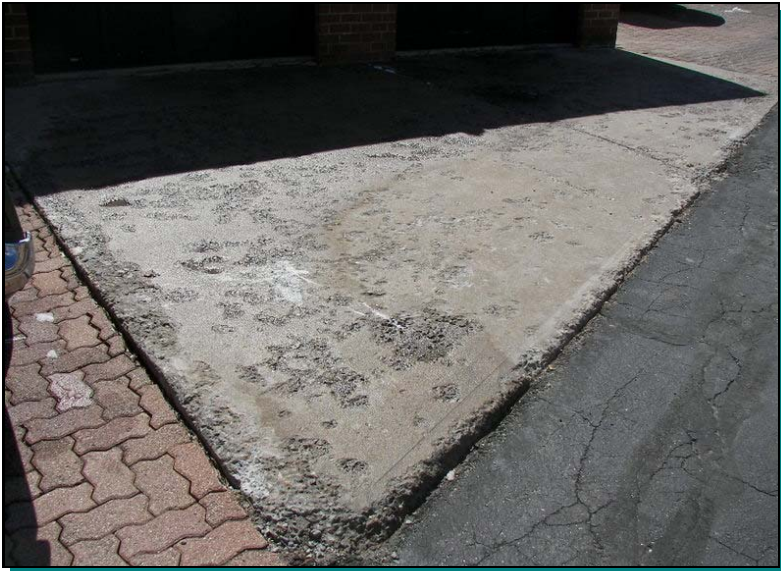
Spalls at concrete driveway

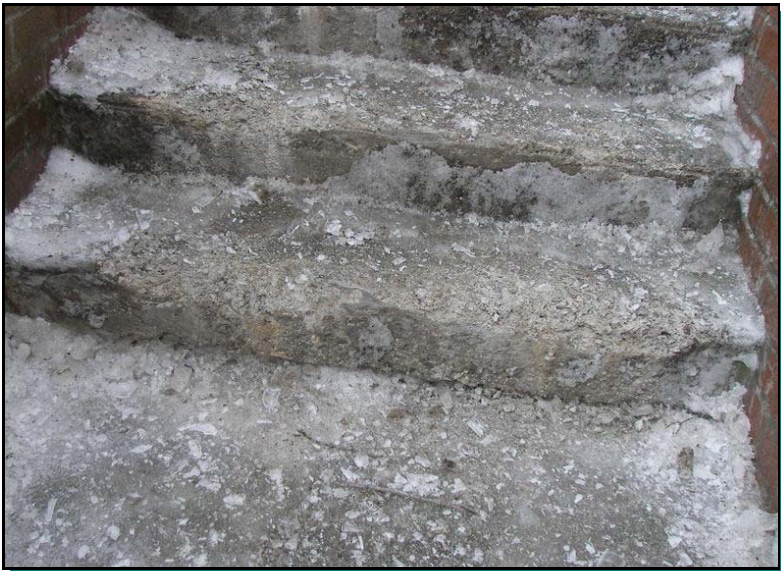
Spalls and deterioration at concrete steps

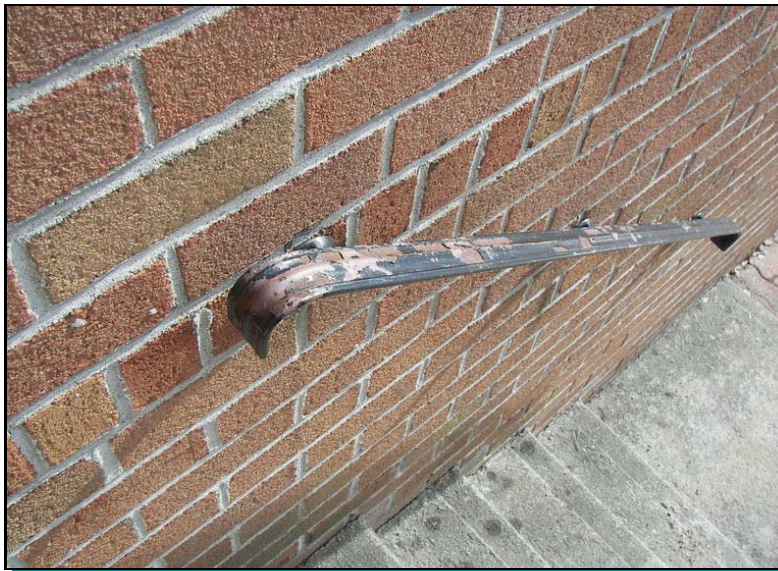
Paint deterioration at metal handrail

*(note Association funds periodic paint finish applications and repairs through operating budget)*

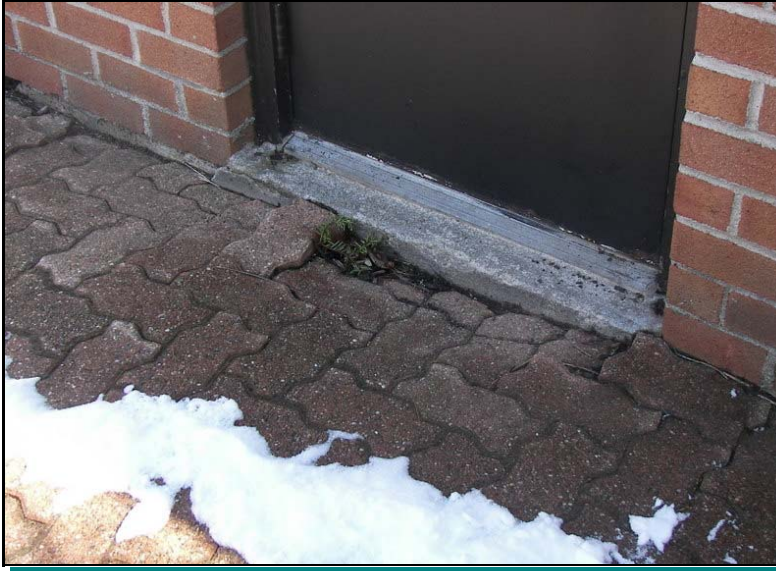
Example of settled and heaved brick pavers

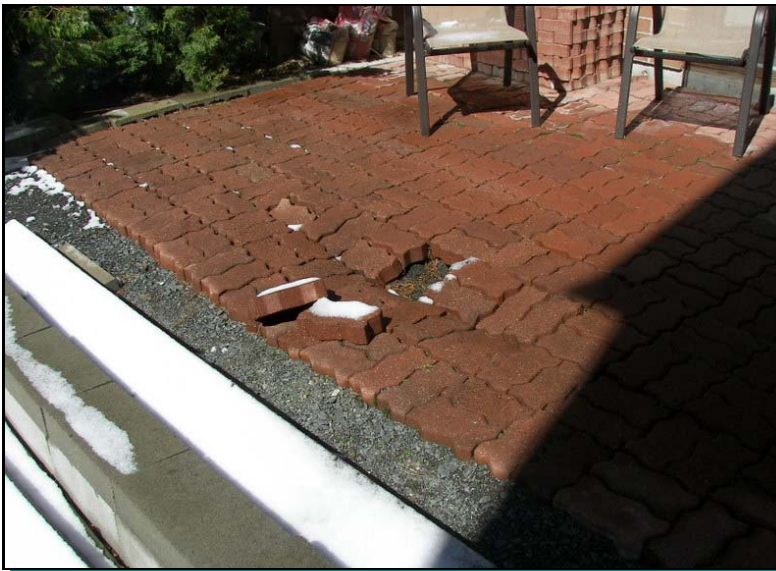
Settled and loose brick pavers at patio

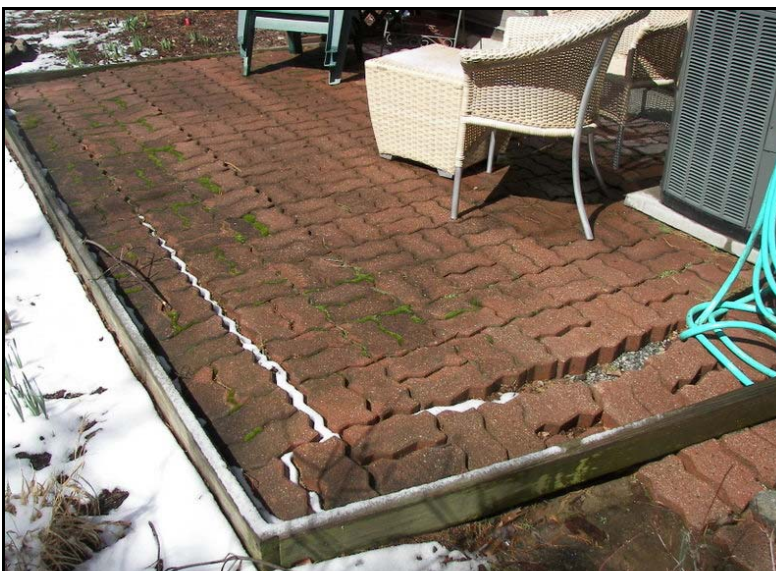
Considerable settlement and organic growth visible at brick paver patio

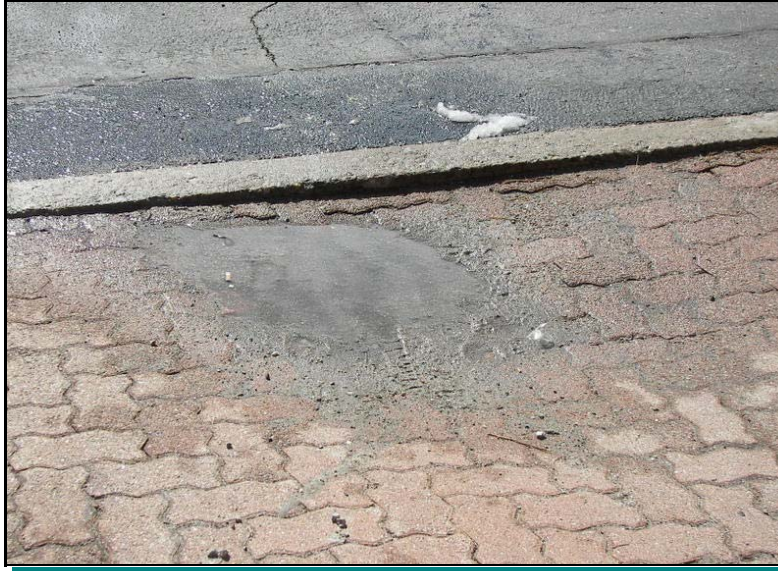
Standing water and settled brick pavers at parking area

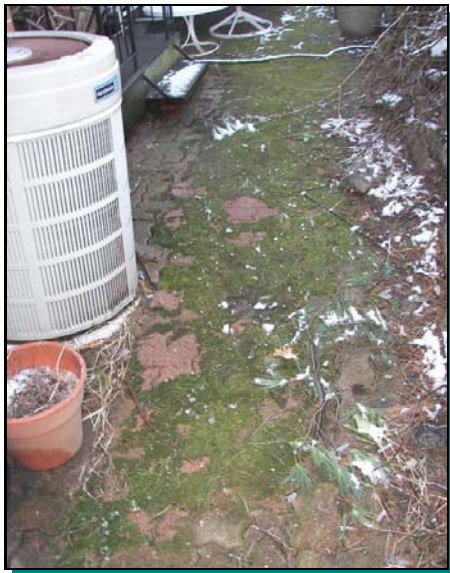
Brick paver patio exhibits substantial organic growth

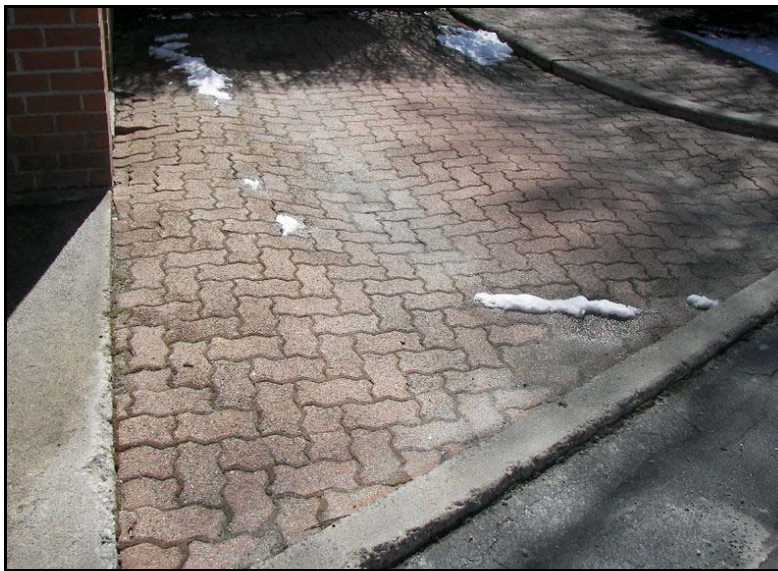
Rutting evident at brick paver parking area

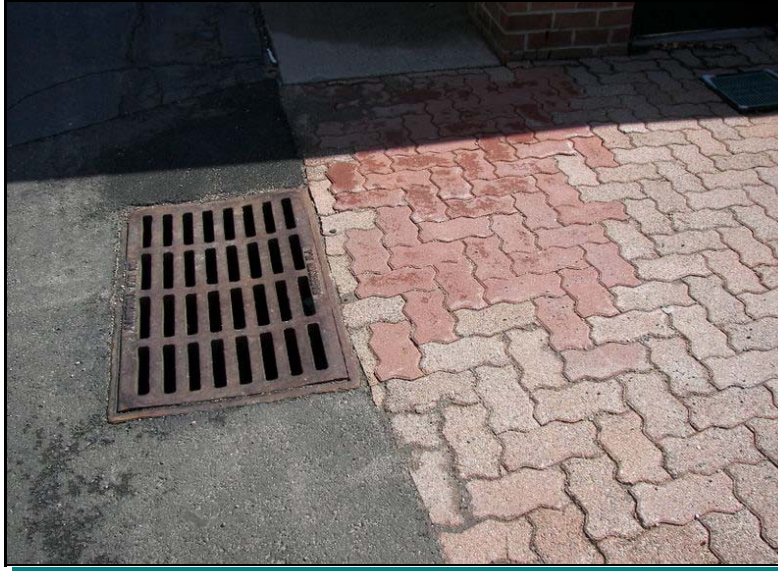
Example of previous partial brick paver replacement

*(note typical catch basin)*
