# CONEJOS RIVER

## DIVERSION INFRASTRUCTURE INVENTORY

**Structure Name:** EL SERRITO D

**Date:** April 15, 2019

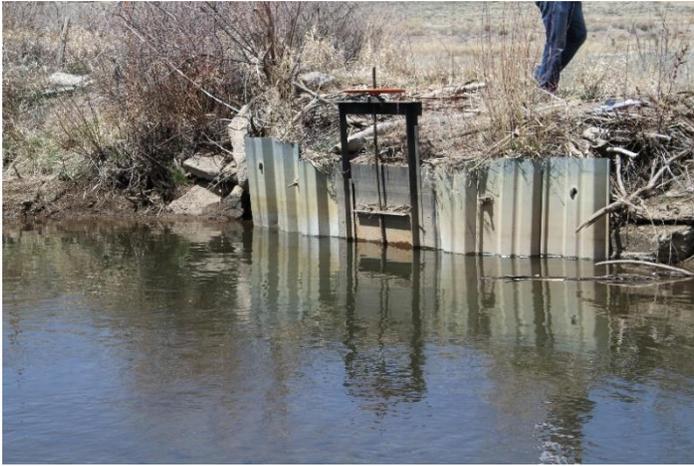
Headgate looking downstream

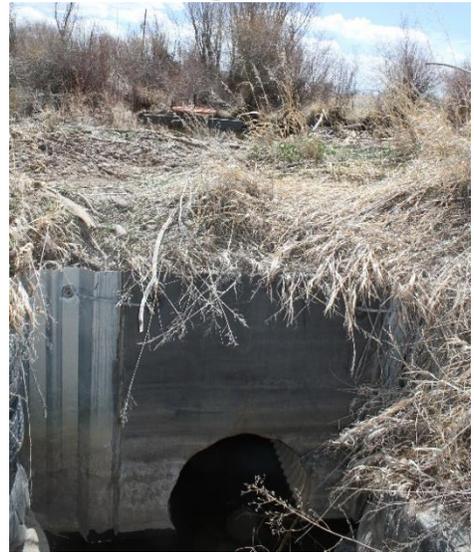
Headgate outlet

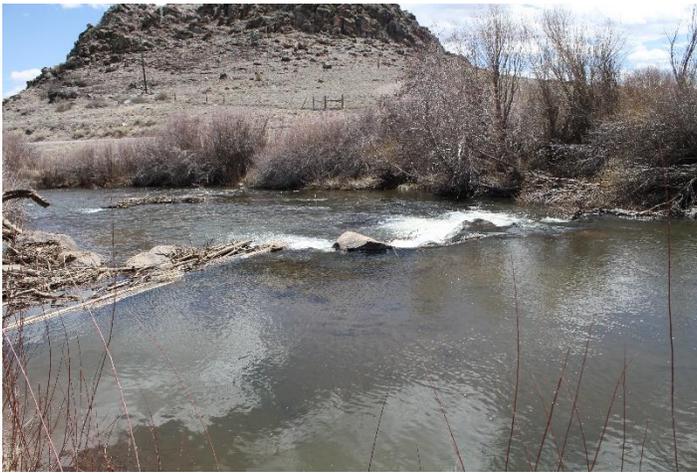
Diversion dam looking downstream

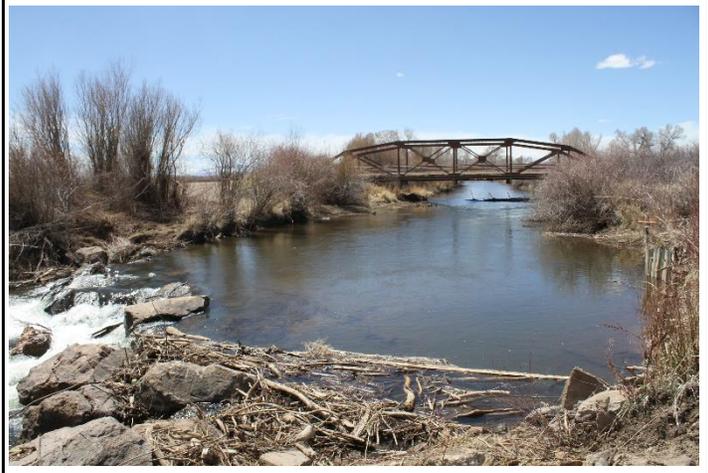
**Repair(s) or Improvement(s) Currently Needed:** Apart from regular debris clearing on the diversion dam, headgate, flume, and ditch, no immediate repair or improvements needs were noted at this structure. However, there is potential for adverse effects in the future. The County Road M Bridge, located ~110 ft upstream of this structure may negatively affect this structure, particularly during a high flow event. Large gravel piles have accumulated on the banks of the river, leading to increased velocity and scour downstream of the bridge. This scour may cause sedimentation at the diversion dam and headgate for this structure if it is not addressed. In addition, a fence crossing the river just upstream of the bridge collects woody debris. If the fence washes out, the debris flow could damage this structure. Additionally, there is potential to improve fish passage and riparian vegetation in this area. Fish and boat passage should be considered as part of any improvements to the diversion. Riparian restoration should also be included in any future repairs or improvements.

Diversion dam and Road M bridge looking upstream

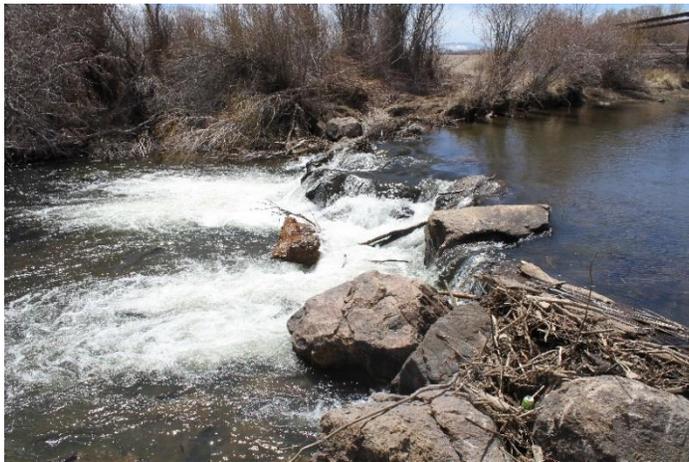
Diversion dam

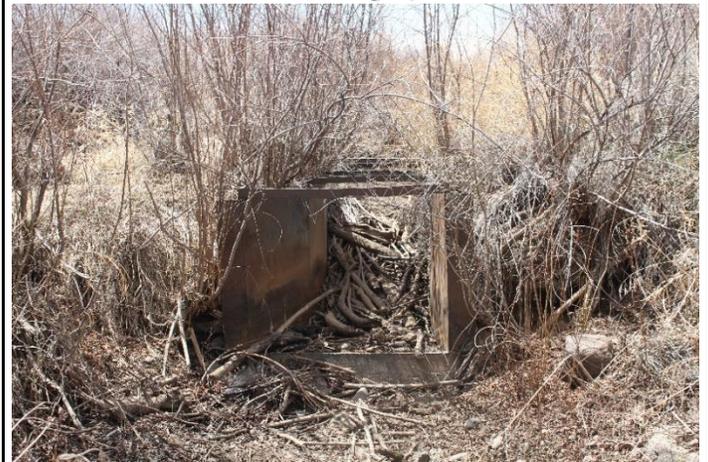
Flume looking upstream

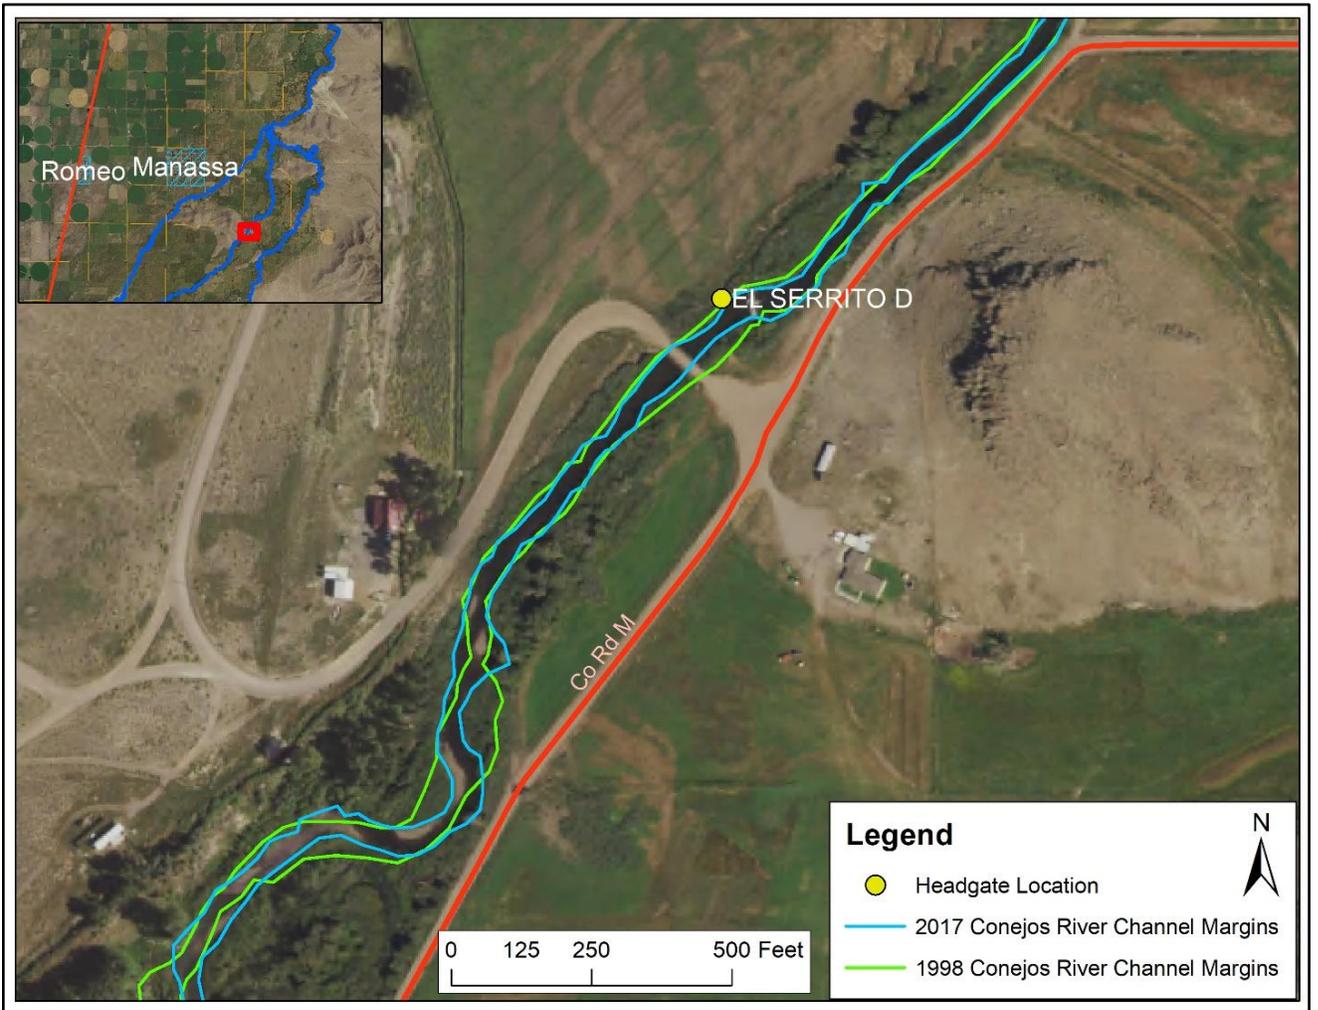
**Structure Description:** Located on the South Branch of the Conejos River just downstream of the County Rd M bridge. A stacked rock diversion dam directs water to the headgate, which is located on the north bank of the channel. The river channel has migrated very little in the last 45 years, due to the geologic controls of the surrounding bedrock hills as well as County Rd M running parallel to the river.

Map of headgate location with 1998 and 2015 channel margins overlaid.
