Home Inspection Report

123 Main Street, Anytown, NY 12866

Inspection Date:

Wednesday, April 5, 2023

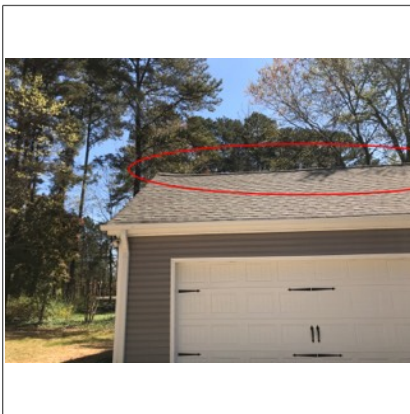
Foundations	<ul style="list-style-type: none"> •Deterioration of the mortar between the concrete blocks was observed on the foundation walls. This condition is common in many old homes and does not usually represent a serious structural concern unless there is substantial loss of material. In an effort to prevent long term deterioration, it would be wise to consider repointing (replacing the mortar in between the blocks) over the deteriorated areas. Lot drainage improvements and elimination of water or roof runoff splashing against foundation walls as outlined in the Exterior section of this report are also recommended also.
Roof	<ul style="list-style-type: none"> •The ridge and rafters of the roof structure show evidence of sagging. Strengthening the roof structure would resist further movement. This improvement is not priority unless the roof is likely to be subjected to heavy loads from additional layers of roofing material whose weight could cause further damage. Additional support can often be added easily.

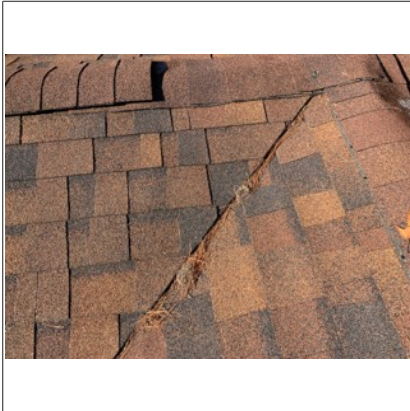
Sloped •Debris should be removed from the roofing to reduce risk of leaks and early roof wear.

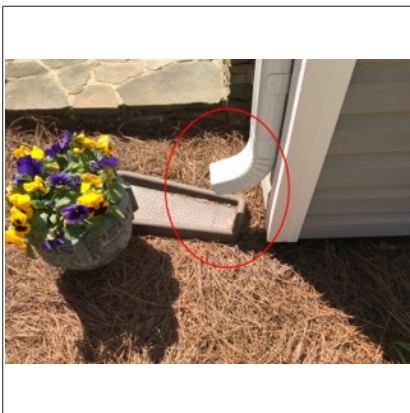
Gutters & downspouts •The downspout(s) should discharge water at least five (5) feet from the house. Storm water should be encouraged to flow away from the building at the point of discharge.
•The gutters require cleaning to avoid spilling roof runoff around the building - a potential source of water entry or water damage.

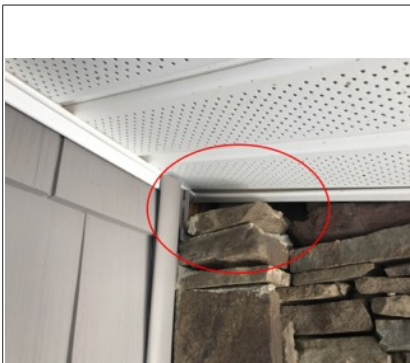
An opening above the veneer stone should be sealed as necessary.

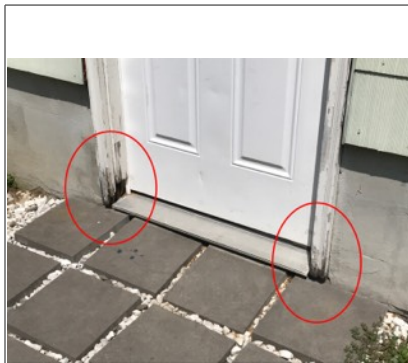
Localized rot on wood trim.

- Localized rot was observed in the wood trim of this home. Following repair of the damaged areas (which should be combined with exterior painting/maintenance) proper maintenance of the wood trim and control of water from roof or surface runoff can avoid further damage. Vegetation should be trimmed away from the house to avoid damage to the building.

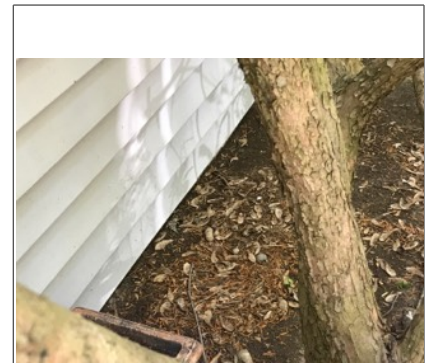
Siding to soil contact.

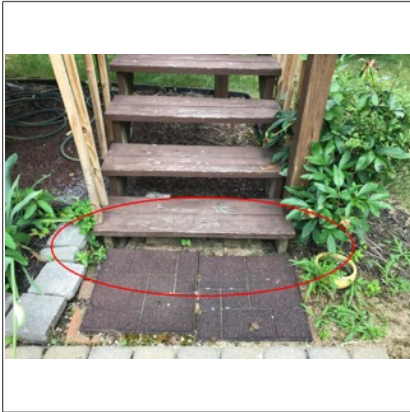
- Wood to soil contact should be avoided on the steps of the deck to reduce insect and rot-damage risk.
- A center stringer should ideally be provided for the rear deck steps.
- A graspable hand railing not wider than 2.5 inches should be provided for the rear deck steps.

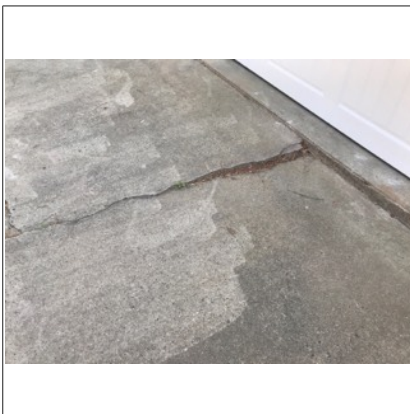
- The driveway shows evidence of cracking and heaving. Re-surfacing/repairs of the driveway defects would be a logical improvement.

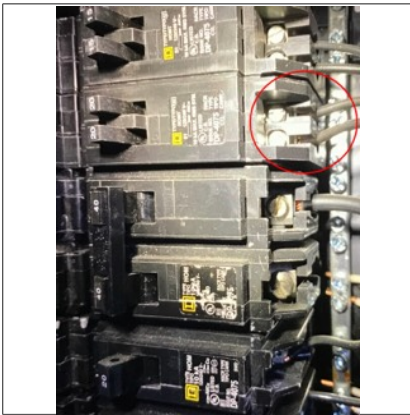
Main panel •Oversized breakers within the main distribution panel should be replaced. These breakers are serving 14 gauge household branch circuit wires and should be sized at fifteen (15) amps.

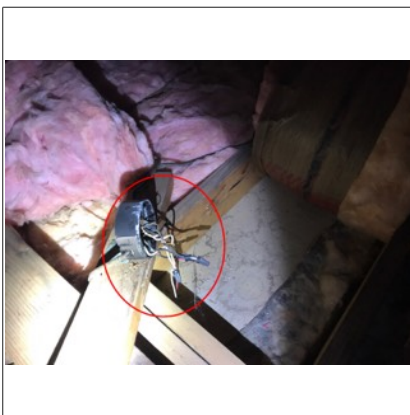
Distribution wires •Improper electrical connections should be repaired. All electrical connections should be made inside junction boxes fitted with cover plates.
•All junction boxes should be fitted with cover plates, in order to protect the wire connections.

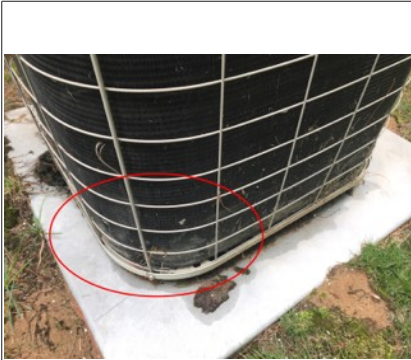
- The fins of the outdoor portion of the air conditioning system were observed to be damaged. This condition can reduce the efficiency of the system.
 - Damaged and or missing insulation on refrigerant lines should be repaired. These outside lines should be insulated all the way to the compressor unit to prevent condensation moisture damage (water pooling around the foundation).

Fin damage.

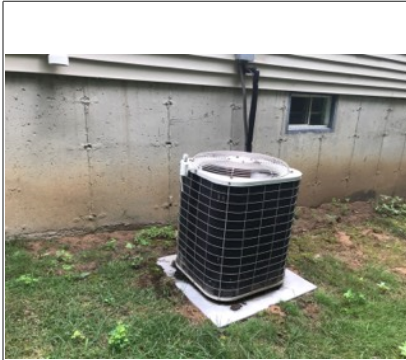
- The outdoor unit of the air conditioning system is out of level. This should be improved.
 - The outdoor unit of the air conditioning system is dirty and requires cleaning.

Outdoor AC unit out of Level.

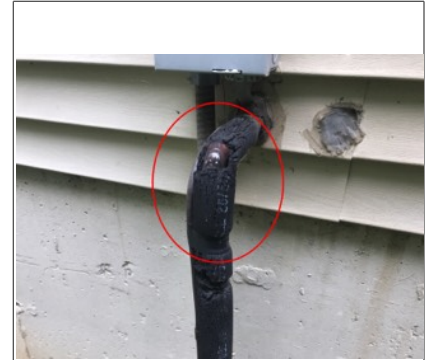
Damage / missing refrigerant line insulation.

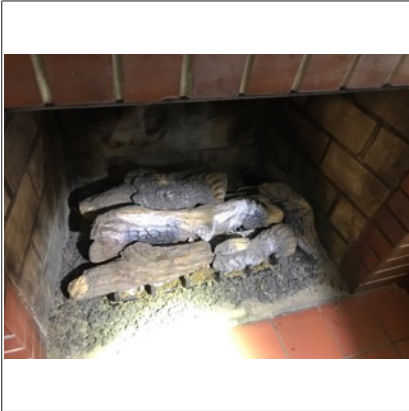
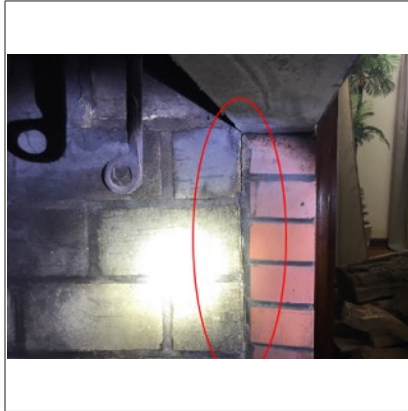
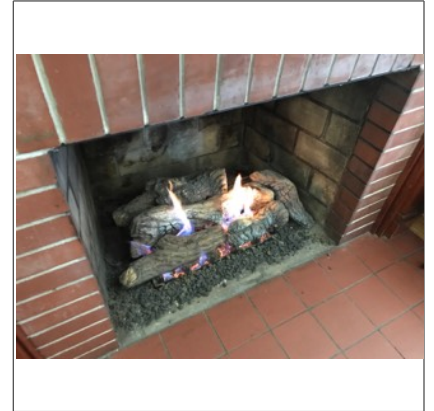
- Fireplace**
- The fireplace firebox mortar should be improved.
