CONEJOS RIVER DIVERSION INFRASTRUCTURE INVENTORY

Structure Name: MARTINEZ D

MARTINEZ DITCH

Conejos River Stream Management Plan

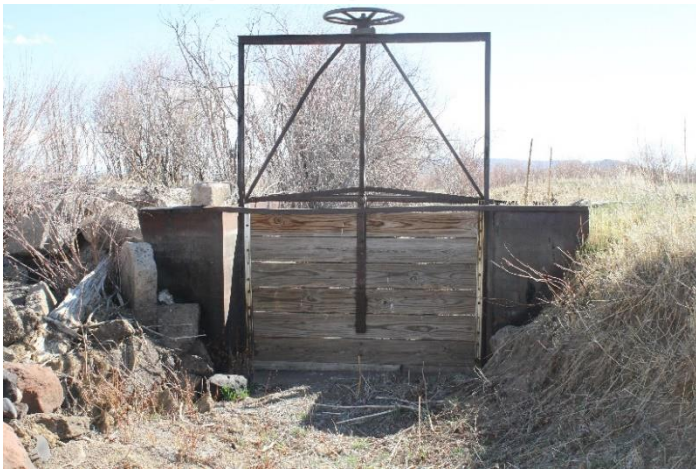
Headgate looking downstream

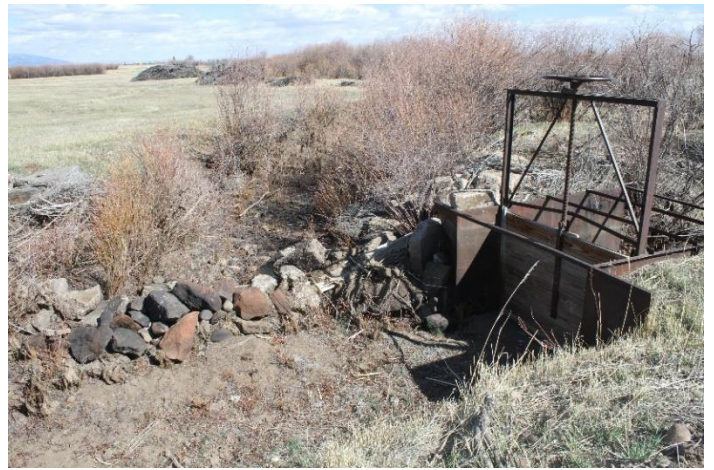
Headgate and diversion dam

Repair(s) or Improvement(s) Currently Needed: Regular maintenance on diversion dam, including clearing woody debris from the headgate and diversion dam. Fish passage and riparian area restoration should be considered as part of any future repairs or improvements.

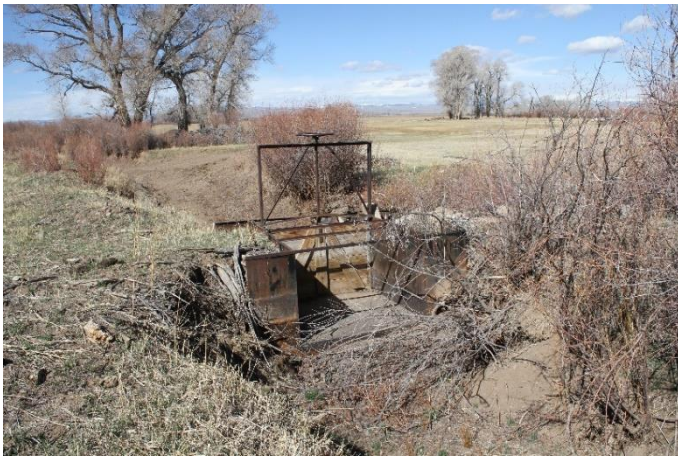
Headgate outlet

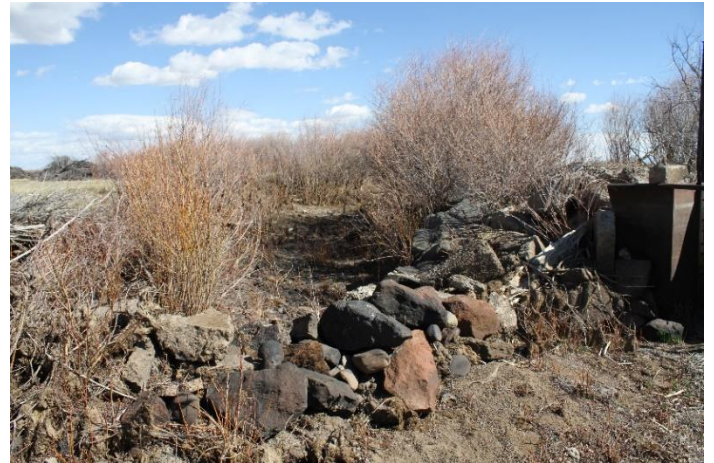
Diversion dam

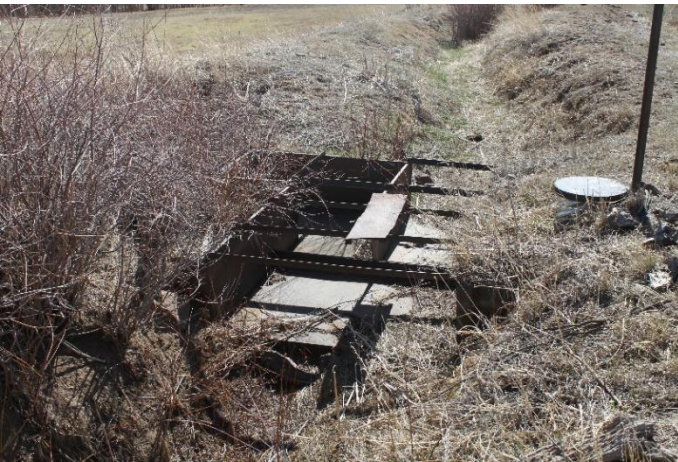
Flume looking downstream

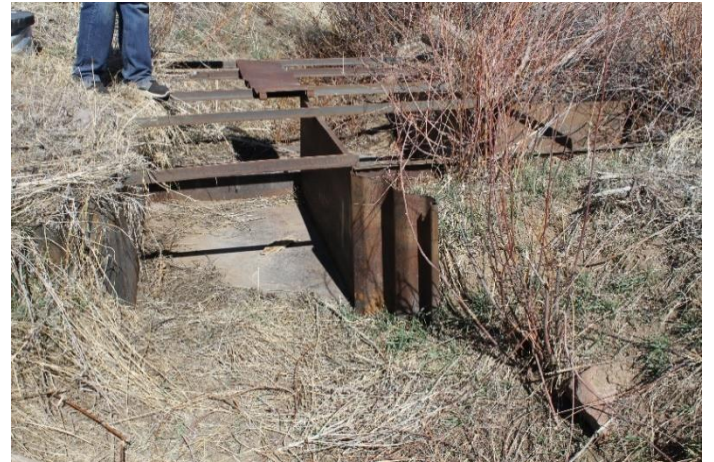
Flume looking upstream
