DEPARTMENT OF REGULATORY  
AND ECONOMIC RESOURCES

MINIMUM INSPECTION PROCEDURAL GUIDELINES  
FOR BUILDING ELECTRICAL RECERTIFICATION

- a. Name on Title: Village at Dadeland Condominiums (A)
- b. Street Address: 7300 SW 82nd St. Miami, Florida 33143
- c. Legal Description: Village at Dadeland Condominiums
- d. Owner's Name: Village at Dadeland Condominiums
- e. Owner's Mailing Address: 7300 SW 82nd St. Miami, Florida 33143
- f. Folio Number of Property on which Building is Located: 30-4035-047-XXXX
- g. Building Code Occupancy Classification: R2 - Residential
- h. Present Use: Condominium, Residential
- i. General Description, Type of Construction, Size, Number of Stories, and Special Features

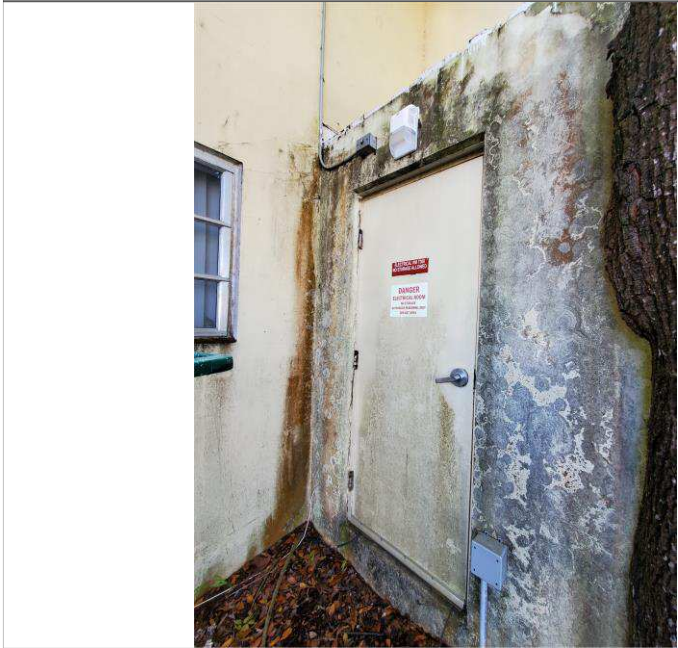
Photo 1 – Village of Dadeland Condominium Association

Existing Electrical Room - 1st FL  
No Storage Permitted

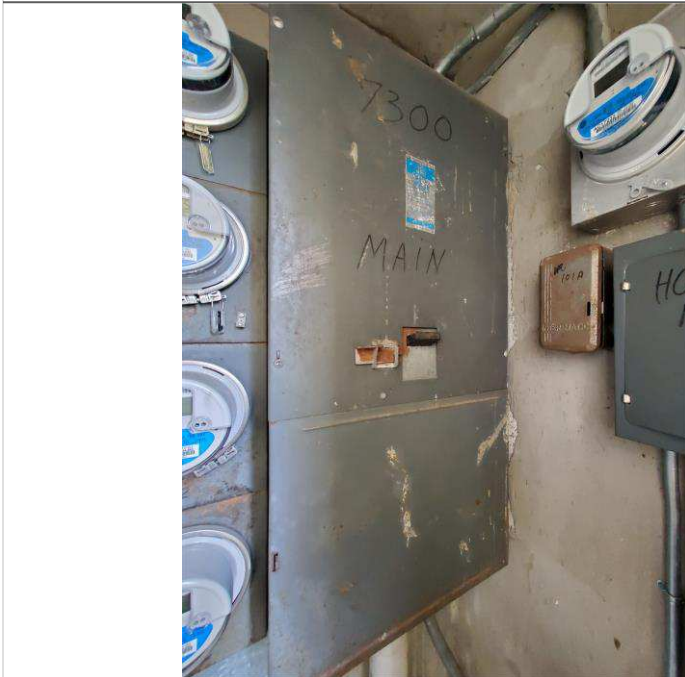
Photo 5 – Village of Dadeland Condominium Association

Existing Electrical Room - 1st FL  
Building Main Disconnect is  
considerably corroded.  
50 year old electrical  
component.

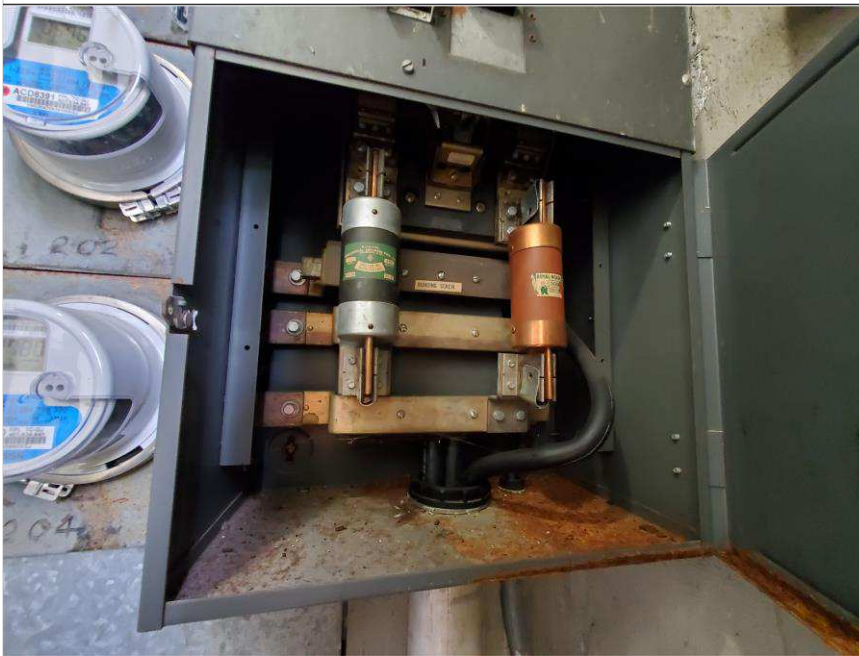
Photo 6 – Village of Dadeland Condominium Association

Existing Electrical Room - 1st FL  
Building Main Disconnect  
interior is corroded.  
50 year old electrical  
components.

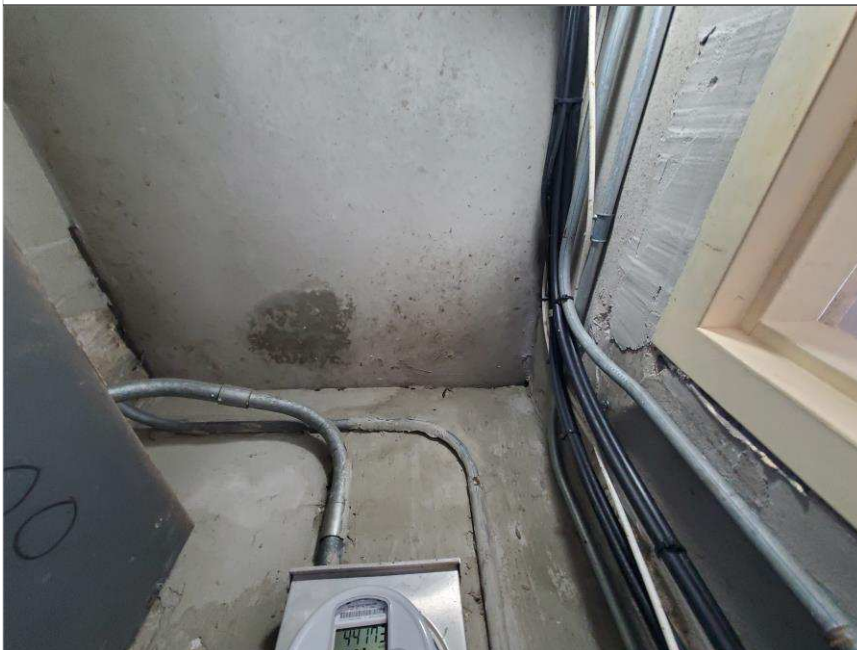
Photo 8 – Village of Dadeland Condominium Association

Existing Electrical Room - 1st FL  
Possible moisture intrusion  
from roof above.

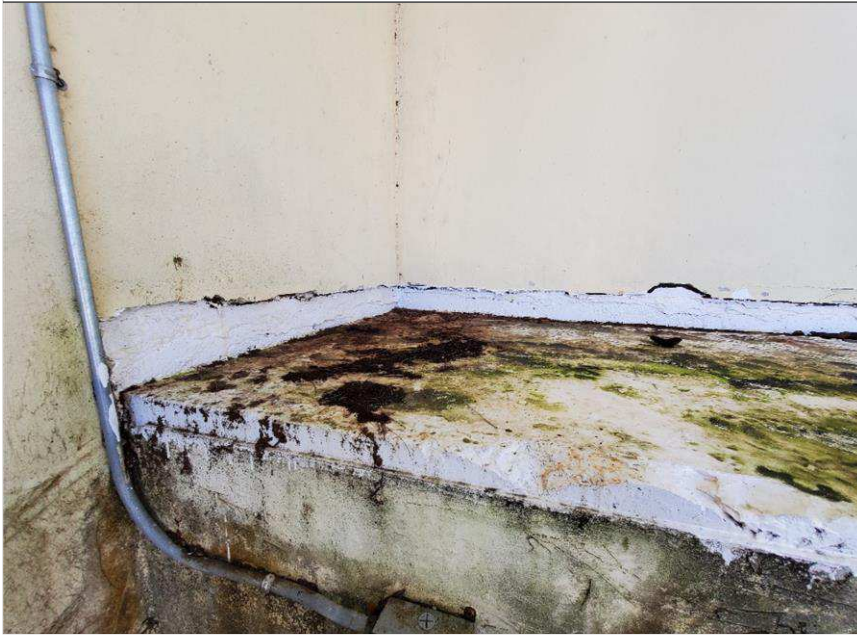
Photo 9 – Village of Dadeland Condominium Association

Existing Electrical Room - 1st FL  
Main Electrical Room Roof

Possible moisture intrusion  
from roof above.  
Main Electrical Room Roof to  
be sealed.

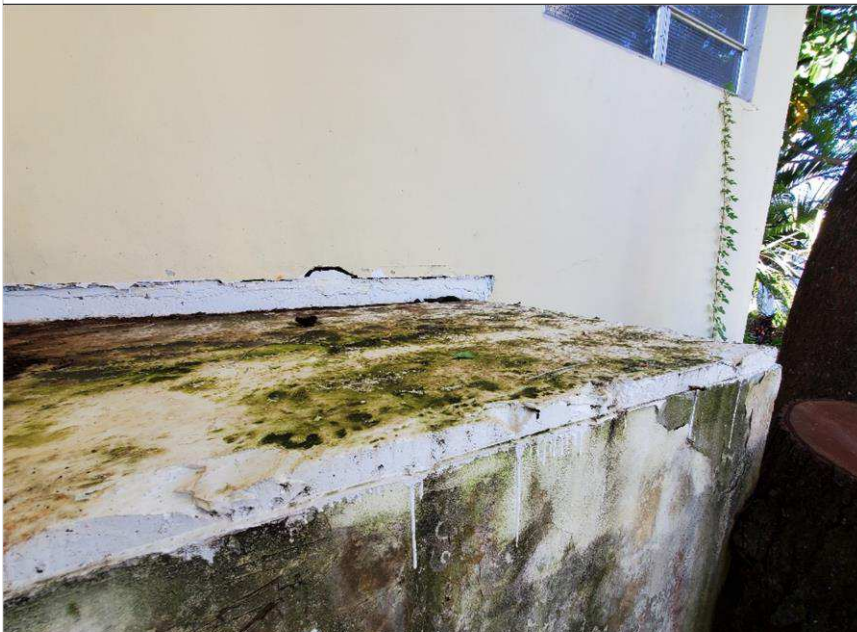
Photo 10 – Village of Dadeland Condominium Association

Existing Electrical Room - 1st FL  
Main Electrical Room Roof

Possible moisture intrusion  
from roof above.  
Main Electrical Room Roof to  
be sealed.

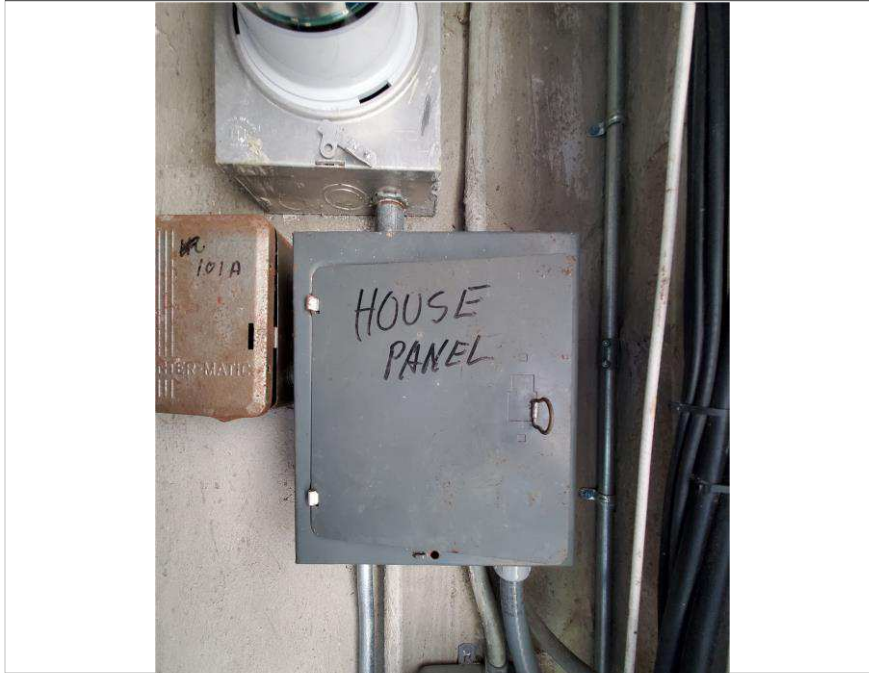
Photo 11 – Village of Dadeland Condominium Association

Existing Electrical Room - 1st FL  
House Panel Board is corroded.  
50 year old electrical  
components.

Oxidized time clock

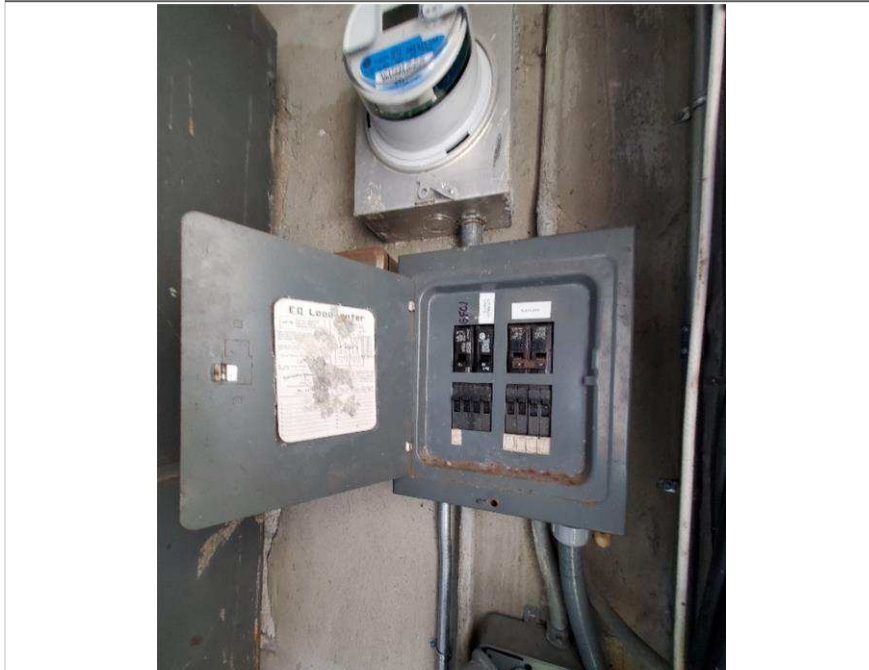
Photo 12 – Village of Dadeland Condominium Association

Existing Electrical Room - 1st FL  
House Panel Board and breakers  
are corroded.  
50 year old electrical  
components.

Missing branch circuit directory.

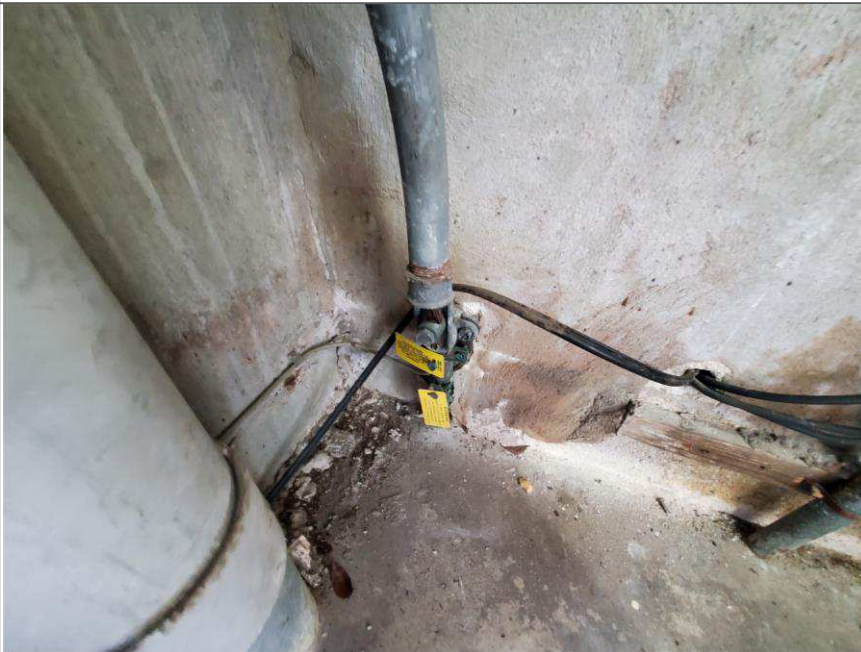
Photo 16 – Village of Dadeland Condominium Association

Existing Electrical Room - 1st FL  
Main Service Grounding  
resistance to be tested to  
determine if repairs and/or  
maintenance are required.

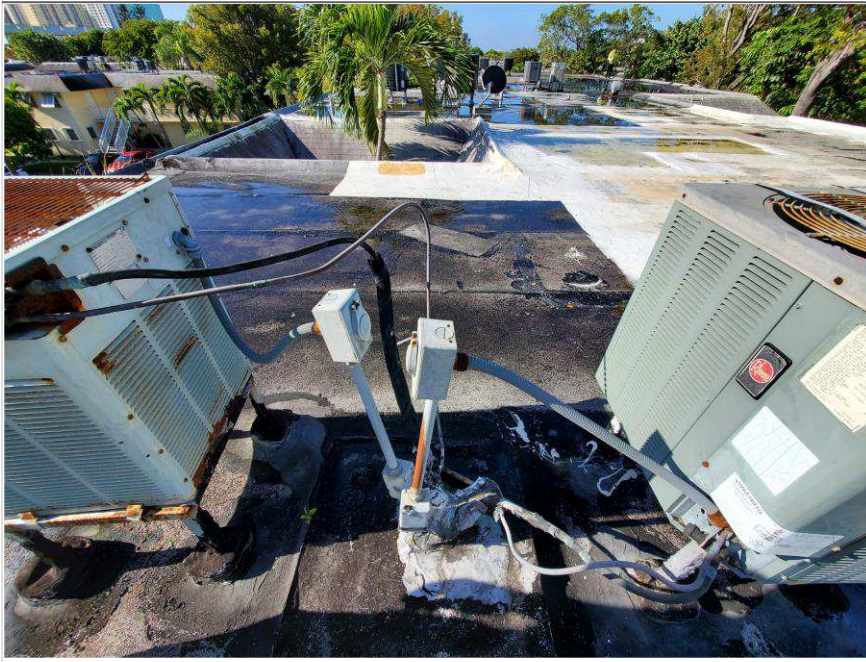
Photo 17 – Village of Dadeland Condominium Association

Roof -  
Rooftop Condenser Units -  
Corroded junction boxes and  
conduits.

Junction boxes not properly  
supported.

Missing disconnect switches.

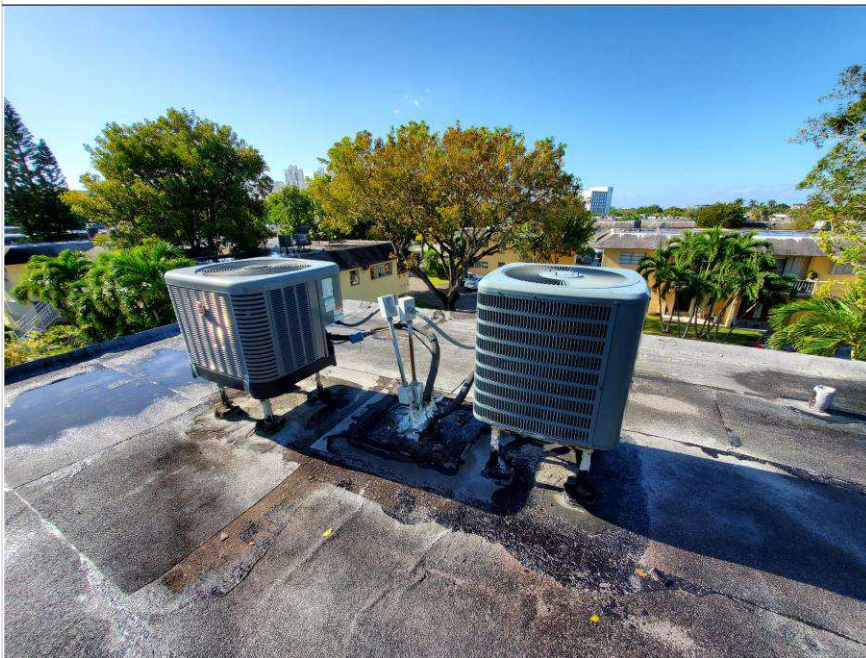
Photo 18 – Village of Dadeland Condominium Association

Roof -  
Rooftop Condenser Units -  
Oxidized junction boxes and  
conduits.

Junction boxes not properly  
supported.

Missing disconnect switches.

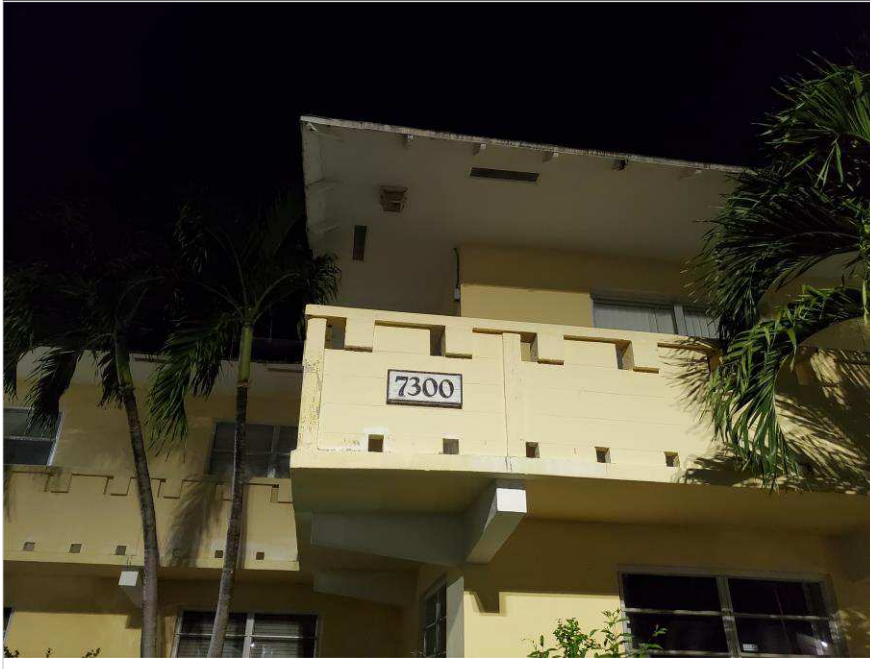
Photo 19 – Village of Dadeland Condominium Association

Points of Egress  
Poorly illuminated Catwalks  
Exterior light not functional.

Catwalk light is out.

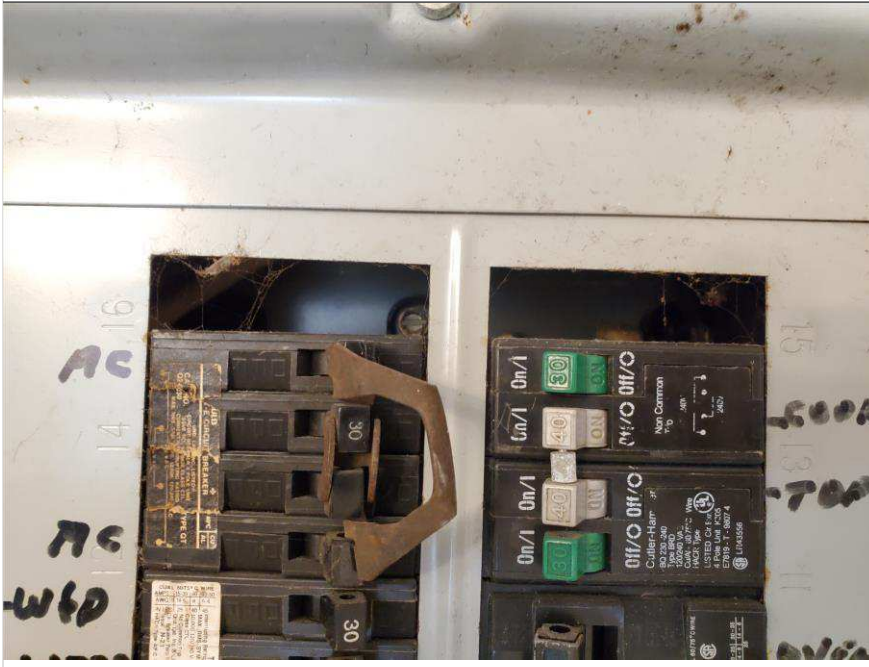
Photo 22 – Village of Dadeland Condominium Association

Apartments - Old Electrical  
Panels

Old, corroded breaker to be  
replaced.

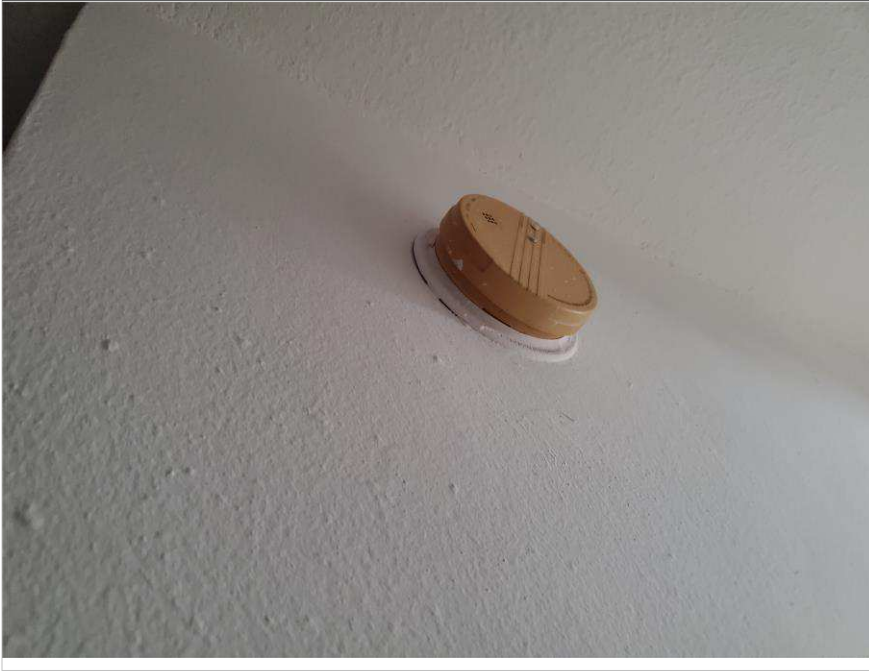
Photo 25 – Village of Dadeland Condominium Association

Apartments - Old Smoke  
Detectors

Old Smoke detectors to be  
replaced.  
Photo is an example.

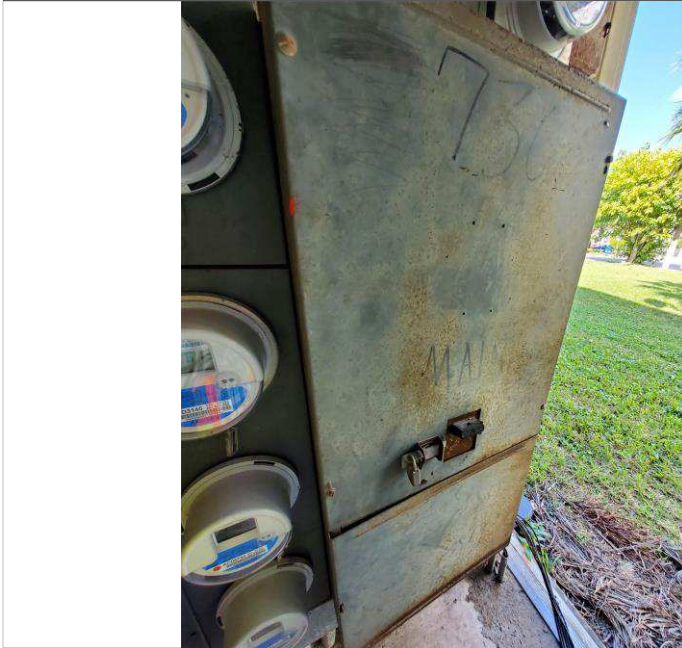
Photo 3 – Village of Dadeland Condominium Association

Existing Electrical Room - 1st FL  
Building Main Disconnect -  
considerably corroded 50 year  
old electrical component.

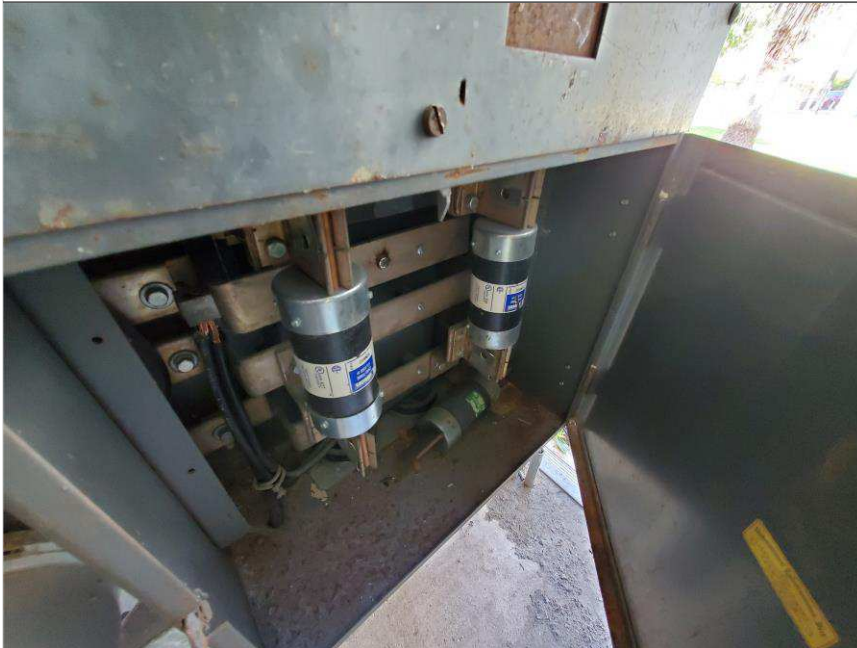
Photo 4 – Village of Dadeland Condominium Association

Existing Electrical Room - 1st FL  
Building Main Disconnect –  
interior showing fuses with  
corroded 50 year old electrical  
components.

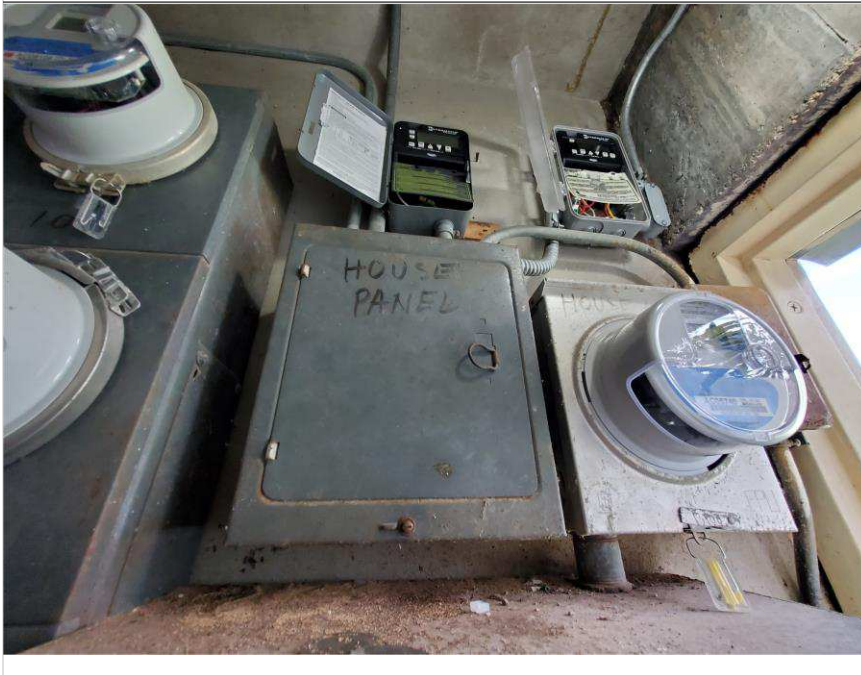
Photo 5 – Village of Dadeland Condominium Association

Existing Electrical Room - 1st FL House Main Meter and Panel Board – corroded 50 year old electrical component. Time Clocks installed too high.

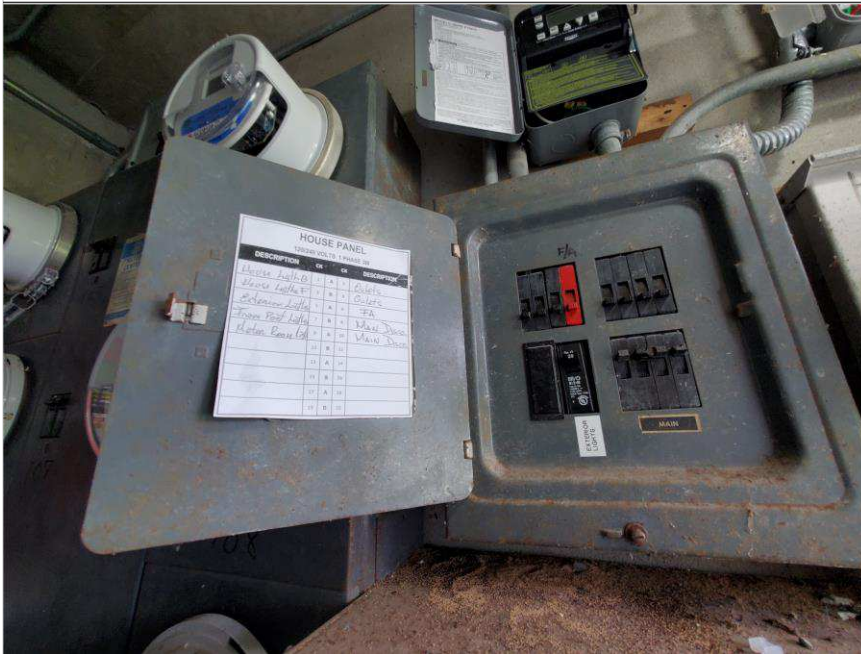
Photo 6 – Village of Dadeland Condominium Association

Existing Electrical Room - 1st FL House Main Distribution Panel Board and Breakers - corroded 50 year old electrical components.

Missing Name Plate Rating.

Top of Main Disconnect Switch is corroded.

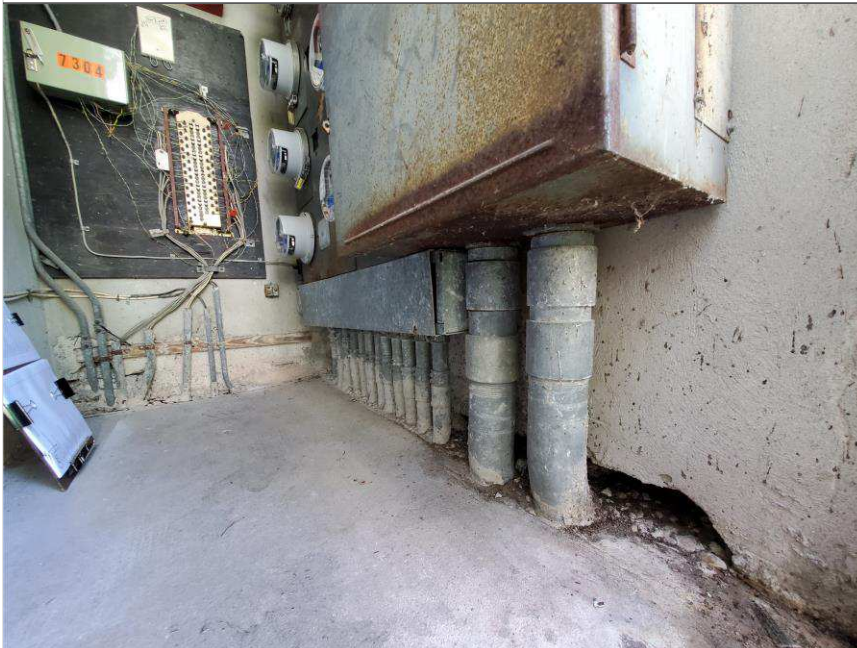
Photo 8 – Village of Dadeland Condominium Association

Existing Electrical Room - 1st FL  
Building Main Disconnect -  
Corroded 50 year old electrical  
components.

Deteriorated and Oxidized Main  
Gutter.

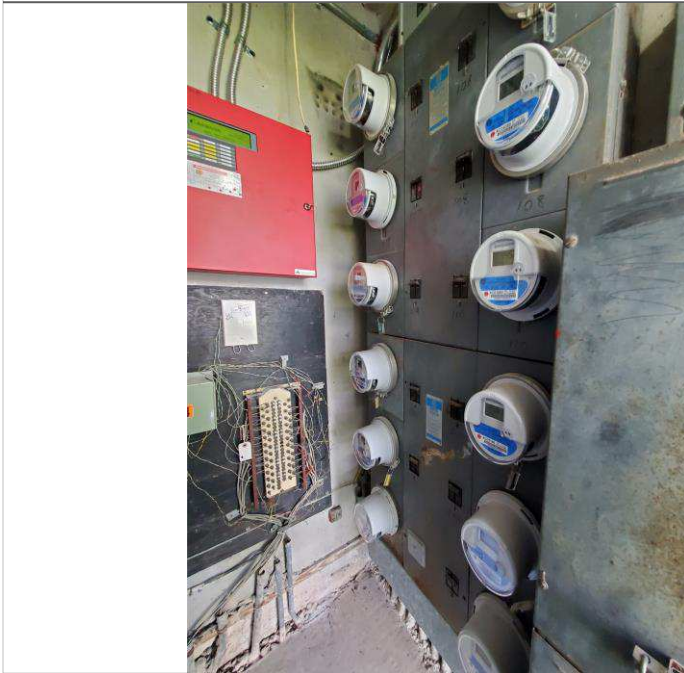
Photo 9 – Village of Dadeland Condominium Association

Existing Electrical Room - 1st FL  
Apartment Meters, Main  
switches and Gutter.

Old and corroded meter stacks.

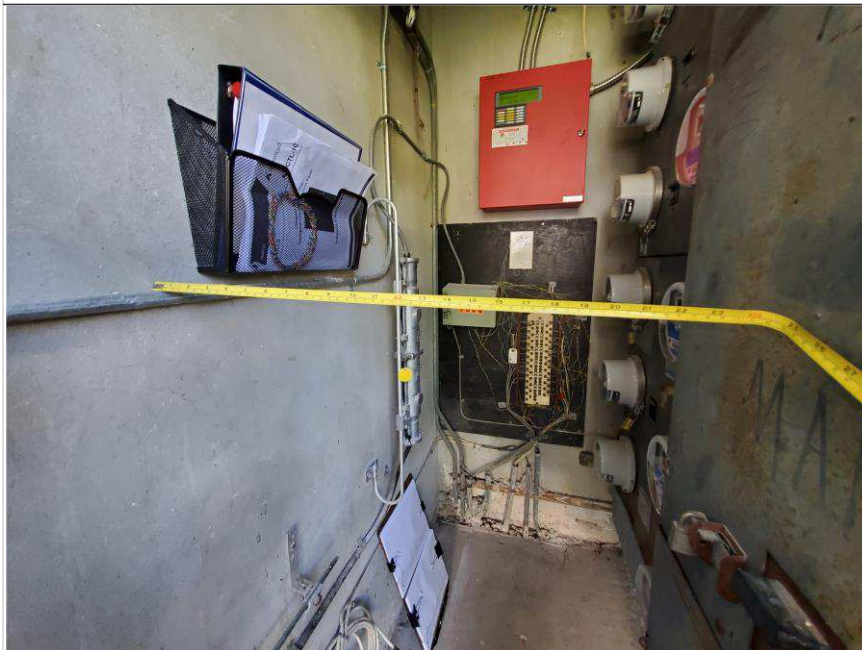
Photo 10 – Village of Dadeland Condominium Association

Existing Electric Room - 1<sup>st</sup> FL  
Apartment and Main  
Distribution – has insufficient  
clearance.

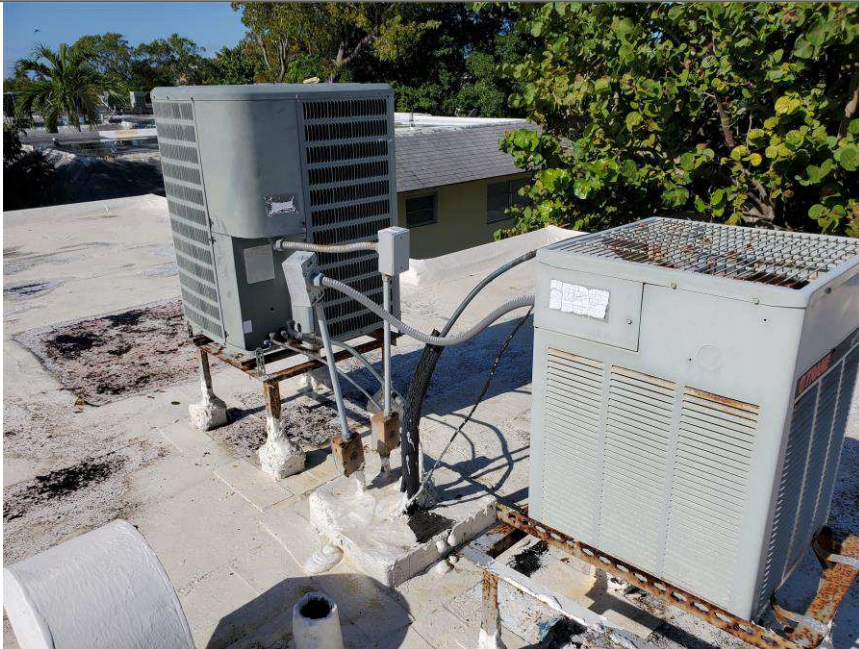
Photo 12 – Village of Dadeland Condominium Association

Rooftop -  
Rooftop Condenser Units -  
corroded junction boxes and  
conduits.

Junction boxes not properly  
supported.

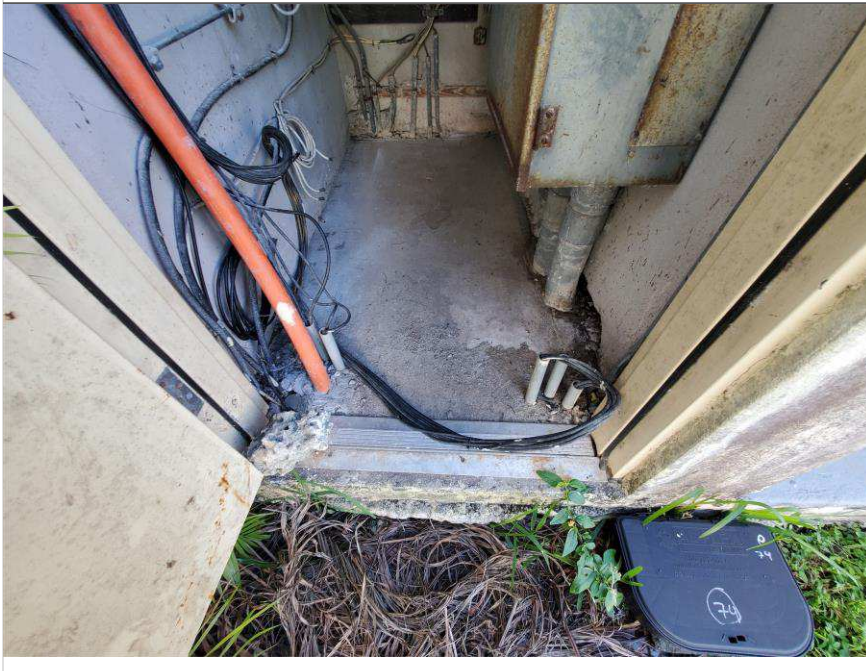
Photo 16 – Village of Dadeland Condominium Association

Existing Electrical Room - 1st Fl  
Cables/conduit as installed are  
creating a Tripping Hazard at  
entry door to the Electrical  
Room.

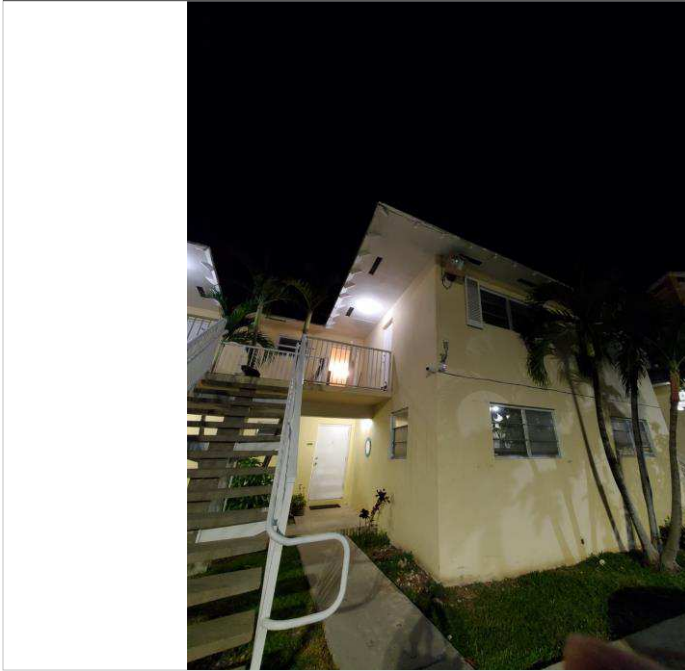
Photo 17 – Village of Dadeland Condominium Association

Points of Egress - Poorly Illuminated Building Points of Egress and Catwalks – Light Fixtures are too far apart, and some are not functioning properly.  
Exterior lights not functional

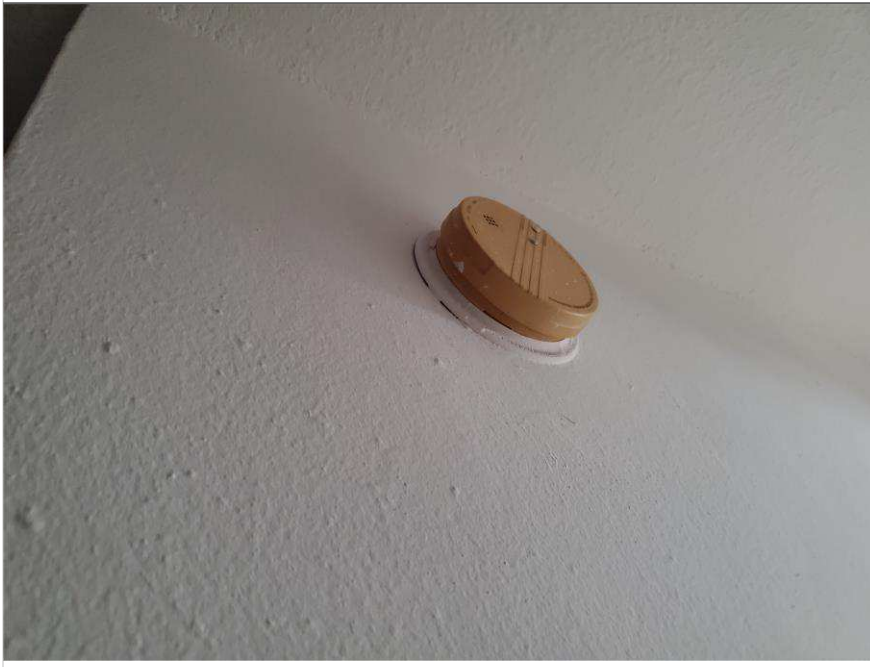
Photo 24 – Village of Dadeland Condominium Association

Apartments - Old Smoke  
Detectors

Old Smoke Detectors to be  
replaced.

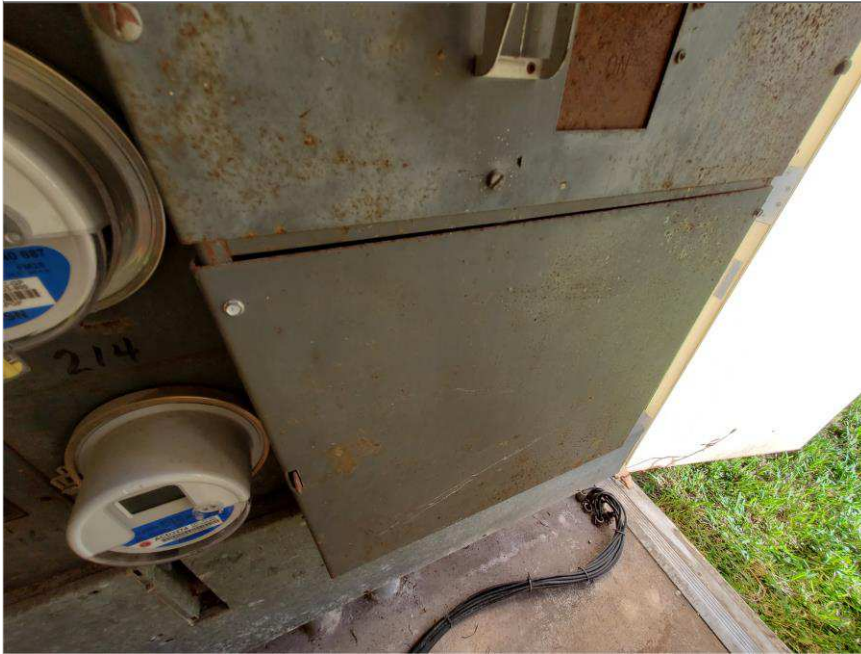
Photo 5 – Village of Dadeland Condominium Association

Existing Electrical Room - 1st FL  
Building Main Disconnect is  
corroded.  
50 year old electrical  
component.

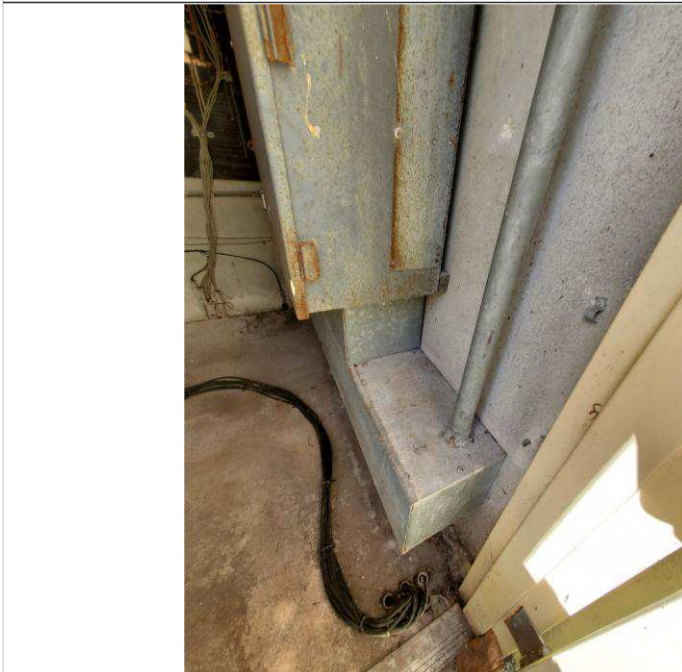
Photo 6 – Village of Dadeland Condominium Association

Existing Electrical Room - 1st FL  
Building Main Disconnect is  
corroded.  
50 year old electrical  
components.

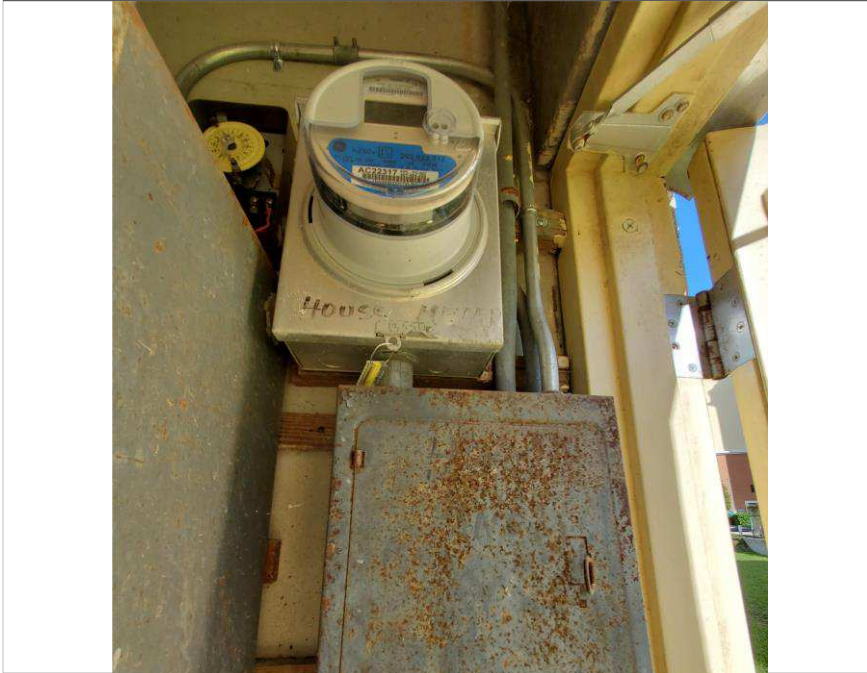
Photo 7 – Village of Dadeland Condominium Association

Existing Electrical Room - 1st FL  
House Panel meter.  
House Panel Board is corroded.  
50 year old electrical  
component.

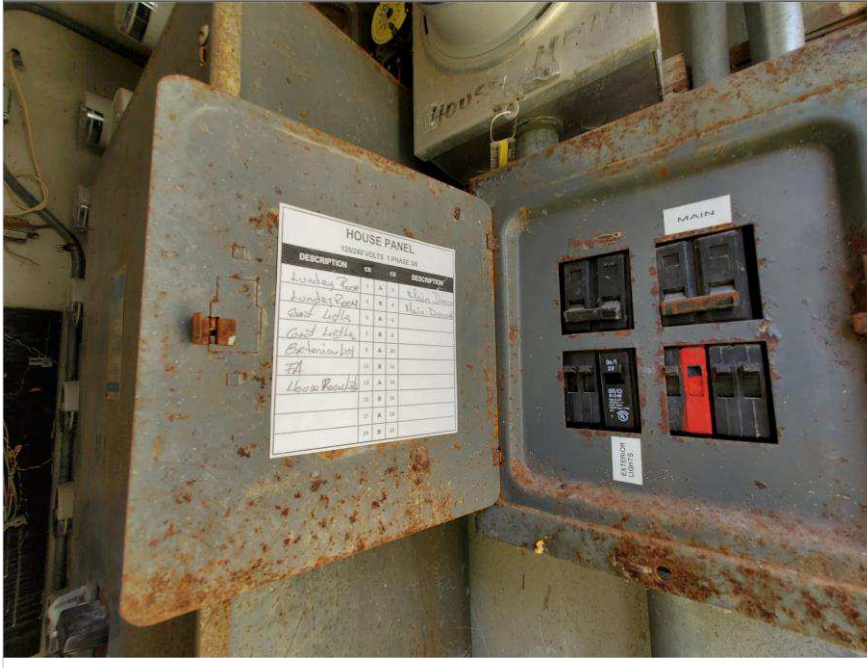
Photo 8 – Village of Dadeland Condominium Association

Existing Electrical Room - 1st FL  
House Panel Board and  
Breakers are corroded.  
50 year old electrical  
components.

Missing Name Plate Rating.

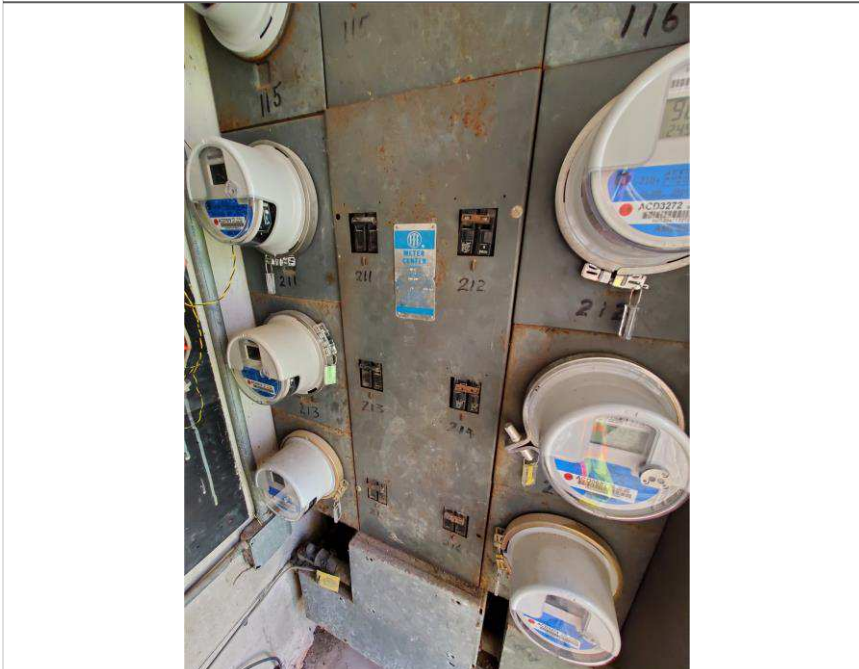
Photo 9 – Village of Dadeland Condominium Association

Existing Electrical Room - 1st FL  
Apartment Meters, Main  
Switches and Gutter.

Old and corroded meter stacks.

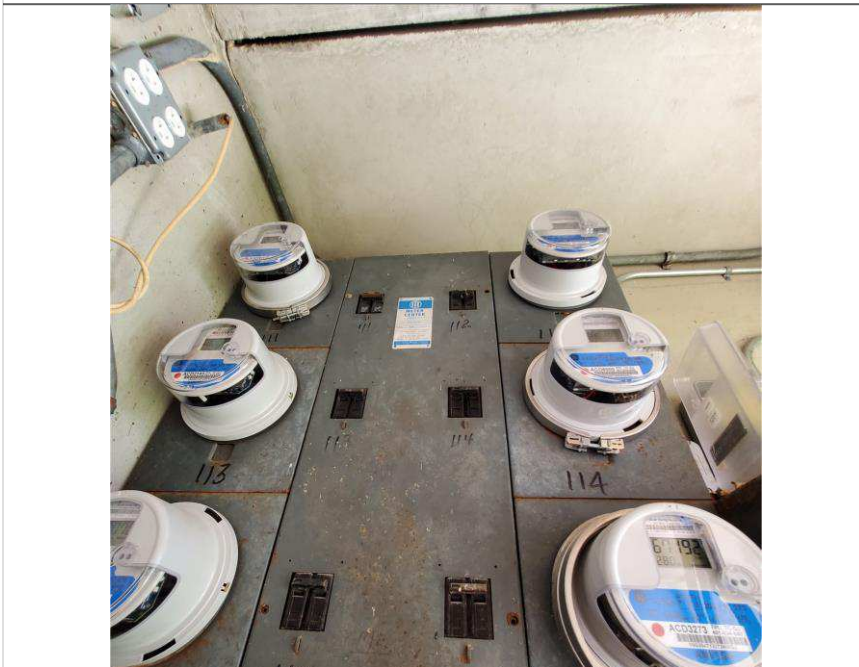
Photo 10 – Village of Dadeland Condominium Association

Existing Electrical Room - 1st FL  
Apartment Meters, Main  
Switches and Gutter.

Old and corroded meter stacks  
and breakers.

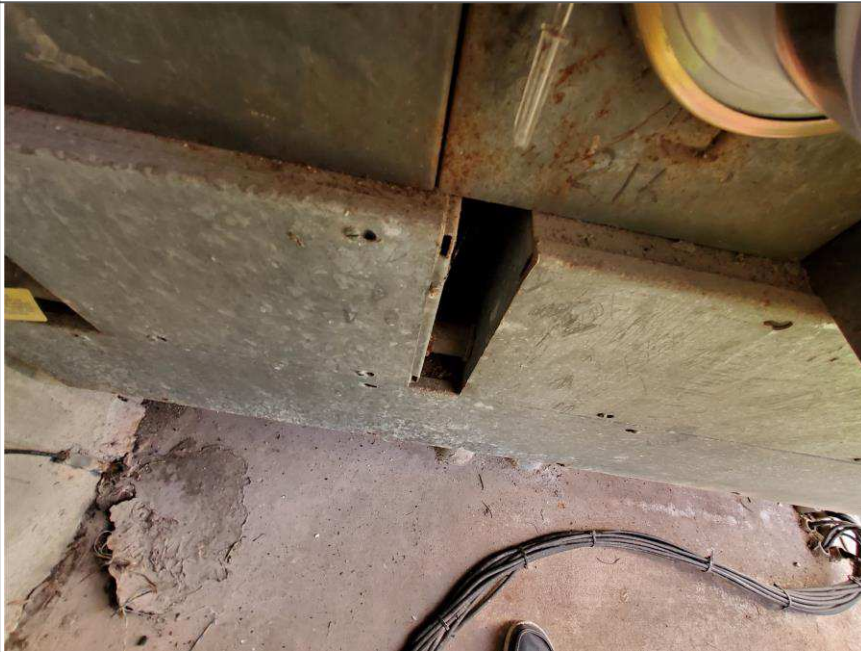
Photo 11 – Village of Dadeland Condominium Association

Existing Electrical Room - 1st FL  
Apartment Meters, Main  
Switches and Gutter

Old and corroded meter stacks  
and gutter.

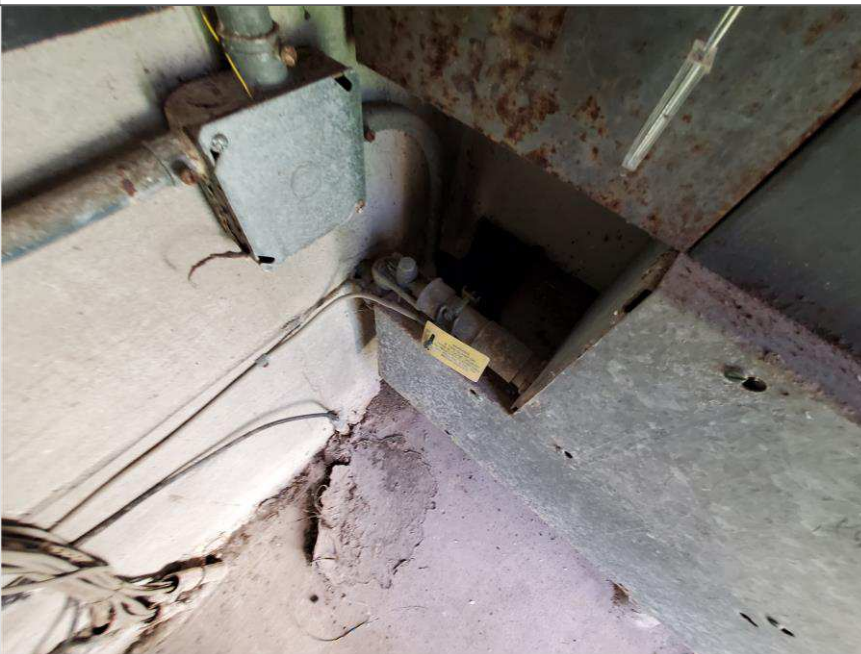
Photo 12 – Village of Dadeland Condominium Association

Existing Electrical Room - 1st FL  
Main Service - Grounding

Grounding resistance to be  
tested to determine if repairs  
and/or maintenance are  
required.

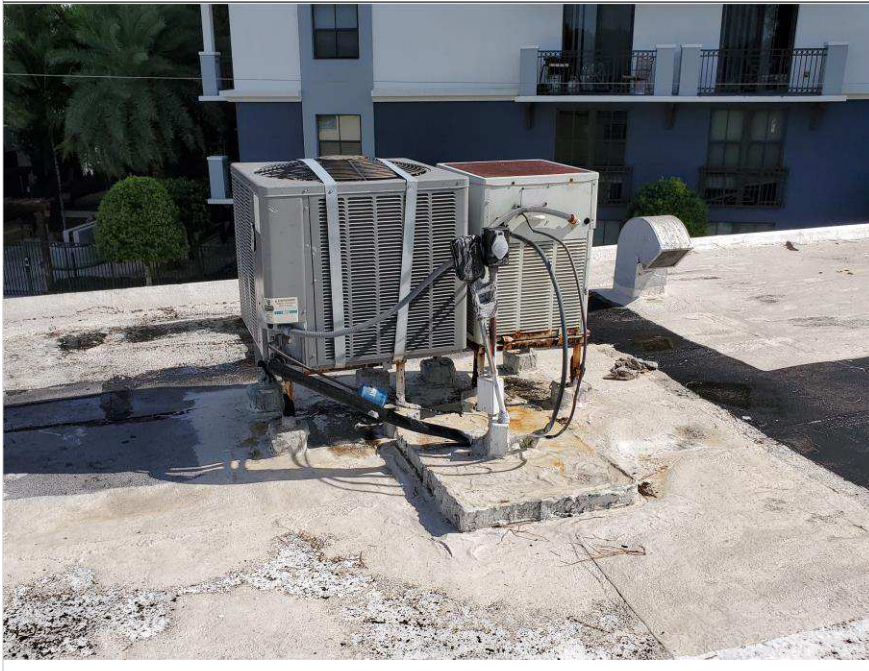
Photo 13 – Village of Dadeland Condominium Association

Roof -  
Rooftop Condenser Units -  
corroded junction boxes and  
conduits.

Junction boxes not properly  
supported.

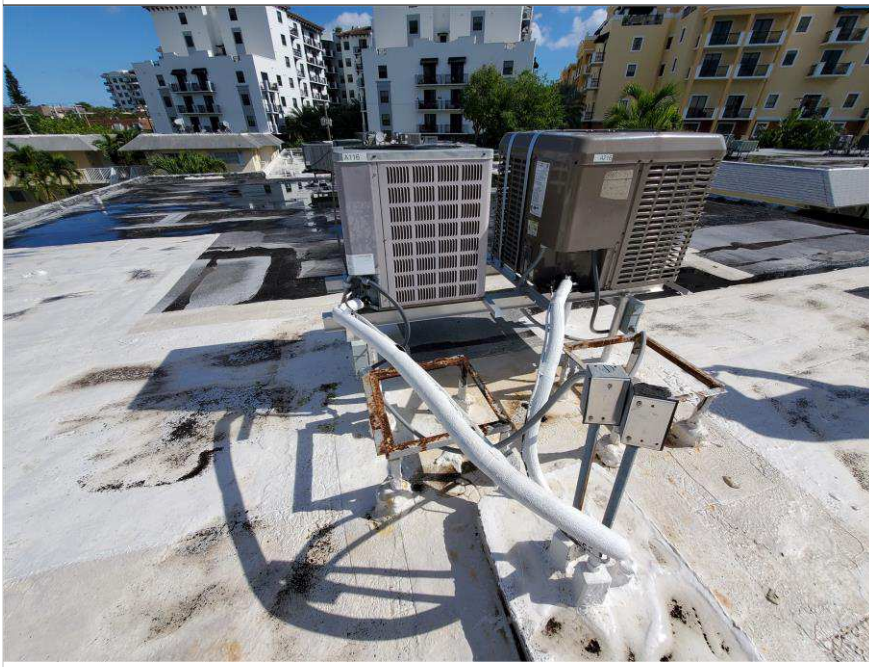
Photo 14 – Village of Dadeland Condominium Association

Roof -  
Rooftop Condenser Units -  
corroded junction boxes and  
conduits.

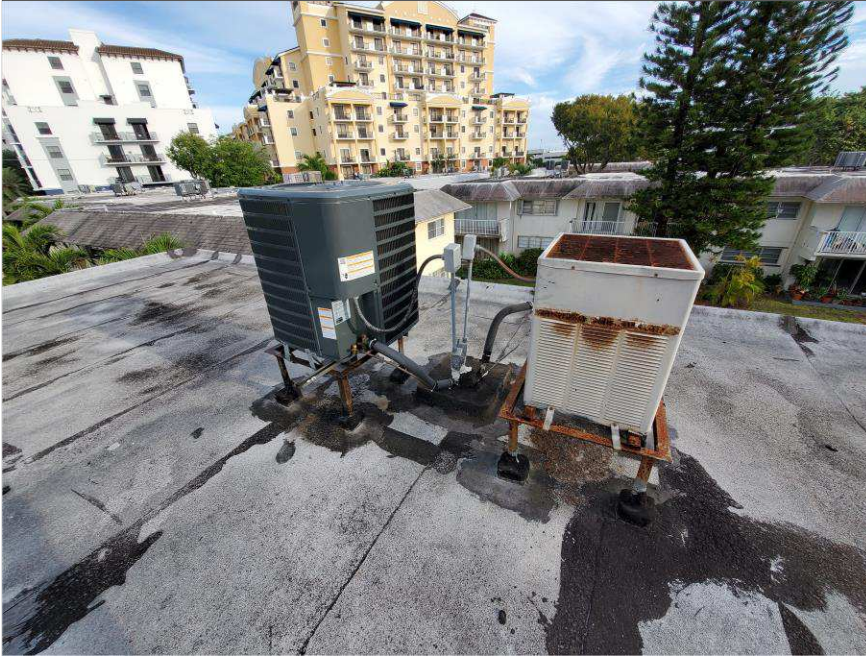
Photo 10 – Village of Dadeland Condominium Association

Rooftop Condenser Units -  
corroded junction boxes and  
conduits.

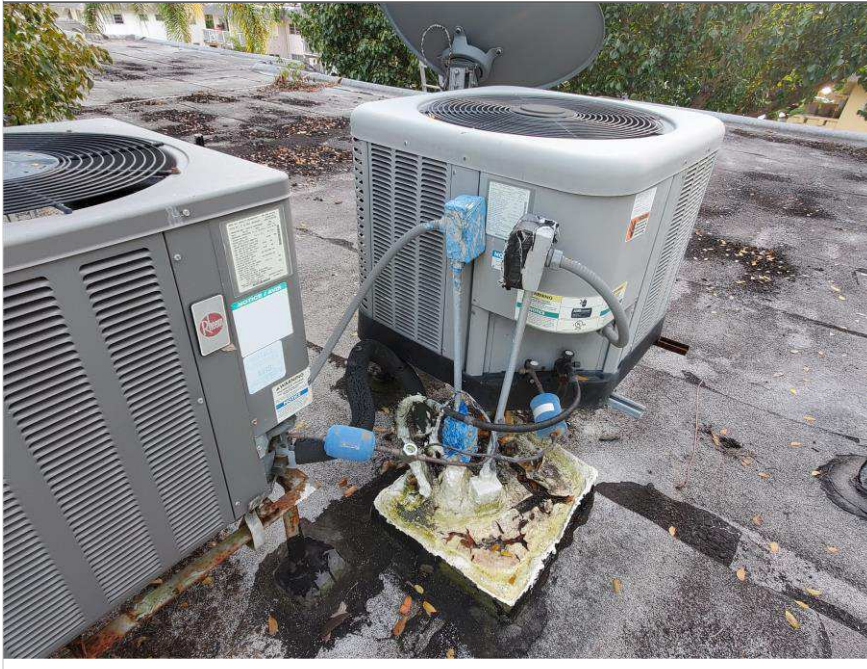
Photo 11 – Village of Dadeland Condominium Association

Rooftop Condenser Units -  
Oxidized junction boxes and  
conduits.

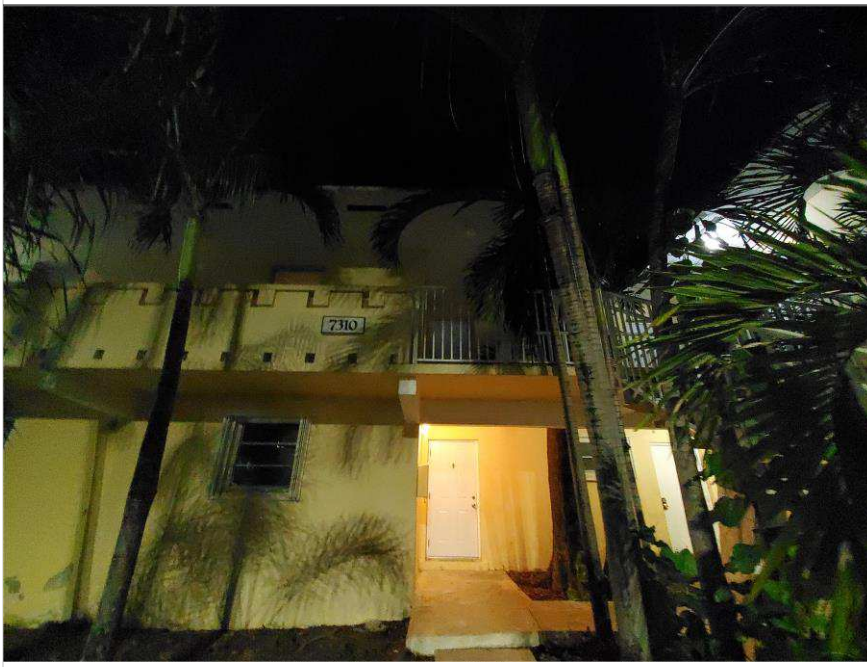
Photo 12 – Village of Dadeland Condominium Association

Points of Egress - Poorly  
illuminated Catwalks  
Exterior light not functional.
