DEPARTMENT OF REGULATORY  
AND ECONOMIC RESOURCES

MINIMUM INSPECTION PROCEDURAL GUIDELINES  
FOR BUILDING ELECTRICAL RECERTIFICATION

- a. Name on Title: Village at Dadeland Condominiums (A)
- b. Street Address: 7300 SW 82nd St. Miami, Florida 33143
- c. Legal Description: Village at Dadeland Condominiums
- d. Owner's Name: Village at Dadeland Condominiums
- e. Owner's Mailing Address: 7300 SW 82nd St. Miami, Florida 33143
- f. Folio Number of Property on which Building is Located: 30-4035-047-XXXX
- g. Building Code Occupancy Classification: R2 - Residential
- h. Present Use: Condominium, Residential
- i. General Description, Type of Construction, Size, Number of Stories, and Special Features

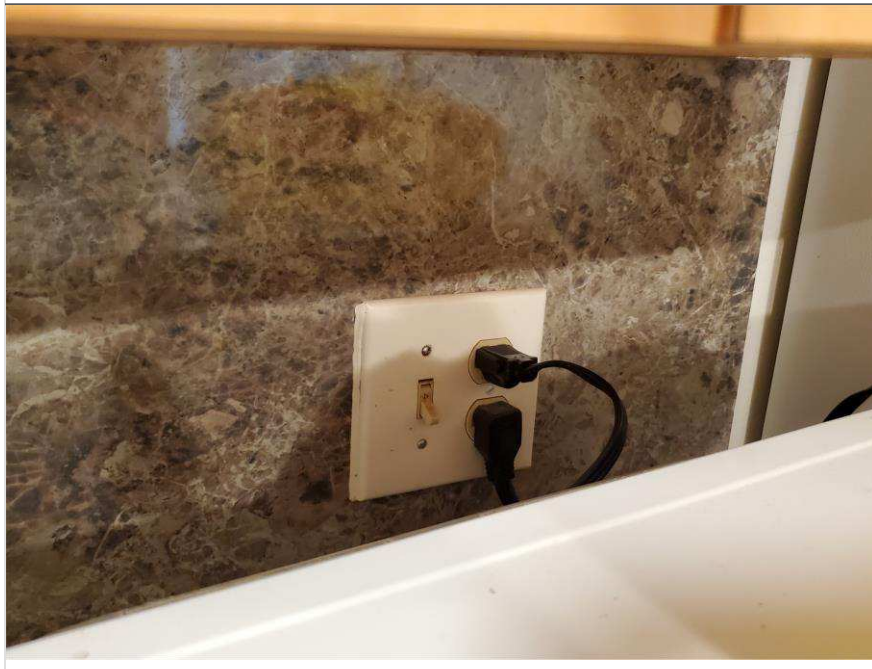
Photo 16 – Village of Dadeland Condominium Association

Apartments - Kitchen outlets not GFCI type.

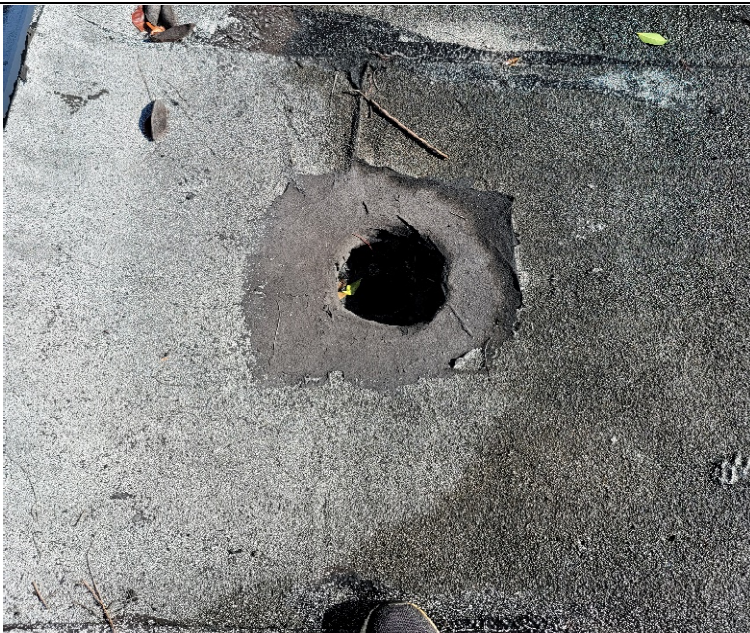
Photo #2:

The strainers for the interior  
drain lines were found to be  
rusty or non-functional  
since many of them are  
missing or not in their  
proper position.

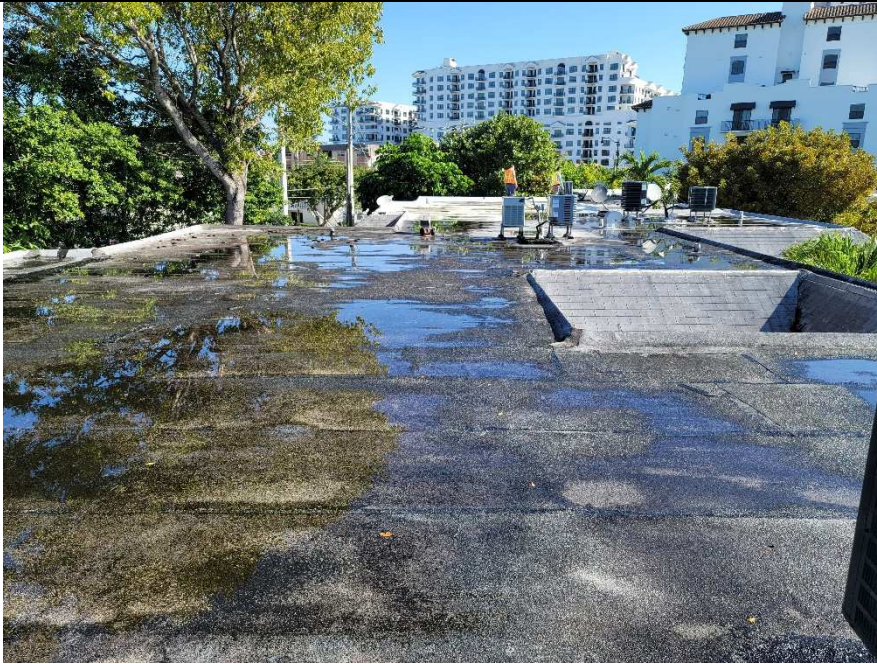
Photo #3:

Water ponding observed on the roof.

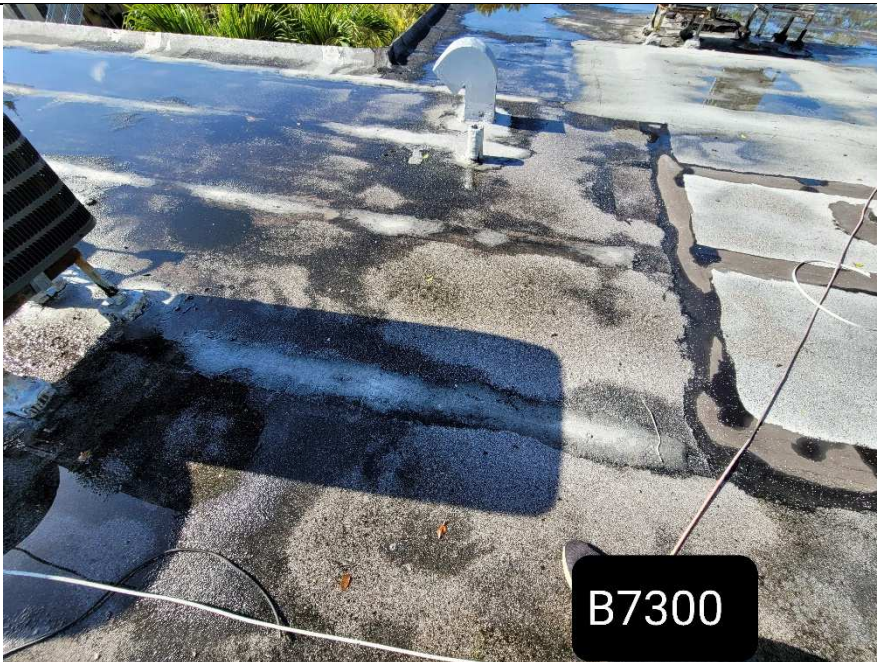
Photo #4:

The bituminous roof membrane was deemed to be in fair condition but sign of weathering/distress are evident.

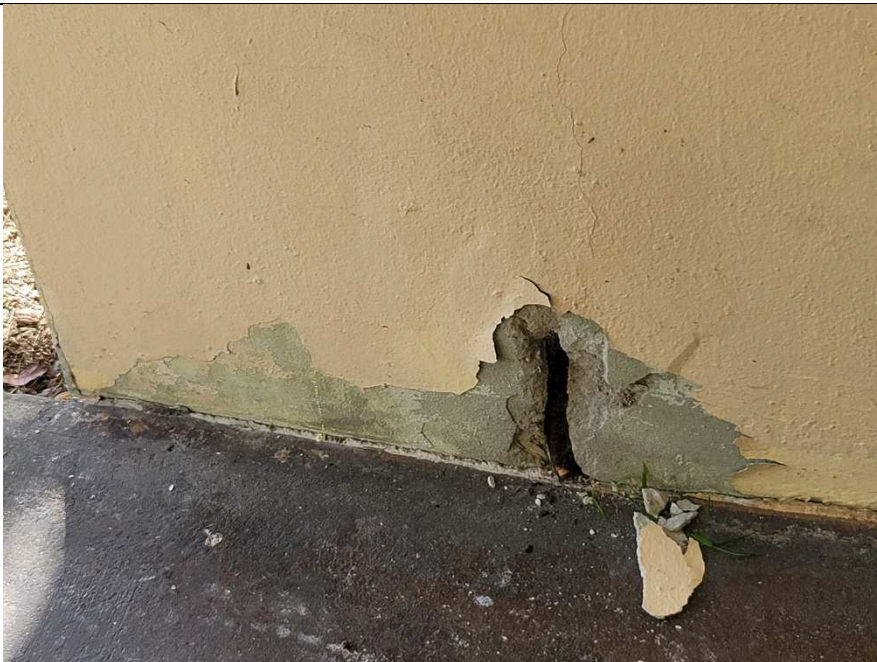
Photo #6:

Spall concrete at the vertical wall and should be repaired in the next exterior repair/maintenance cycle of the building.

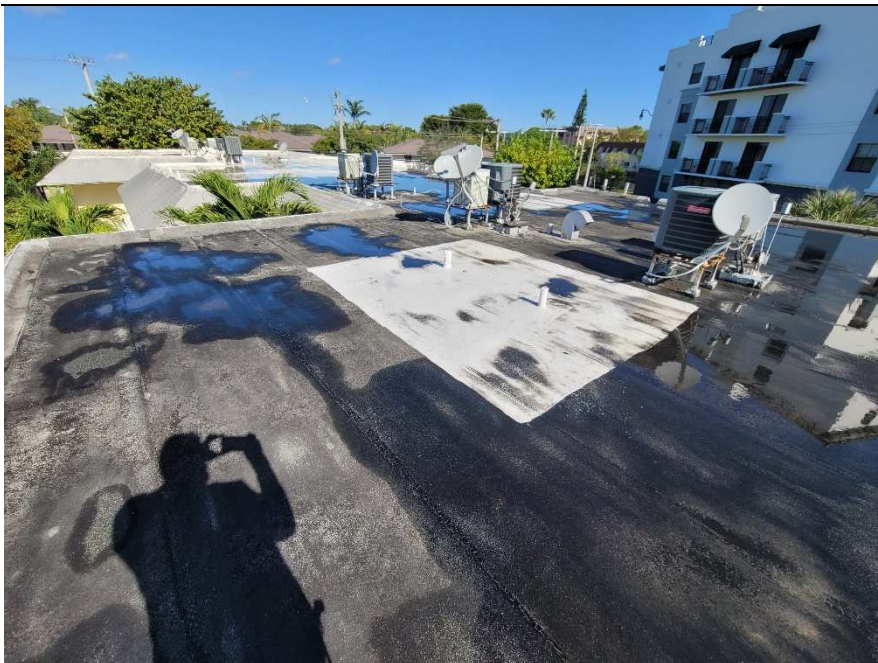
Photo #2:

Water ponding observed on the roof.

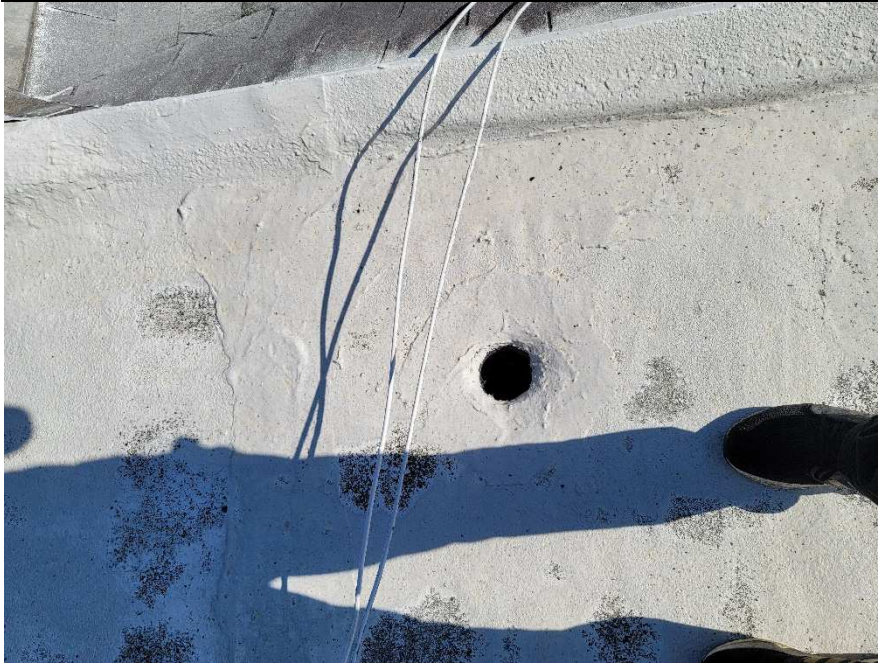
Photo #3:

The strainers for the interior drain lines were found to be rusted or non-functional since many of them are missing or not in their proper position.

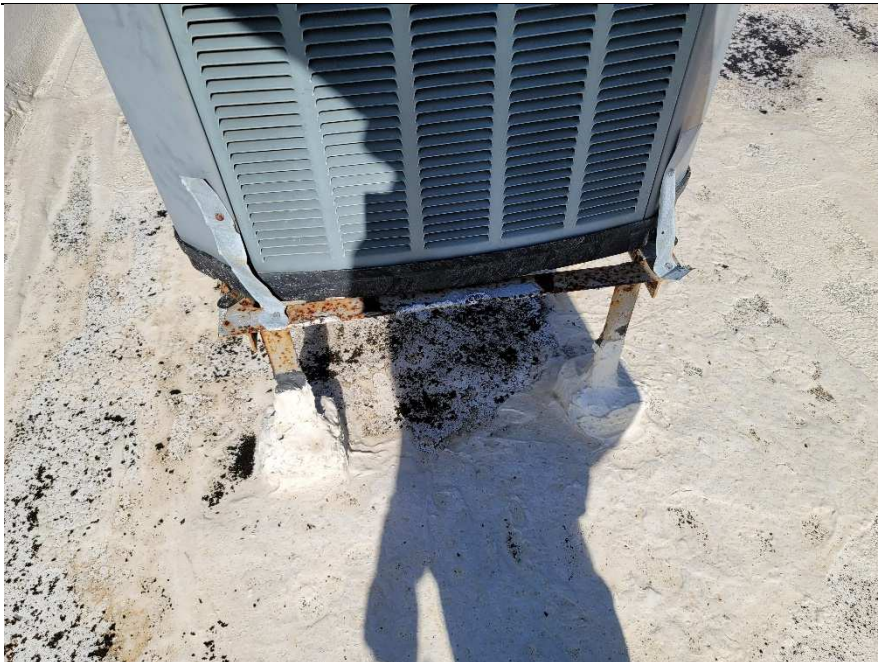
Photo #4:

The bituminous roof membrane was deemed to be in fair condition but sign of weathering/distress are evident.

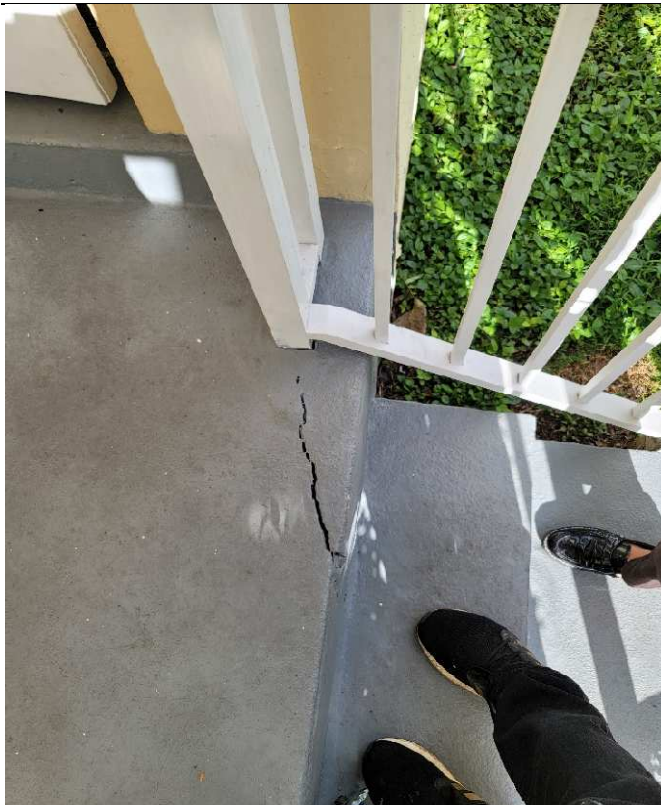
Photo #6:

Spall concrete at the precast steps and should be repaired in the next exterior repair/maintenance cycle of the building.

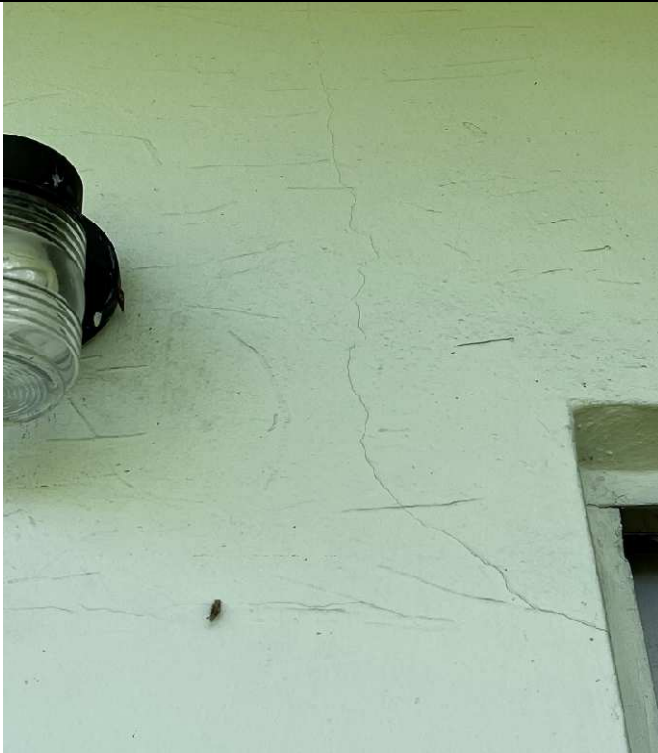
Photo #7:

Vertical wall cracks noticed at unit 108 balcony.

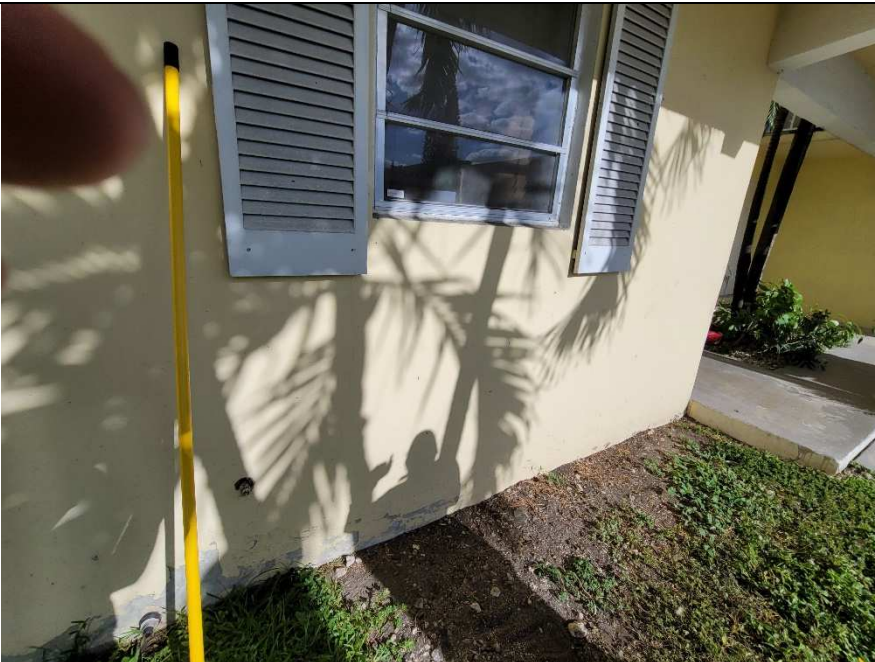
Photo #8:

Miscellaneous wall penetrations should be properly sealed to prevent water infiltration into the building, and/or surface decay of the stucco membrane in the vicinity of the penetration.

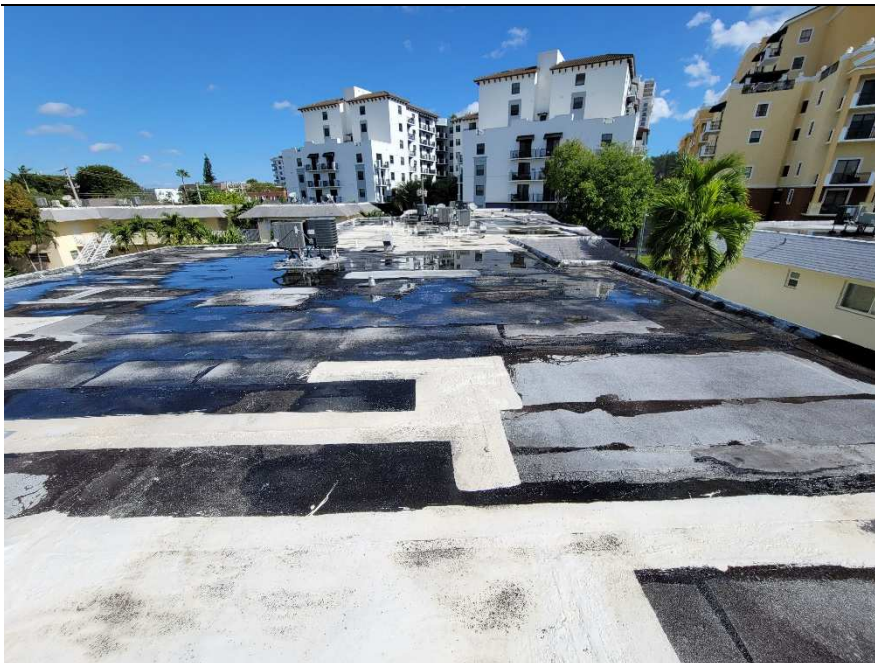
Photo #2:

Water ponding observed on the roof.

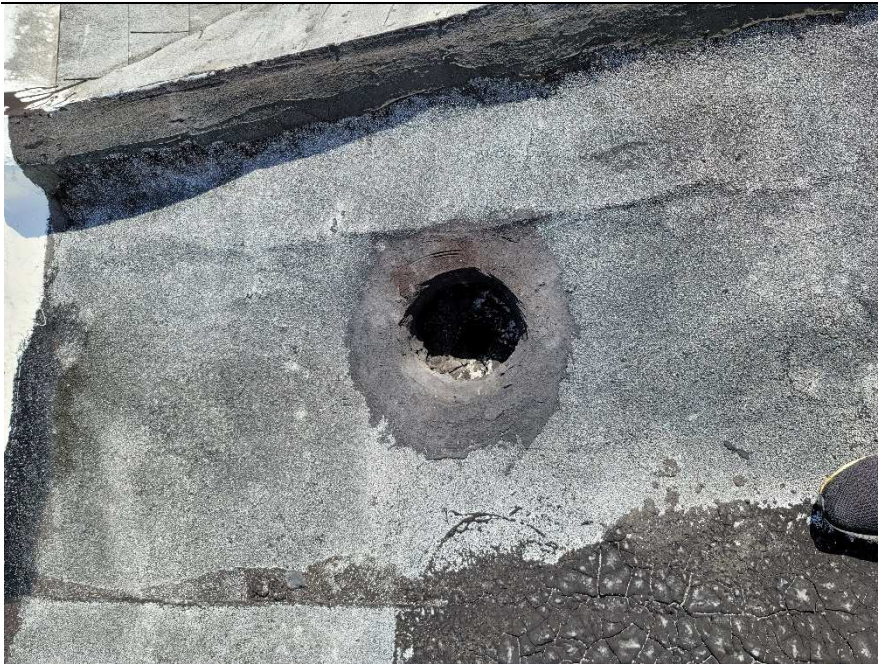
Photo #3:

The strainers for the interior drain lines were found to be rusted or non-functional since many of them are missing or not in their proper position.

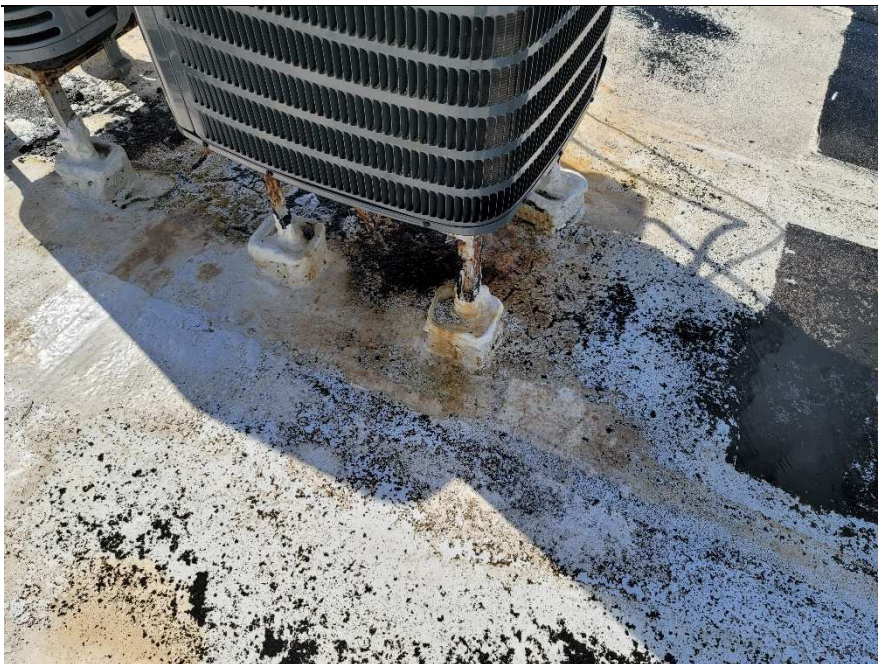
Photo #4:

The bituminous roof membrane was deemed to be in fair condition but sign of weathering/distress are evident.

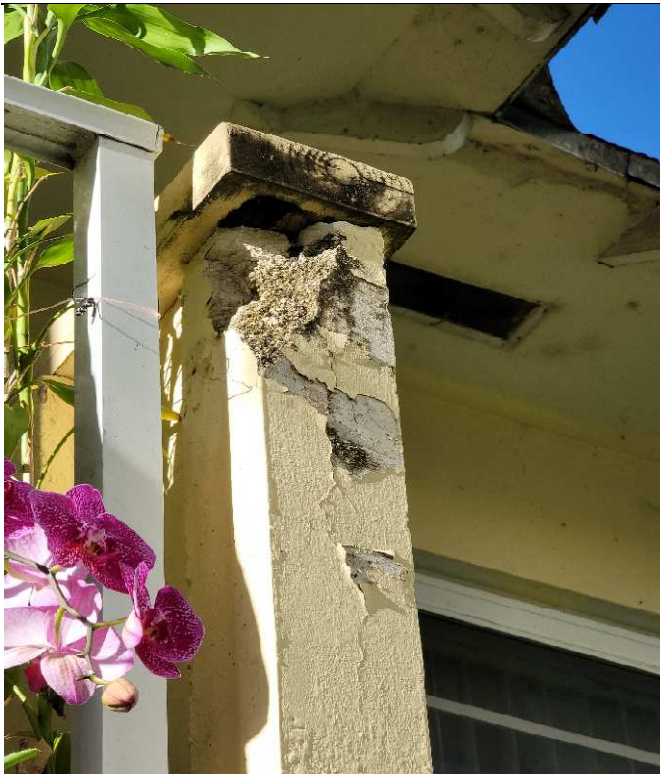
Photo #6:

Spall concrete at column and should be repaired in the net exterior repair/maintenance cycle of the building.

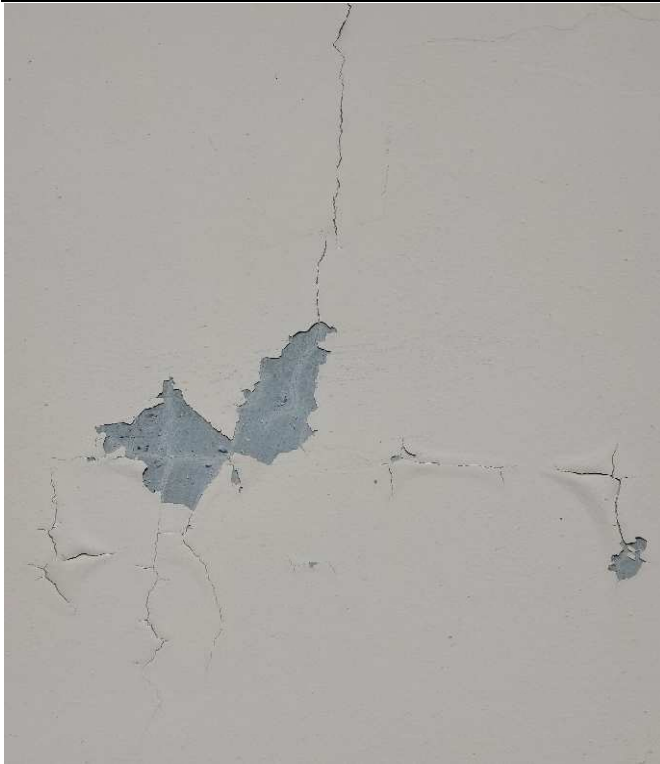
Photo #7:

Vertical wall cracks on exterior wall.

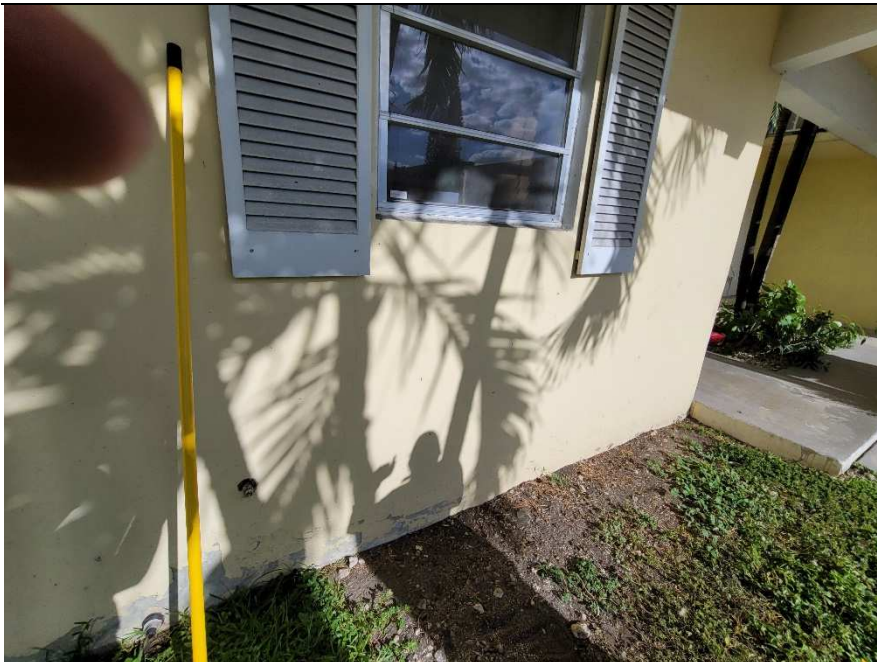
Photo #8:

Miscellaneous wall penetrations should be properly sealed to prevent water infiltration into the building, and/or surface decay of the stucco membrane in the vicinity of the penetration.

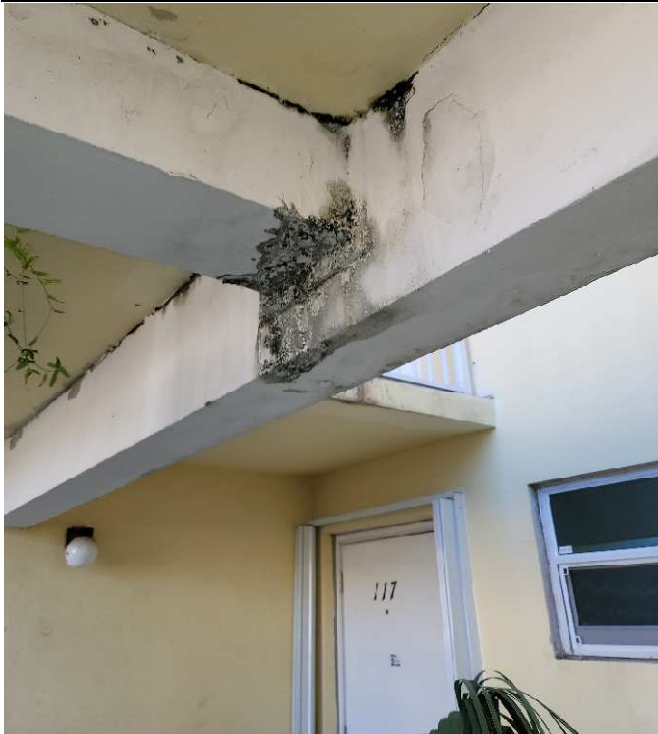
Photo #3:

Staining and vegetation growth was observed at the exposed edges of the concrete beams supporting the catwalks. The members are still sound but maintenance of the paint/waterproofing is required to prevent deterioration of the concrete.

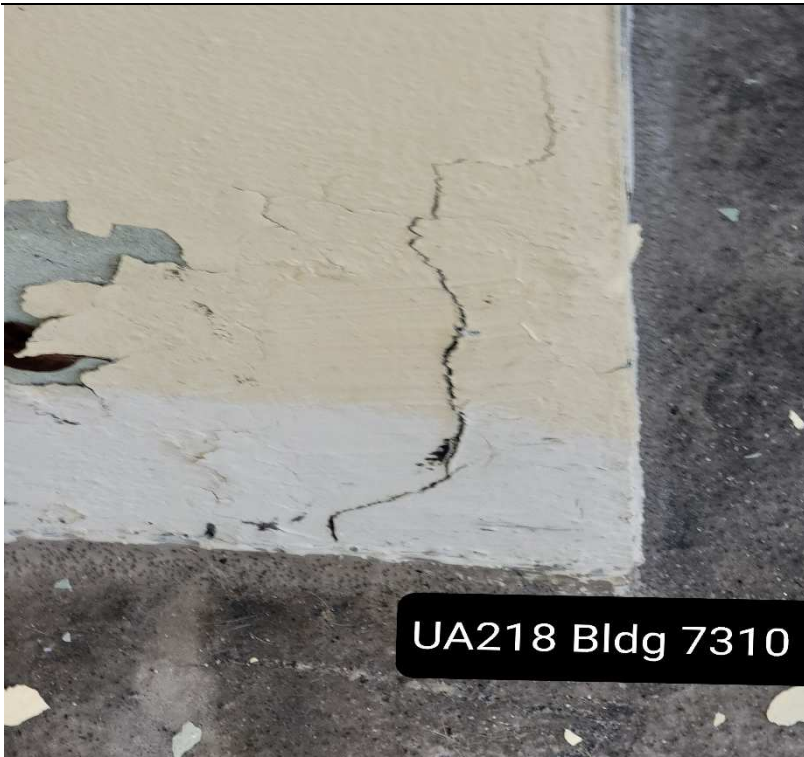
Photo #4:

Spall concrete at the edge of vertical wall and should be repaired in the next exterior repair/maintenance cycle of the building.

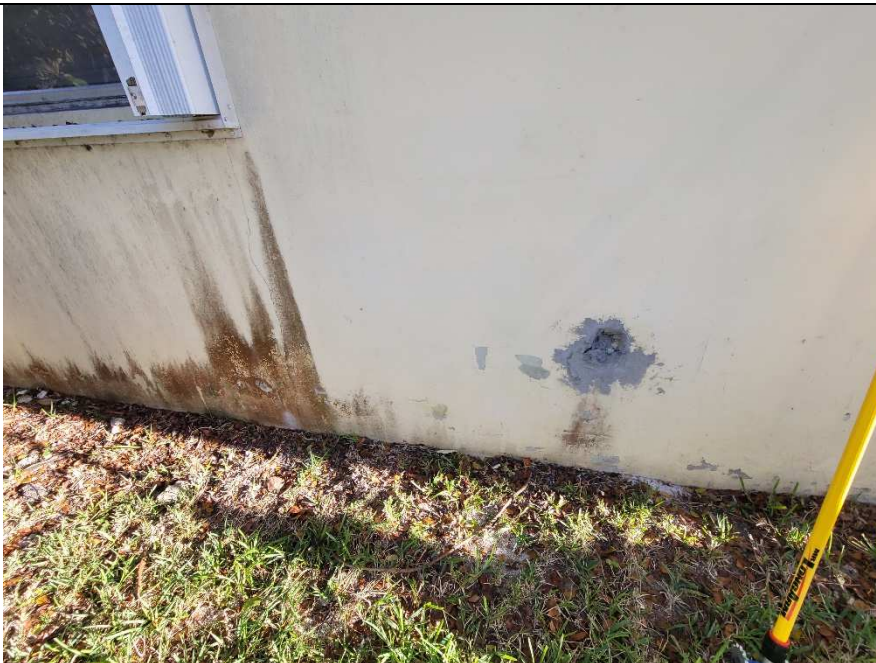
Photo #6:

Miscellaneous wall penetrations should be properly sealed to prevent water infiltration into the building, and/or surface decay of the stucco membrane in the vicinity of the penetration.
