THE DAY AFTER:

Documentation of Damage to Roofs from a Hailstorm and the Subsequent Restoration Efforts

By Karl A. Schaack, RRC, PE

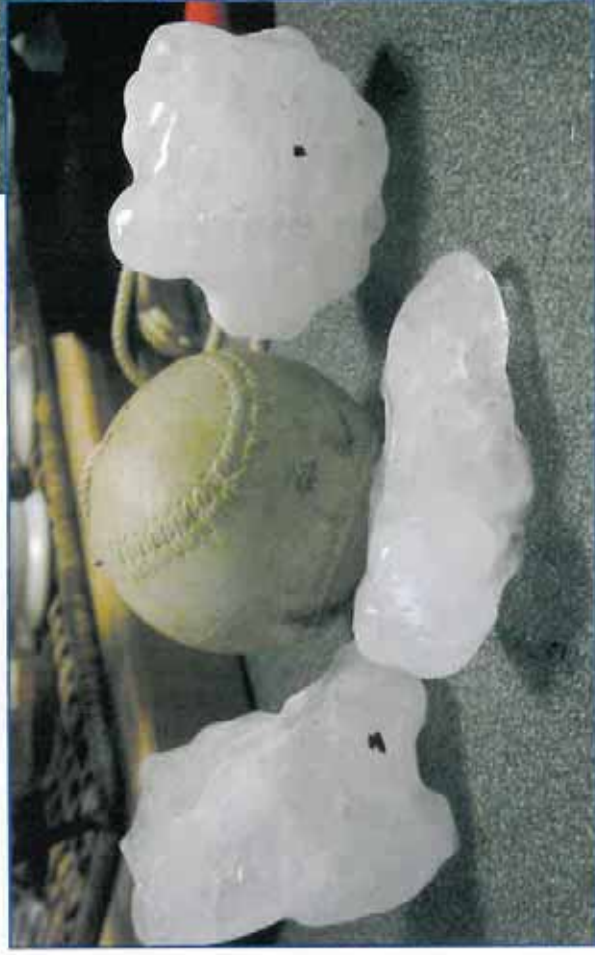
Photo 1 – Hailstones collected by homeowner on May 4, 2006⁽⁴⁾.

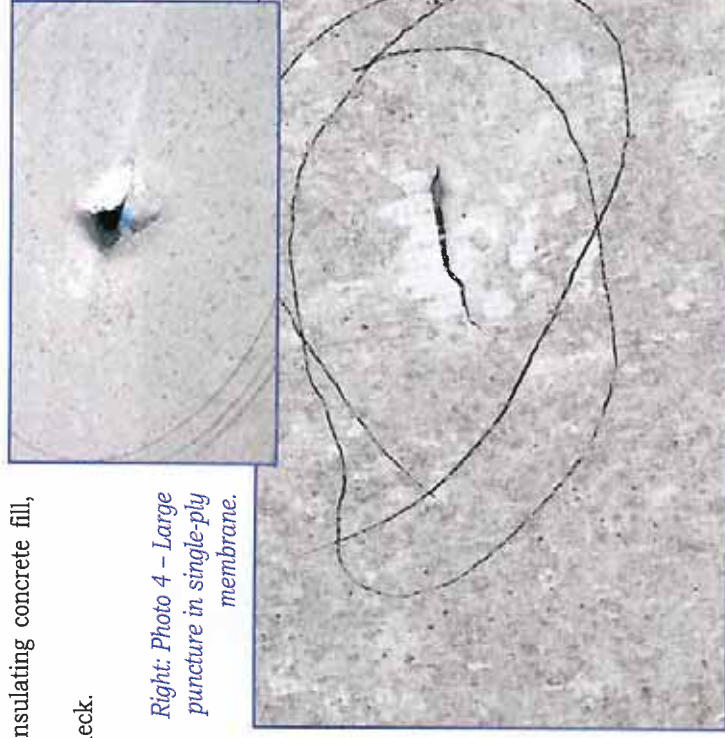
Right: Photo 4 – Large puncture in single-ply membrane.

3 and 4). This level of damage was widespread but sporadic, with no uniformity across the roofs. These punctures were found in approximately one to four locations within a 100-sq-ft area.

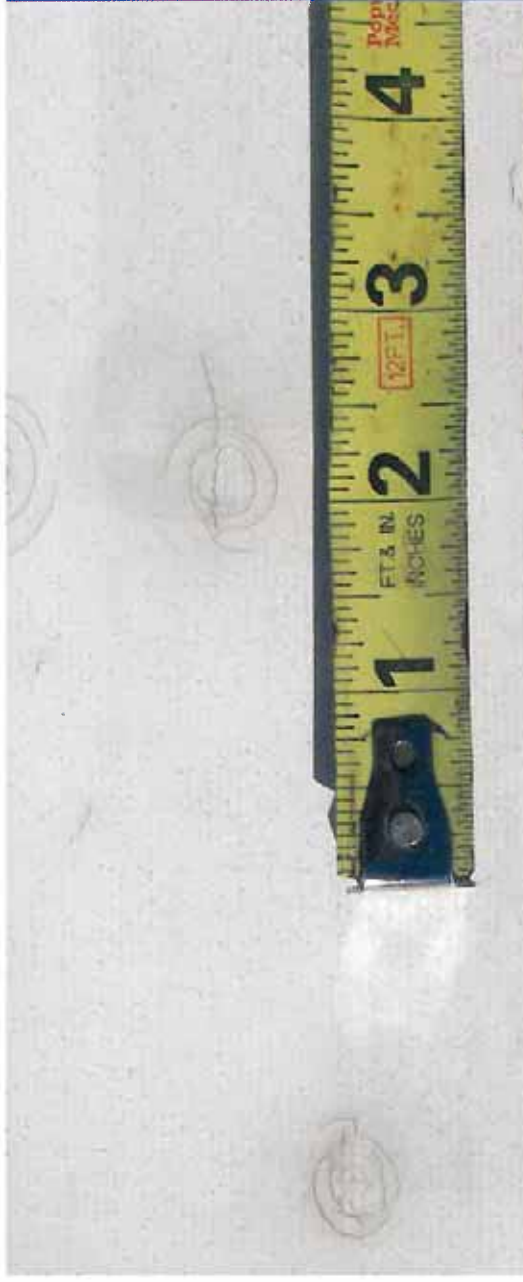
Below: Photo 6: -
Spiral and linear
fractures in single-
ply membrane.

The more prominent damage that was observed on thermoplastic single-ply membranes consisted of numerous cylindrical or spiral-shaped fractures in the membrane (Photos 5 and 6). Other, less obvious damage consisted of small linear cracks in the membrane. This type of damage was consistent on the various types of PVC single-ply membranes that were installed over rigid insulation. (Note: Separator sheets were installed between the PVC membranes and EPS.) The single-ply membranes that appeared to perform better were installed directly over plywood sheathing. Cylindrical fractures were not as widespread and numerous on the CSPE and CPE sheets, even though these membranes may have been older than other PVC membranes.

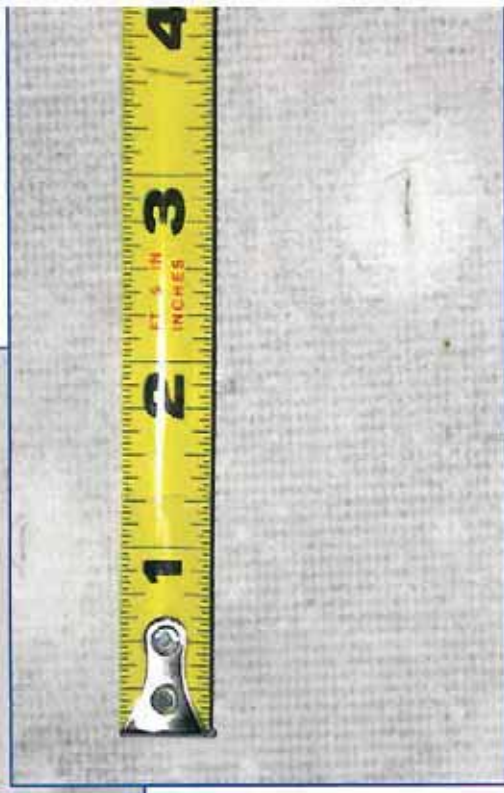
Photo 5 - Spiral fractures in single-ply membrane.

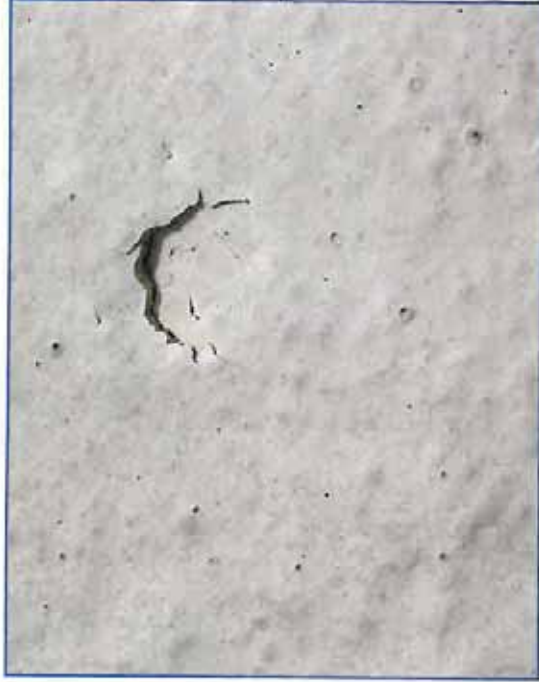
Similar damage was also observed on the spray-applied polyurethane foam roofs on the high school. This damage ranged from spiral-shaped cracks in the elastomeric coating to punctures through the coating, exposing the underlying foam core (Photos 7 and 8). The foam was more readily damaged in areas containing blisters. However, physical damage was also observed where the foam was sound and intact.

Photo 8 – Hail impact on SPUF.

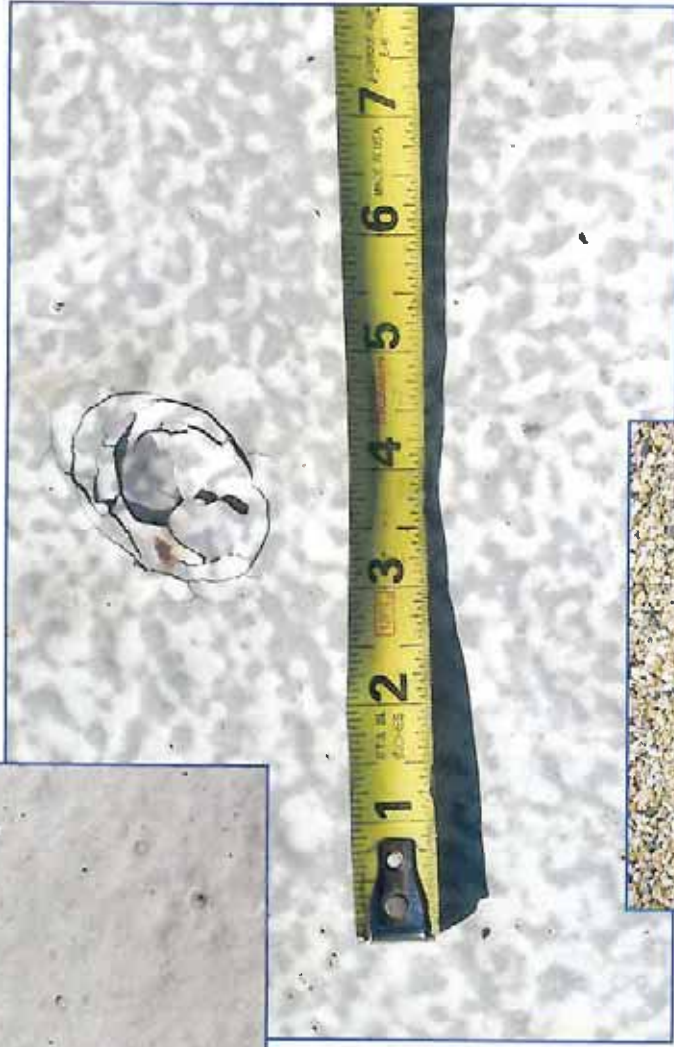
Photo 7 – Hail impact on SPUF.

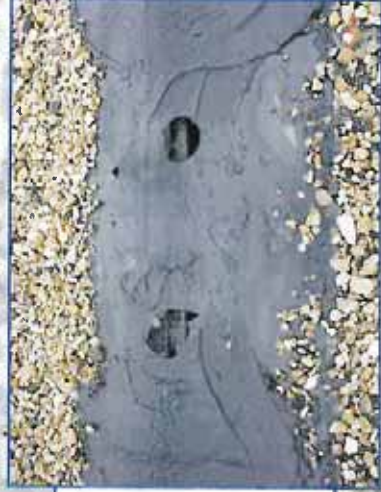
There was no obvious evidence of any physical damage on the gravel-surfaced, built-up roof membrane. Physical damage did occur to an elastomeric bellows expansion joint cover. Many large punctures (approximately 2 inches in diameter) were observed throughout the length of the bel-

lows (Photo 9), which was somewhat brittle and weathered.

Photo 9 – Punctures in weathered expansion joint.

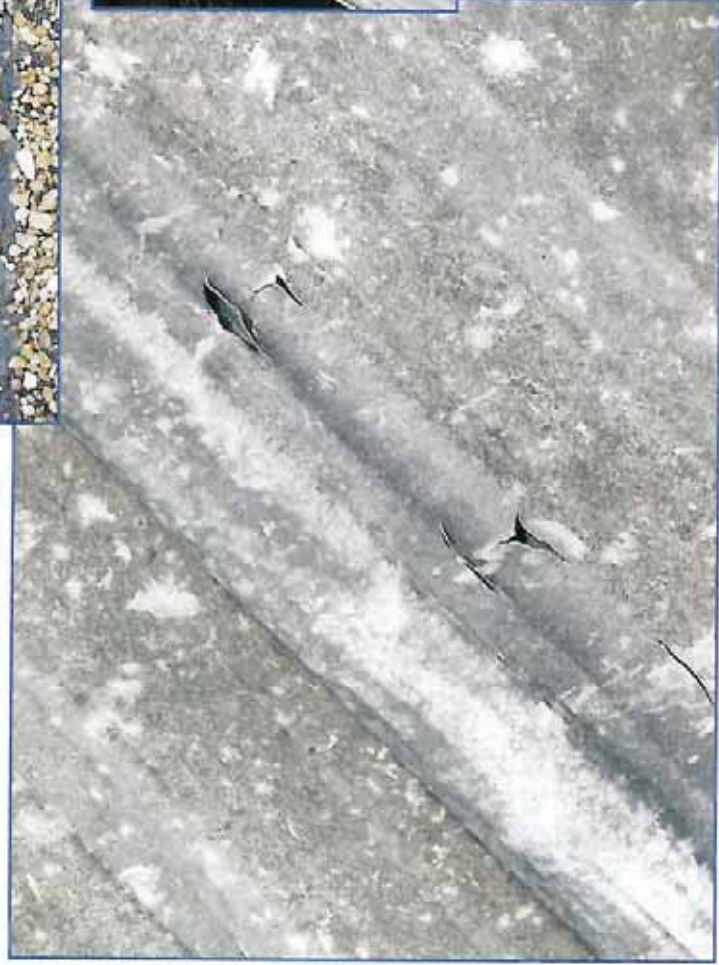
Observations of metal roofs indicated that damage was more cosmetic than damaging to the weatherproofing ability of the panel. Indentations were observed in prefinished metal panels, but the paint finish did not appear to have been affected. On the coated corrugated metal panels, chips were observed in the coating, which exposed the underlying metal core (Photo 10). Large indentations were observed in light-gauge corrugated metal panels that were installed over building entrances (Photo 11).

Photo 11 – Large dents in metal canopy.

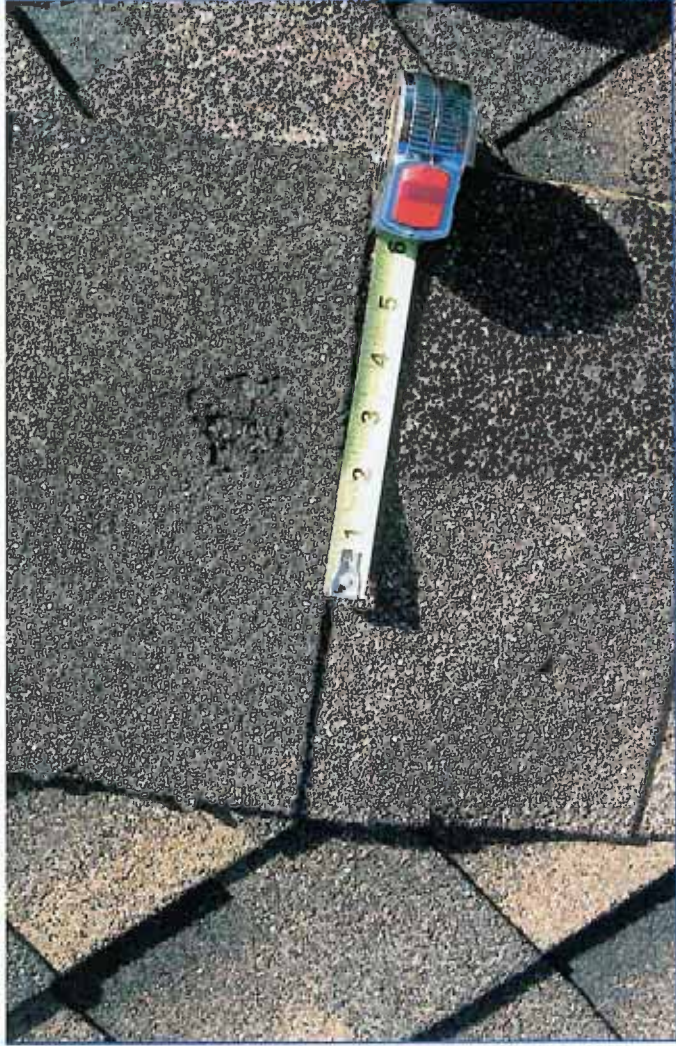
Photo 13 – Damage to edges of ridge shingles.

Damage observed on asphalt shingles varied from granule loss and breakage at unsupported ends and sides to large abrasions and indentations (Photo 12). Physical damage was more prevalent along the ridges (Photo 13).

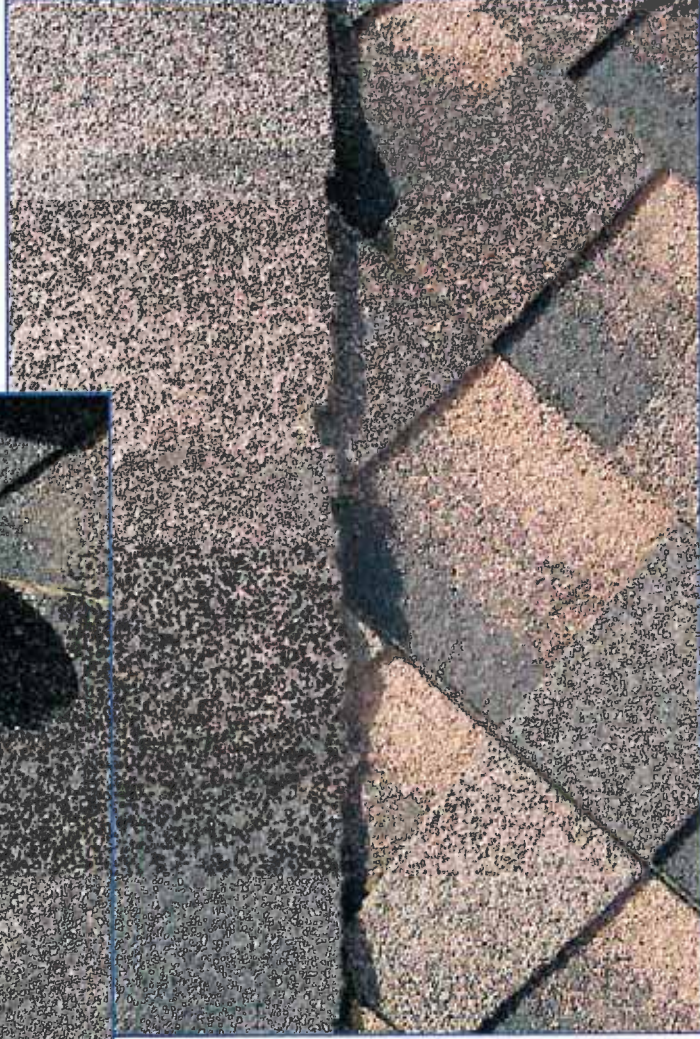
Photo 12 – Large impact on ridge shingle.

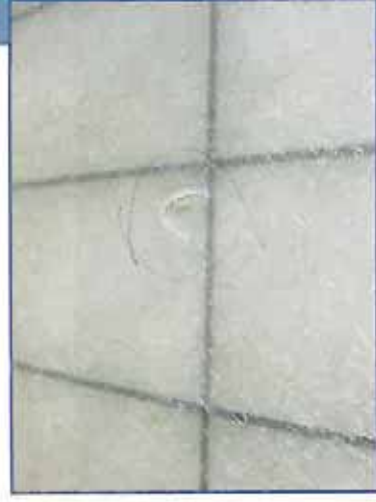
Damage to skylights included fracturing of glazing material (i.e., fiberglass and acrylic). See Photos 14 and 15. Large punctures and holes completely penetrated the glazing material (Photos 16 and

Photo 14 – Fracture in fiberglass skylight.

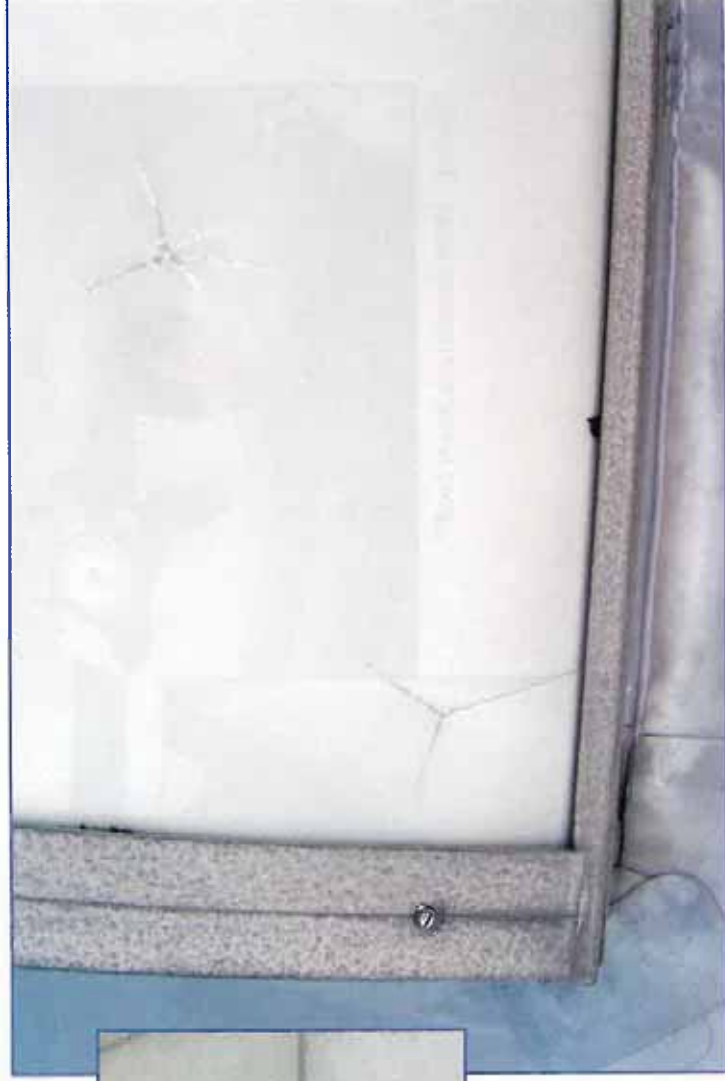
Photo 15 – Fracture in acrylic skylight.

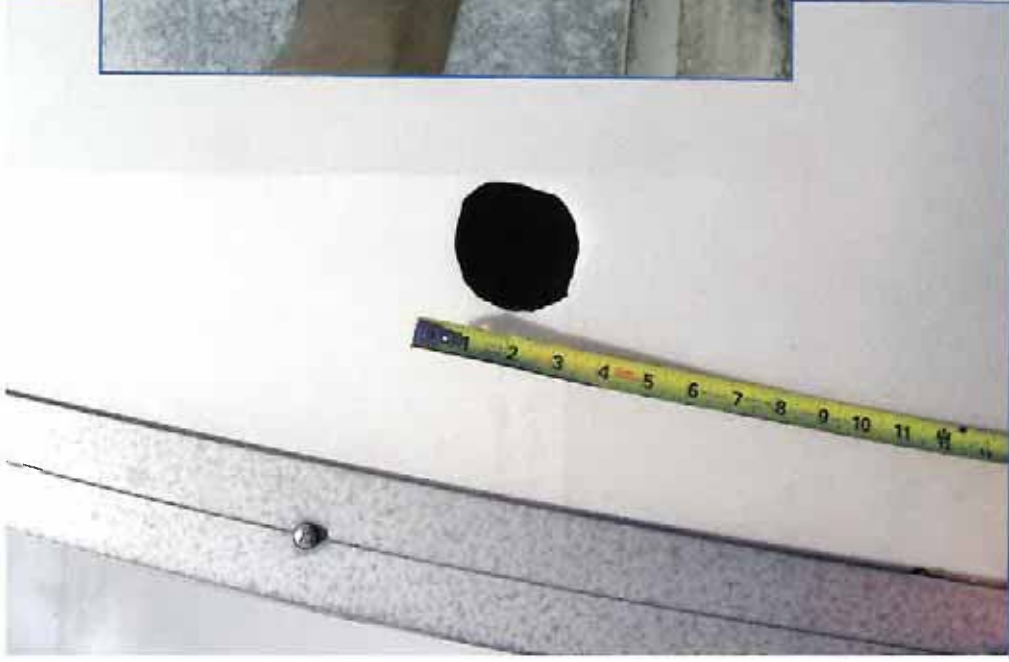
Photo 16 – Hole in barrel skylight.

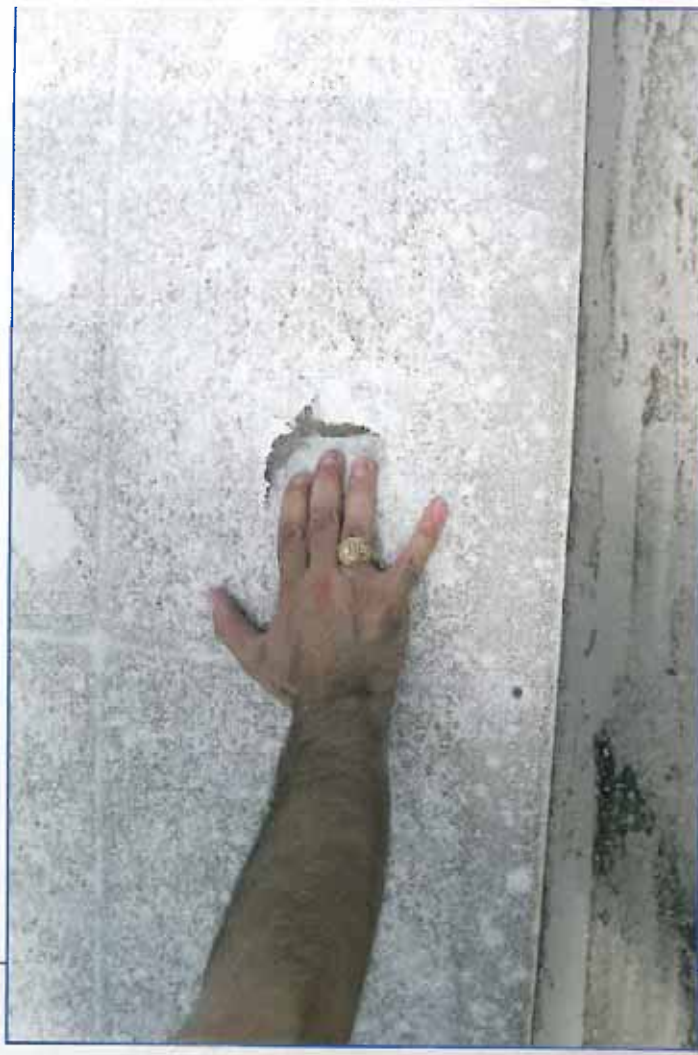
Photo 17 – Puncture in fabric skylight.

17). Damage on the fiberglass sandwich panels occurred only on the top layer of fiberglass. Some domes did not exhibit any visible damage.

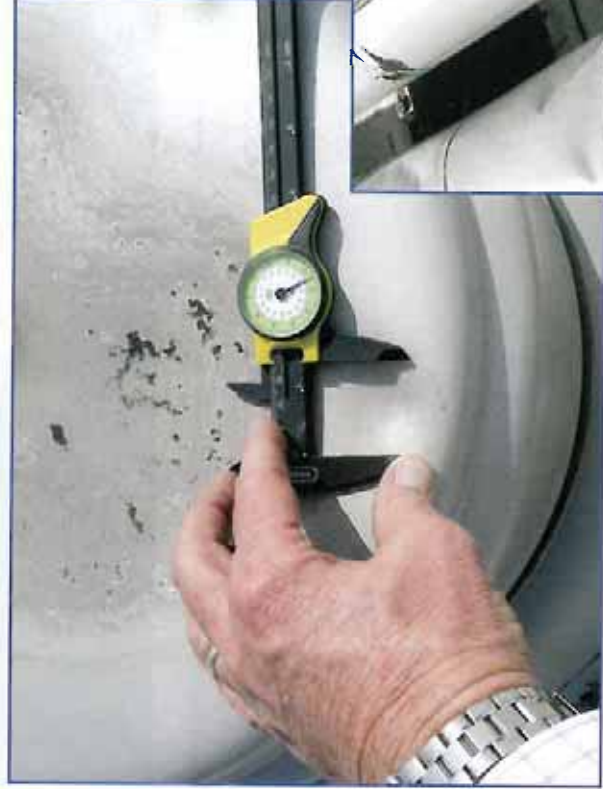
Indentations were observed on many light-gauge sheet-metal equipment hoods (Photo 18), as well as metal jackets on insulated water piping (Photo 19). Both corrugated fiberglass-reinforced panels and flat-glass panels utilized as sloped glazing for greenhouses sustained damage. Punctures and isolated fractures were noted in fiberglass-reinforced panels (Photo 20). Glass panels sustained widespread breakage (Photo 21). Exterior insulated ductwork exhibited similar large punctures extending through the fabric covering and into the fiberglass insulation (Photos 22 and 23).

Photo 18 – Dents in metal equipment hood.⁽⁵⁾

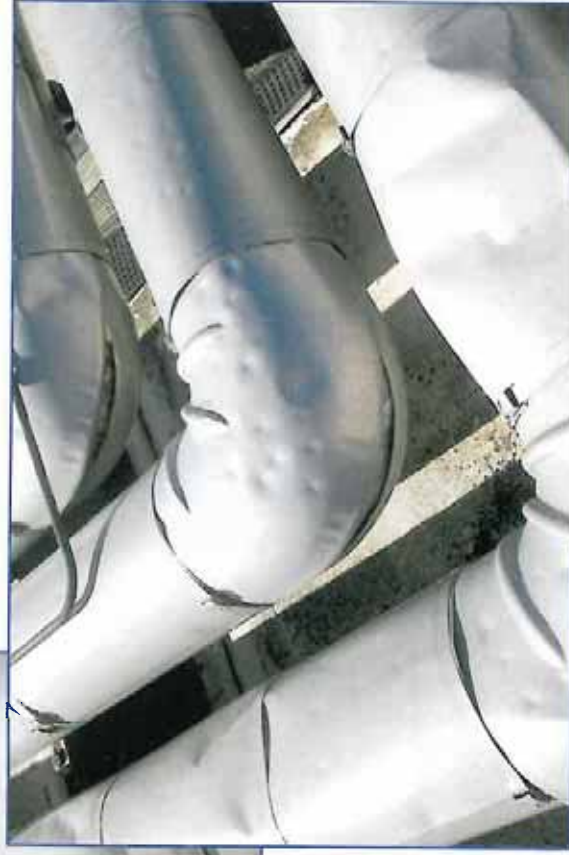
Photo 19: Dents in metal jacket on insulated piping.

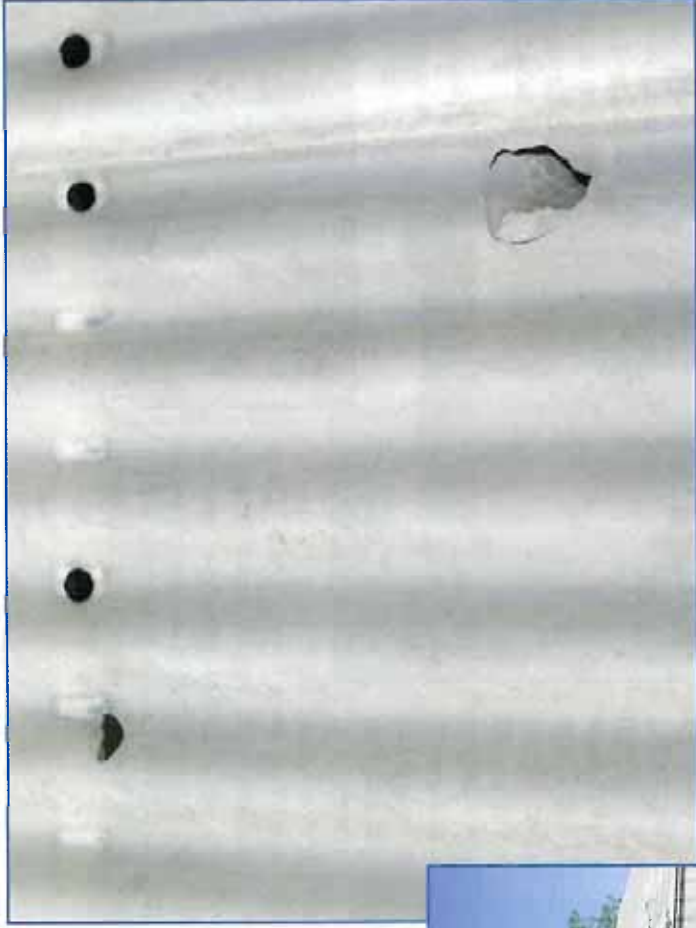
Photo 20 – Puncture in corrugated fiberglass panel.

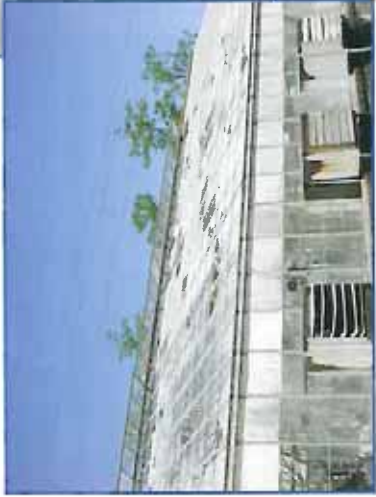
Photo 21 – Significant damage to glass panels.

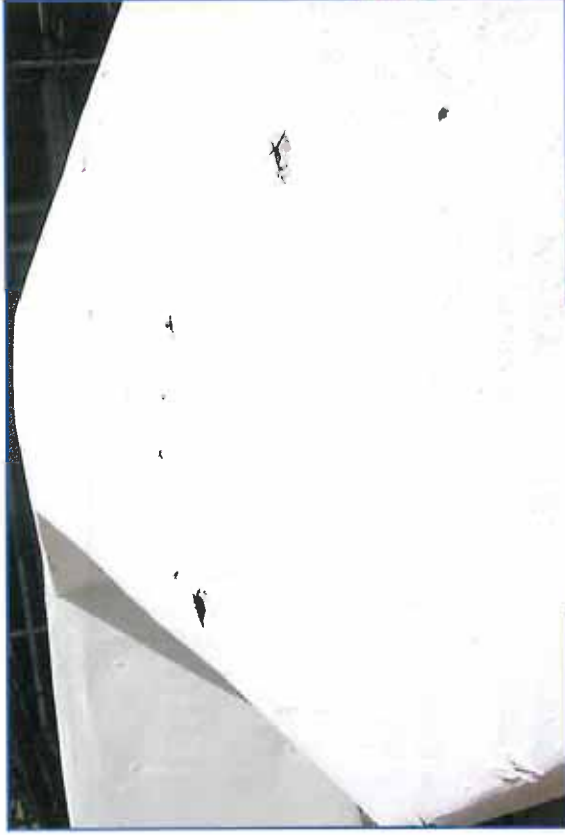
Photo 22 – Punctures in exterior insulated duct.

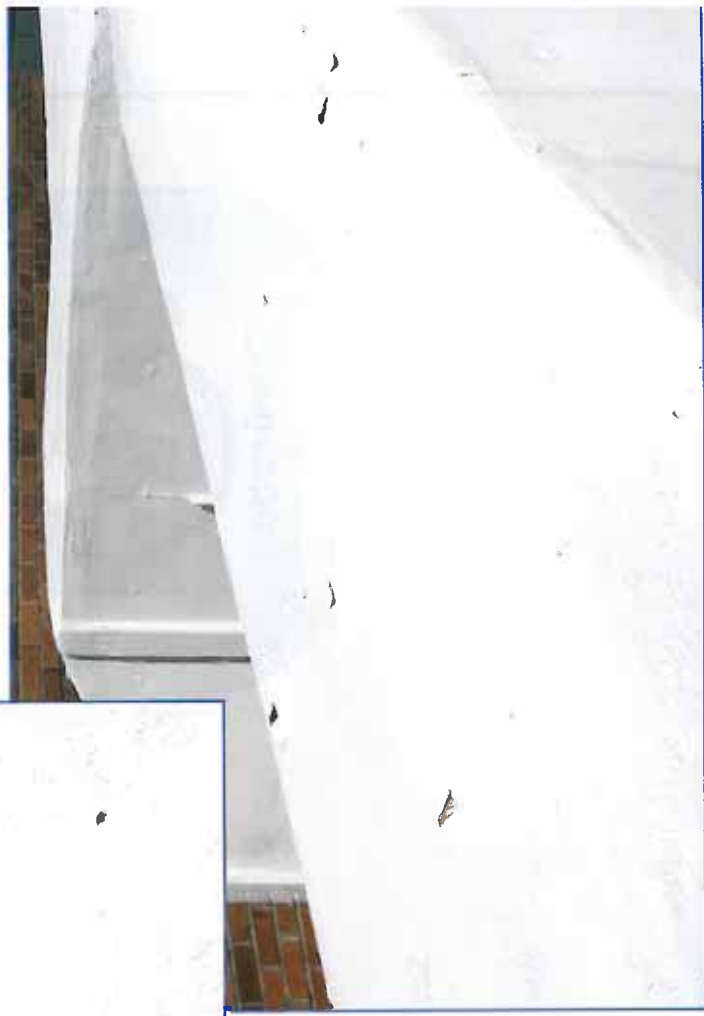
Photo 23 – Punctures in exterior insulated duct.

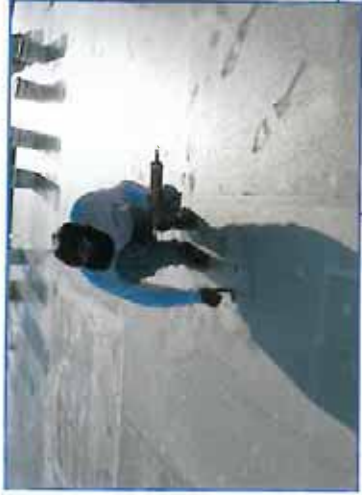
Photo 24 – Applying sealant to damaged areas on single-ply.

Immediately after the storm, school district personnel performed emergency repairs on damaged single plies until more permanent repairs could be implemented. This was to alleviate water infiltration into the buildings and to prevent subsequent damage to interior finishes and goods. Emergency repairs consisted of wiping the area of the membrane clean with a damp towel (to remove surface dirt), gunning a dollop of polyurethane sealant over the puncture, and troweling or tooling sealant to form a cap bead over the damaged area (*Photo 24*). This repair was performed in each area that exhibited an obvious puncture or fracture through the membrane. It was effective in stopping direct water infiltration during brief rain

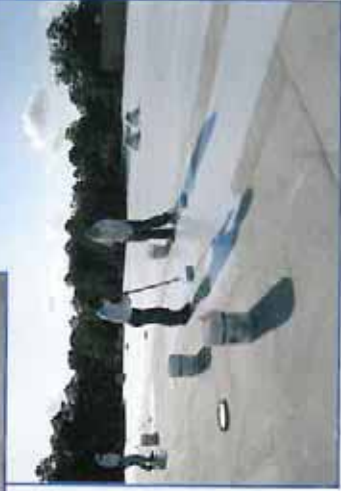
Photo 25 – Applying coating to damaged single-ply membrane.

performed, due to the chances of further introduction of moisture into the roof and building. After the surface preparation, a single layer of an elastomeric coating was applied with a roller to the roof membrane and flashings. This repair process was performed on a total of three schools and was found to be effective in alleviating further water infiltration until the roofs could be replaced.

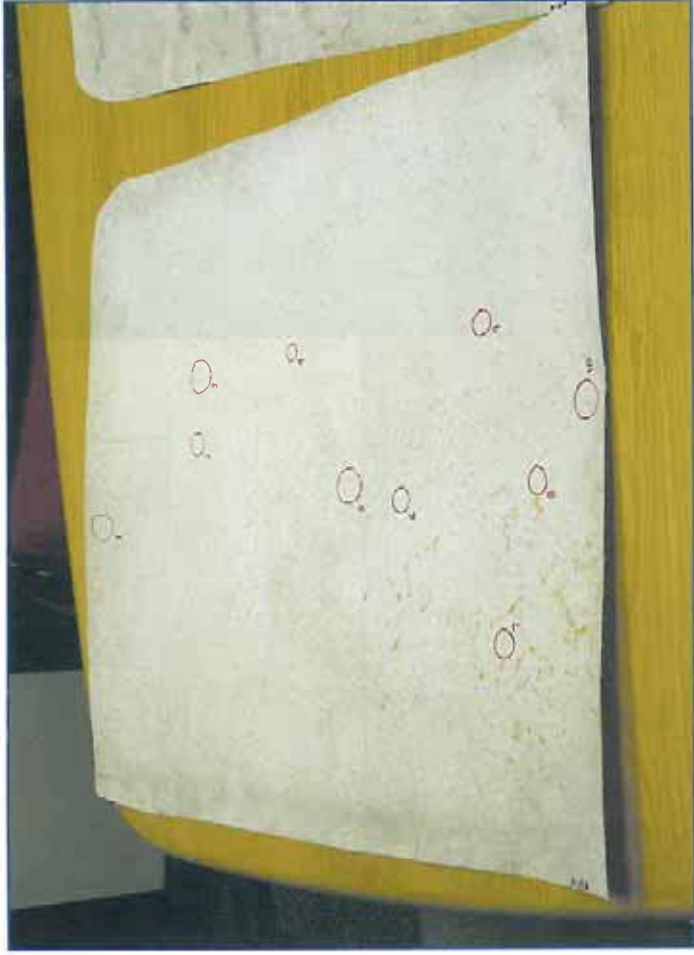
Upon initial review, physical damage was evident at approximately four to six random locations (Photos 26 and 27). However, after cleaning the top surface of

Photo 26 - Top view of typical sample.

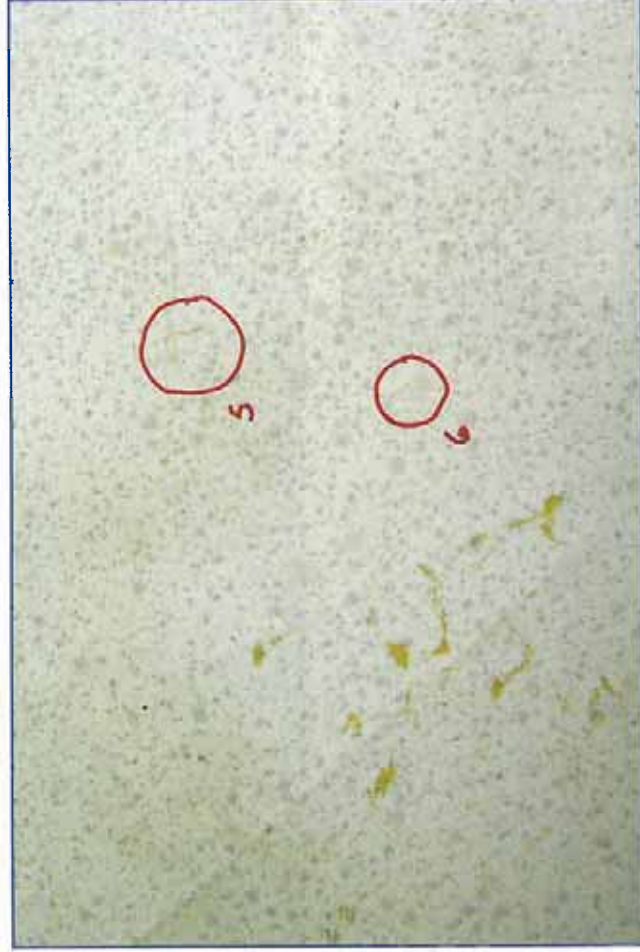
Photo 27 - Close-up view of typical damage on top side.

the membrane and upon closer visual inspection, physical damage was observed at three to four locations, which were considered to be relatively small, at 1/4 in to 1/2 in long. This extent of damage was not readily visible when walking the roof or handling the uncleaned sample at arm's length, due to the small size of the actual damage (1/8 inch to 1/4 inch in length) and to dirt accumulation on the membrane top surface.

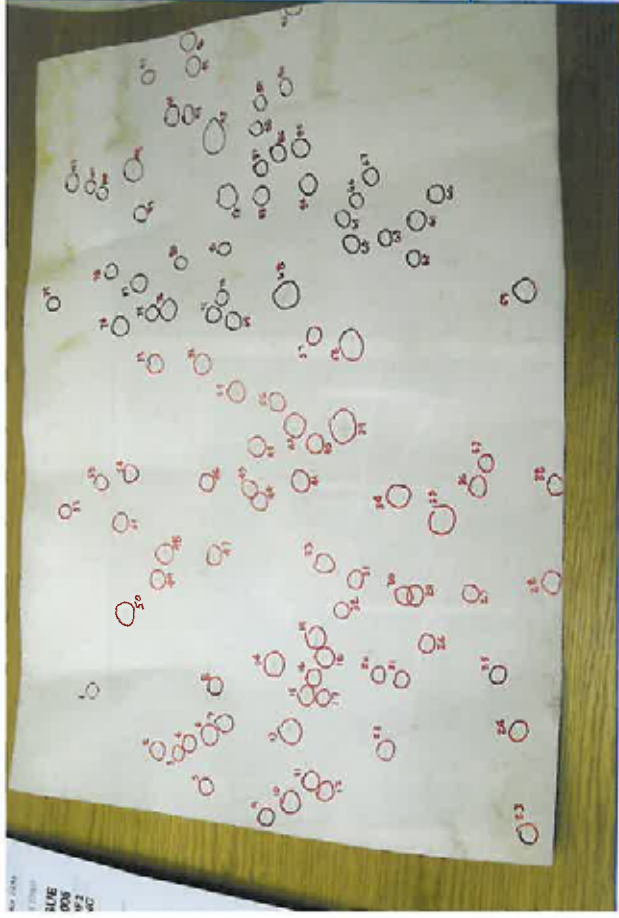
only at the locations corresponding to the top surface spots but also at additional problem locations throughout the samples (Photos 28 and 29). Since the underside of the membrane was relatively clean, the damage was readily evident.

Photo 28 – View of damage from bottom of sample.

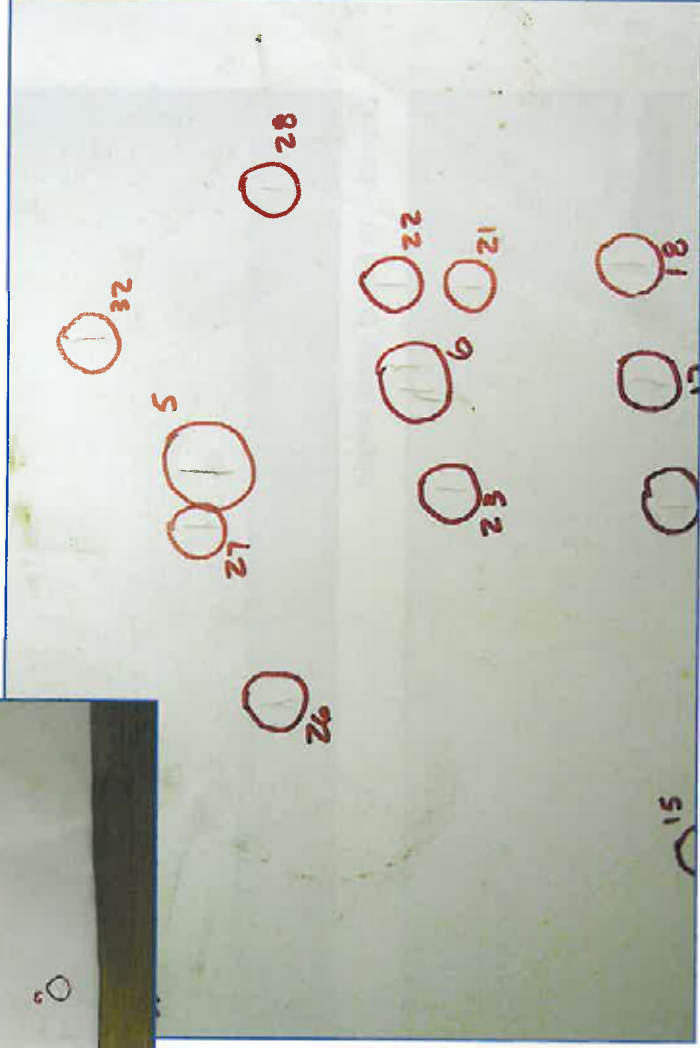
Photo 29 – Close-up view of damage on bottom side.

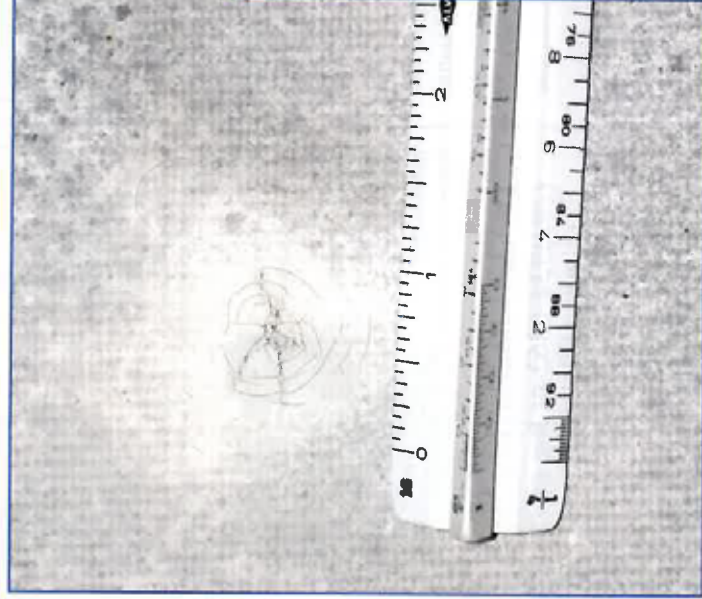
The damage, when viewed on the top surface (Photo 30), was circular- or spiral-shaped (or concentric rings). However, when viewed from the bottom, the damage typically appeared to be more "star-shaped," or composed of linear cracks intersecting at midpoint or propagating from a central focal point (Photo 31).

Photo 30 – Typical fracture in top side of membrane.

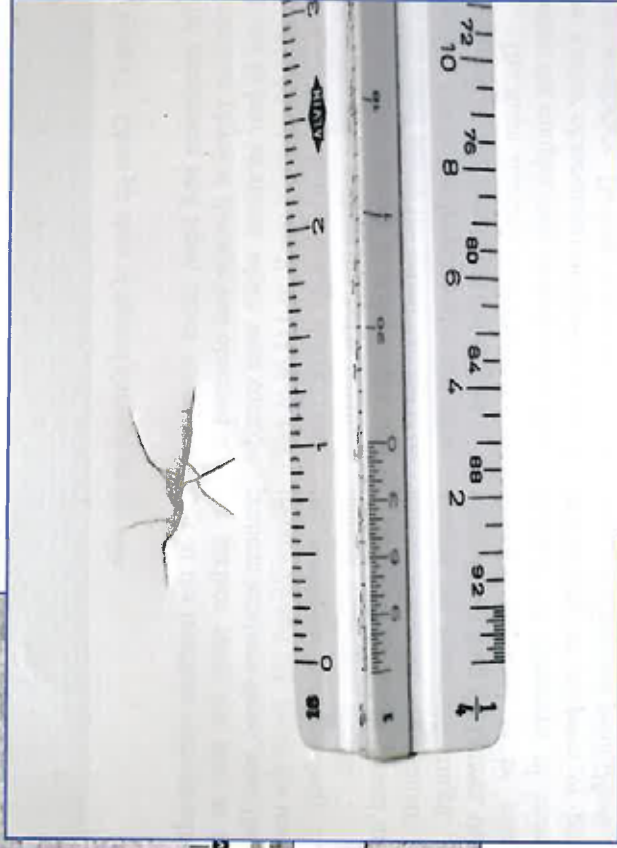
Photo 31 – Typical view of fracture from bottom of membrane.

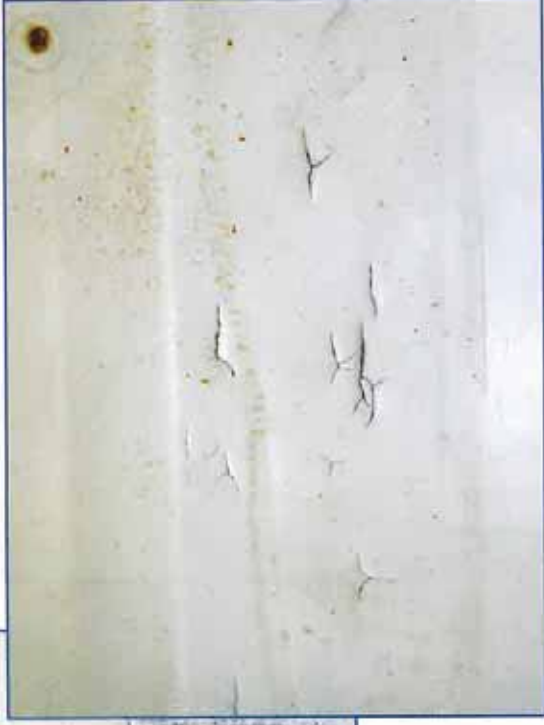
Photo 33 – View of damage on bottom of membrane.

mentioned manner. At one of these schools, similar conditions were revealed when the underside of the membrane was inspected in a closer manner (Photos 32 and 33). Based on this more detailed inspection, an additional

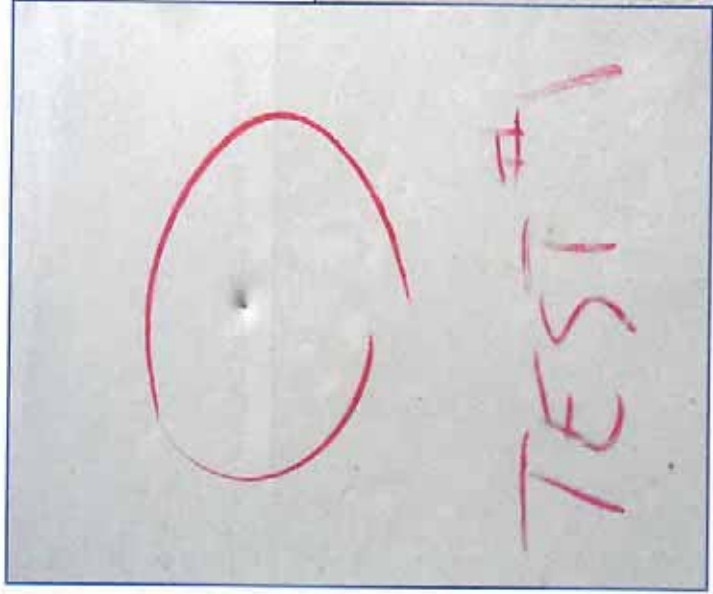
Photo 34 – Depression in membrane.

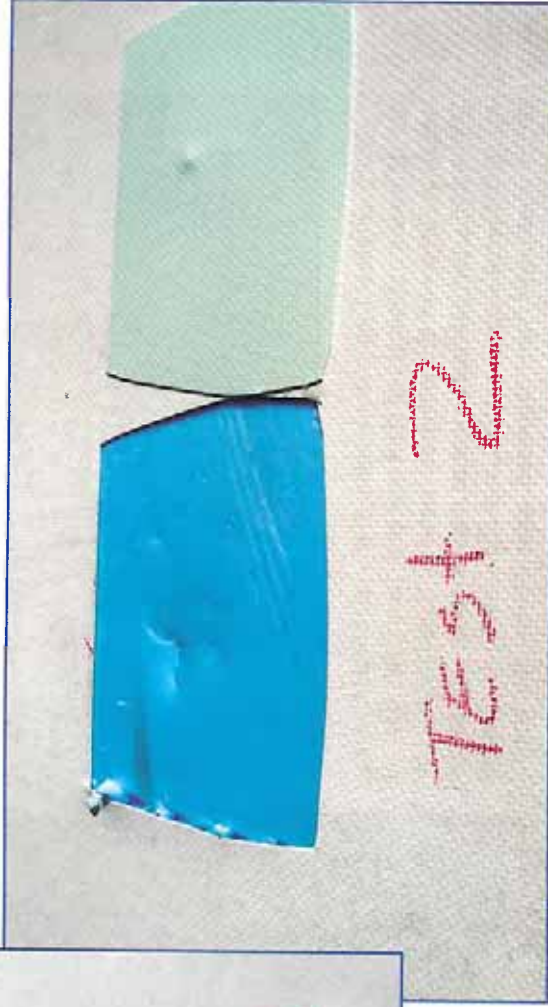
Photo 35 – Large depression in insulation board.

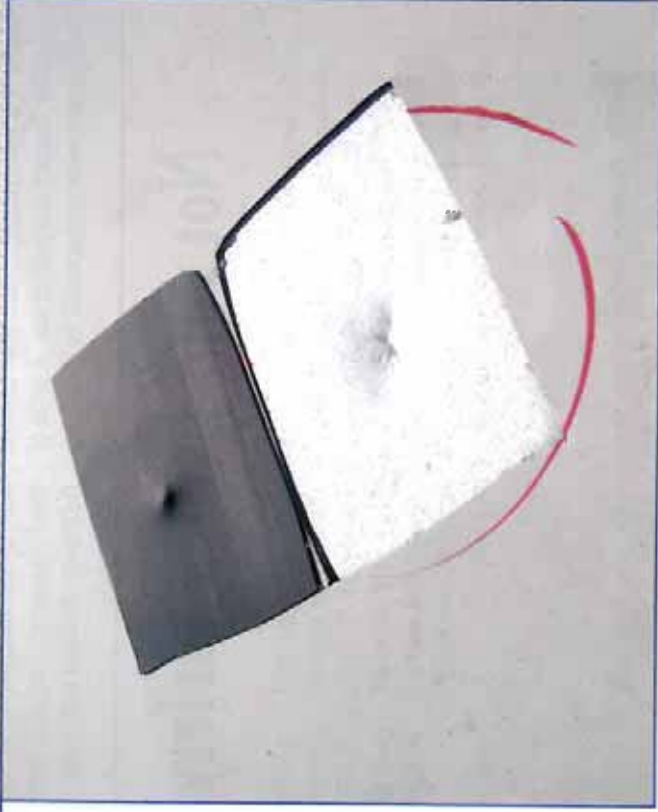
Photo 36 – Large depression in insulation board.

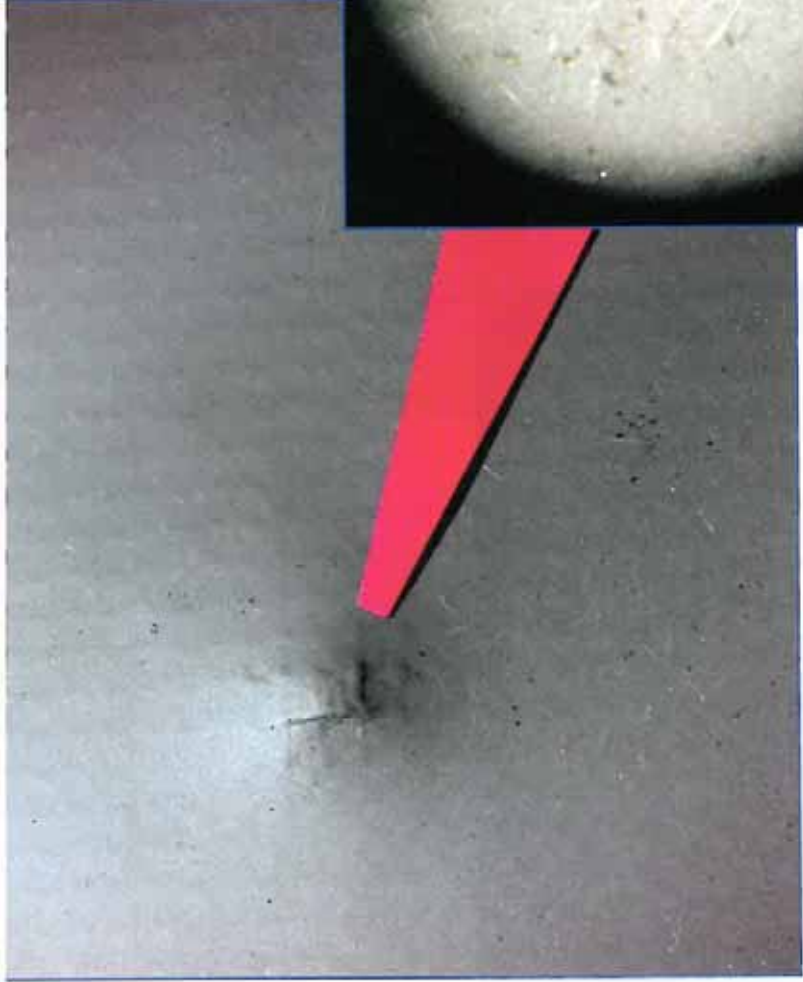
Photo 37 – Close-up view of underside of membrane at depression.⁽⁵⁾

The damage was small linear fractures in the membrane polymer coating, either on the top or bottom surface (Photos 37 through 40). Due to the isolated location and minimal frequency of this level of damage, the affected areas were repaired. This damage appears to have been caused by the larger-sized hailstones. These membranes also did not appear to have been affected by the smaller-sized hailstones.

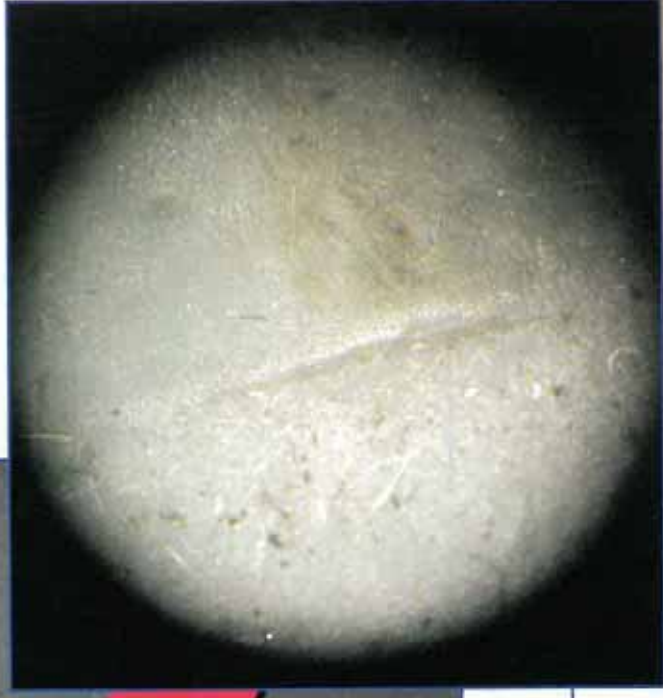
Photo 38 – Magnified view (10x) of depression showing minor crease in membrane.⁽⁵⁾

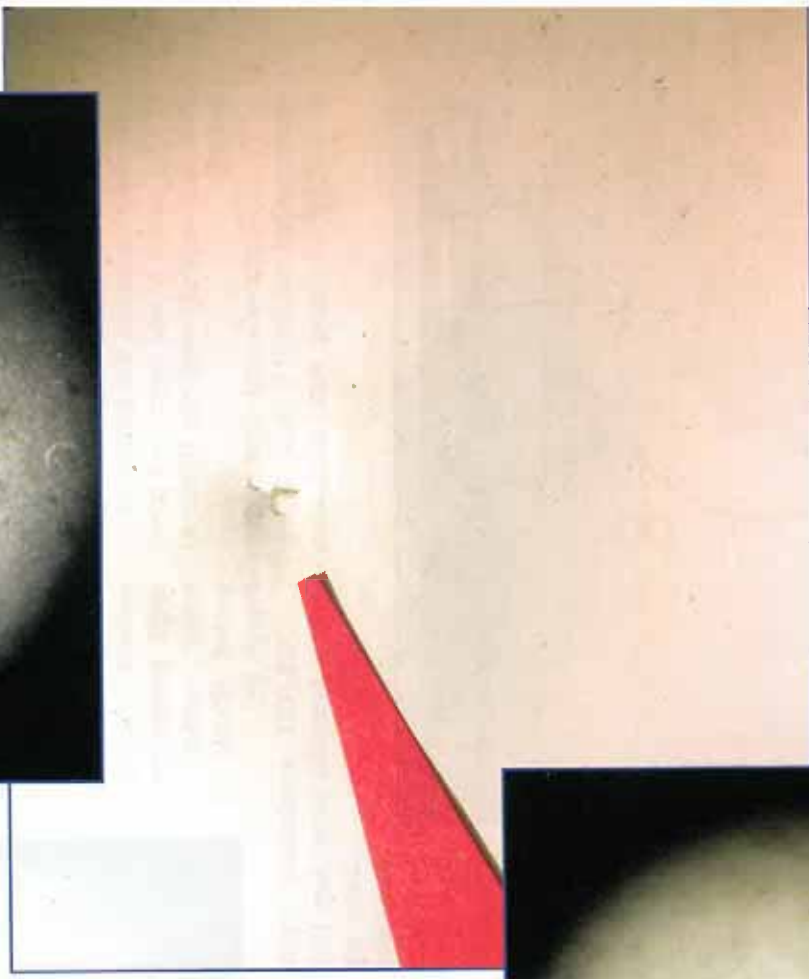
Photo 39 – Close-up view of top side of depression.⁽⁵⁾

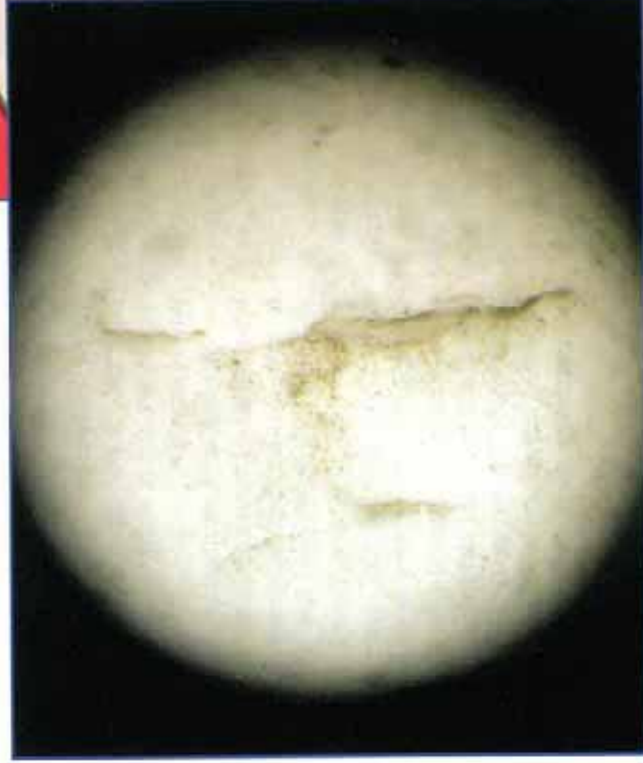
Photo 40 – Magnified view (10x) of top side of depression showing minor crack in membrane coating.⁽⁵⁾

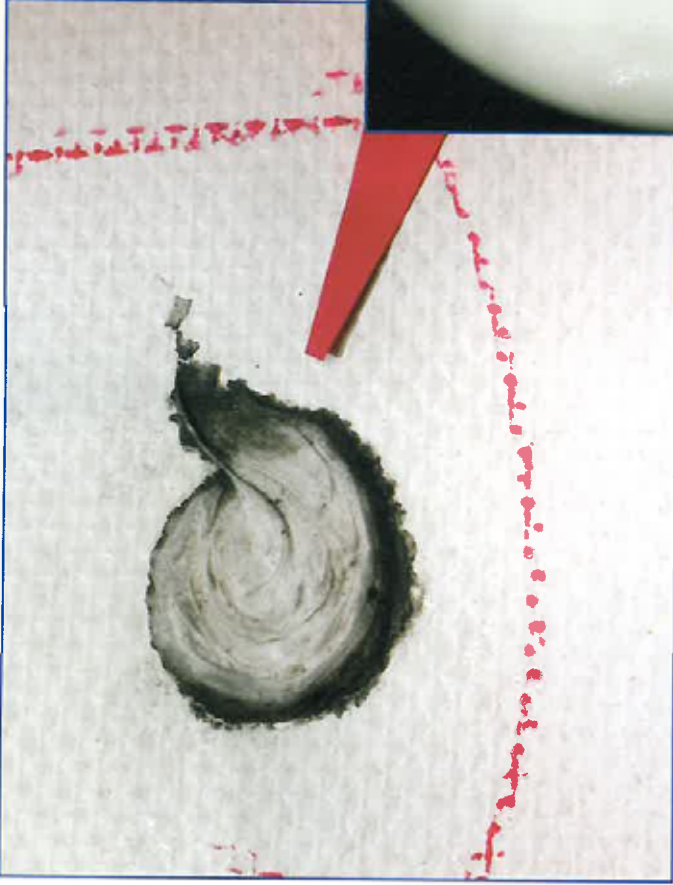
Photo 41 – Sealant applied over damaged area.⁽⁵⁾

The “temporary” emergency repair, using urethane sealant, was found to be an effective means to seal larger-sized punctures on a single-ply membrane (Photos 41 and 42).

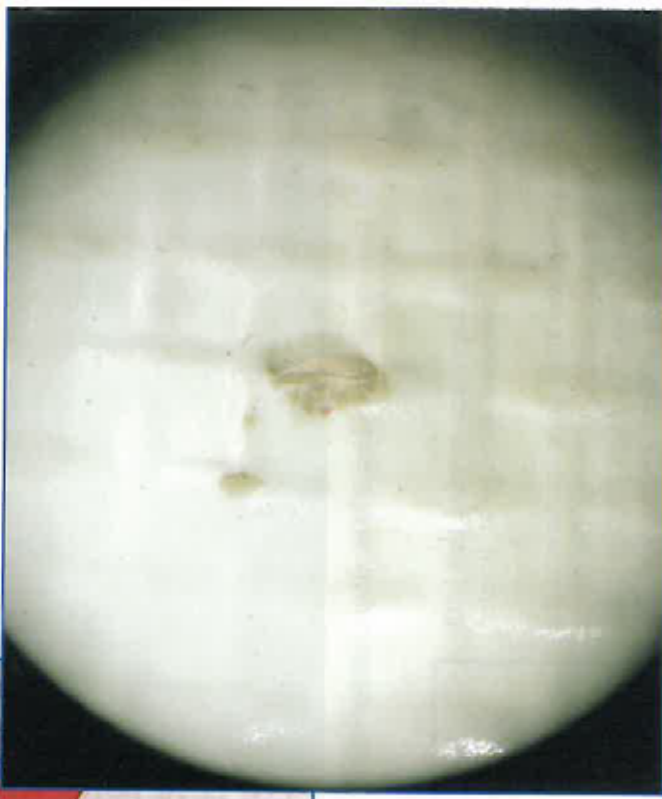
Photo 42 – Close-up view (10x) of underside of membrane showing sealant permeating the fracture.⁽⁵⁾
