THE DAY AFTER:

Documentation of Damage to Roofs from a Hailstorm and the Subsequent Restoration Efforts

By Karl A. Schaack, RRC, PE

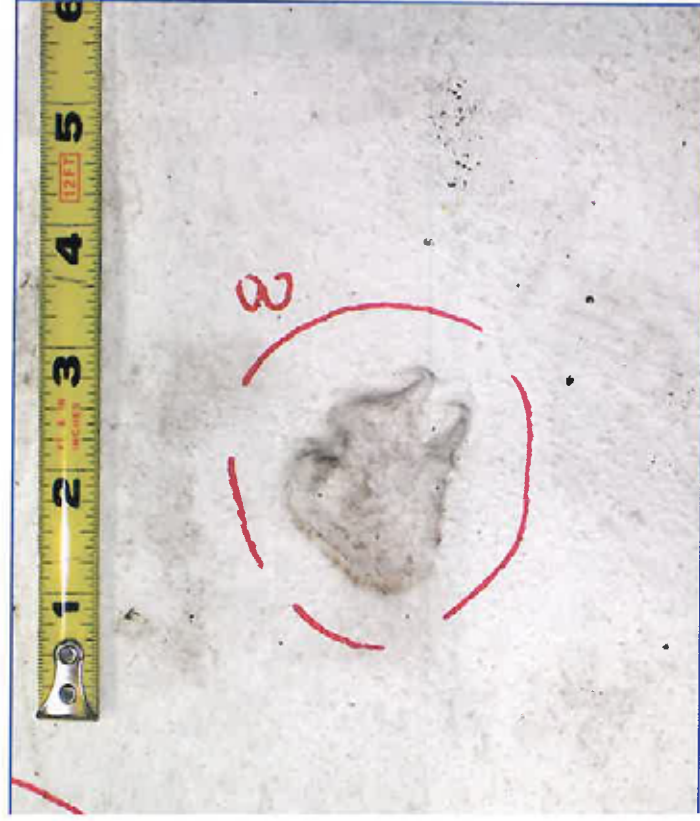
Photo 43 – Sealant and coating applied over membrane.

The application of a single layer of elastomeric coating was found to be an effective method for alleviating water infiltration

through the numerous fractures in the single-ply membrane for a relatively effective time frame (six months) and, in the author’s opinion, could provide even longer service if needed (Photos 43 through 45).

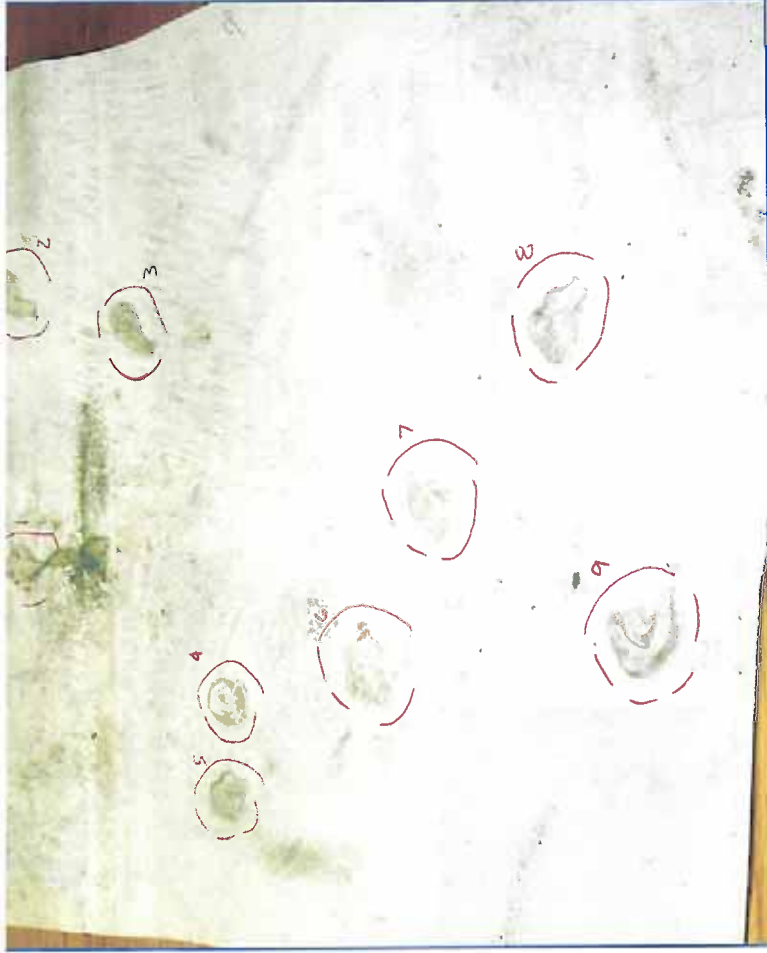
Photo 44 – Sealant and coating applied over membrane.

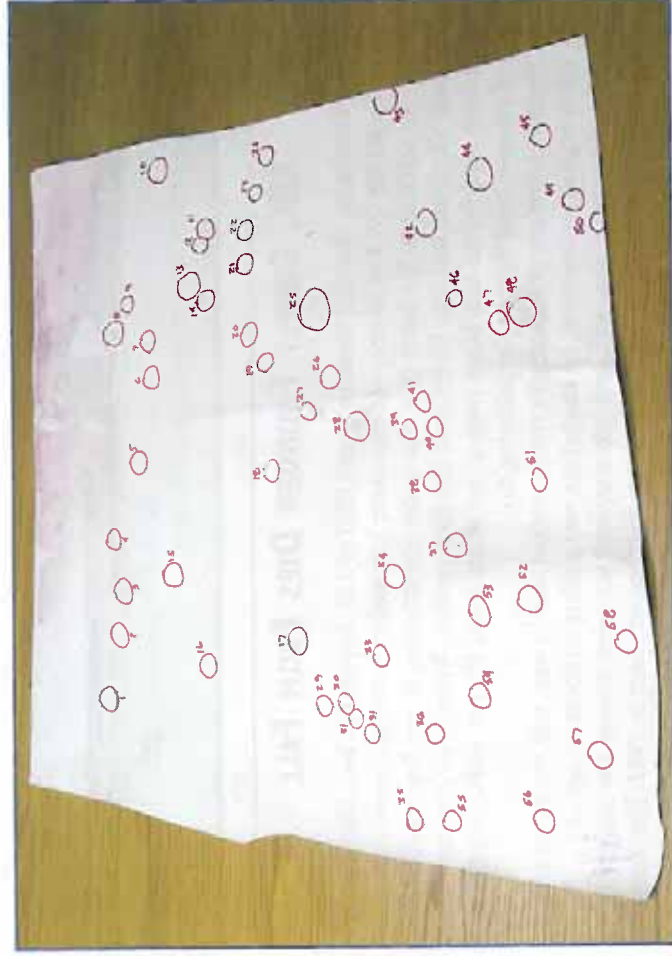
Photo 45 – View of underside of membrane showing numerous areas of damage.
