CONEJOS RIVER DIVERSION INFRASTRUCTURE INVENTORY

Structure Name: BAGWELL D

Date: April 15, 2019

PHOTO LOG

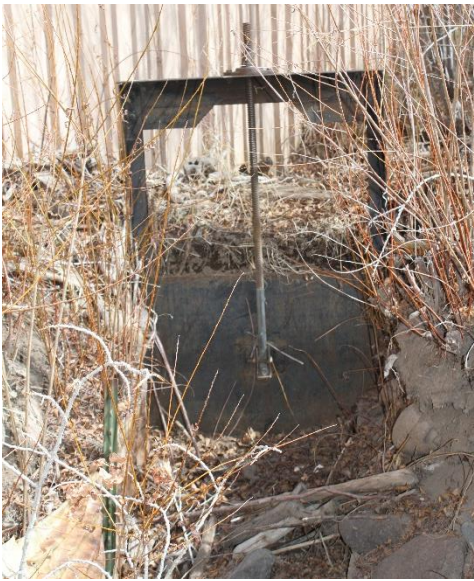
Headgate looking downstream

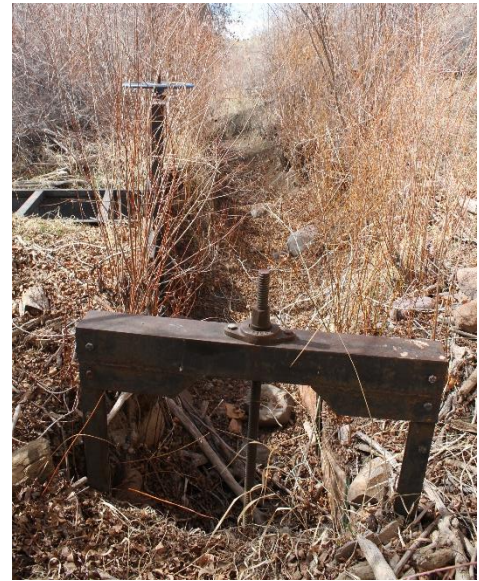
Headgate and sluice gate

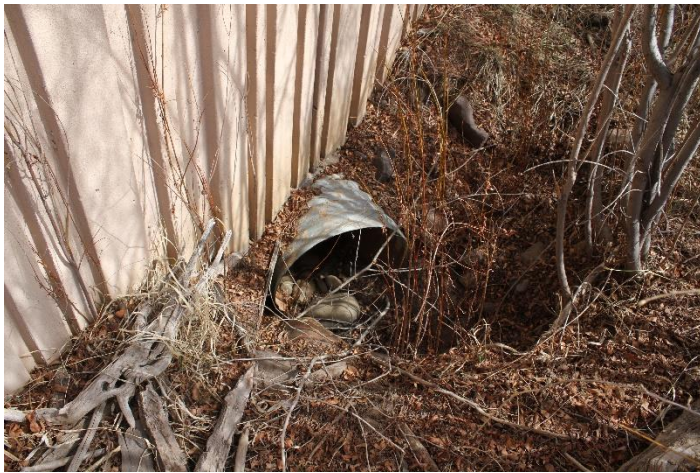
Headgate outlet

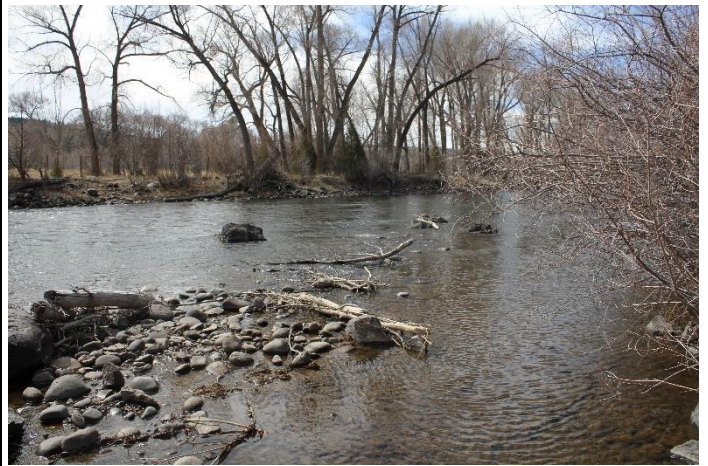
Diversion dam

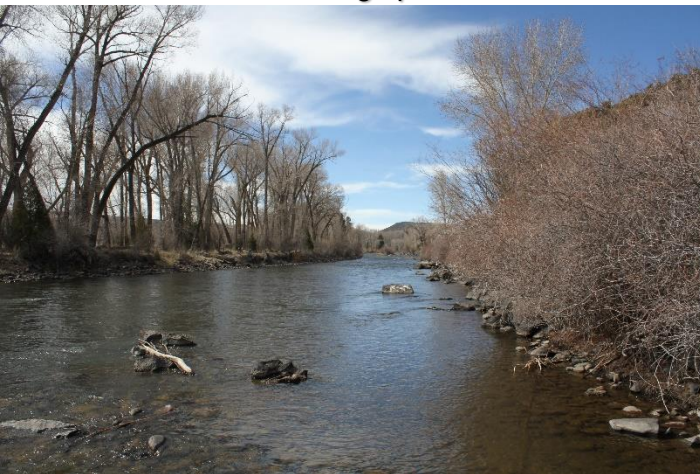
River looking upstream

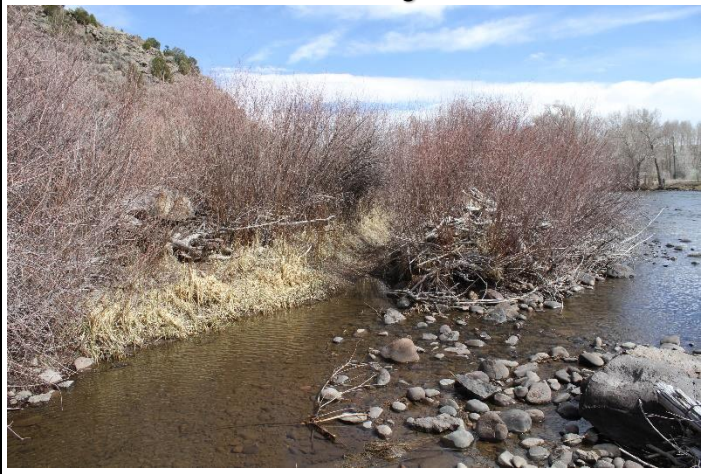
Ditch entrance looking downstream
