SAGUACHE CREEK DIVERSION INFRASTRUCTURE INVENTORY

Structure Name: HOUGLAND D

Date: April 12, 2019

Saguache Creek Stream Management Plan

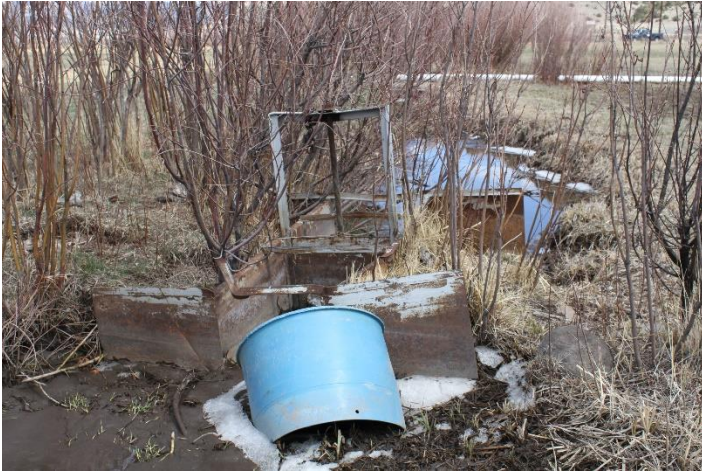
Headgate looking downstream

Structure Description: This ditch is located on the outside of a meander between Hodding Creek and Mill Creek. A boulder diversion dam directs water to the headgate, which is located on the south bank of the river. The headgate is tilted and does not function well. The diversion dam is narrow and tall, leading to scour downstream and creating a barrier to fish passage. The meander on which the diversion is located is tightening and may be cut off during a high flow event.

Repair(s) or Improvement(s) Currently Needed: Recommendations include resetting the headgate so that it is level and fixing the leak in the headgate. Bank stabilization is recommended to mitigate headgate erosion and prevent the meander on which this diversion is located being cut off. Fish passage and riparian restoration should be considered as part of any future repairs or improvements.
