## **RESERVE STUDY**

### **SPYGLASS LANDING CONDOMINIUM**

### **MARSHFIELD, MASSACHUSETTS**

| DATE: | October 2016 |

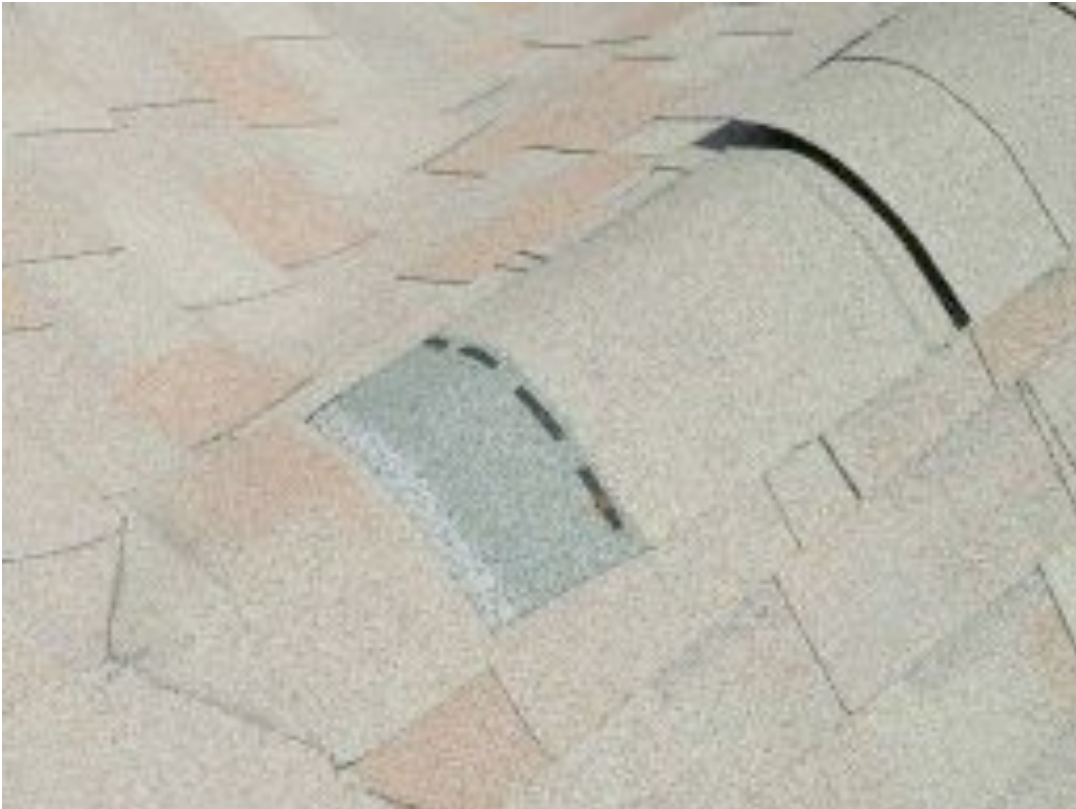
A FEW MISSING RIDGE CAP SHINGLES WERE NOTED (NOT WIDESPREAD)

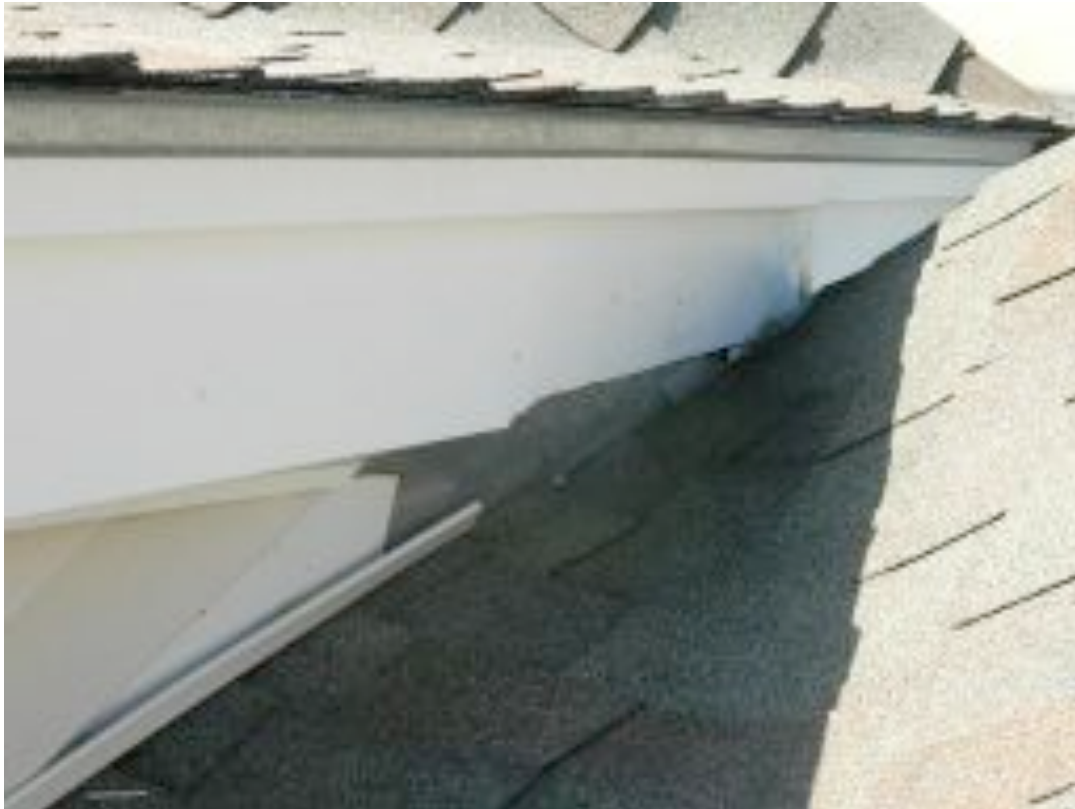
We did note some locations where the units merge that appear potentially vulnerable to leakage. In many cases, the units merge at a step-flashed cheek wall, some of which end against adjacent roofing systems, and appear vulnerable to trapping water, snow or ice (see photos). Without a complete re-design, little can be done about this now, but if any leakage were to occur in the general area, we would suspect a flashing/underlayment deficiency where the units meet.

QUESTIONABLE FLASHING DETAILS WERE FOUND WHERE SOME UNITS MERGE

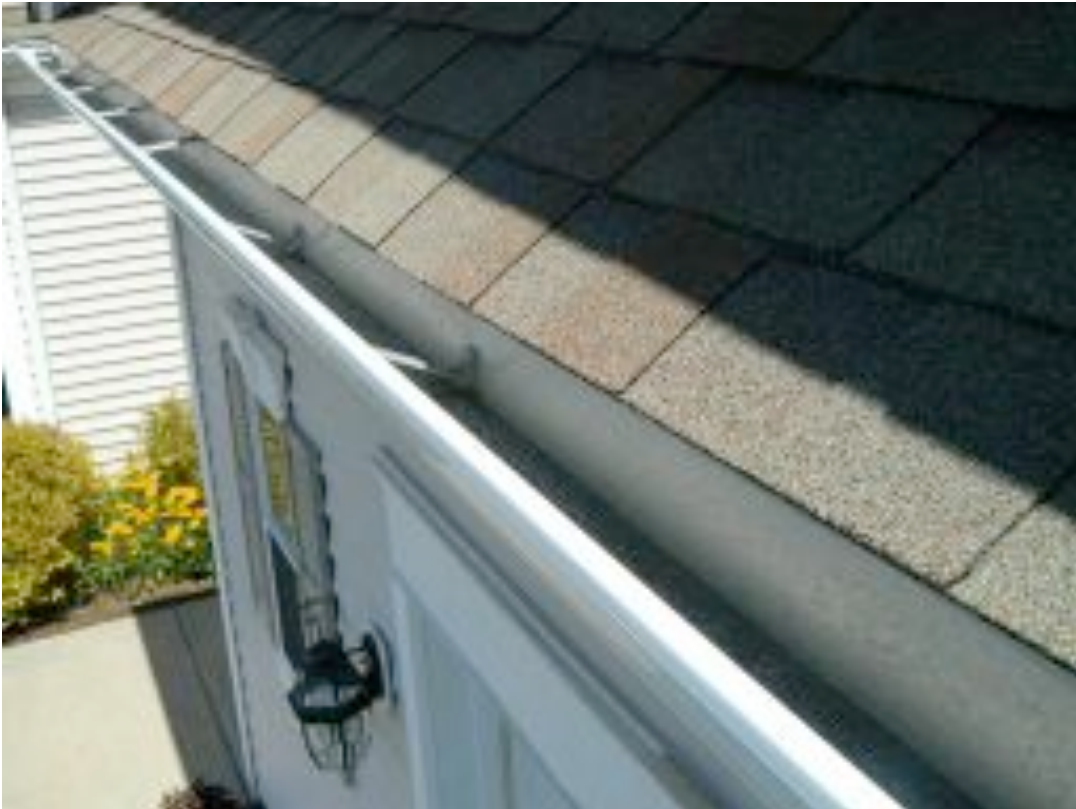
THE GUTTERS ARE ATTACHED WITH A BAR-HANGER SYSTEM (NOTE DETACHED HANGERS)

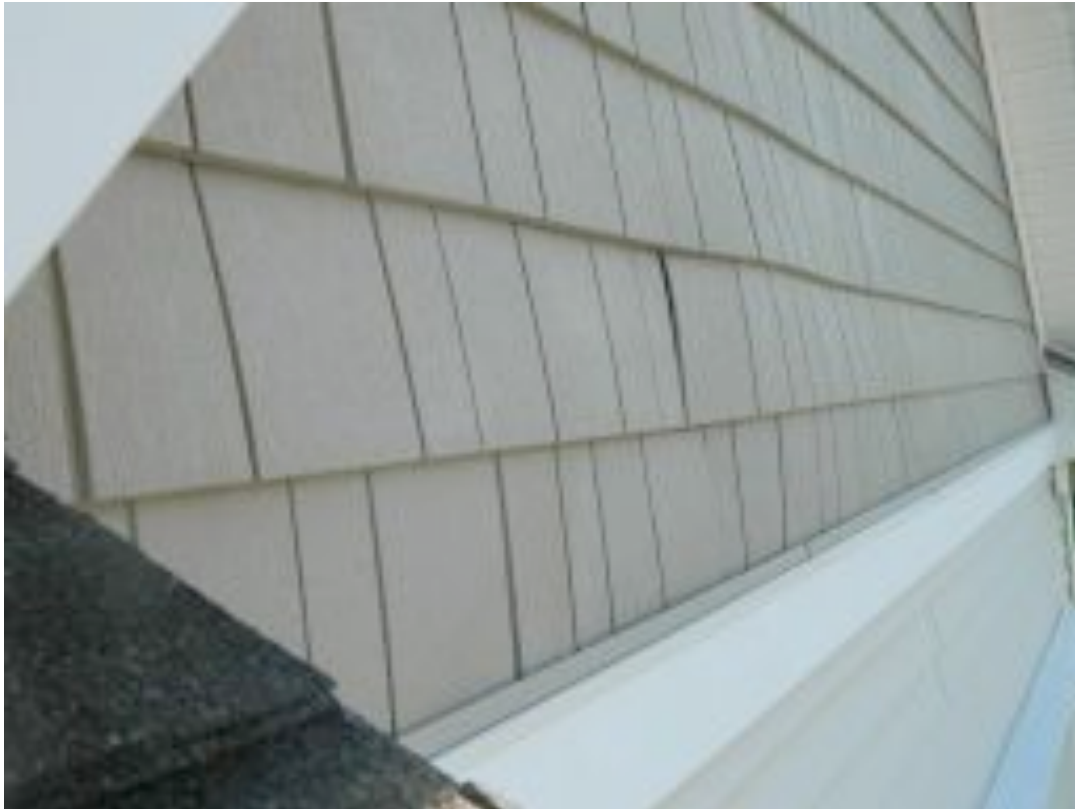
THE SHINGLE SIDING IS A POLYPROPYLENE PRODUCT (NOTE RIPPLING PANELS)

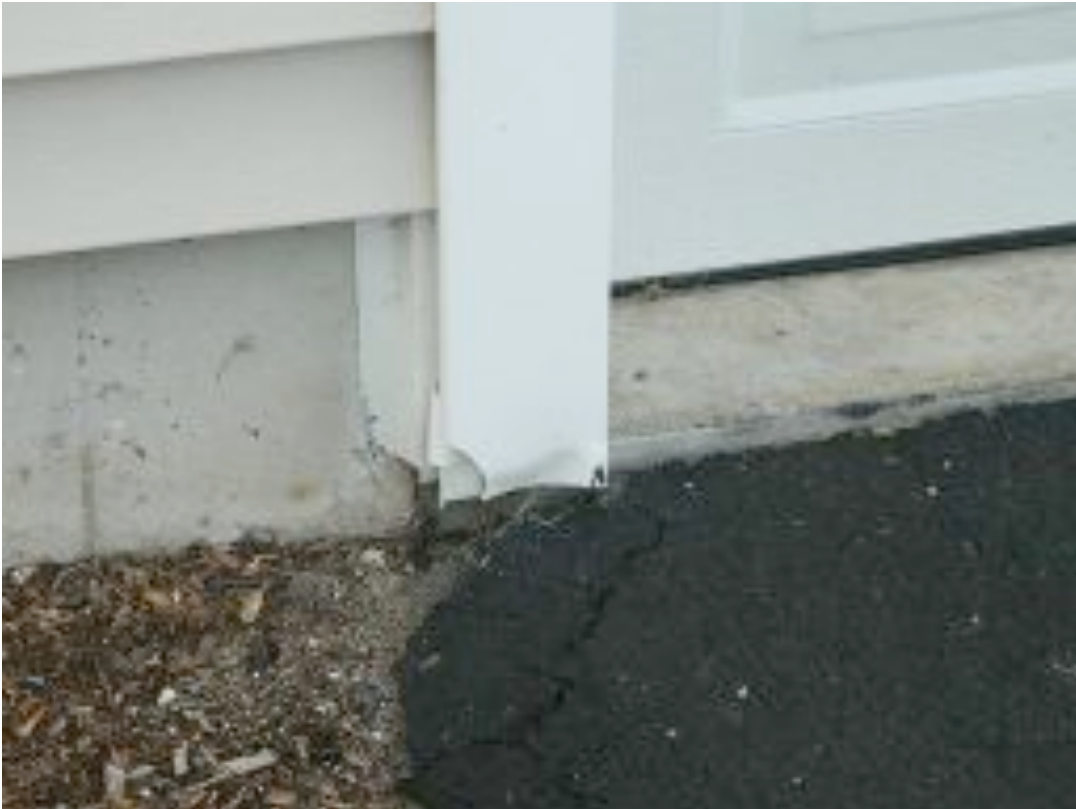
Some minor damage was noted at the base of the walls, again likely caused by landscaping activities. In some instances, the siding is less than 6” from surrounding grade. Although Code allows vinyl siding to be close to grade, the underlying framing members are required to be at least 8” above grade. The vast majority of the buildings have adequate clearance from grade. The damage

SOME DAMAGED SIDING/TRIM WAS FOUND AT THE BASE OF WALLS (NOT WIDESPREAD)

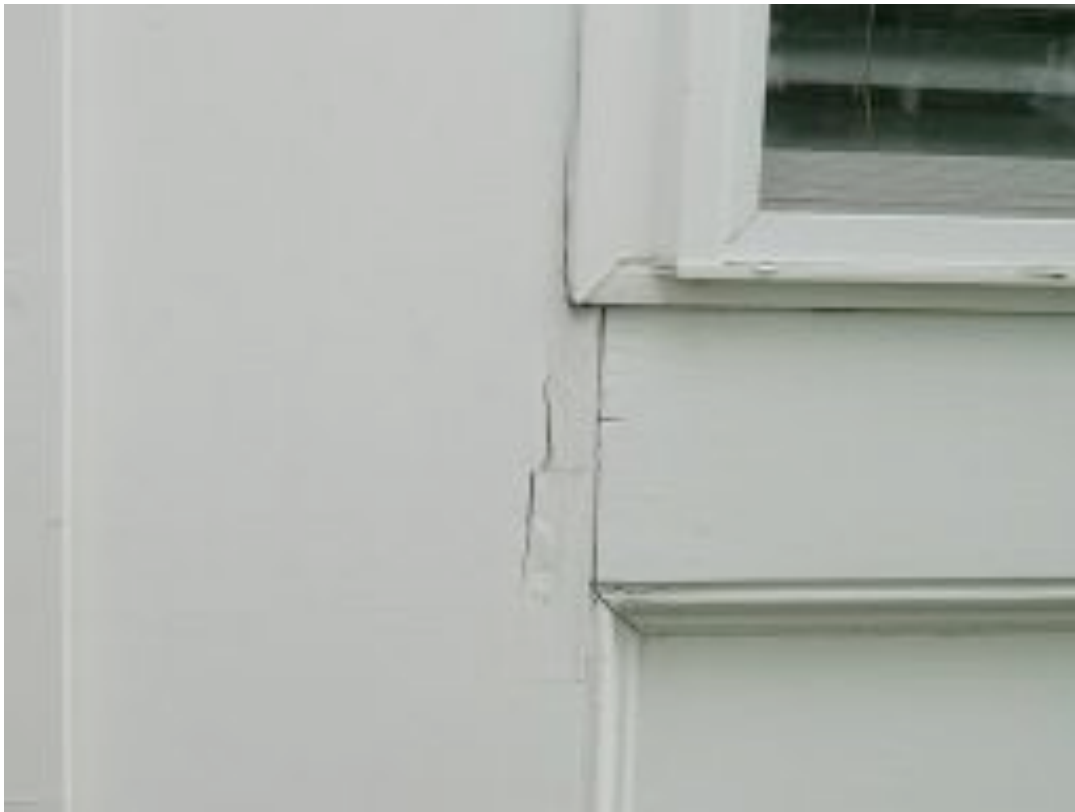
Each building includes areas where there are what appear to be MDO (medium density overlay) panels around windows. We noted several of them have begun to rot (see photos), likely as a result of the failure to properly coat the cut ends prior to installation. This office would advise that any such rot be addressed by removing the deteriorated pieces, and replacing them with new cellular PVC trim. This issue is not widespread at this time, but is expected to accelerate as the property ages.

THE PANELS AROUND SOME WINDOWS ARE BEGINNING TO FAIL

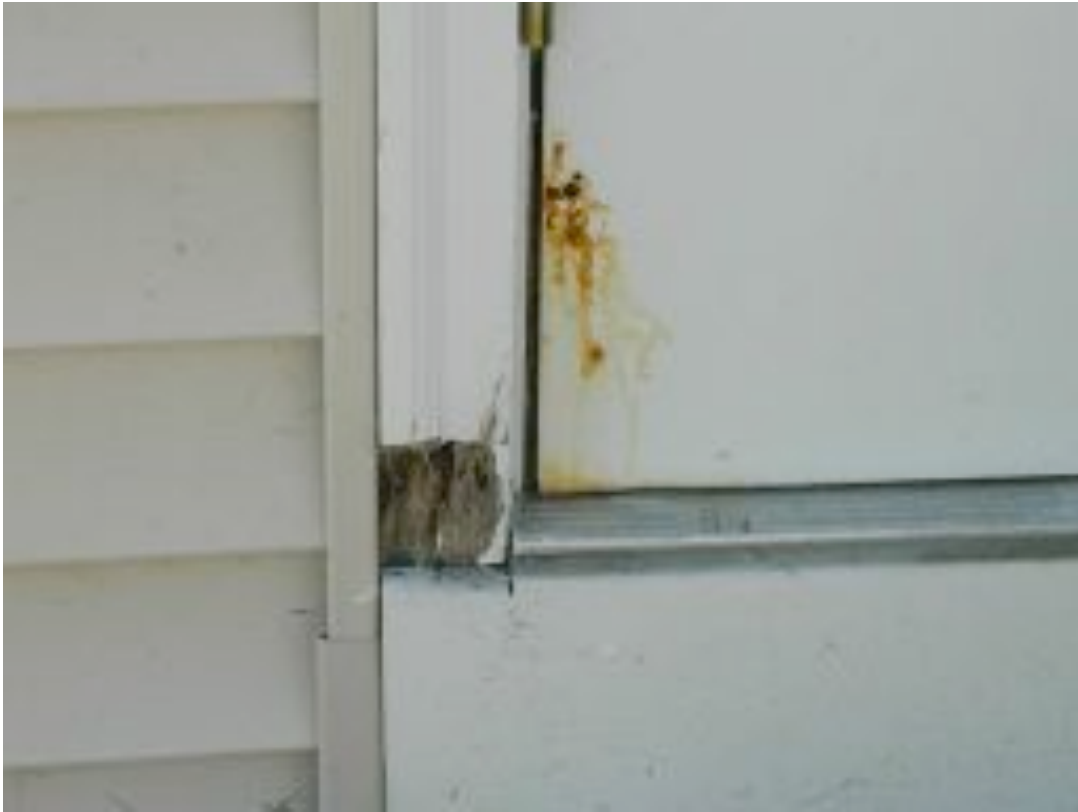
We noted some accelerating trim rot at the exterior doors on the utility rooms (see photos). The doors themselves are pressed-metal units, some of which have also begun to suffer from surface rust. These doors would appear to fall outside of the unit boundaries, and we have included their replacement in approximately 9 more years on the Reserve Schedule (Item #4). The estimated replacement cost reflects removal and replacement with a new equal.

SOME SIDE UTILITY DOORS ARE RUSTING, AND SUFFERING FROM TRIM ROT

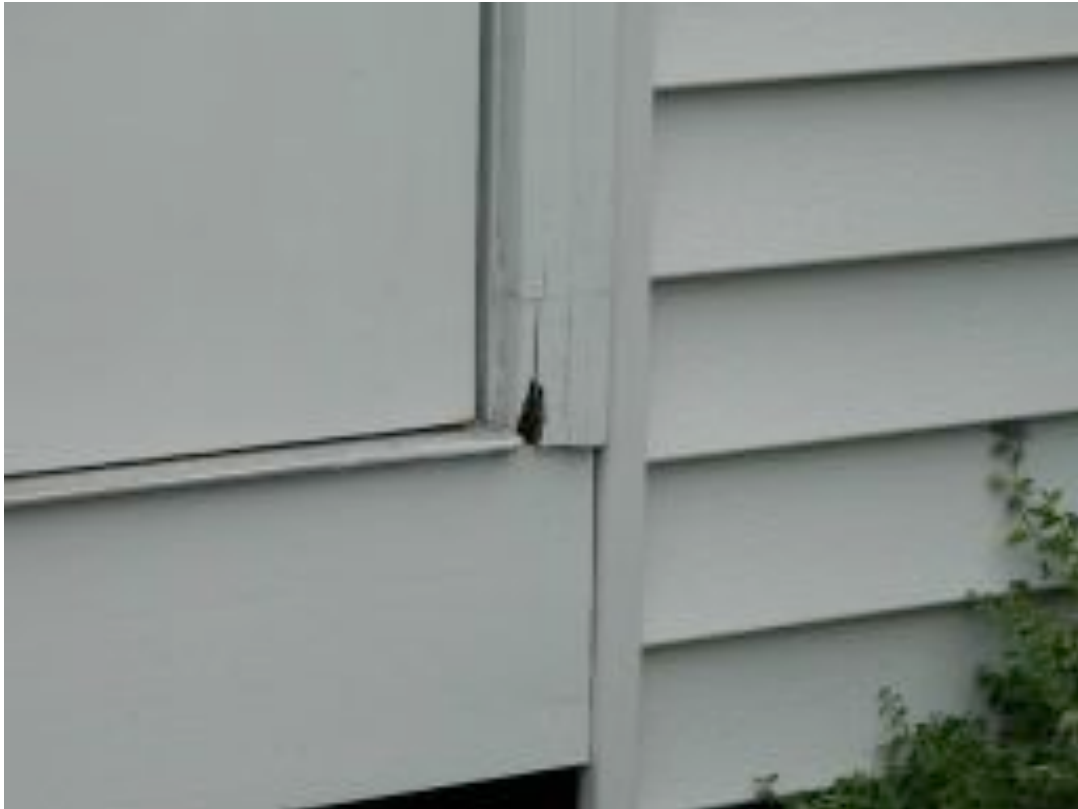
FURTHER EXAMPLE OF TRIM ROT ON A UTILITY ROOM DOOR

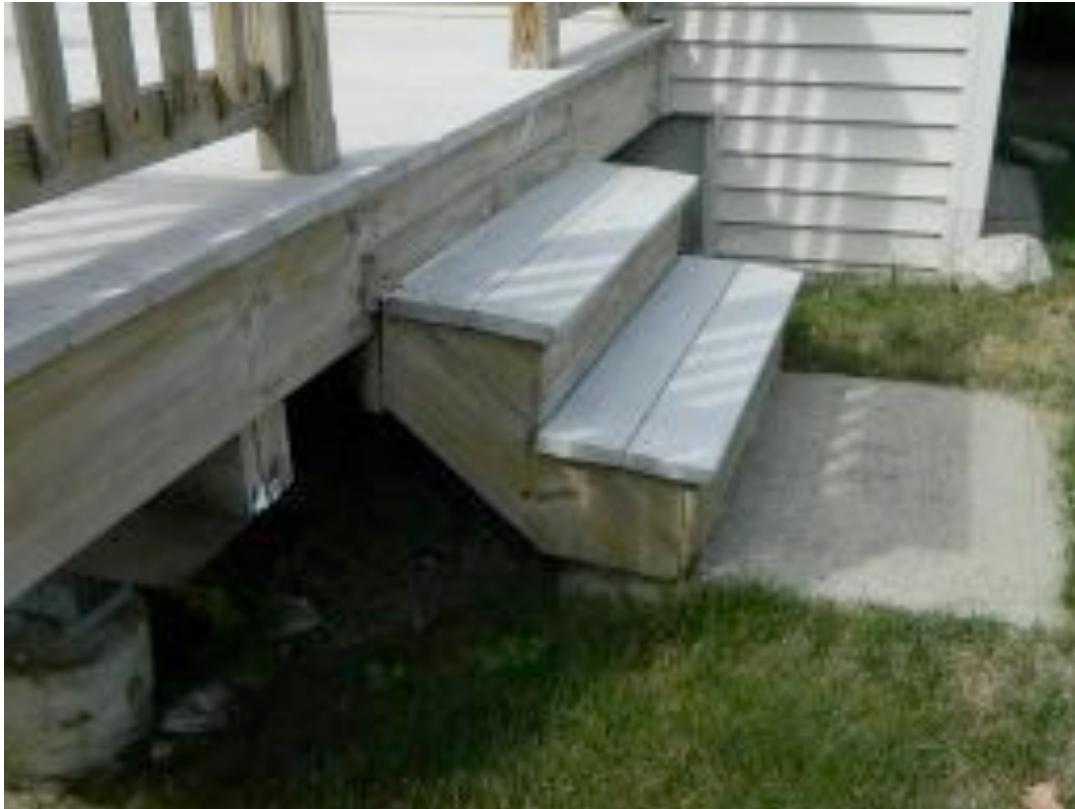
SOME OF THE STEPS HAVE SETTLED

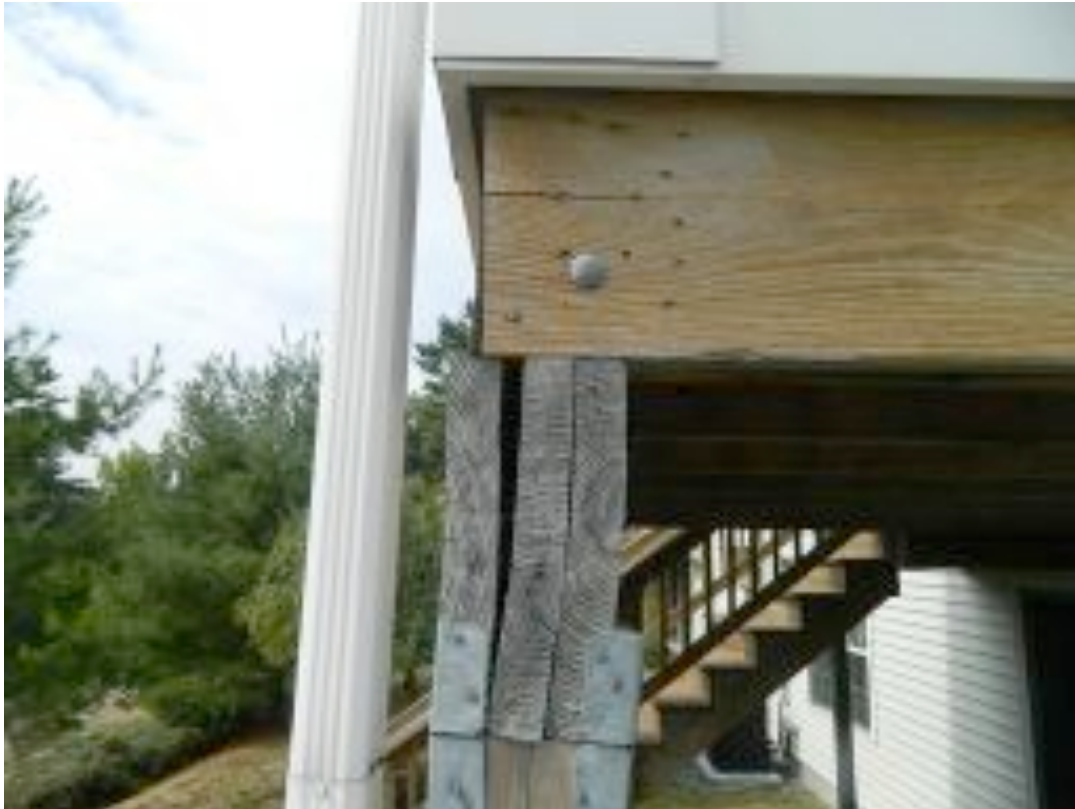
POOR ATTACHMENT AND FASTENER CHOICES HAS COMPROMISED SOME DECK FRAMING

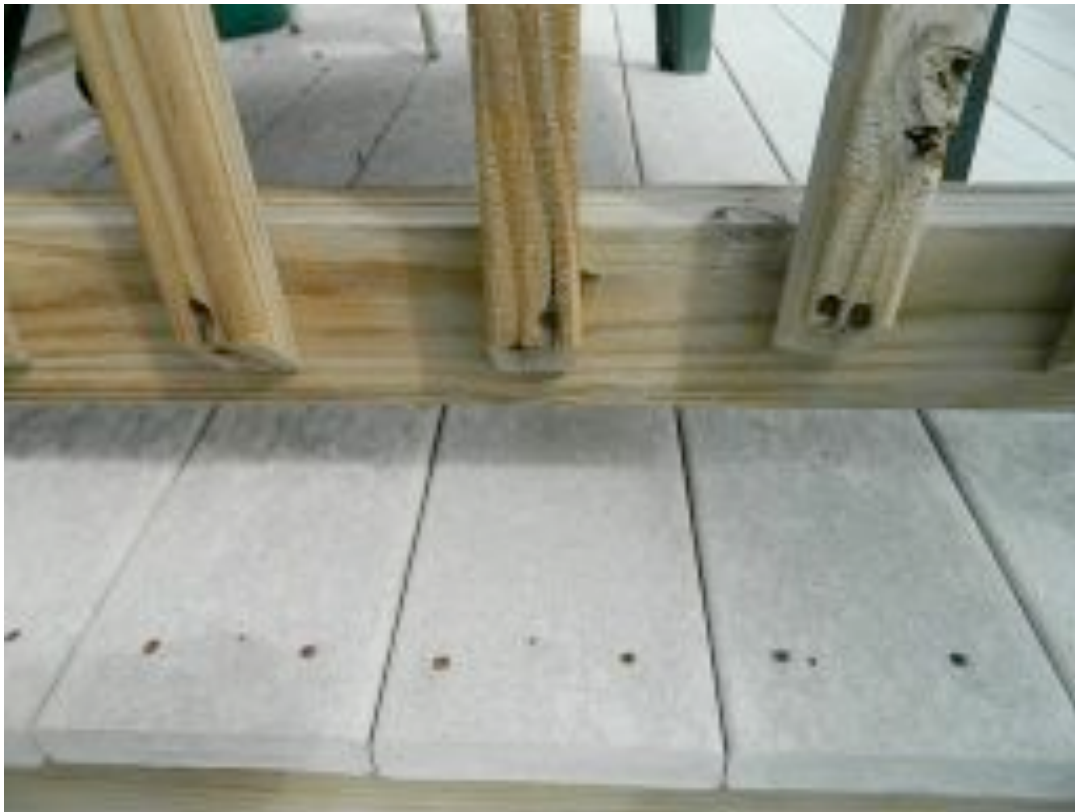
THE SYNTHETIC DECKING IS ATTACHED WITH SCREWS THAT HAVE RUSTED

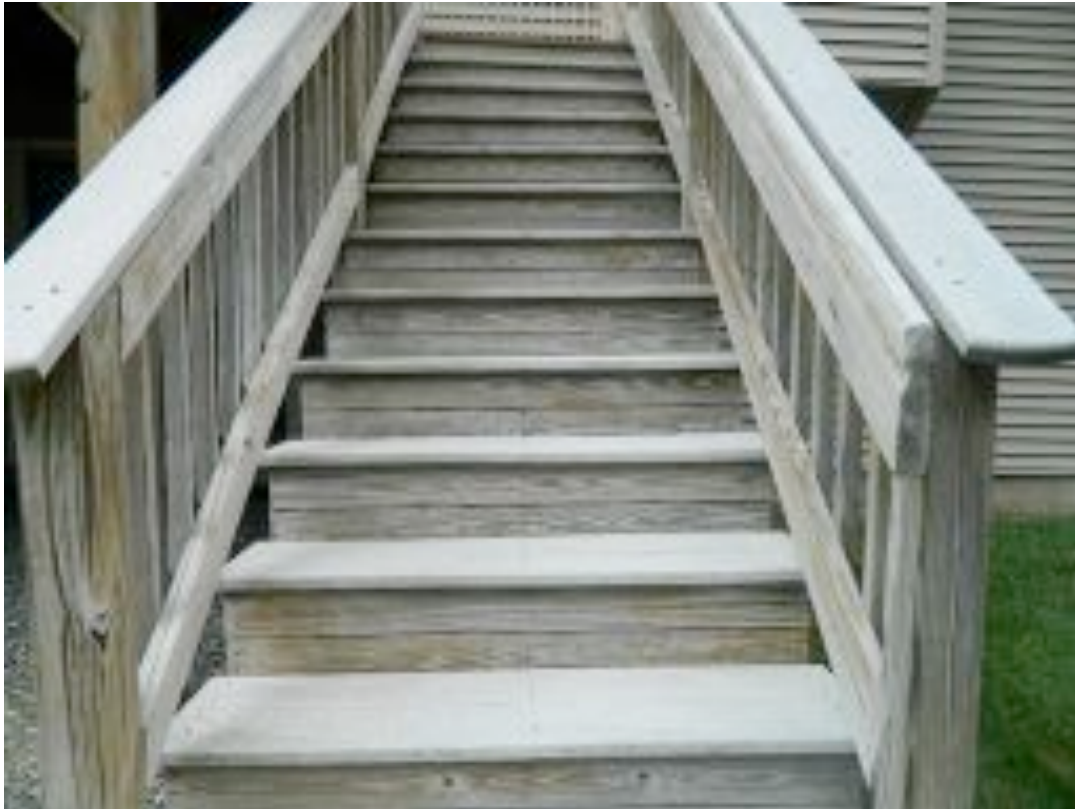
We also noted a few stair stringers that appear to have settled. The most severe such location was found at the rear deck of 22 Schooner, where the steps appear to have settled over 1" (see photos). This appears to be the result of inadequate (or omitted) stringer footings. It seems that many of the steps rest only on the concrete pads at the bottom of the steps.

SETTLING DECK STEPS AT THE REAR DECK OF 22 SCHOONER

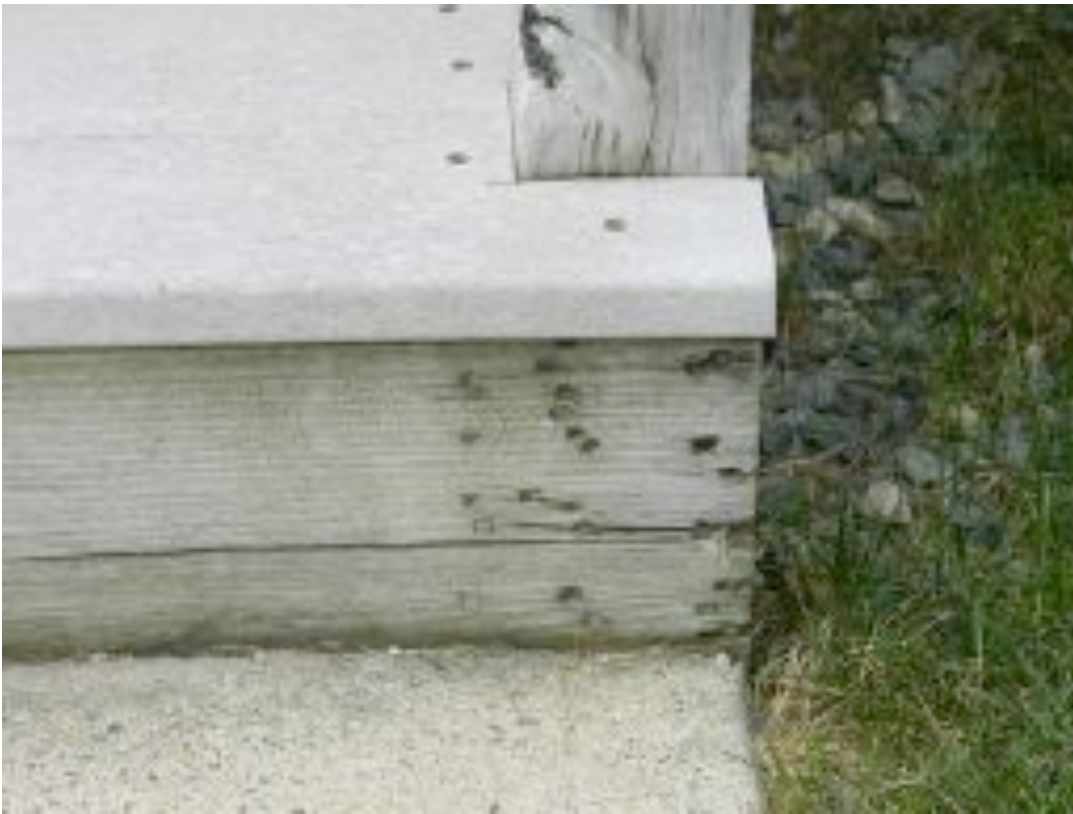
The decks utilize synthetic decking and top railing caps. The railings themselves are also of preservative-treated lumber, with 2 x 4 top and bottom rails, and 2 x 2 balusters installed with nails. Many of the nailed components were found to be suffering from cracking, splitting or other damage (see photos). It appears that some of the nailed connections have been augmented with lag or carriage bolts. It's unclear if the bolts were a part of original construction, or if they were added after the fact. We suspect that many of the decks will require

MANY OF THE DECKS ARE “OVERNAILED” WITH INAPPROPRIATE FASTENERS

remedial repairs, in the form of augmenting nailed connections that are failing, in order to achieve the anticipated remaining life of 14 years.

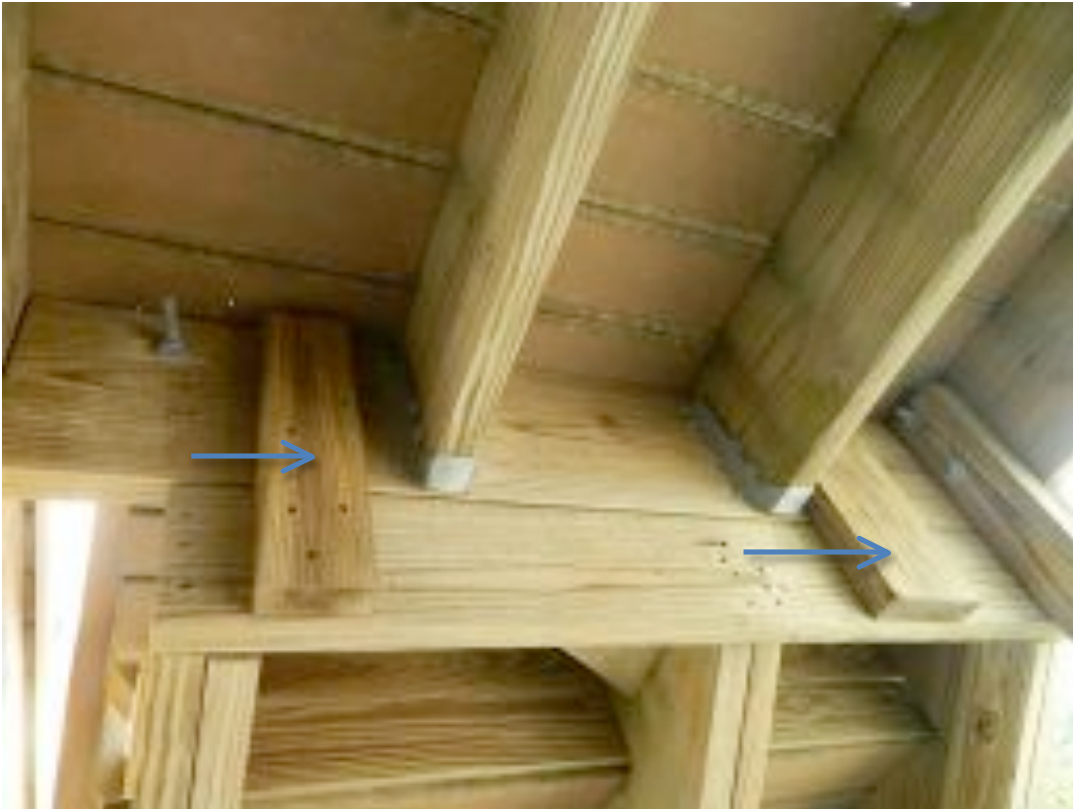
This office has some concern with the way the stair stringers are attached to the main decks. In some of the locations that were directly examined, they are fastened with 2 x 4's nailed to both the deck frame and stringer ledger (see photo). A much better attachment detail would utilize either lag or carriage bolts, or as a minimum, rated screws. We noted some locations where the stringers appear to be pulling away as a result of poor attachment (see photo). This issue is not widespread, but monitoring of the deck stringers should be a regular part of site maintenance/inspection.

OPTIMALLY THE STRINGER BRACKETS SHOULD BE BOLTED (FASTENED WITH NAILS ONLY)

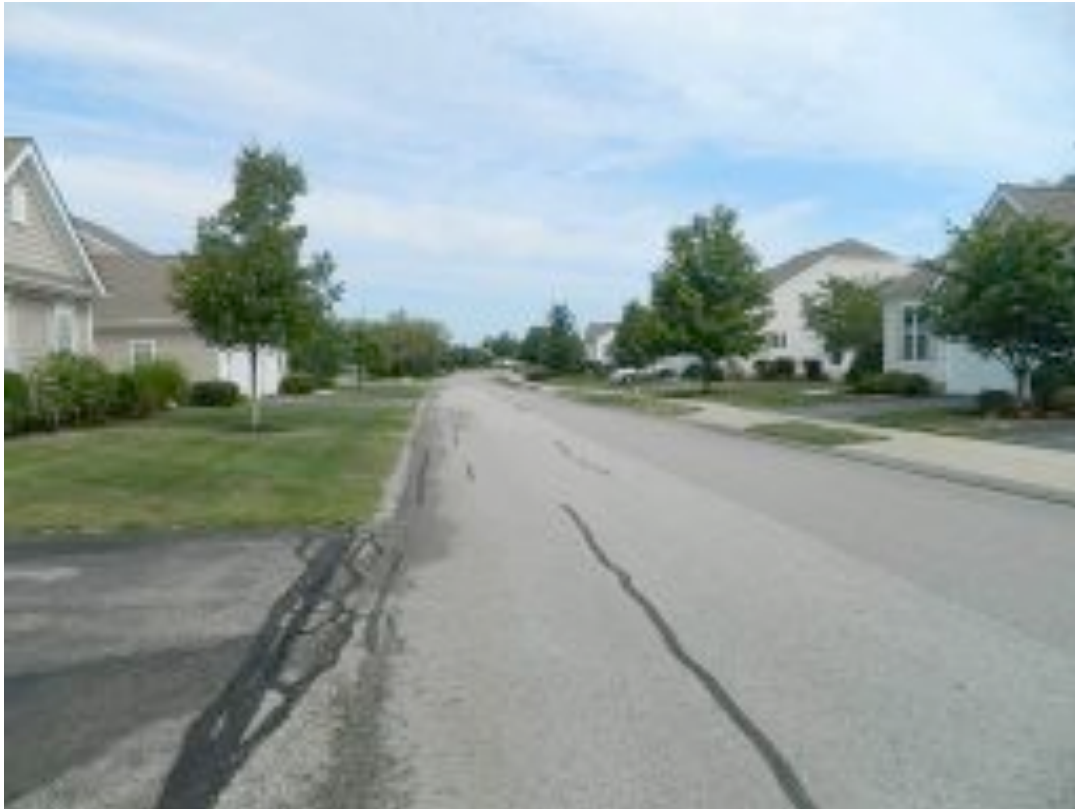
The pavement is in what this office would consider “age appropriate” condition. We did note cracking throughout the property, but the vast majority of the cracks have been sealed (see photos). We also noted some apparent

THE ASPHALT PAVEMENT IS IN “AGE APPROPRIATE” CONDITION

Crack sealing must be a regular part of pavement maintenance, and should be an ongoing process. It is critically important to seal pavement cracks on an annual basis, preferably before every Winter. The cracks most commonly occur at course lines, driveway transitions in the pavement, or at penetrations. When water gets below the pavement, it can cause frost heaves or wash-out of the substrate, which will lead to settlement.

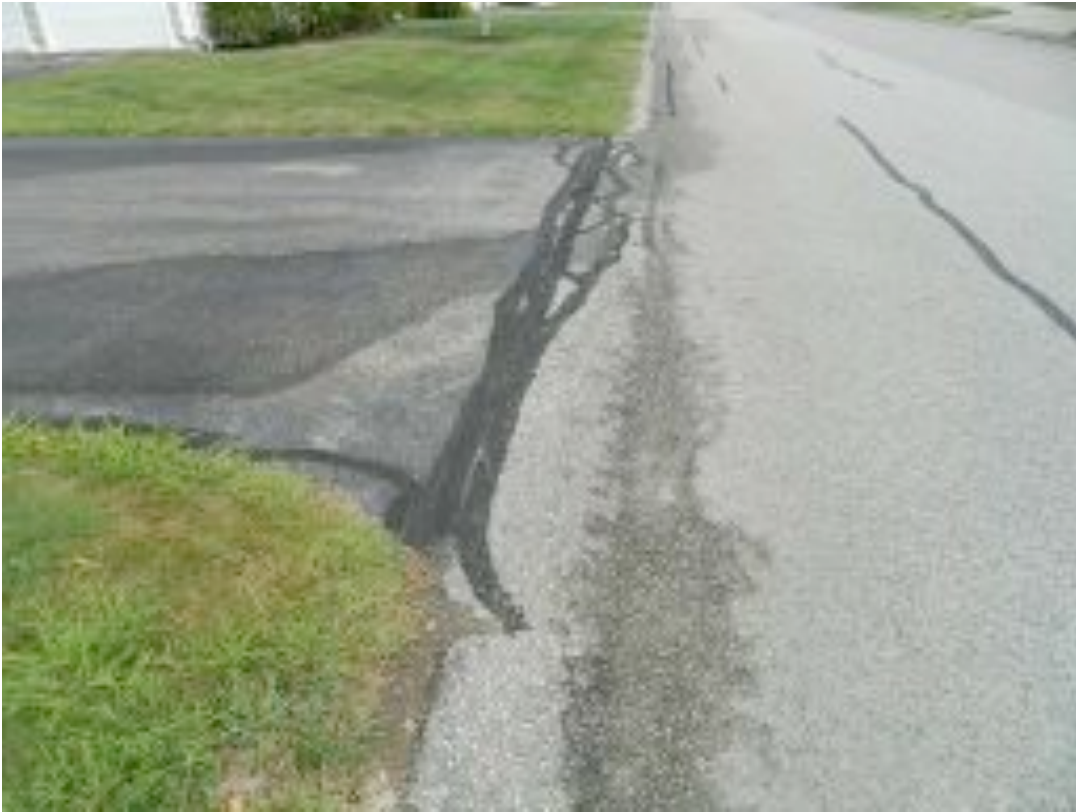
SEALED CRACKS WERE FOUND AT THE END OF MOST DRIVEWAYS

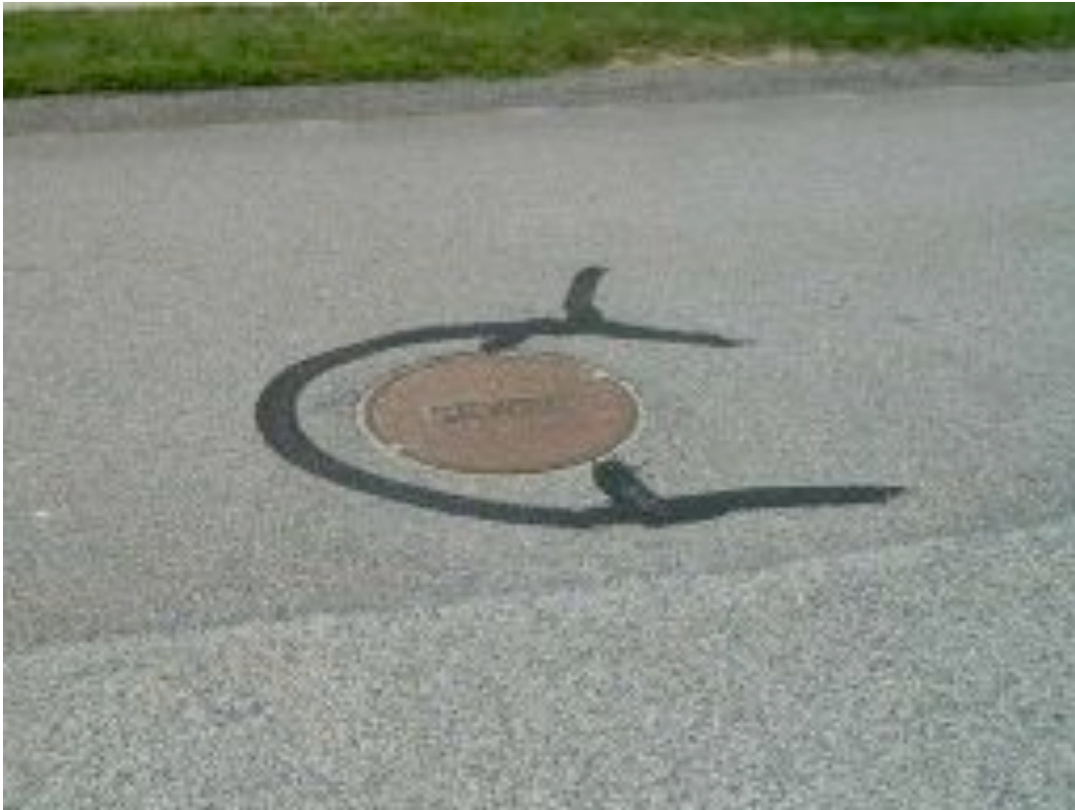
“settlement cracks” around catch basin grates and man holes, but not anything excessive.

SOME SEALED CRACKING WAS NOTED AROUND ROADWAYS STRUCTURES

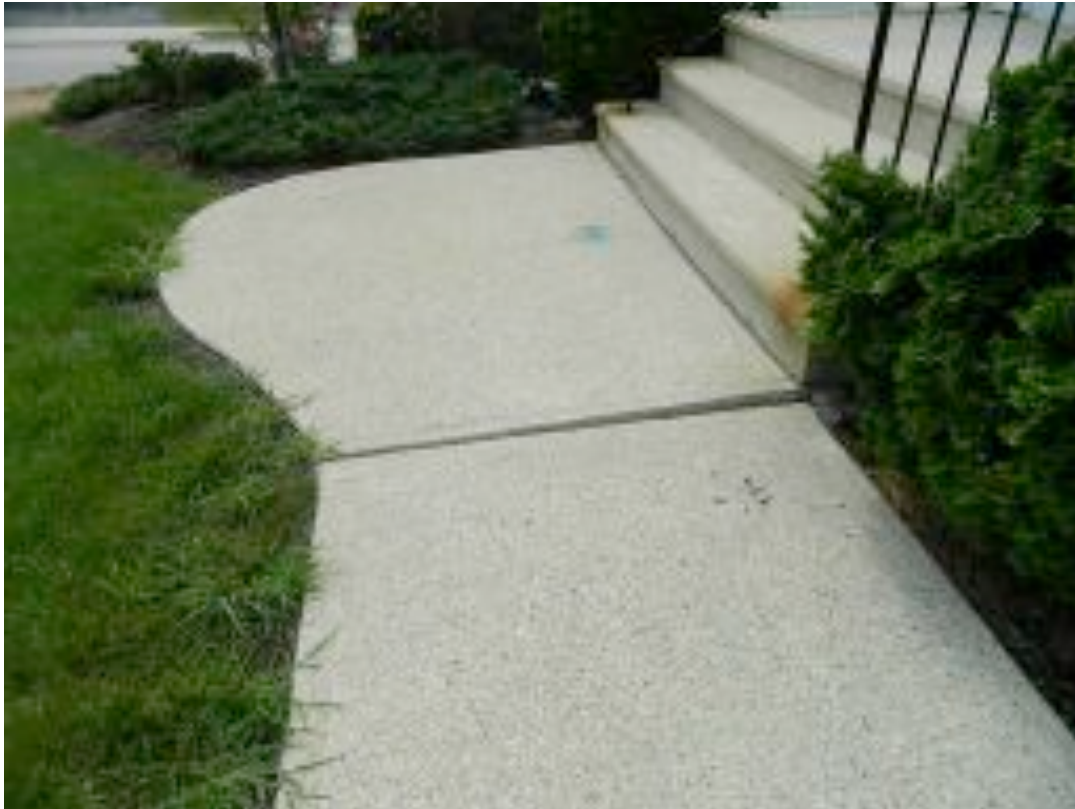
We noticed differential settlement in several areas that have created tripping hazards (see photos). When tripping hazards arise, if the concrete itself remains in good condition, grinding the lifted portion down flat is an option. From a planning standpoint, we feel that with aggressive maintenance, and replacement/grinding as the need arises, the walks in general can likely remain in safe condition for another 19 years, at which point they will be 30 years old.

A FEW TRIPPING HAZARDS WERE NOTED (NOT WIDESPREAD)

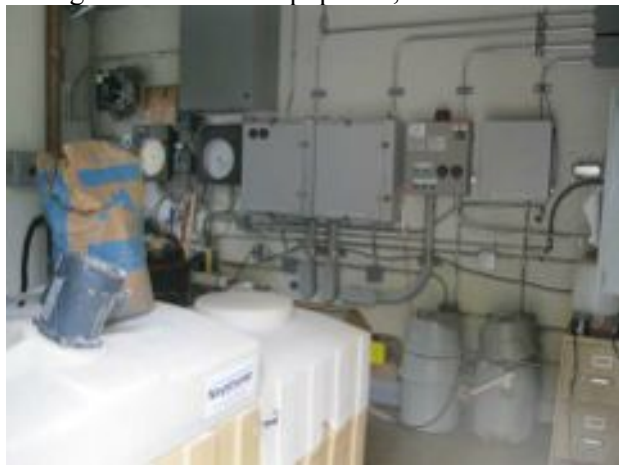
The treatment process is underground, outside the control building. It only houses the electric controls and stores some chemicals. Due to its exposure to sun, an exhaust fan should be on a timer, to prevent heat damage to the control equipment, in the summer months.
