SAGUACHE CREEK DIVERSION INFRASTRUCTURE INVENTORY

Structure Name: JACQUES D

JACQUES DITCH

Saguache Creek Stream
Management Plan

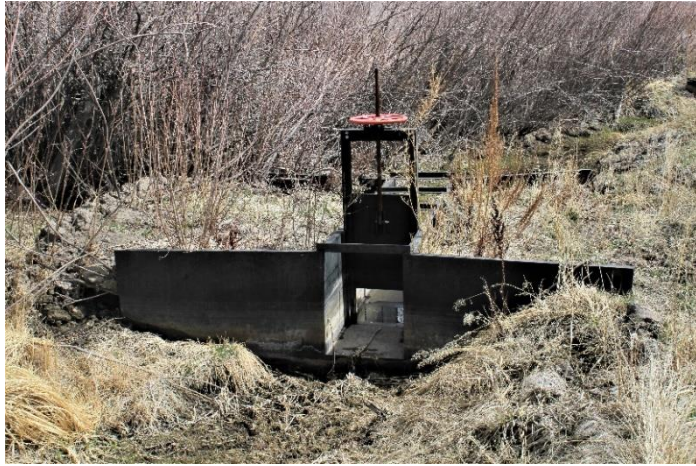
Headgate looking downstream

Repair(s) or Improvement(s) Currently Needed: Calibrate the staff gauge on the headgate. Fish passage and riparian restoration should be considered as part of any future repairs or improvements.

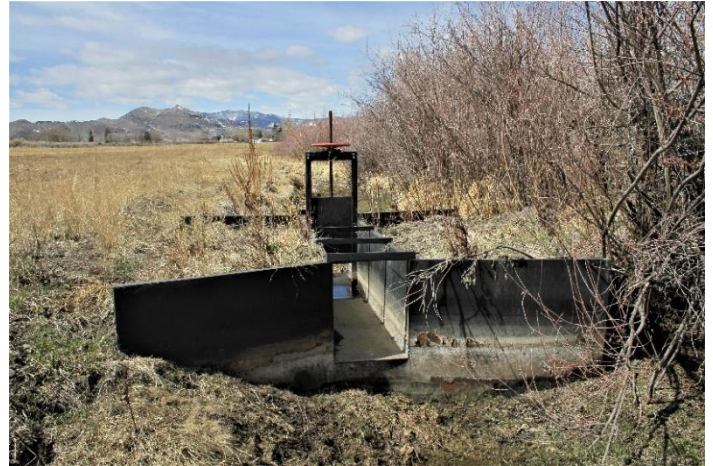
Headgate outlet

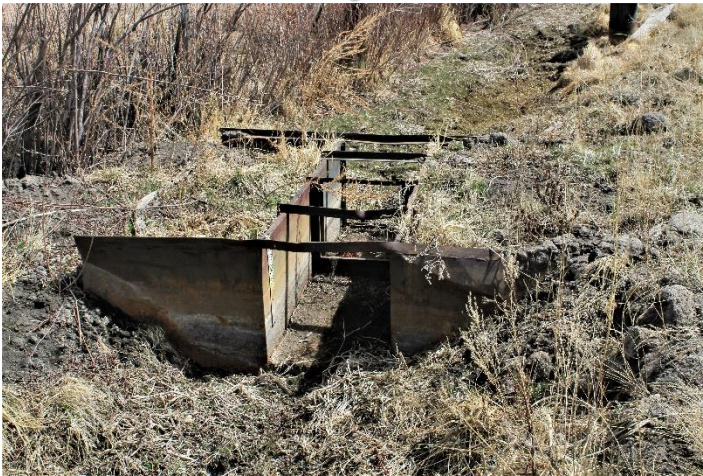
Flume looking downstream

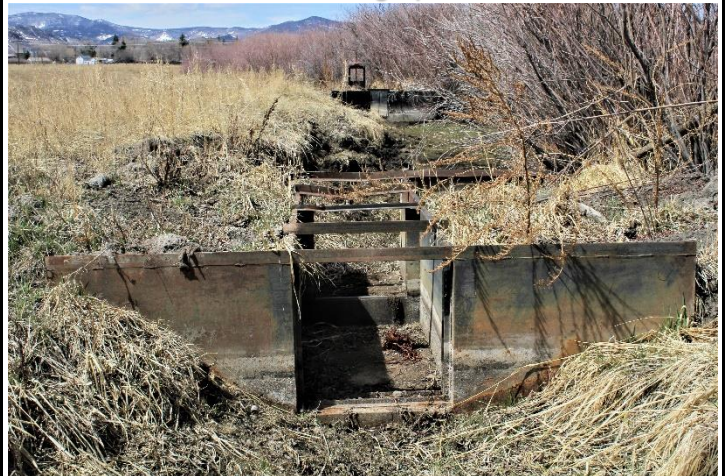
Flume looking upstream
