RIO GRANDE DIVERSION INFRASTRUCTURE INVENTORY

Structure Name: SAN JUAN D

Date: May 7, 2019

PHOTO LOG

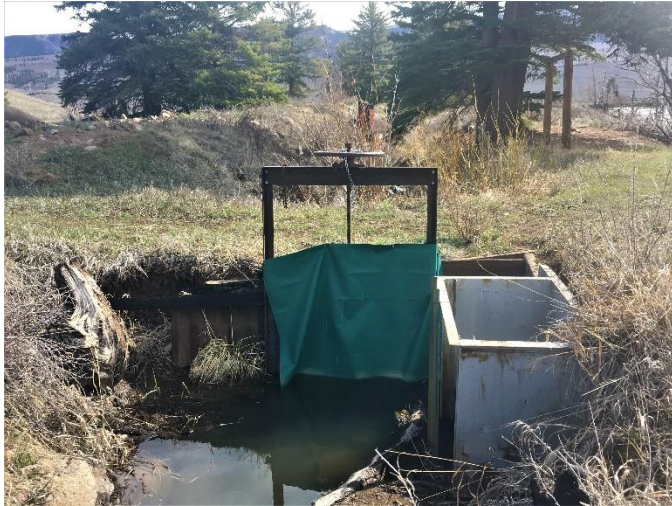
Headgate looking downstream

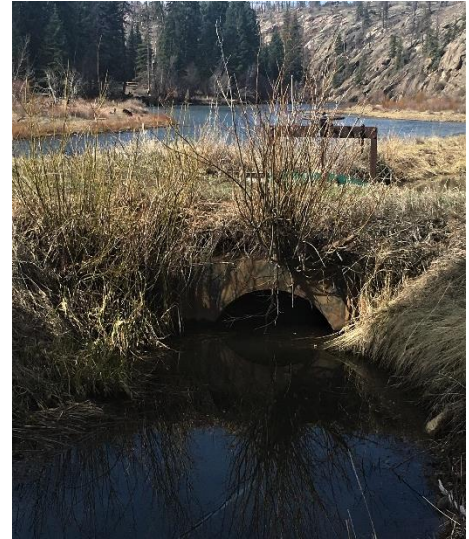
Headgate outlet

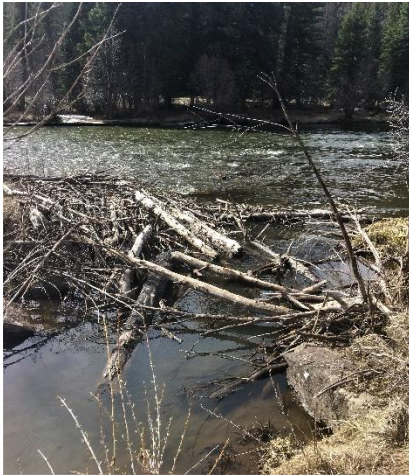
Structure Description: This structure is located at the Mouth of the Rio Grande Box Canyon. There is no formal diversion dam, but the entrance to the ~750 ft long feeder ditch is located on a riffle on an outside bend of the river and receives its full decree when the ditch is in priority.

Diversion dam and feeder ditch

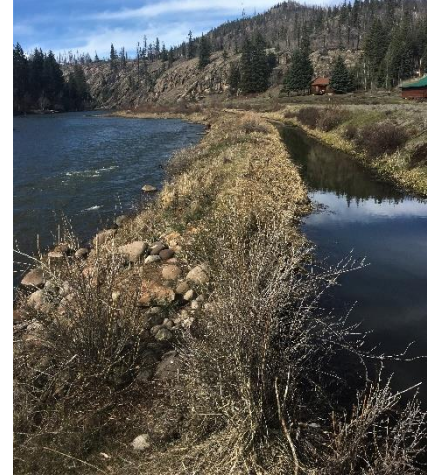
Feeder ditch looking upstream

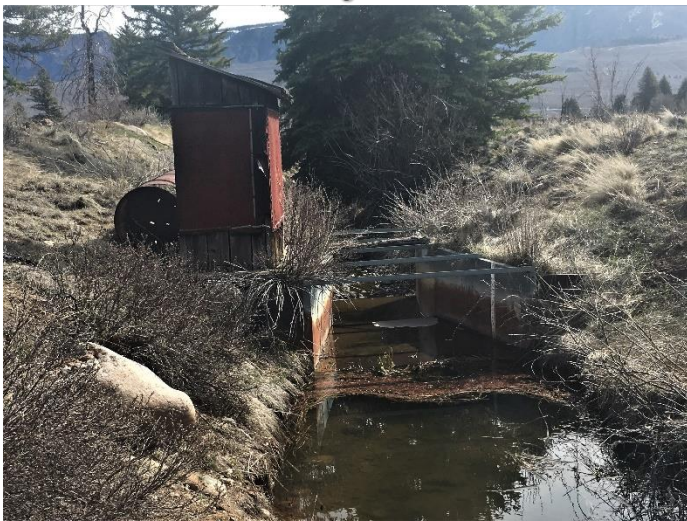
Flume looking downstream

Repair(s) or Improvement(s) Currently Needed: The flume needs to be reset to measure more accurately. Existing fish and boat passage should be maintained and riparian restoration should be considered as part of any repairs or improvements.

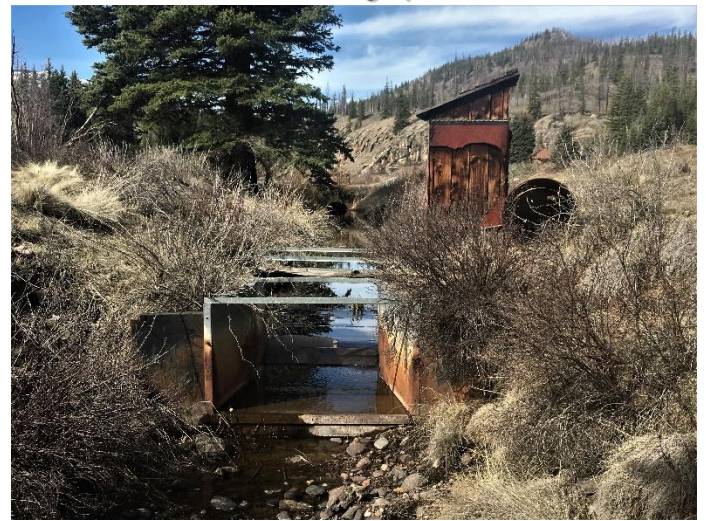
Flume looking upstream
