TALCO
Home Inspection

Inspection Report

202 Scarborough Beach Road
Richmond KY 40475

Date: 3/14/2018	Time: 10:00 AM till 02:00 PM	Report ID: 180314KNUE
Property: 202 Scarborough Beach Road Richmond KY 40475	Customer: Ms. Sharon Anthony	Real Estate Professional:

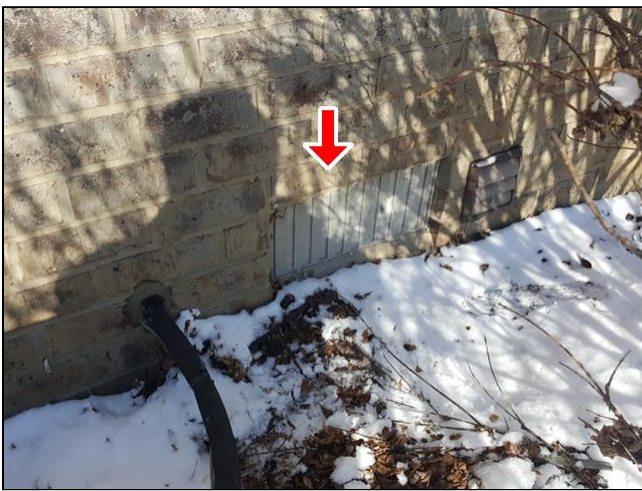
1.8 Item 1(Picture) left side of home

1.8 The vents have been sealed up in the crawl space. However the crawlspace has not been prepared encapsulation. Though there was no condensation noted at the time of the inspection, it is possible to have a dry crawlspace that is prepared for no ventilation however certain steps are required for this to be achieved. High humidity within the crawl could be experienced during certain times of the year which can cause condensation to form or cause joists to sag over time. Recommend this area be monitored during the seasons to see if condensation is occurring in the crawlspace and if so a qualified contractor should be consulted to eliminate cause. The vents may need to be opened. I would still recommend a qualified crawlspace contractor further evaluate the crawl to determine if other measures are required due to no ventilation. Opinions vary on whether or not your crawlspace should be ventilated.

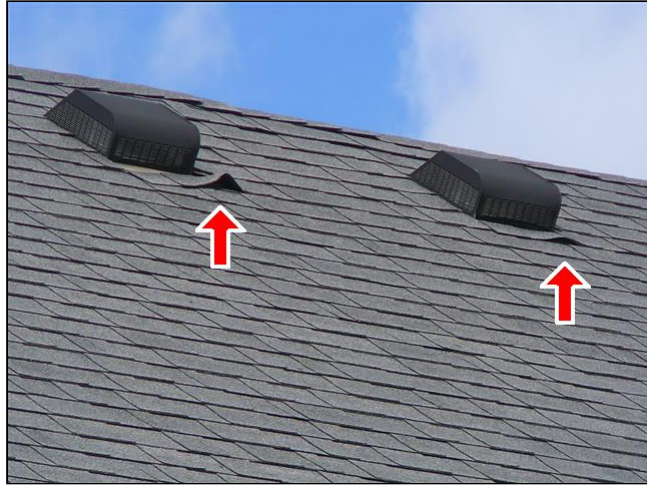
2.0 Item 1(Picture)

2.0 (1) The shingles on the roof at the rear of the home where indicated by the photo(s) are starting to lift and may not be secured correctly. The sealant of the shingle tab maybe failing. Shingle damage or roof leakage can occur at these areas. They are also at risk to be blown off by high winds. If the shingle is raised by more than 1/2" the nails should be reseted to prevent water entry under the shingles. Recommend a qualified roofing contractor repair as needed.

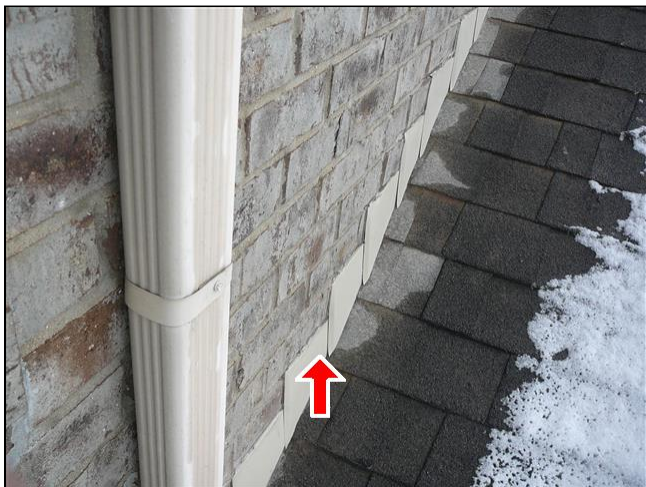
2.1 Item 1(Picture)

2.1 (2) There are some gaps in the step flashings around the home, and they should be sealed to prevent water entering behind the flashing which can lead to water leaks in the attic and wall cavity which can cause deterioration of the roof and wall structure. Recommend sealing gaps with caulk as needed.

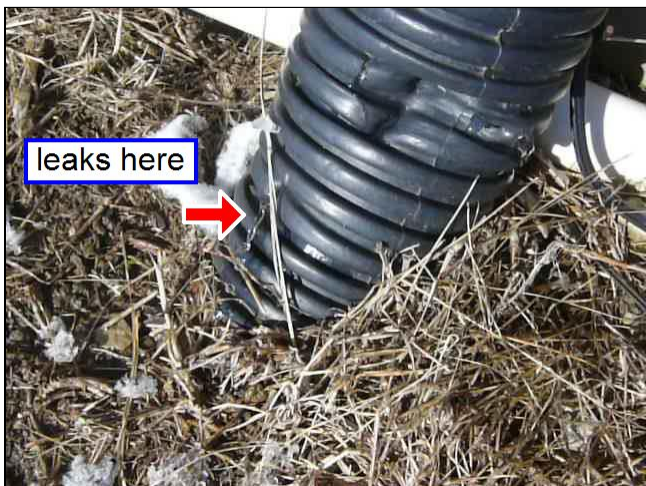
2.3 Item 1(Picture)

2.3 (1) The downspout extension is cracked and leaks at the rear right corner of the home. This can cause crawlspace leakage, settlement of the foundation wall and possible soil erosion near the foundation perimeter. Recommend repair or replacement as needed by a general contractor.

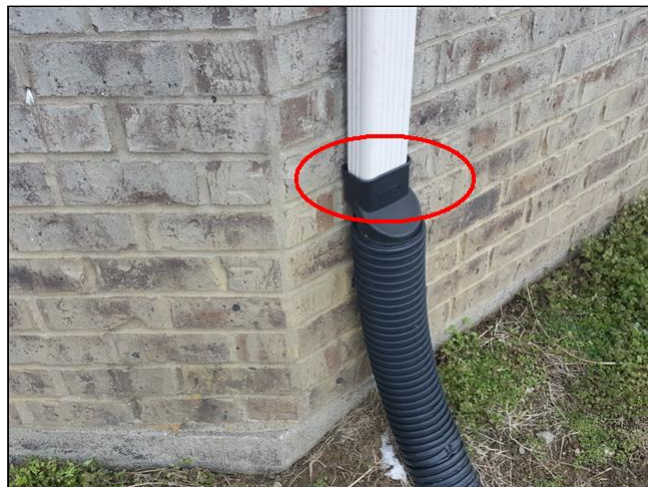
2.3 Item 12(Picture) rear right side of home

2.3 (3) Recommend the downspout extension(s) be attached to the downspout at the where indicated in the photos by placing a screw at the top and bottom where it connects to the downspout to ensure the extension(s) does not pull away from the downspout(s). Failing to do this may create future problems to the foundation around the home due to soil erosion and water entering the crawlspace which may result in the foundation settlement if the extension detaches from the downspout.

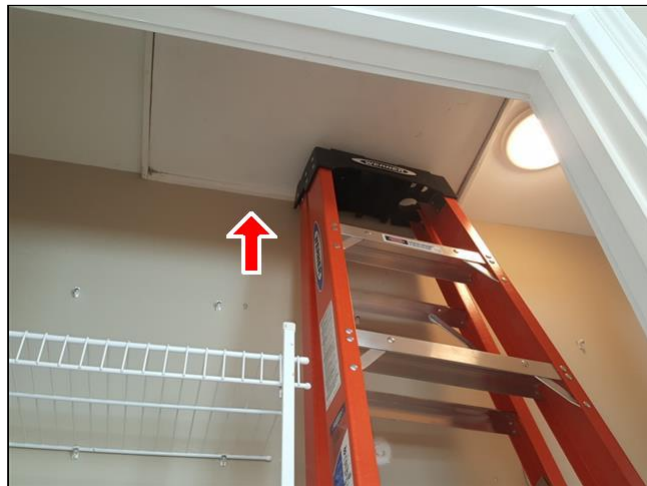
2.4 Item 2(Picture) 2nd bedroom closet

2.4 (2) Recommend the attic access hatch be insulated to prevent air and heat loss for energy conservation.

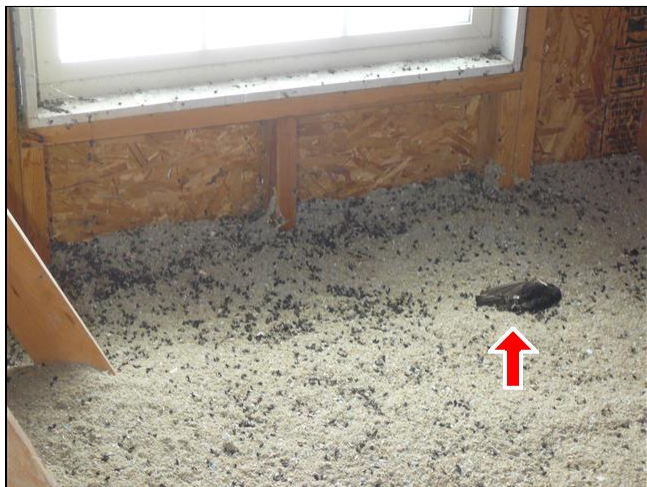
2.5 Item 9(Picture)

2.5 (4) There was a dead bird found in the main attic at the front of the home. It may have entered from the gable vent. Recommend the dead bird be removed and screens be placed inside the attic behind the gable vents to prevent further intrusion of birds and/or rodents. A qualified person or pest control contractor should remove the dead bird for health and safety.

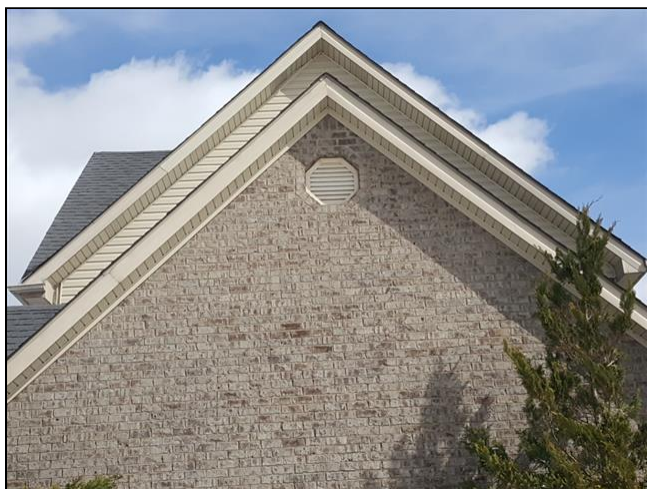
2.6 Item 1(Picture)

2.6 Recommend the gap between the gable vent and the brick siding at the right side of the home be sealed with caulk to prevent insects and water intrusion into the attic. Water intrusion could lead to deterioration of the wall framing. [Choosing the right caulk](#)

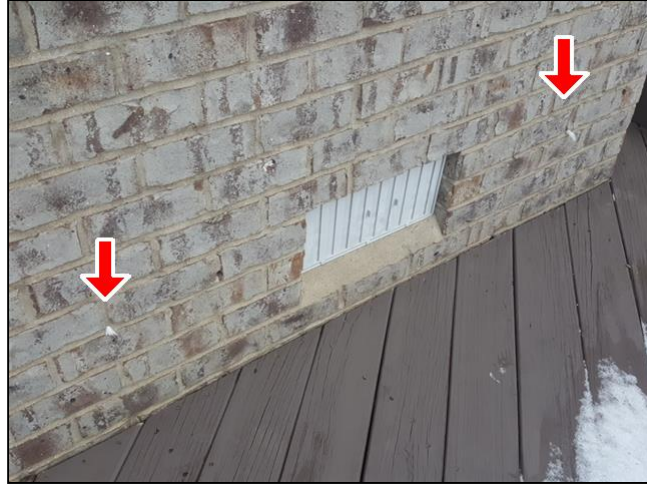
3.0 Item 1(Picture) above garage

3.0 Rope protruding out of the brick siding are known as weep holes. These pieces of rope should not be pulled out. They will deteriorate over time, however they should have been trimmed after house was built. Weep holes are openings close to the bottom of brick mortar joints that allow drainage. They are also recommended over door and window openings. This is for your information.

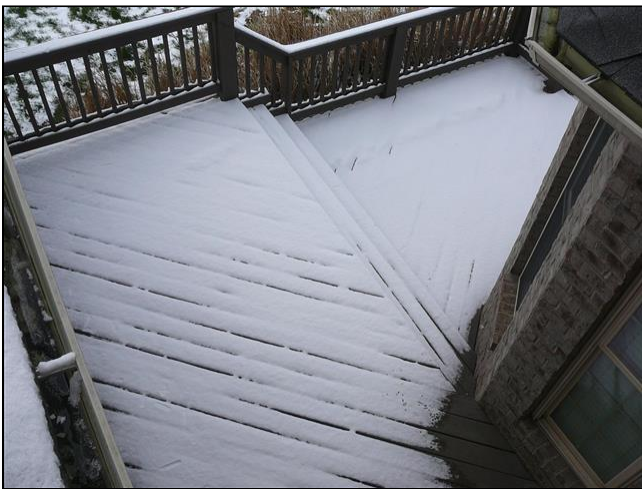
3.6 Item 1(Picture)

3.6 Due to the deck is partially covered with snow we were unable to properly examine and inspect some of and/or all the components related to this item. There were no obvious problems found.

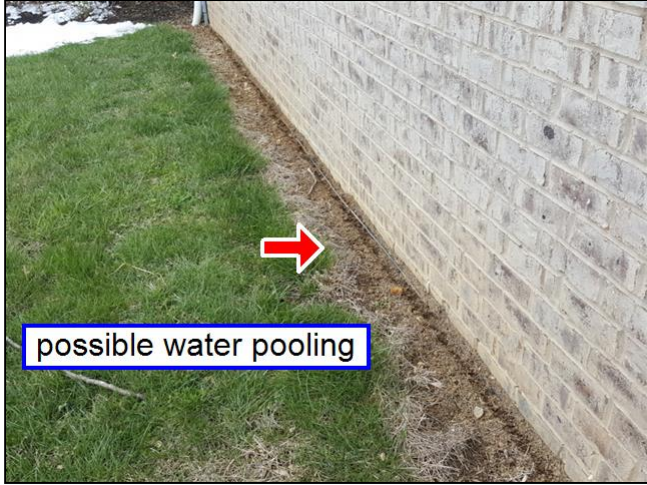
3.10 Item 2(Picture)

3.10 There are depressions in the soil around the foundation perimeter at the left side of the home. Recommend filling all depressions and re-grading the soil so the soil slopes away from the home around the foundation to ensure water pooling does not occur in these areas. Water pooling could lead to to crawlspace leakage.

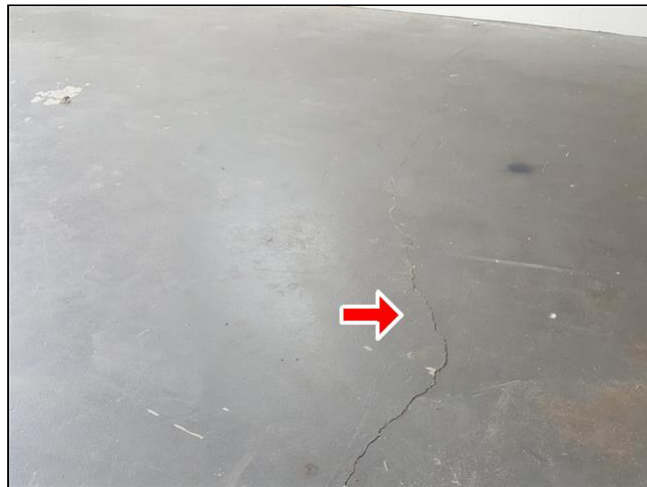
4.2 Item 1(Picture)

4.2 (1) The garage flooring has typical cracks in areas highlighted in photos. These cracks do not appear significant and seem typical. Cracks that are usually 1/8 inch or wider are need for concern. The cracks are usually the result of shrinkage and/or settling of the slab. Also this crack maybe due to freezing soil underneath placing upward pressure on the slab. Recommend these cracks be sealed then apply an epoxy coating on the floor to ensure water intrusion does not occur. It is recommended that you monitor annually after repairs. If these cracks should reoccur a masonry contractor who is familiar with foundation repair should be consulted. [Caulk for Concrete Cracks](#) This is for your information.

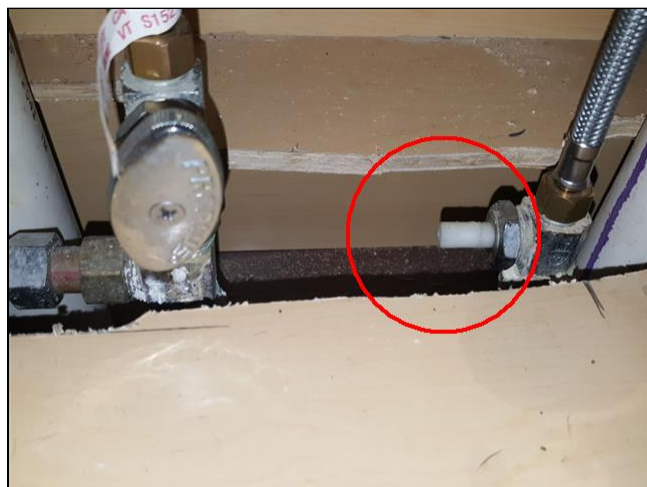
5.0 Item 1(Picture)

5.0 The stop-valve(s) is missing at the cold water line under the sink in the kitchen. The valve is required to be able to turn the water supply off if a leak occurs or when work is performed to the plumbing in this area. Recommend a qualified plumber replace as needed.

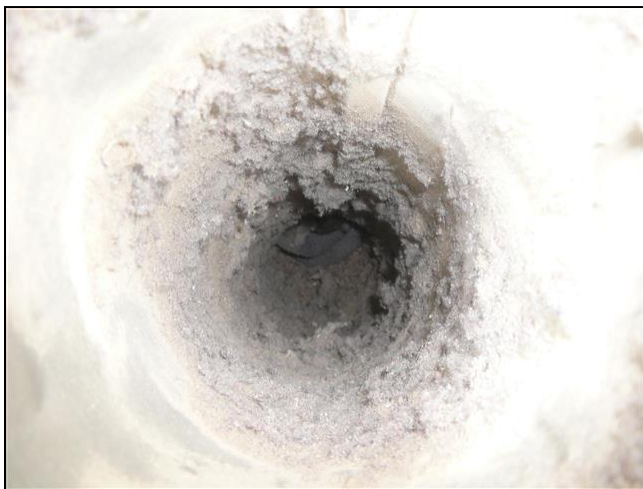
5.10 Item 6(Picture)

5.10 (3) The dryer vent pipe has a large build up of lint inside. This is restricting the flow and may cause a back-draft. This can cause a fire to occur due to excessive heat build up in the vent pipe. Also your dryer runs longer, putting more wear and tear on it and therefore cutting the machines life in half. Strongly recommend cleaning the dryer vent for safety before moving in and operating dryer.

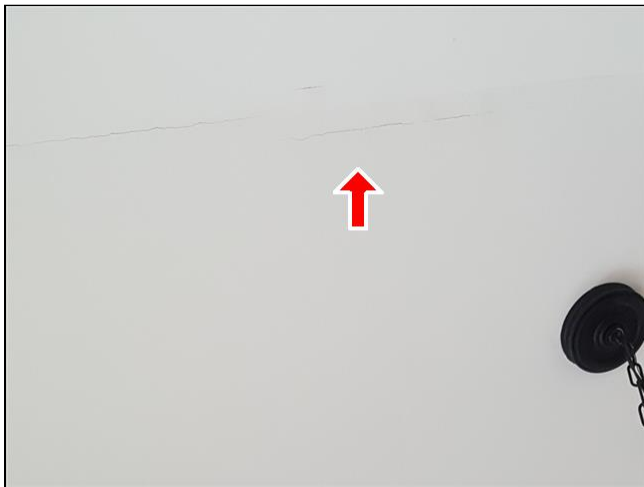
6.0 Item 1(Picture) dining room

6.0 (1) There are seams in the drywall ceiling in the dining room which are loose. This is a cosmetic issue. This is common and often caused by moisture, changing temperature, or framing shrinkage due to lack of ventilation of vaulted ceilings. Repairs are recommended to improve the ceilings appearance. This is for your information.

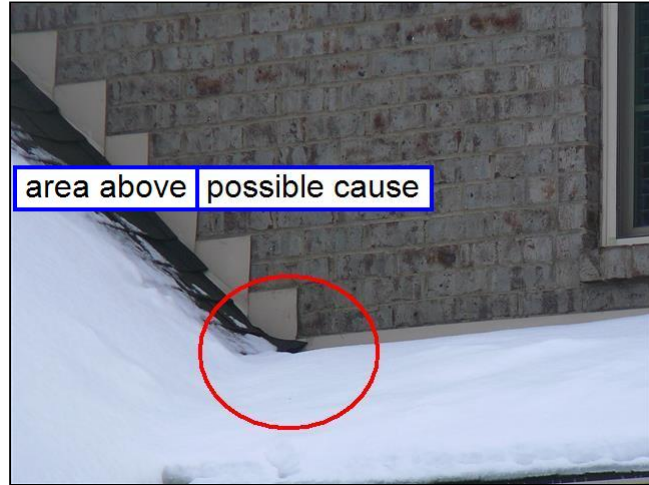
6.0 Item 2(Picture)

6.0 (3) The drywall at the ceiling in the hallway closet above the roof intersection reveals an old water stain indicating a leak did or still exists where indicated by the photo(s). Although there was no leaking or elevated moisture content found at this time, I could not determine how the stain existed. Perhaps ask the owner of the home to explain cause of the stain. Inspections are limited and destructive inspections are excluded. Recommend cleaning the drywall then monitor this area to see if a leak is active and if a leak does exist, recommend further investigation and repair as needed. The repair work will likely involve the removal of the covering in order to determine where the leak is coming from and if it still exists. The extent of the damage cannot be realized until the covering is removed.

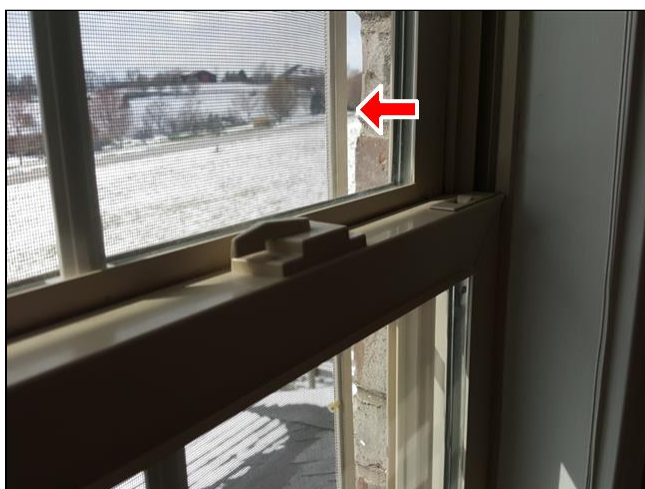
6.5 Item 2(Picture)

6.5 (2) The screen is loose on the right side window in the 2nd bedroom. Recommend correcting as needed.

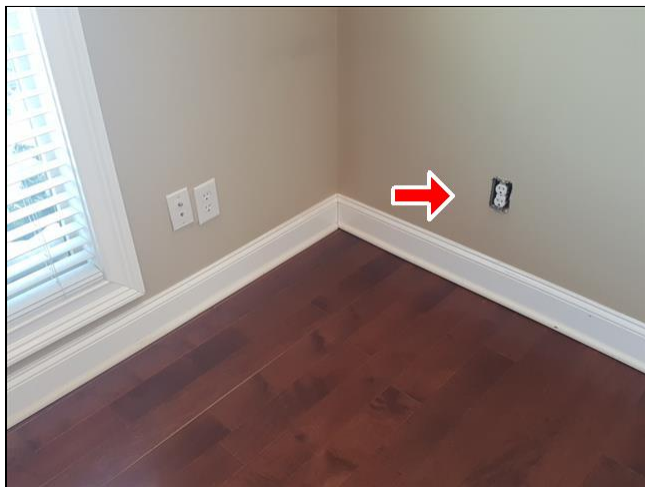
6.7 Item 5(Picture) sitting room

6.7 (2) The outlet(s) in the sitting room where indicated in the photo(s) is missing a cover-plate. All missing covers should be installed to prevent touching the sides of the devices to prevent an electric shock which can cause an injury or death. Electrical issues are considered a hazard until repaired, and this is considered to be unsafe. A qualified licensed electrical contractor should correct as needed prior to moving in.

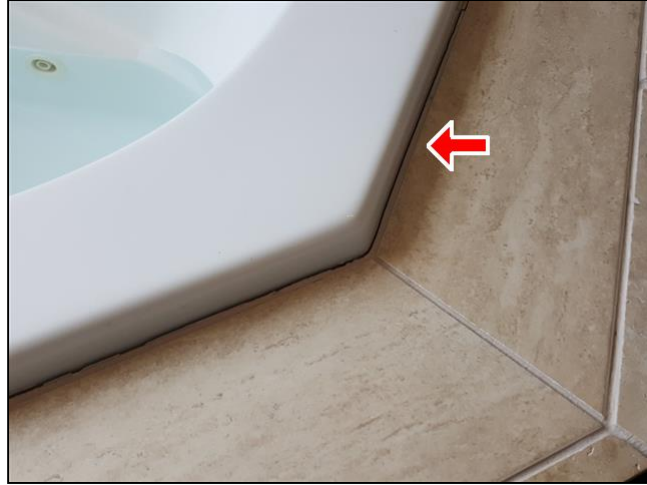
7.8 Item 3(Picture)

7.8 (2) Cracked grout around the jacuzzi enclosure should be sealed and replaced with new grout to prevent water entry behind the finished materials. If the grout is damaged and not properly repaired it could allow water entry. Water entry can damage the walls, framing or loosen the tiles and cause mold growth. A qualified contractor should be able to make any repairs that are needed.

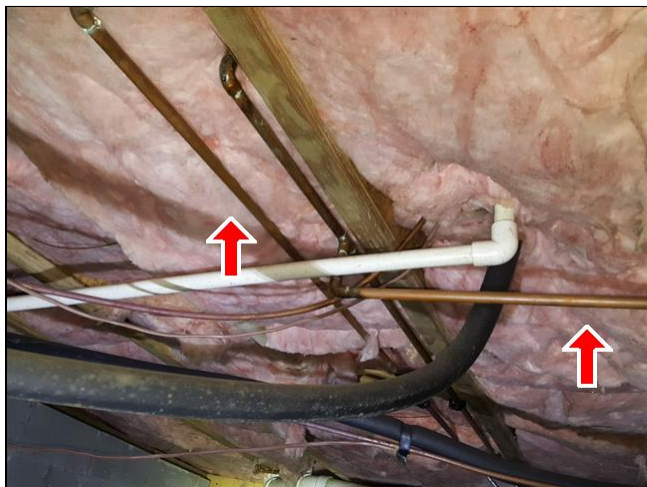
8.1 Item 1(Picture)

8.1 (2) Recommend insulating the water supply pipes underneath in the crawlspace (hot and cold) to ensure pipes do not freeze in winter which may cause a serious plumbing leak in the crawlspace, and to prevent heat loss of water when hot water is flowing into home. This will improve efficiency. This is for your information.

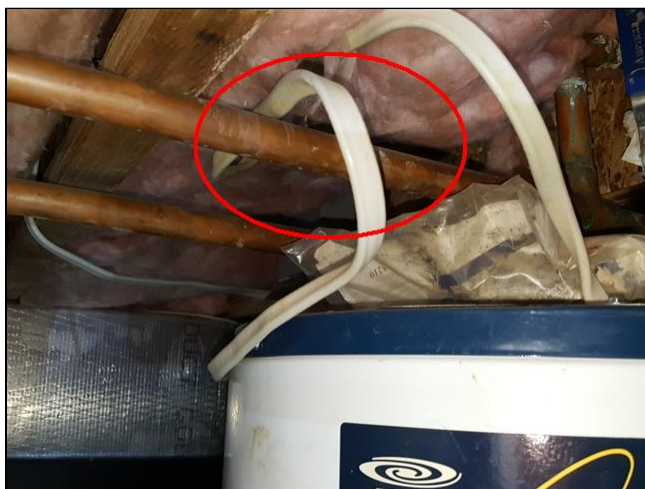
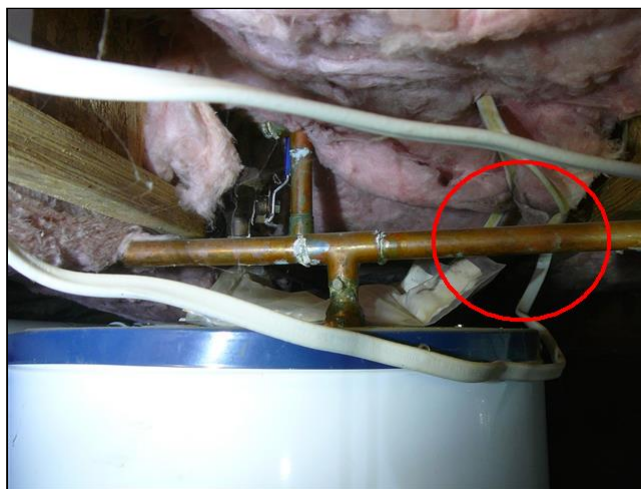
8.2 Item 2(Picture)

8.2 (5) Electric lines running across the top of the water heater should be protected in a conduit and/or secured to joists to protect the wire jacket from damage. The electrical wire may contact the hot water line which can melt the insulation which can lead to an energized wire. The wiring for the water heater should be in a conduit and have a romex connector connecting it to the water heater. This is a safety issue as an injury or death could occur from an electrical shock. Recommend a licensed electrical contractor correct, repair or replace as necessary.

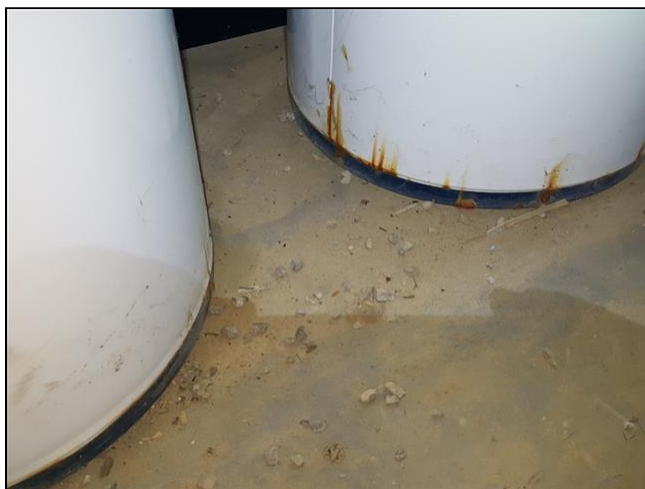
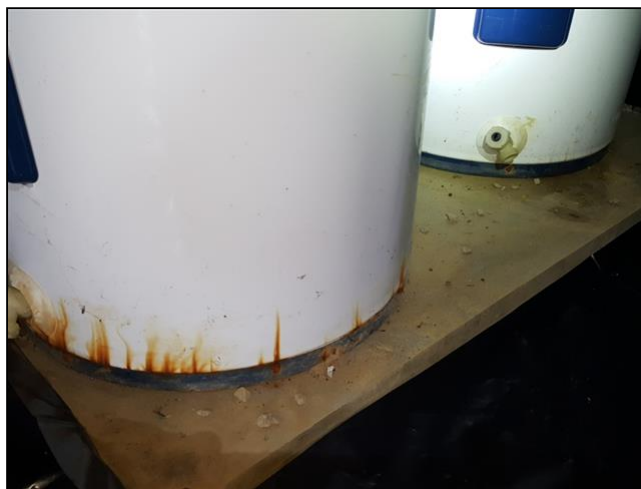
8.2 Item 4(Picture)

8.2 (6) The base of the water heater has surface rust. This may be caused from moisture and/or condensation forming due to the water heaters being located in an unconditioned area and in the crawlspace. There was no evidence of leaking water from the base of water heater at time of inspection. Over time the rust could develop further causing a leak. Recommend the water heaters be relocated in the garage when replacement is needed. You should monitor this area quarterly to determine if further rusting is occurring before a major water leak develops.

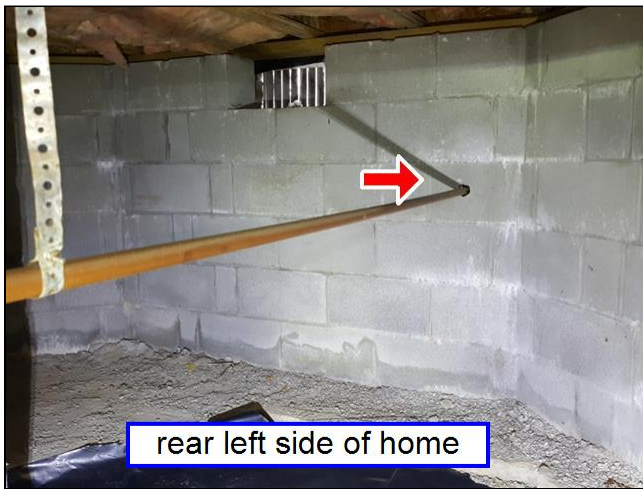
8.3 Item 1(Picture)

The exit port was obstructed with snow and vegetation.

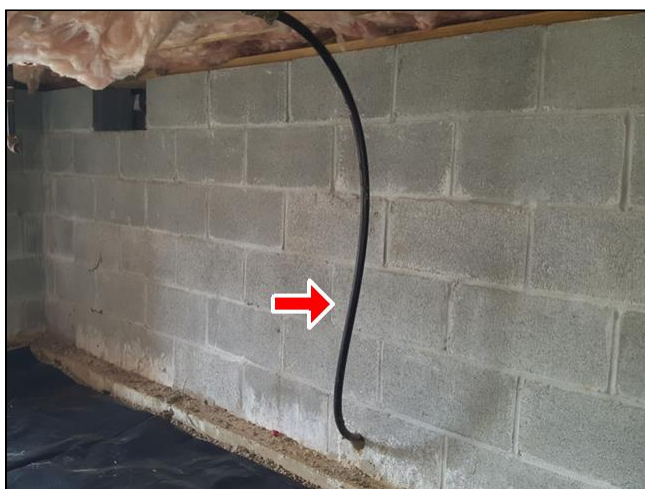
8.4 Item 2(Picture)

8.4 (2) Recommend insulating the main water supply line pipe in the crawlspace due to the pipe is located in an unconditioned area. This will ensure that the pipe does not freeze in winter which may cause a serious plumbing leak and prevent costly damage to the home. This is for your information.

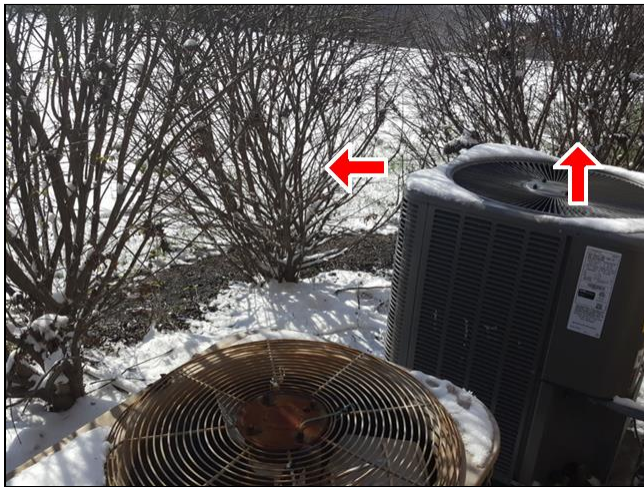
10.0.A Item 1(Picture)

10.0.A (2) Vegetation in the vicinity of the outdoor unit of the Heat Pump should be cut back to prevent obstruction of the airflow. This can damage to the unit via running hot ,shorten it's life expectancy, and cause it to run inefficient. Recommend removing all the vegetation surrounding the unit so that the fins are not obstructed.

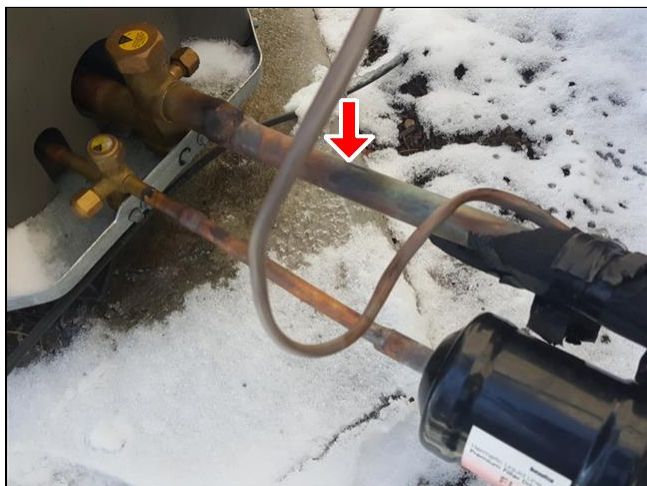
10.3.A Item 2(Picture)

10.3.A (2) Missing/Damaged foam insulation was found on the exterior large suction line for the Heat Pump compressor. This insulation is to maintain or stabilize the temperature of the cooling system. The outside temperature can influence this gas and cause efficiency fluctuations of the unit. Replacement of the insulation where needed will help maintain efficiency of the compressor and/or can cause energy loss and condensation. Recommend installing a new sleeve, this will help maintain efficiency of the compressor.

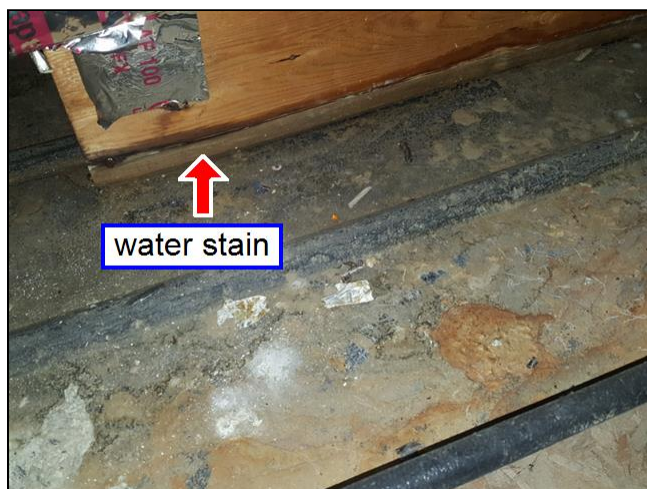
10.0.B Item 5(Picture)

10.0.B (6) Water stains noted in the drain pan under the air handler in the attic. This may have occurred due to leakage or age of the unit. Recommend this be monitored to ensure there is no leakage occurring at the air handler when in the cooling mode. If leakage is experienced a qualified licensed HVAC contractor should be consulted for repairs as needed. No leakage was experienced during the inspection when the unit was in heating mode.

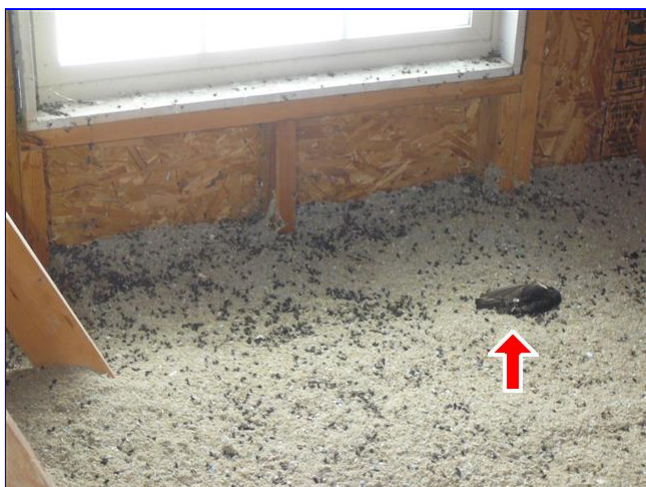
2.5 Item 9(Picture)

(4) There was a dead bird found in the main attic at the front of the home. It may have entered from the gable vent. Recommend the dead bird be removed and screens be placed inside the attic behind the gable vents to prevent further intrusion of birds and/or rodents. A qualified person or pest control contractor should remove the dead bird for health and safety.

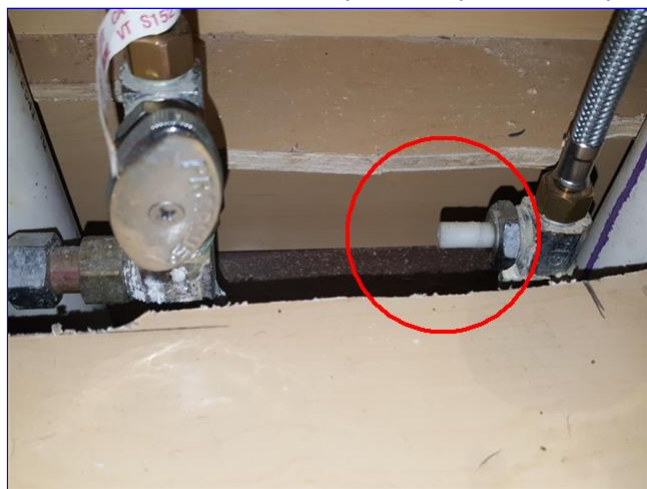
5.0 Item 1(Picture)

The stop-valve(s) is missing at the cold water line under the sink in the kitchen. The valve is required to be able to turn the water supply off if a leak occurs or when work is performed to the plumbing in this area. Recommend a qualified plumber replace as needed.

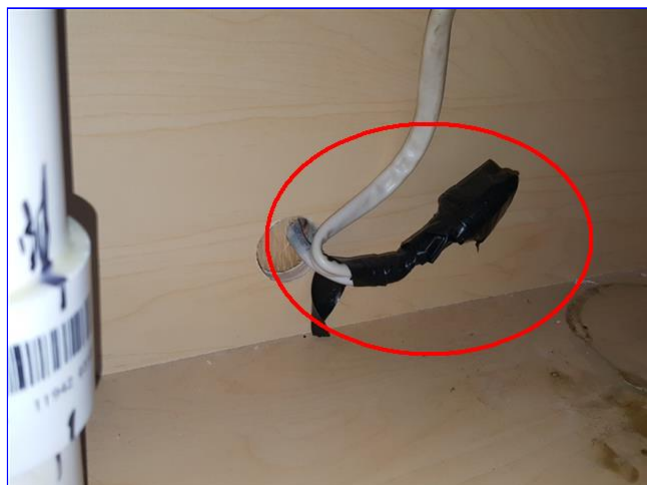
5.3 Item 1(Picture)

possible fire develop under the sink. Recommend a licensed electrician repair as needed to prevent accidental electric shocks.

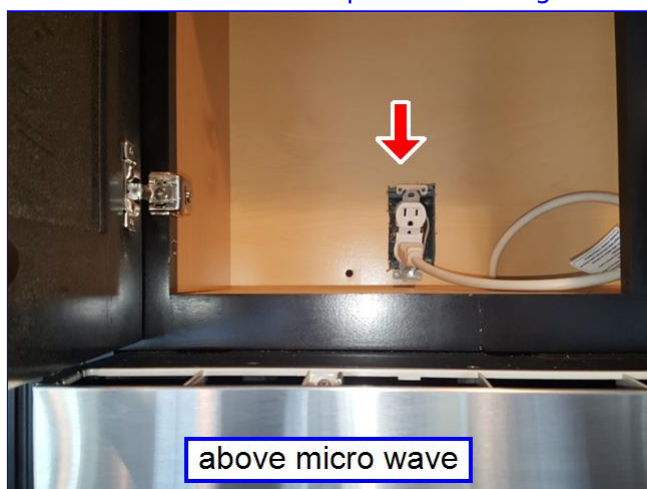
5.9 Item 1(Picture)

(3) The outlet(s) in the kitchen where indicated in the photo(s) is missing a cover-plate. The outlet was not tested. All missing covers should be installed to prevent touching the sides of the devices to prevent an electric shock which can cause an injury or death. Electrical issues are considered a hazard until repaired, and this is considered to be unsafe. A qualified licensed electrical contractor should correct as needed prior to moving in.

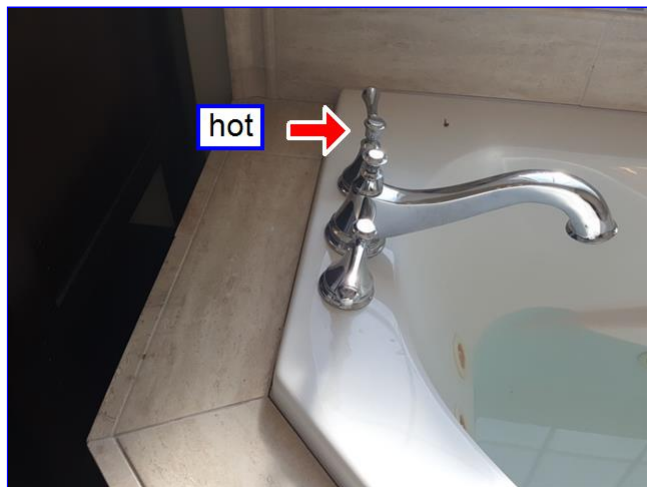
7.4 Item 1(Picture)

(1) The hot and cold water lines are connected in reverse from their normal positions in the Master bathroom at the jacuzzi tub. This could result in scalding burns of a person or child and is a safety issue. Recommend they be changed to the accepted normal locations with the cold water valve on the right side of the fixture. Recommend a licensed plumber correct as needed.

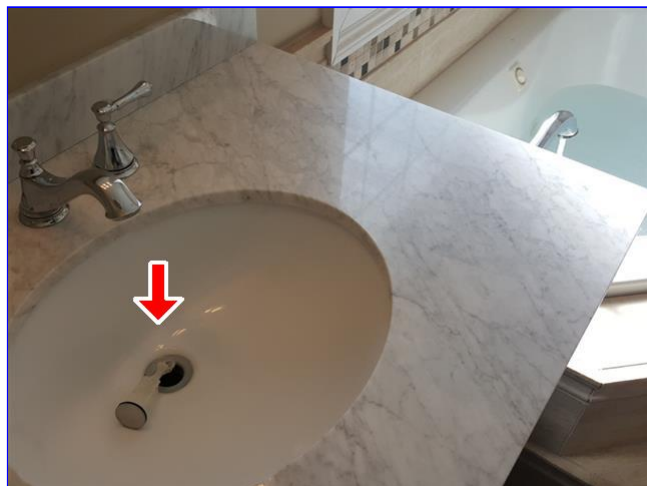
7.4 Item 2(Picture)

(2) The drain control stopper is not connected at the sink and does not function in the master bathroom. Recommend correcting to allow easy use of the drain lever and to ensure it functions properly. Repair or correct as needed.
