CCR Unit: SCA #2 Ash Landfill

Owner: Sunnyside Cogeneration Associates

Annual Inspection: January 2024

This annual inspection has been completed by S. Scott Carlson, PE 187727 in accordance with CCR Rules § 257.84 (b) and Utah State code R315-319-84.

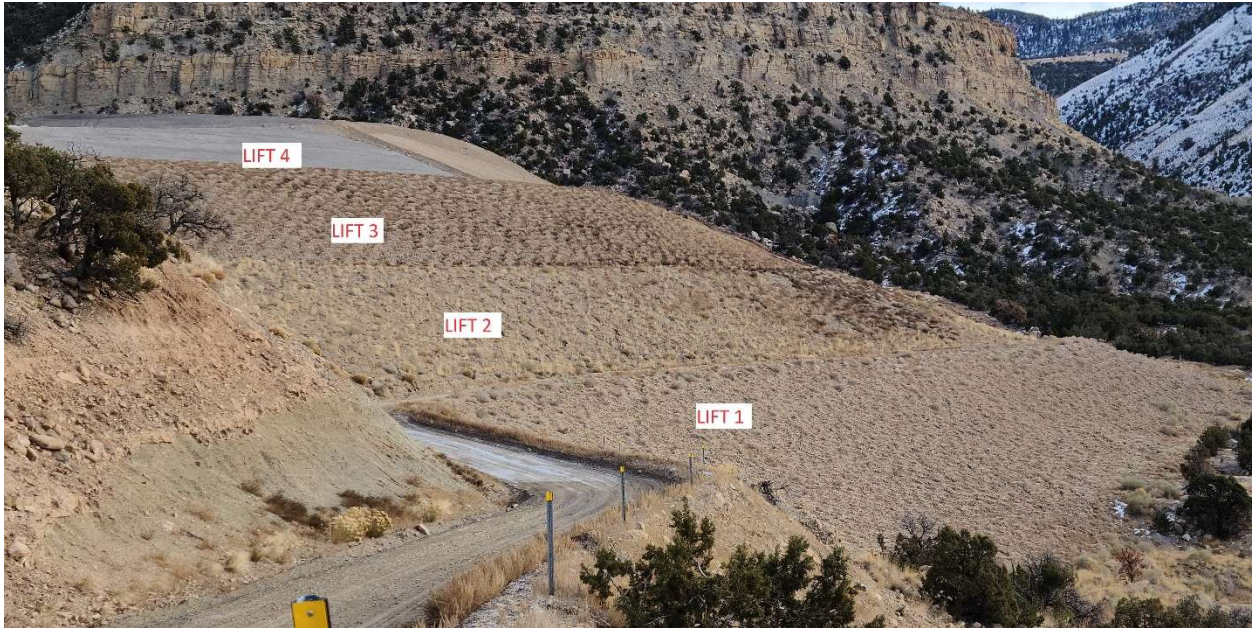
SCA#2 Ash Landfill –looking southeasterly

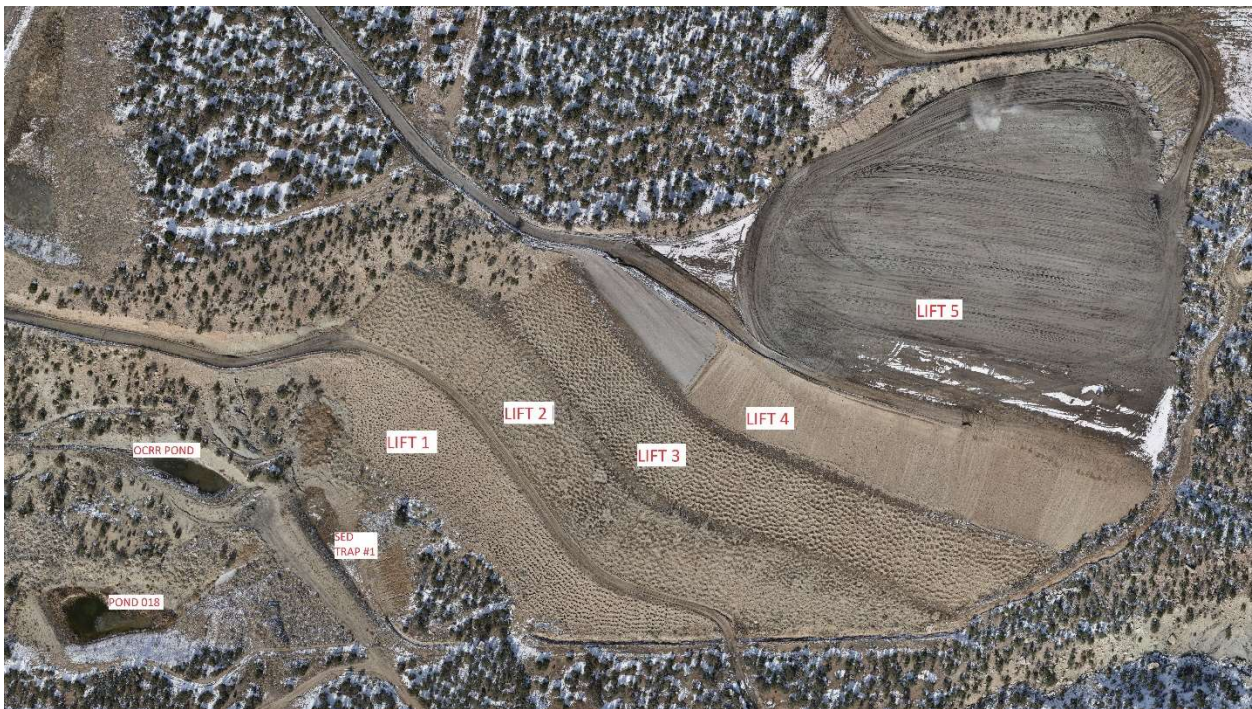
SCA#2 Ash Landfill – Aerial view
Lift #5 in progress

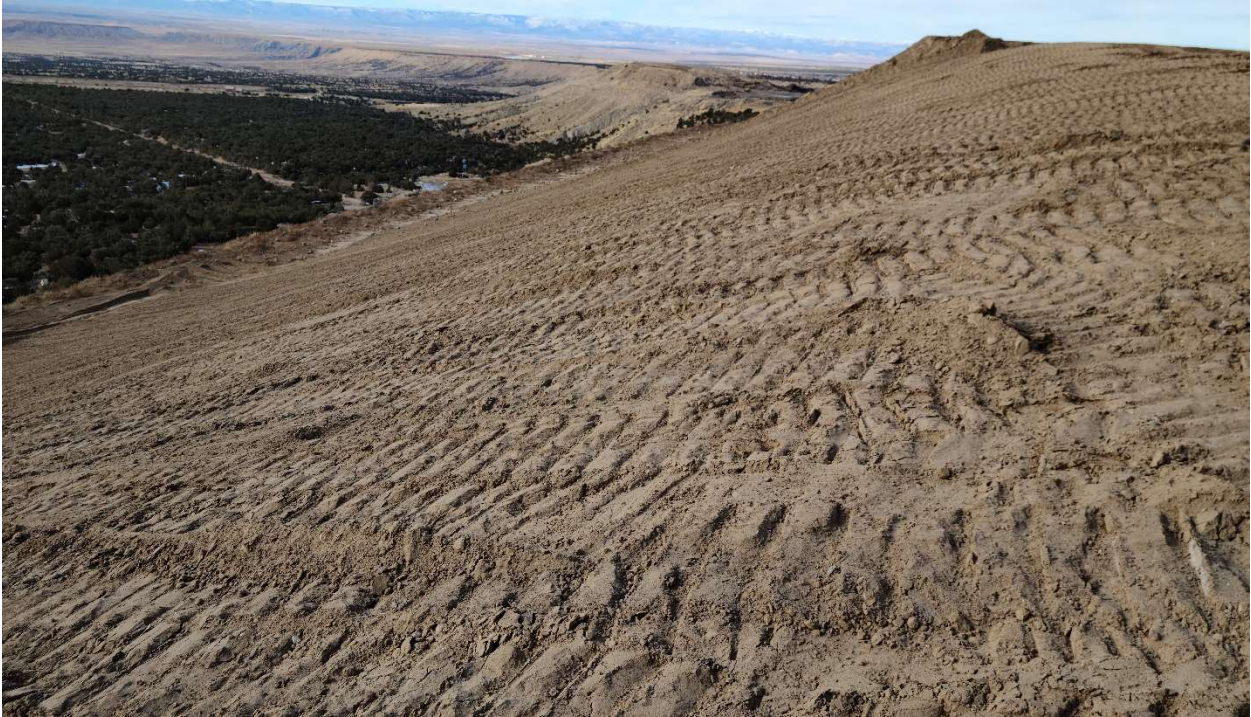
- ii. 4rd lift completed and partially covered. Seeding expected in 2024. Now filling 5th lift. Upper haul road in use. Manual efforts to reduce erosion on revegetated area.

Face of Lift #4 – soil cover in process – photo looking northwest

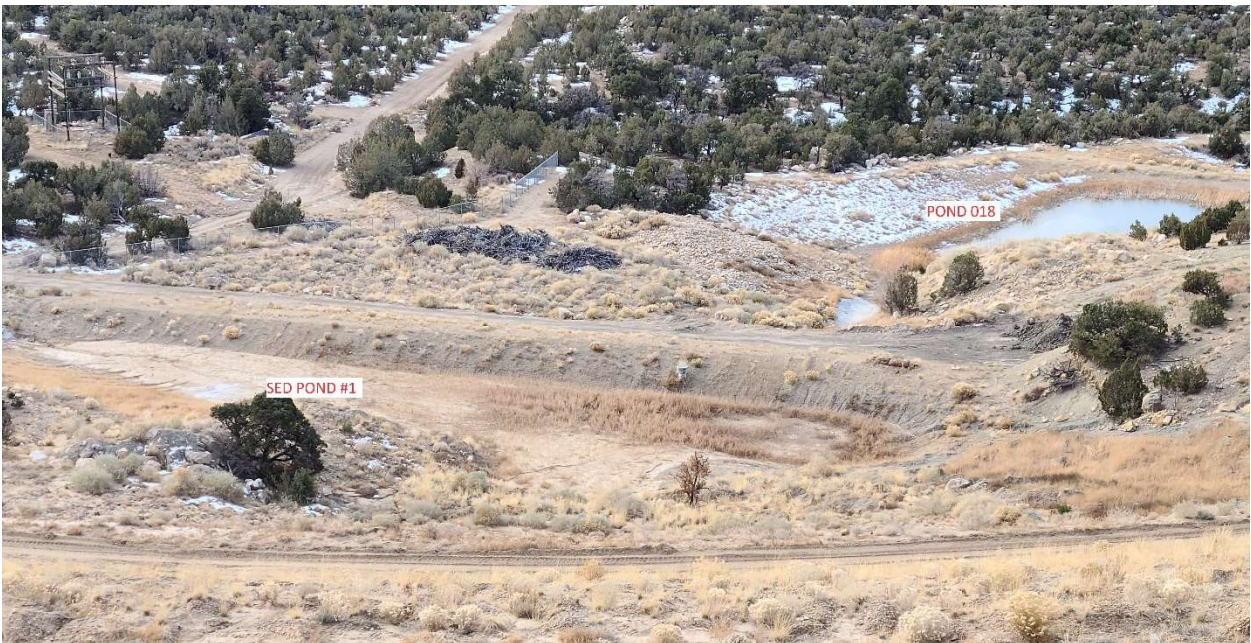
- iii. Run-off control ditch is in place along south side of landfill. Surface of landfill slopes to prevent run-on from flowing across pile.
 - iv. Sediment Trap #1 and Sediment Pond 018 are in operation west (downhill) of the landfill. No discharge recorded in 2023. Pond 018 had water and ice in it at time of inspection. Sed Trap #1 was empty.

Sediment Trap #1 is empty and clean
water flows from trap to pond 018 in normal open condition.

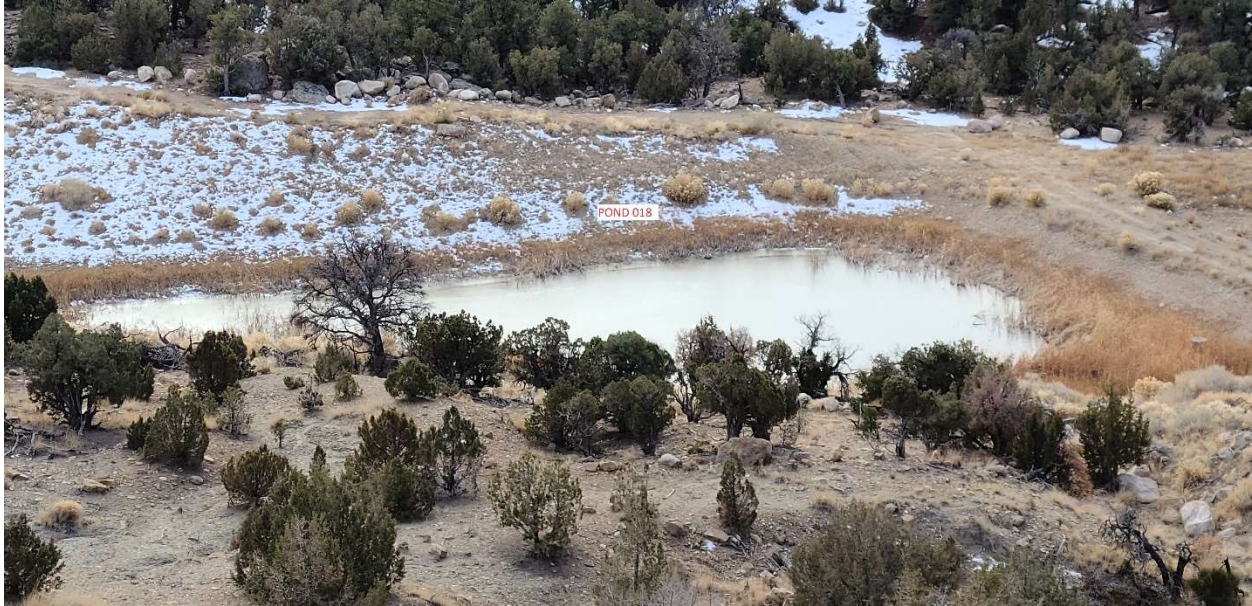
Sediment Pond 018, located west of Sed Trap #1 – photo looking southerly
Pond has some water.
No discharge in 2023
