All Valley Home Inspections

Inspection reference: Sample Report

Confidential Inspection Report

645 Rock Lane

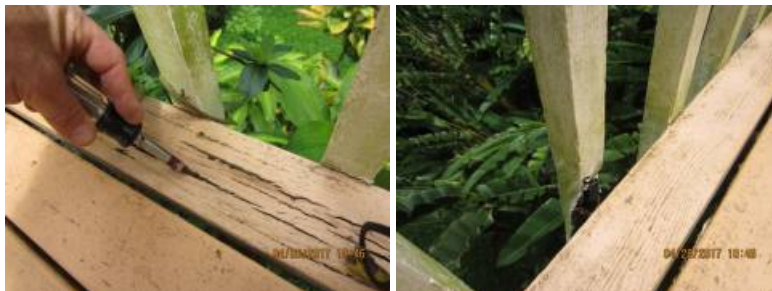
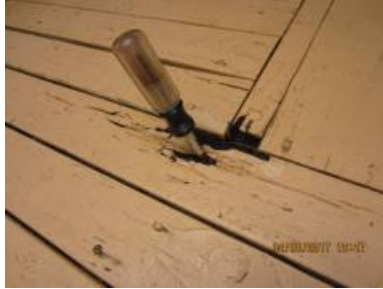
Deck Condition

Repair: Deteriorated, rotted and/or insect damaged deck boards were observed throughout the deck. Replacement of all damaged board material is recommended.

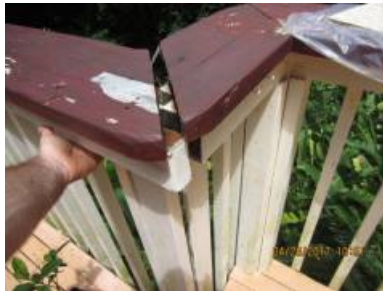
Safety Concern: Railings were damaged and/or deteriorated. Attention to the damaged/deteriorated railing is required for the safe use of the railings and we recommend that the railings be repaired or replaced.

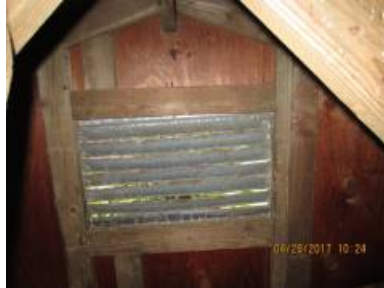
Ventilation Condition

Repair: Gable vent screens for the attic or enclosed rafter space were either damaged or missing at the rear vent. Attention to the vents' screens is required in order to help keep out pests and insects.

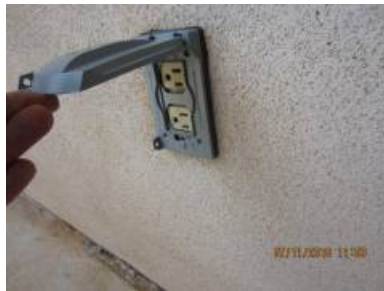
GFCI Condition

Repair: The ground fault circuit interrupter breaker (GFCI) receptacle at the left side had an incorrect cover plate on it that did not allow for the GFCI buttons to be accessed. We recommend replacing the cover plate with the appropriate part.

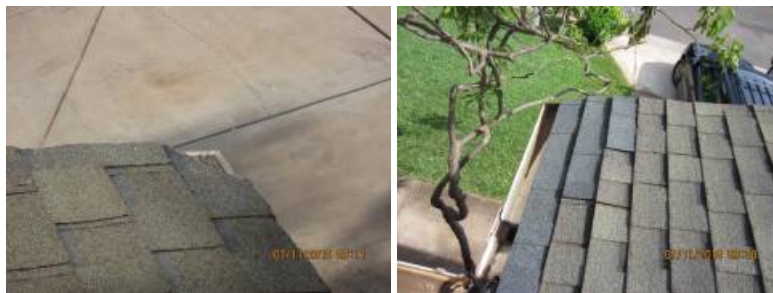
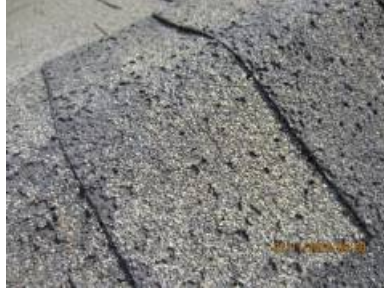
Repair: Damage to the shingle roofing surface was noted at the rear left corner. We recommend that the damaged areas be repaired as required. **Consult Seller:** Evidence of prior patching was observed in the shingle roofing surface on the rear right side. Consult the seller as to the nature of the repair for more information.

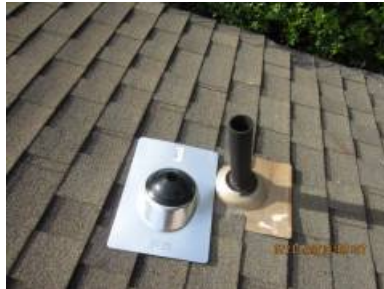
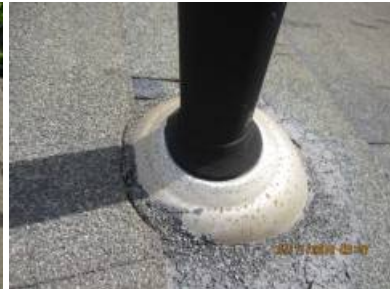
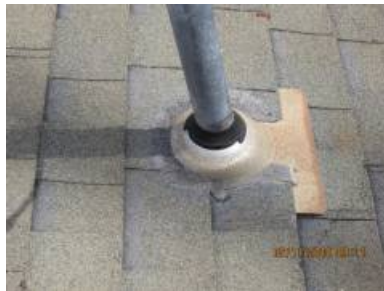
Repair: Separation was noted at several of the rooftop penetrations, i.e.(vent pipes, chimney, heating/cooling ductwork) due to typical aging. We recommend that all rooftop separations be resealed with a roofing mastic to prevent moisture intrusion.

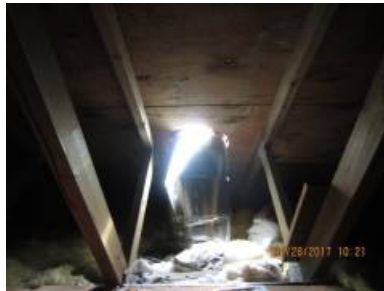
Monitor: One or more of the skylights were installed in a substandard manner, creating conditions conducive to leaking. We recommend that the skylights be monitored and repaired as necessary.

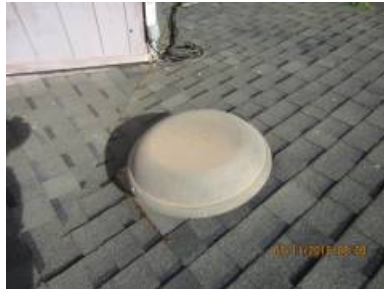
Ventilation Condition **Repair:** A powered vent fan in the attic was not working. We recommend that the fan be repaired or replaced as required.

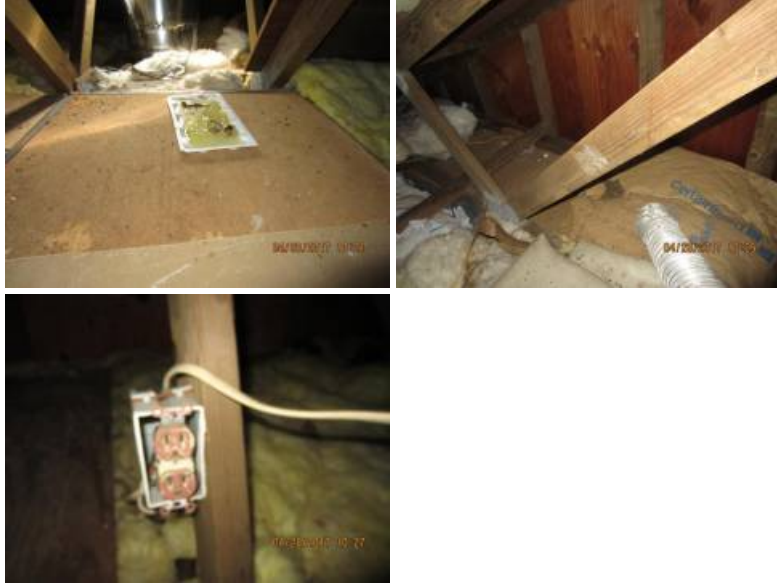
Attic Conditions **Further Review:** Evidence of rodent activity was observed in the attic space. We recommend that a pest control specialist be consulted for a determination of present conditions. **Repair:** One or more electrical junction boxes were seen in the attic above the living room. These should have cover plates installed on them.

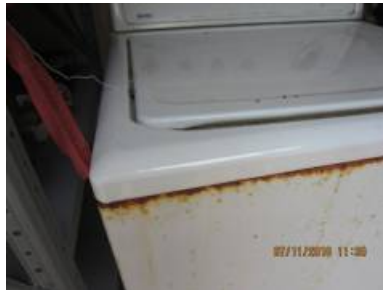
Laundry Conditions

Monitor: The washer and or dryer have some rust on the units. We recommend that the rust be monitored with correction as necessary.

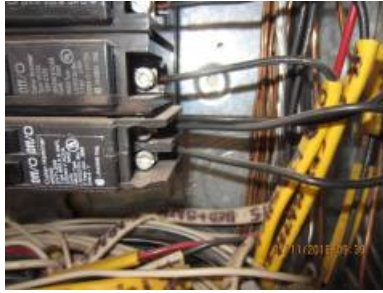
Repair: More than one wire at the subpanel was installed at a breaker or fuse which was designed for the installation of only one wire. This "double tapping" cannot insure that both wires, installed under a screw designed to carry only one wire, receive the same amount of pressure from the screw. Because positive connection for all the wires under the screw may not be the same there is a possibility of arcing or gapping. This arcing can result in dangerous resistance and heat buildup within the circuit, and is

considered an improper electrical trade practice. We recommend elimination of all double tapping, for an increased margin of electrical safety.

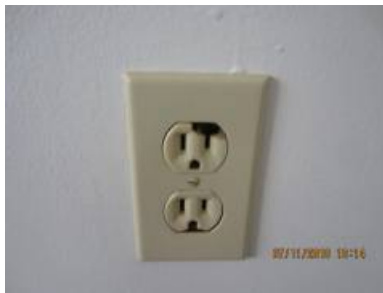
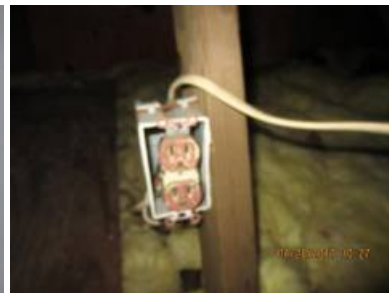
Repair: A receptacle in the master bedroom, near the patio door was damaged, creating a potentially unsafe condition. We recommend that any damaged receptacle be replaced to ensure safe operation. **Repair:** A cover plate was missing or damaged at a receptacle in the attic near the hatch. This presents a risk to personal safety, particularly for small children. We recommend that the missing or damaged cover plate be replaced.

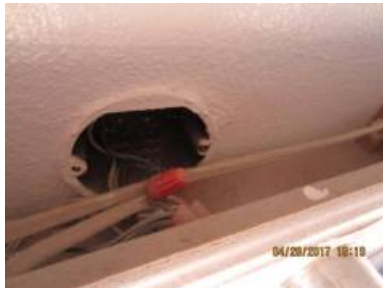
Repair: The light fixture in the hall bathroom was improperly installed. All damaged or improperly installed fixtures, should be repaired or replaced to proper operation by an electrician.

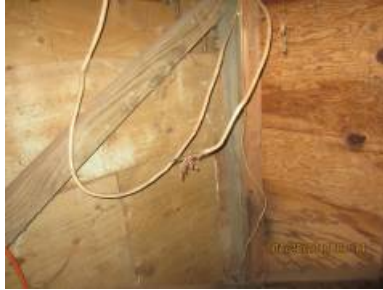
Wiring Problems

Safety Concern: Unterminated live wires were observed at the crawlspace. This is a safety aspect of the building's electrical system and we recommend immediate repair.

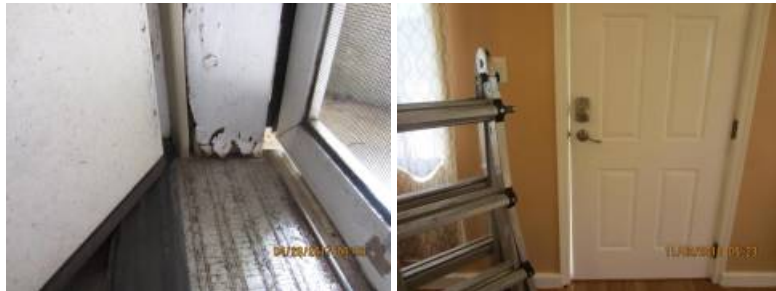
Door Conditions

Repair: The left side patio door was damaged and in need of repair to restore proper operation. We recommend correction as necessary. **Maintenance:** The exterior front door had damaged or missing weather stripping at the door stop trim. We recommend that the weather stripping be repaired or replaced.

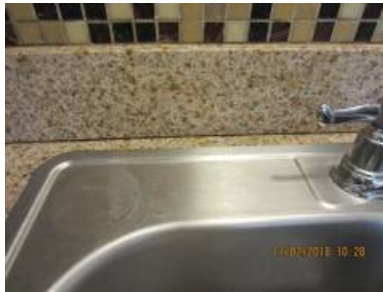
Counter Top Condition

Repair: The caulking for the backsplash is in need of repair or replacement. We recommend that caulking be installed and/or gaps filled to prevent possible water intrusion at the wall areas.

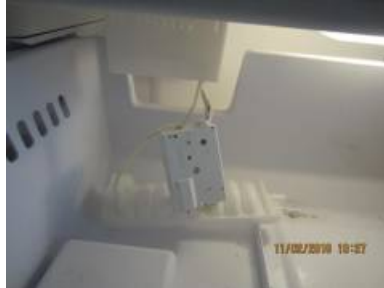
Refrigerator

Repair: The icemaker was not attached in the freezer. We recommend the icemaker be repaired.

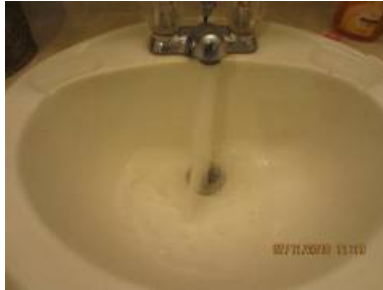
Hall Drain

Repair: The drain stop was inoperable in the hall bath wash basin. We recommend that all inoperable drain stops be repaired or replaced to restore function.

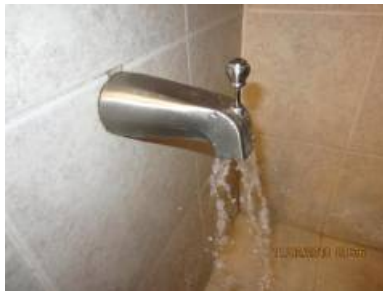
Tub Spouts

Repair: The diverter in the master bathtub did not allow all of the water to be diverted to the shower. We recommend repair or replacement.

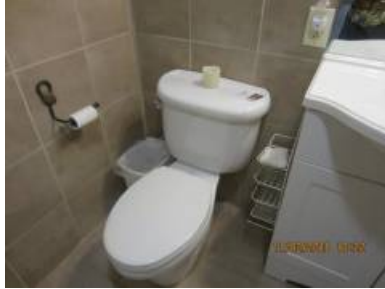
Hall Bath Toilet

Repair: The hall bath toilet was not securely attached to the soil pipe flange at the floor surface. We recommend that the toilet be resecured or repaired for health and safety considerations.
