**NOTICE OF OPEN MEETING  
DESLOGE BOARD OF ALDERMEN SPECIAL MEETING**

DESLOGE BOARD OF ALDERMEN SPECIAL MEETING  
MONDAY, AUGUST 26, 2019  
6:00 p.m.  
DESLOGE CITY HALL, 300 North Lincoln

Re: INS201983 – 200 N Lincoln Street, Desloge, Missouri 63601  
Roof Structural Assessment Report

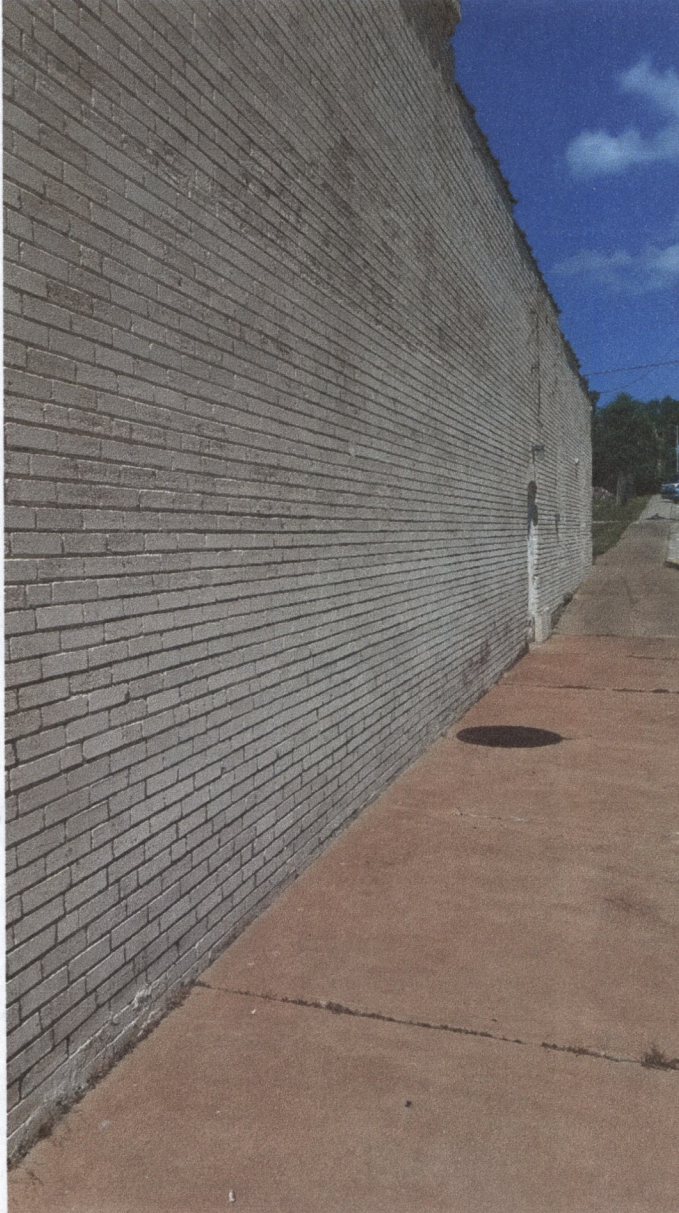
Exterior Masonry Wall: The exterior brick masonry wall on the south side of the building is in good to very good condition especially considering its age. The mortar joints are tight and are without crack and the brick face is smooth and not weathered. There are signs that the wall has received tuck-pointing and should be monitored for signs that additional maintenance is required. The parapet wall has some slight outward lean but not to the point that reinforcing is required.

200 N. Lincoln Street – Exterior view the south side of the building.

Recommendation: The brick masonry should continue to be maintained. The parapet wall should be inspected periodically for signs of deterioration. At the time of the inspection the wall including the parapet looked to be in good condition and does not pose a risk to public or private safety.

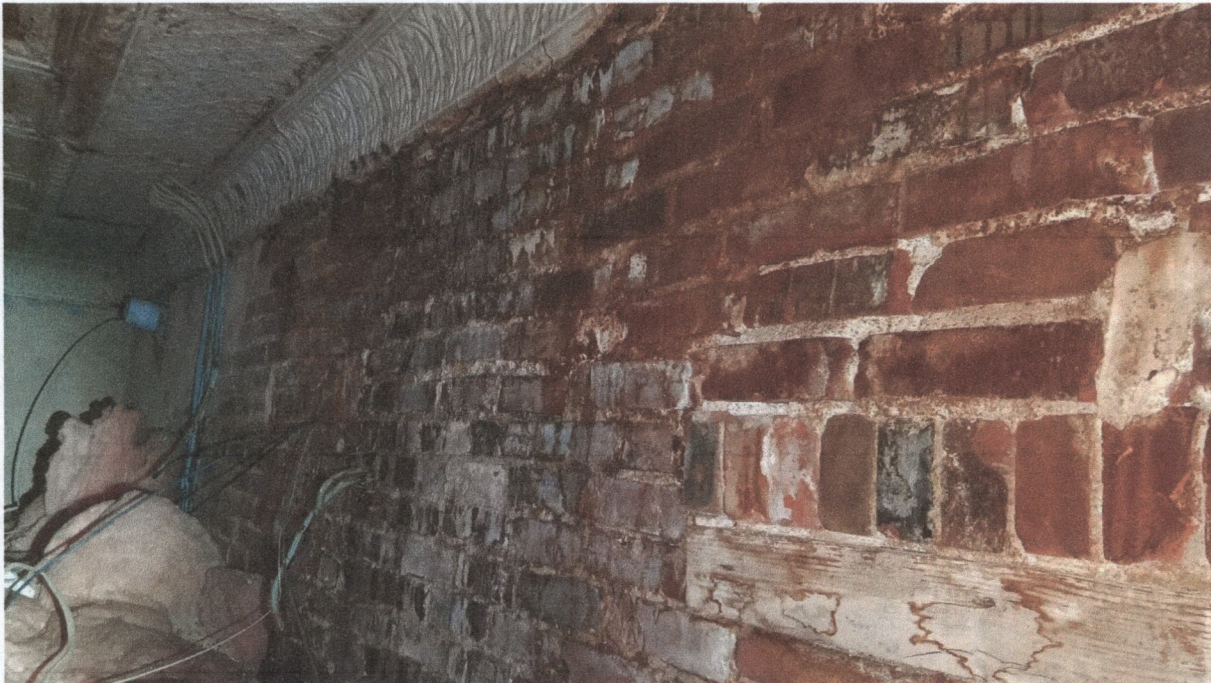
Interior Masonry Wall: The interior of the rear brick masonry wall has deterioration from water seepage especially through the center portion of the wall. The face of the brick has become porous and shows some deterioration. The mortar joints have lost significant material. The wall is not cracked and none of the bricks are dislodged or loose.

200 N. Lincoln Street – View of the interior side of the rear wall of the building showing the water damage to the brick masonry.

Recommendation: The elimination of seepage is essential to protecting the wall from additional damage. Once protected from seepage the wall should be tuck-pointed to repair the mortar joints and the brick should be treated with waterproofing to seal the porous exterior of the brick.

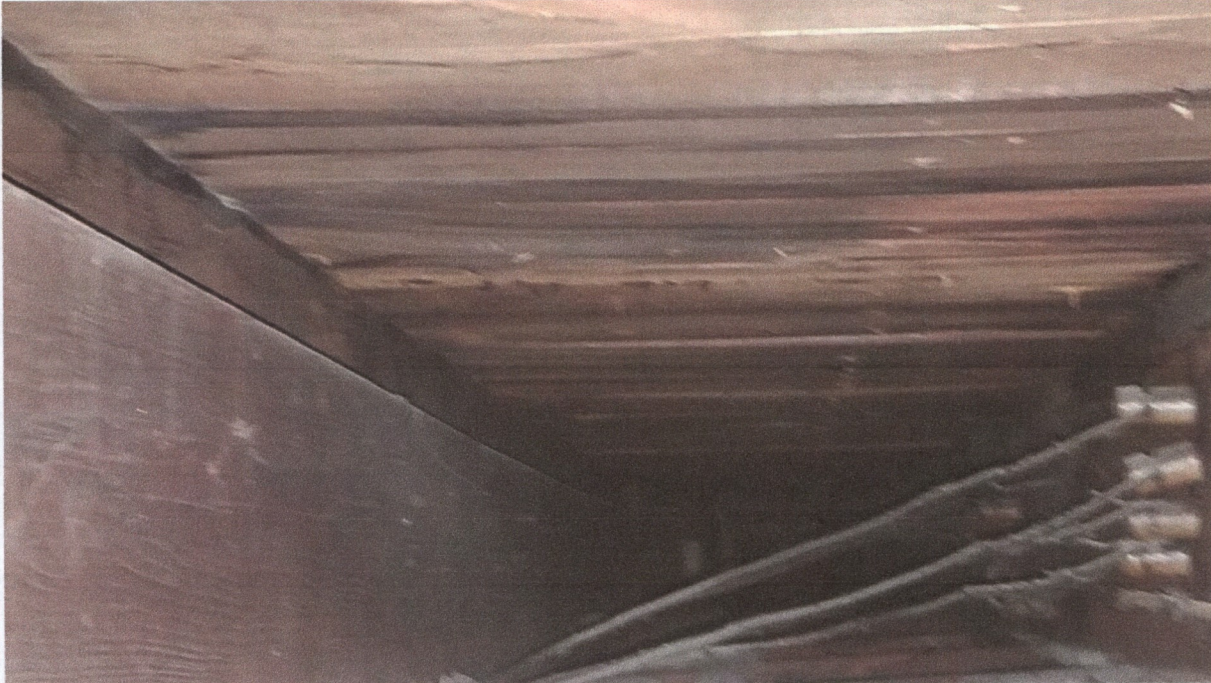
**Roof Construction:** The roof framing includes 2 x 12 rafters that span the width of the building (24 feet). The rafters rest on a masonry ledge at the south wall and bear upon the shared wall on the north. The roof slopes toward the rear is created in two ways: The first is by attaching sister rafters to the side of the bearing rafter adjusting the height on each rafter toward the front. The second is to provide bearing on a wood stud knee wall. A sketch is provided of this construction in the attached Section View. The wood rafters are generally in good condition and do not show signs of cracking or deterioration from water.

200 N. Lincoln Street – View of the 2 x 12 rafters and the sistered rafter and roof decking.

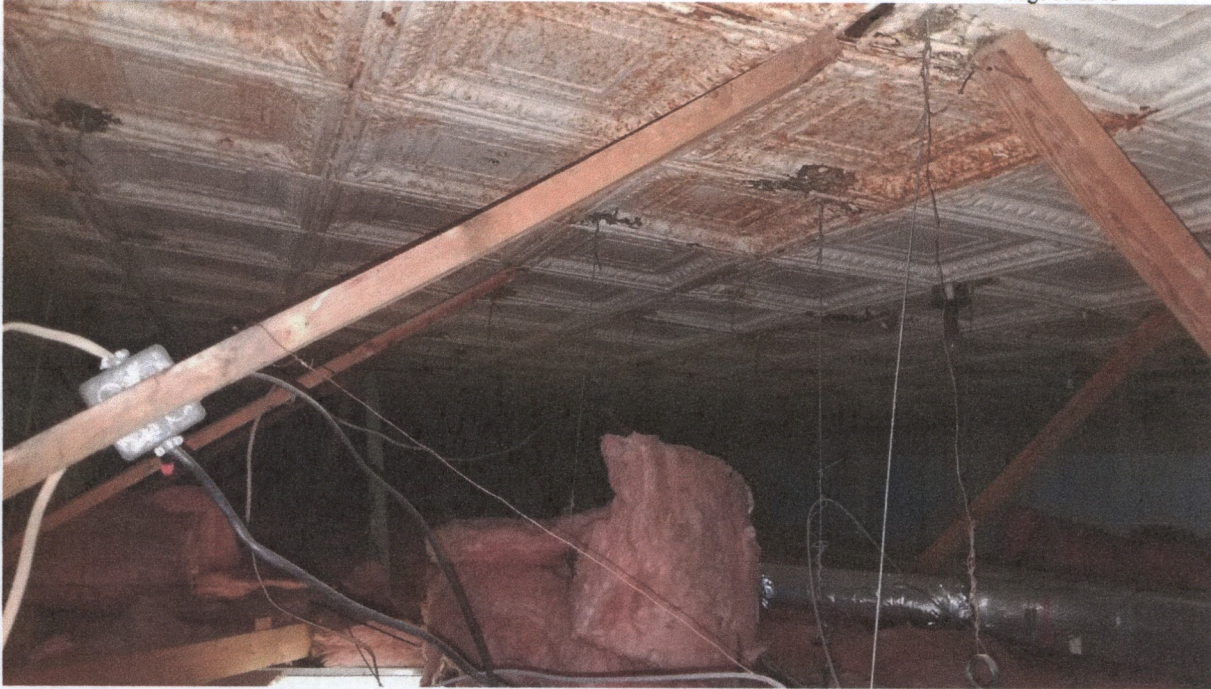
200 N. Lincoln Street – View of the original ceiling showing the rusting and damaged ceiling tiles.

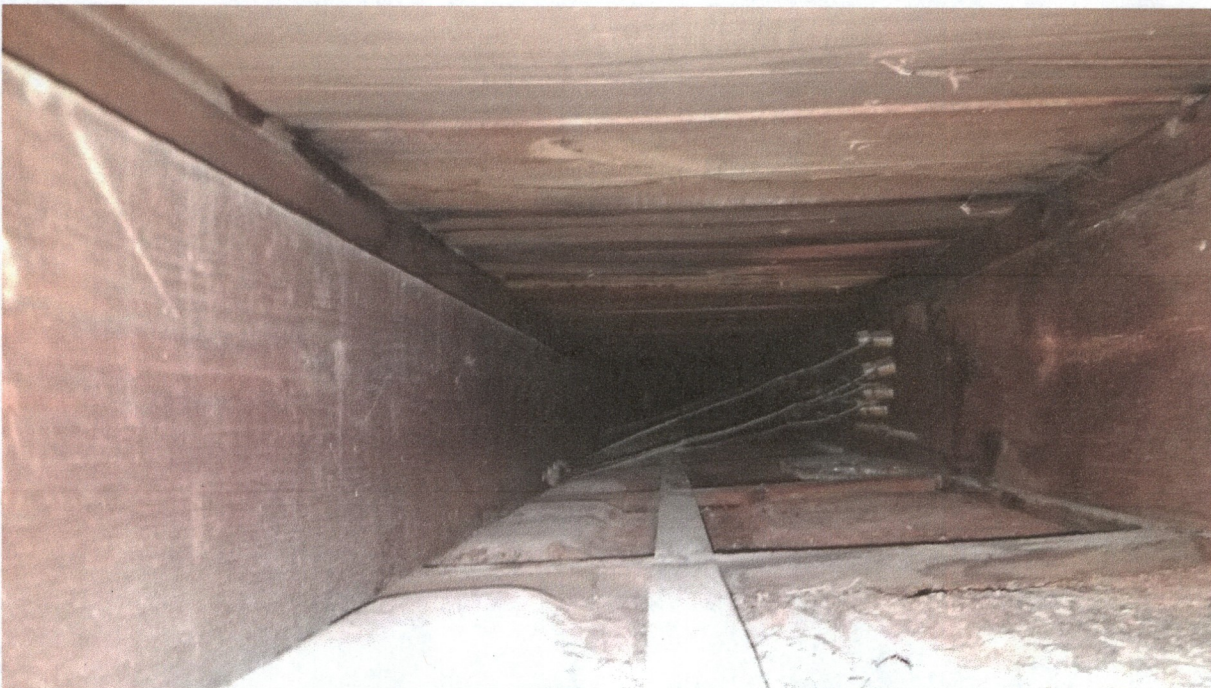
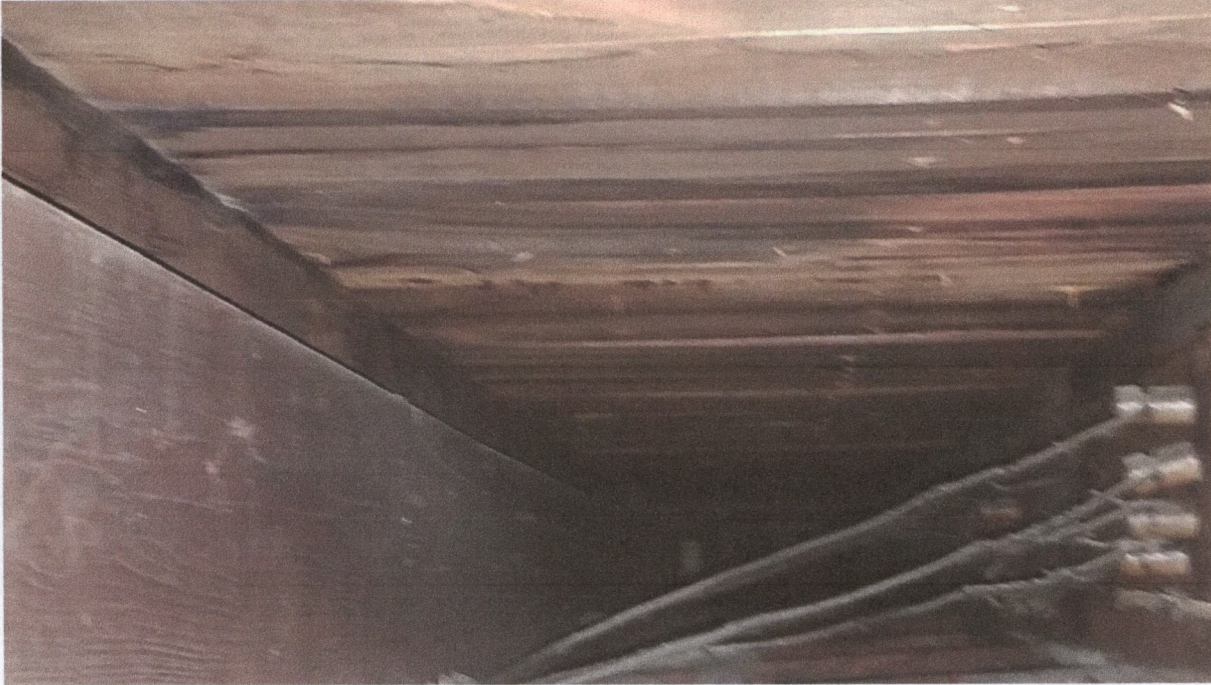
200 N. Lincoln Street – View of the roof decking and the rafters near the rear wall of the building facing the north.

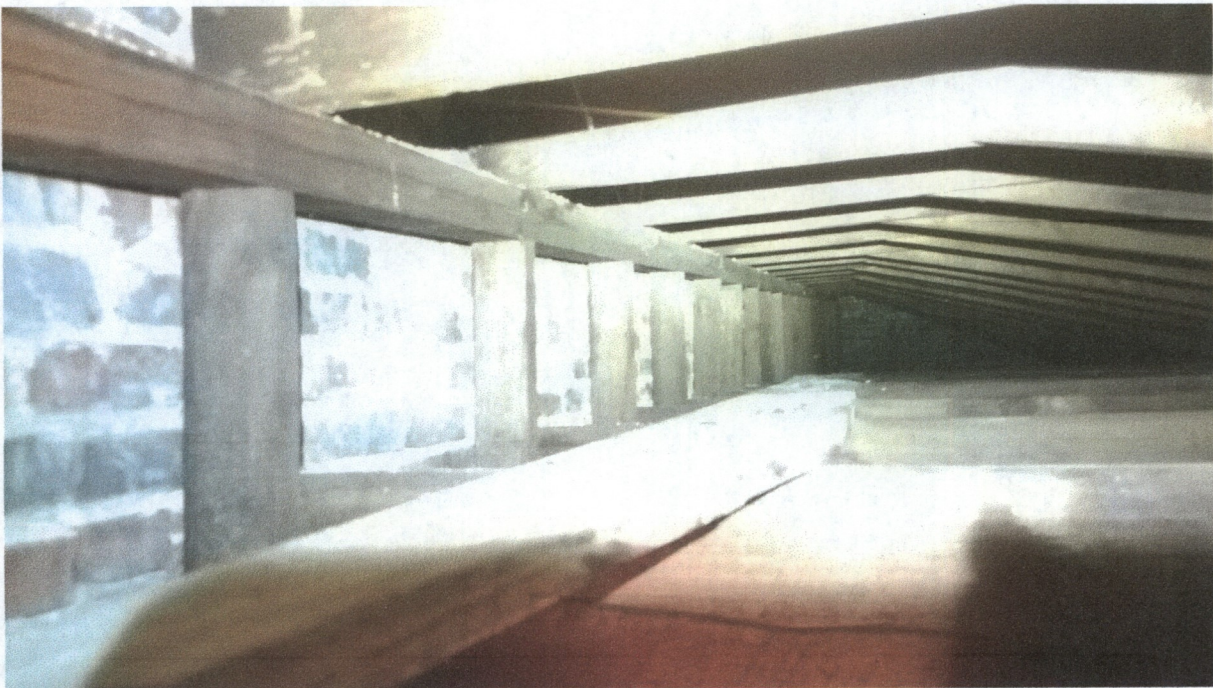
200 N. Lincoln Street – View of the south wall of the building showing the stud knee wall and the 2 x 12 rafters.

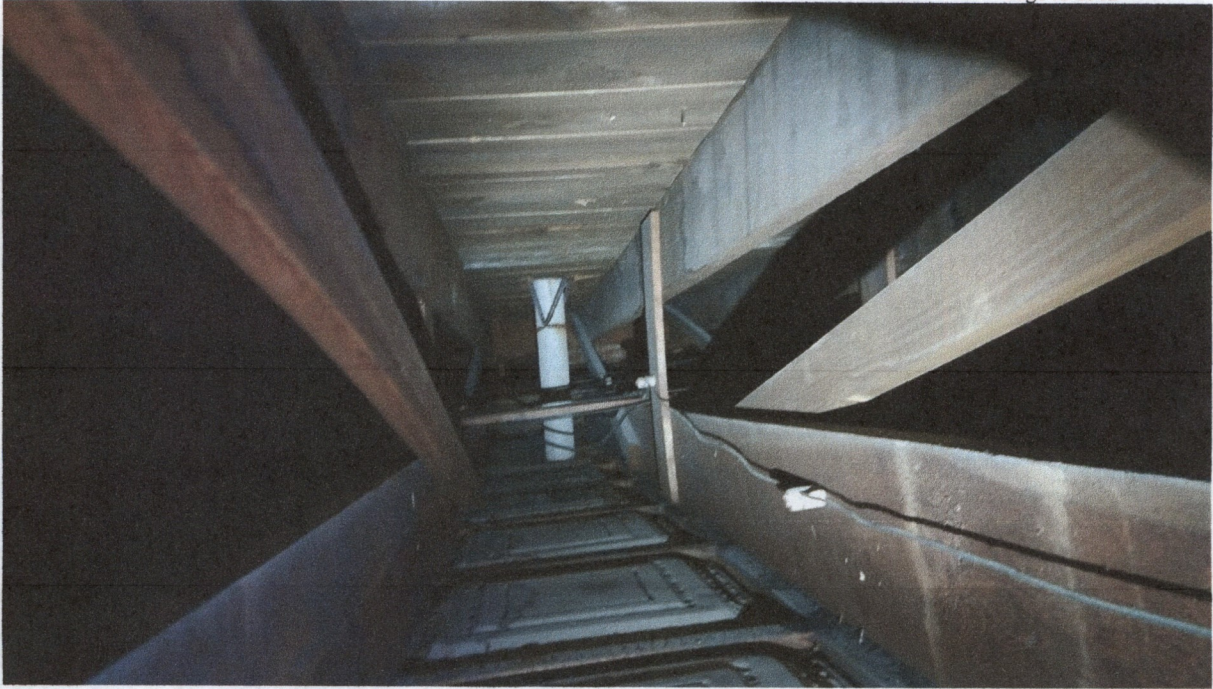
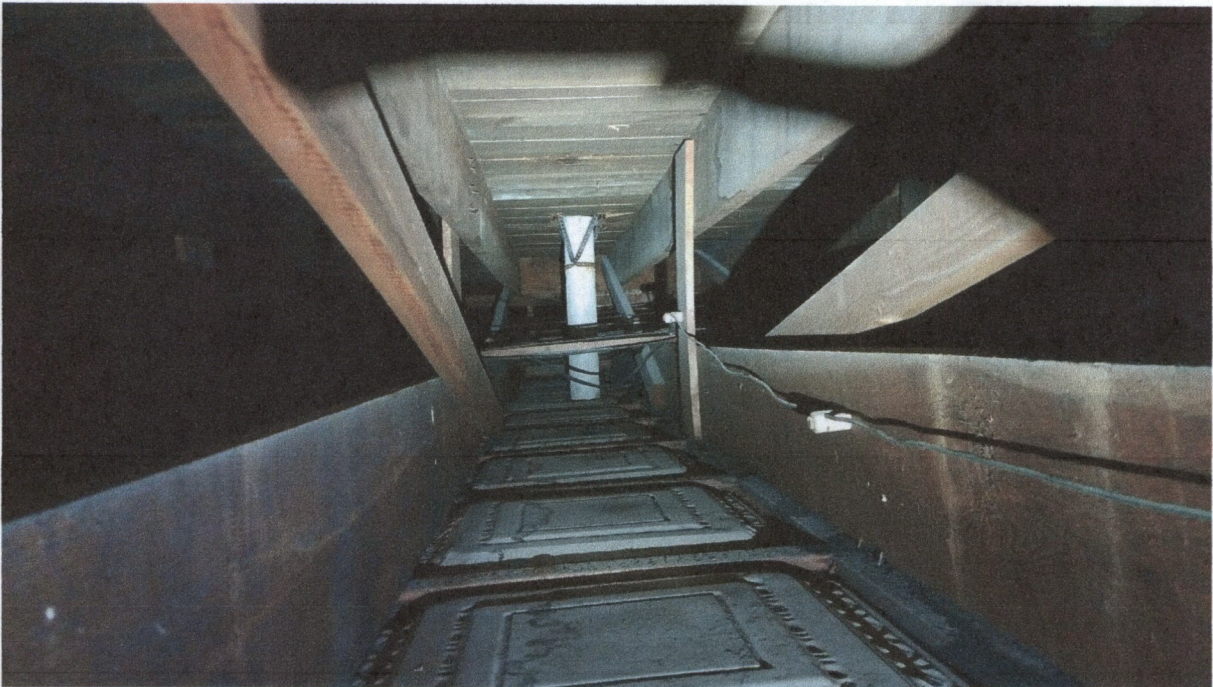
200 N. Lincoln Street – View of the 2 x 12 rafters and the diagonal bracing closer to the middle of the building.

**Preferred Recommendation:** The framing members should be reinforced with additional 2 x 12 members installed between the existing rafters to provide 12 inches on center. The rafters should be laterally braced and may also be supported with center bracing as shown on the existing rafters. The wood joists could be installed to bear on the masonry ledge or the existing knee wall to match elevation. The roof deck should be ½ inch (minimum) marine plywood. Install a single layer EDPM or TPO membrane roof in accordance with the manufacturer's recommendations.

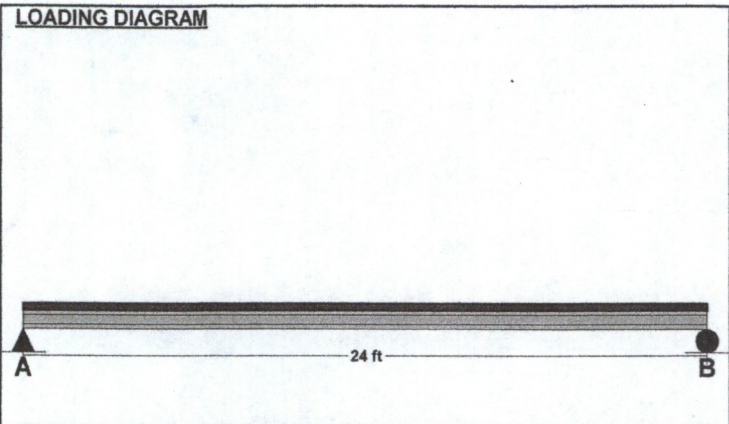
Location: RFT2 - **EXISTING CONDITION**  
 Roof Rafter

**Structural Analysis:** The 2 x 12 roof rafters were analyzed to determine if they are adequate for the loads. The 24-foot span is a concern as the roof has noticeable deflection from live loads and a rooftop AC unit. The lumber is net dimension and modern lumber and analysis programs are nominally sized. The existing 2 x 12 rafters on 24 inch centers are 44.5% Inadequate based upon nominally sized 2 x 12 members.

Section Inadequate By: 44.5%

Controlling Factor: Moment / Depth Required 13.53 In.

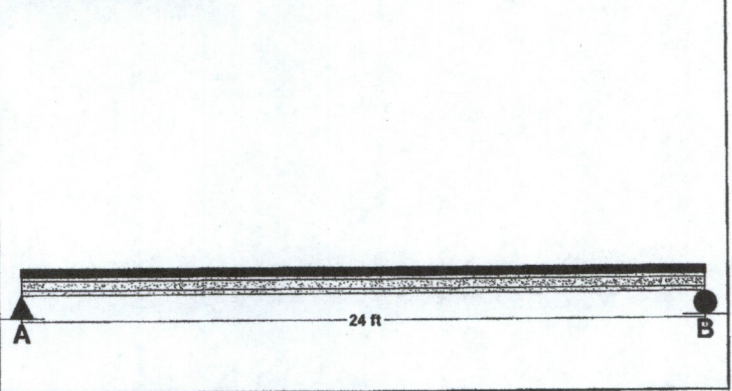
Location: RFT2 - Size Adjusted for Net Lumber Dimensions

The analysis was adjusted to 2 x 14 nominally sized lumber as it has a cross sectional area closer to the post-modern lumber. That analysis indicated that the existing members are 4.2% Inadequate. A third analysis was performed to determine the capacity of reinforcing the roof with 2 x 12 members on 12 inch centers. The result is the rafters would be adequate by 38.4%. So the capacity of the roof could be increased by 42.6% by adding 2 x 12 rafters between each existing rafters.

Section Inadequate By: 4.2%

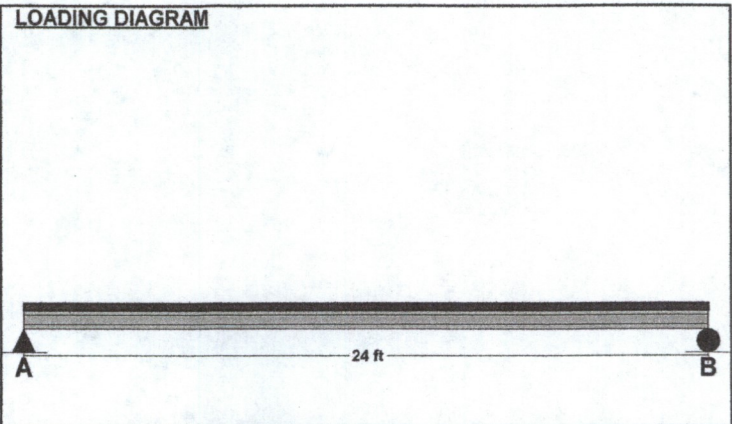
Location: RFT2 - **PREFERRED REPAIR**

Section Adequate By: 38.4%
