Kennedy Inspections

Pre-Drywall Inspection Report

October 6, 2022

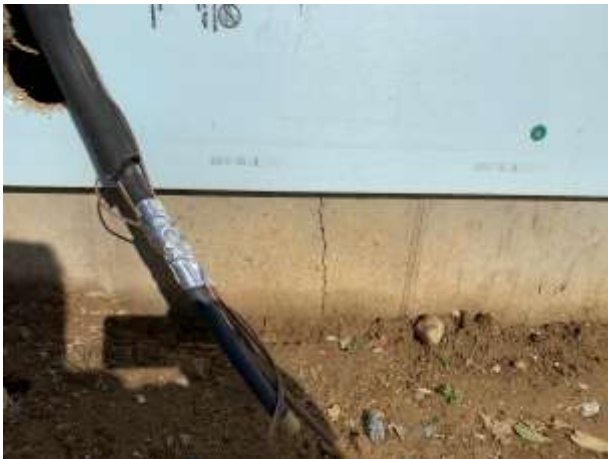
1. Hairline crack is noted in the foundation on the south side wall near the AC refrigerant line. Consult with builder if an epoxy sealant will be applied.

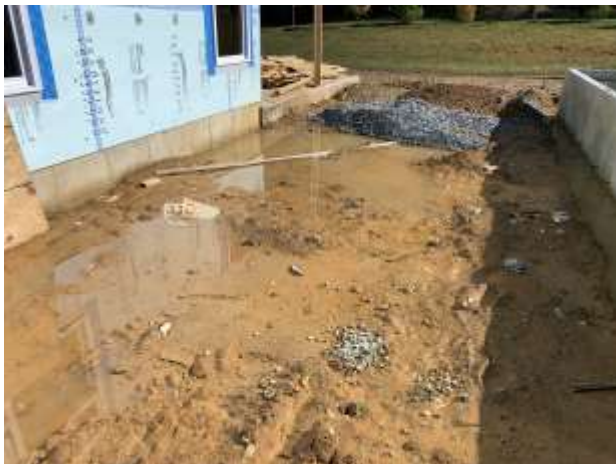
2. Considerable water pooling was noted on the southside yard. Confirm with builder for drainage and grading to draw water away from the structure.

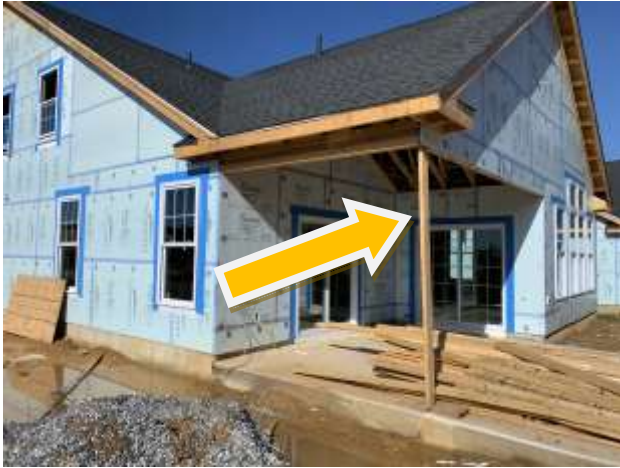
3. 2x4's were noted in the place of a corner post at the south east porch roof overhang. Consult with seller what load beard column will be permanently added at this location

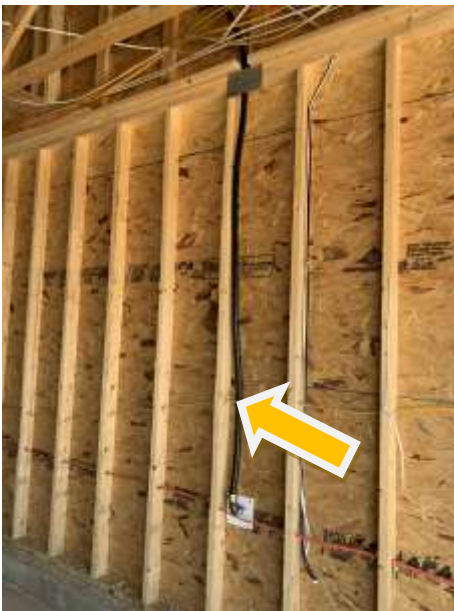
4. Gas line in garage wall has protective plates at the header. Consult with builder if any protections are installed for the vertical length of the gas line as an errant nail or screw that may miss the stud while installing hooks or brackets on the garage wall can still puncture the line.

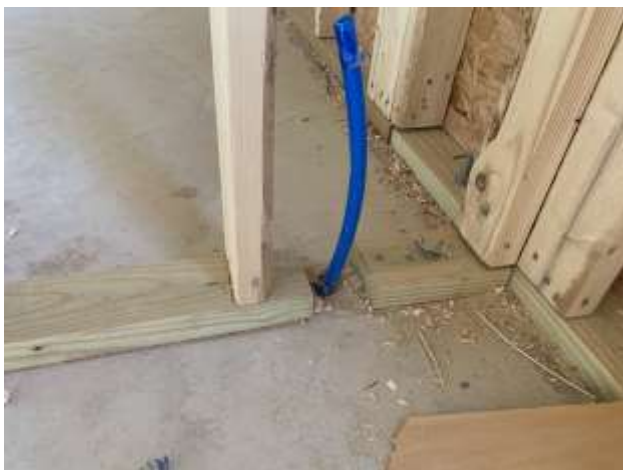
5. Missing kickplates at pex water line to refrigerator. Recommend installation to prevent errant nail or screw puncturing piping

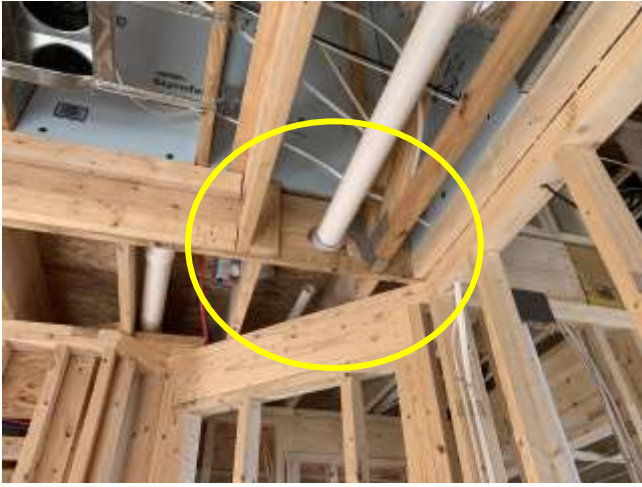
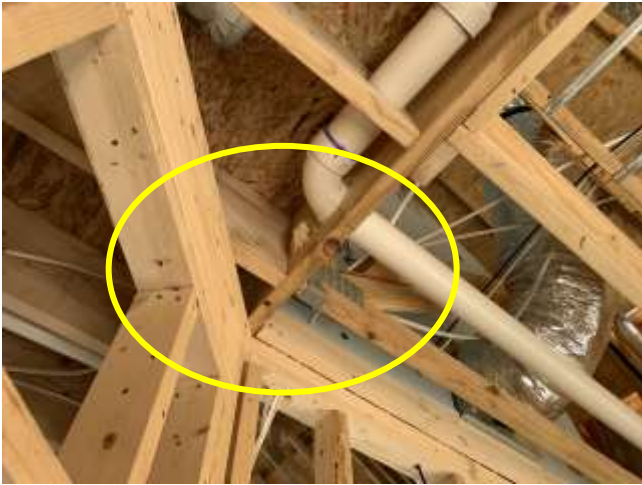
6. Support beam at rear bedroom entrance on first floor has been cut and damaged for plumbing pass-through and the nails from a truss plate. Recommend evaluation by builder to determine if this is causing a weight load deficiency at this location.

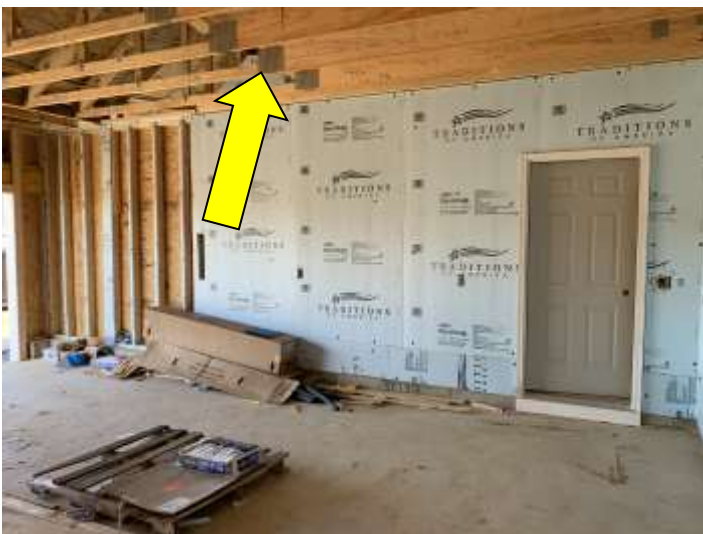
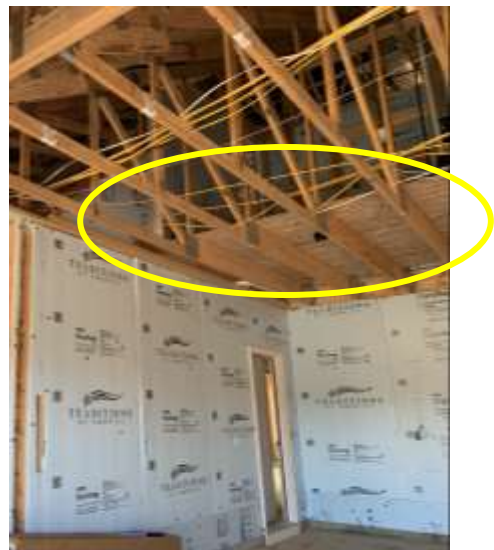
7. Utility room is located above the garage which carries substantial weight load from appliances and potential storage. The floor support is dimensional wood conjoined with roof trusses with metal plates in the ceiling of the garage. The trusses are plated to the rafter chord for support at the top. Recommend final evaluation by the builder and/or an engineer to determine if this is adequate support for a finished utility room
