SAGUACHE CREEK DIVERSION INFRASTRUCTURE INVENTORY

Structure Name: FULLERTON D 2

Date: July 3, 2019

Saguache Creek Stream Management Plan

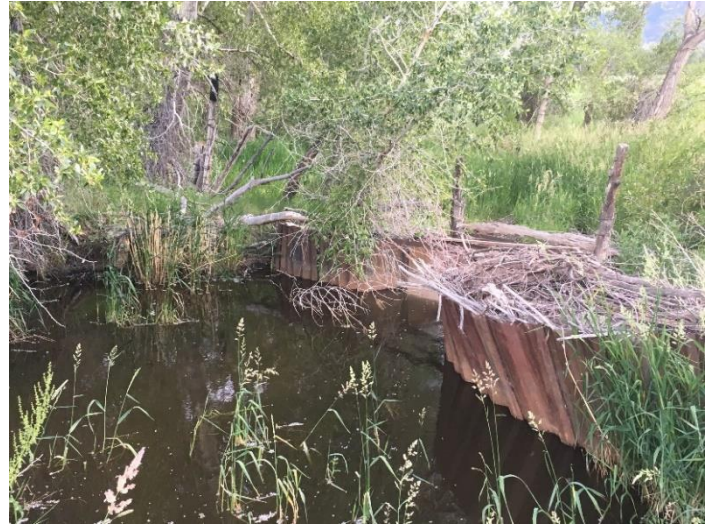
Diversion dam looking downstream

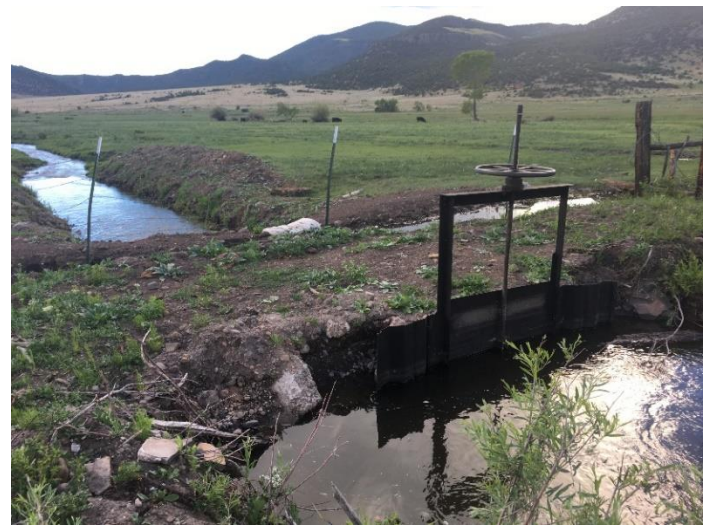
Werner Arroya headgate

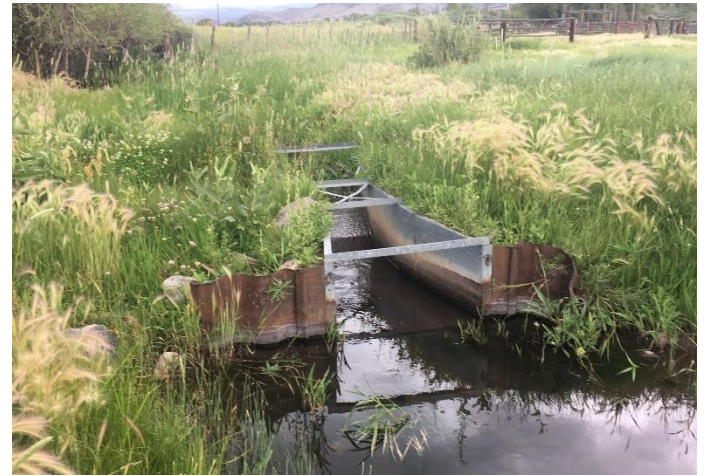
Flume looking upstream

Repair(s) or Improvement(s) Currently Needed: The flume should be leveled and reset to measure accurately. No other immediate repair needs were noted. Fish passage and riparian restoration should be considered as part of any future repairs or improvements.
