MINIMUM INSPECTION PROCEDURAL GUIDELINES FOR BUILDING STRUCTURAL RECERTIFICATION

Table with 1 main section: 1. DESCRIPTION OF STRUCTURE. Rows include: a. Name on Title: Village at Dadeland Condominiums (G); b. Street Address: 7500 SW 82nd St. Miami Florida 33143; c. Legal Description: Village at Dadeland Condominiums; d. Owner's Name: Village at Dadeland Condominiums; e. Owner's Mailing Address: 7500 SW 82nd St. Miami Florida 33143; f. Folio Number of Property on which Building is Located: 30-4035-047-XXXX; g. Building Code Occupancy Classification: R-2 Residential; h. Present Use: Condominium, Residential; i. General Description: The 2-story twelve unit building at the Village at Dadeland Condominium has an approximate footprint of 155ftx40ft. Building 7590 is 1 of 4 buildings that comprise the VILLA "G" area of the community and was constructed circa 1970. Three stairs located on the south front elevation of the building provide access to the 2nd floor catwalk. The building has a bituminous built-up flat roof with perimeter shingled mansard roof elements. Addition Comments: The roof is supported by 2ft tall wood trusses spaced at approximately 2ft on center. Interior main drain

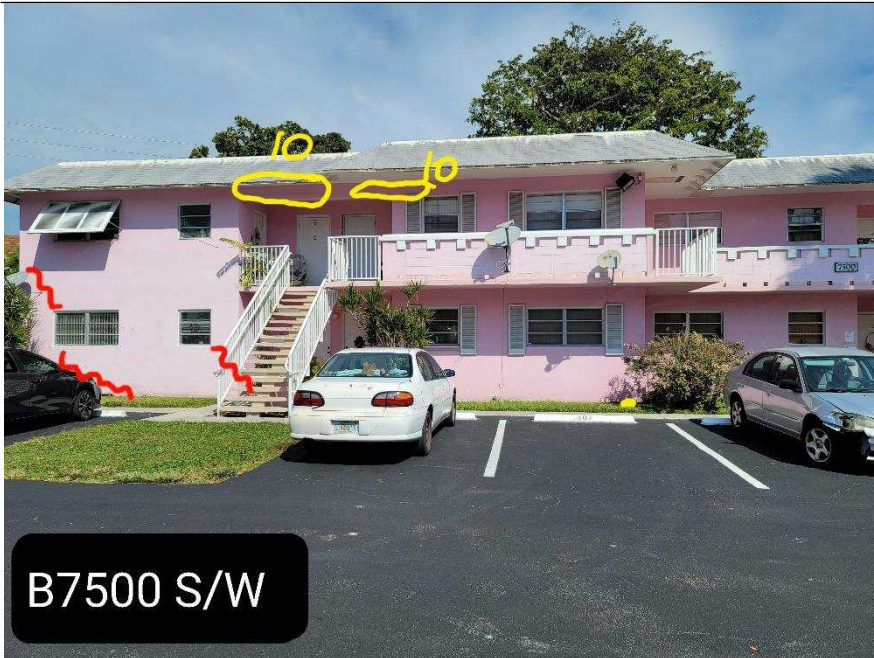
Photo #1:

Front elevation of building 7500 (Villa G)

The stuccoed envelope requires maintenance of the stucco exterior surfaces at many locations. Unsound stucco surfaces and surface cracks discovered at many areas of the exterior envelope.

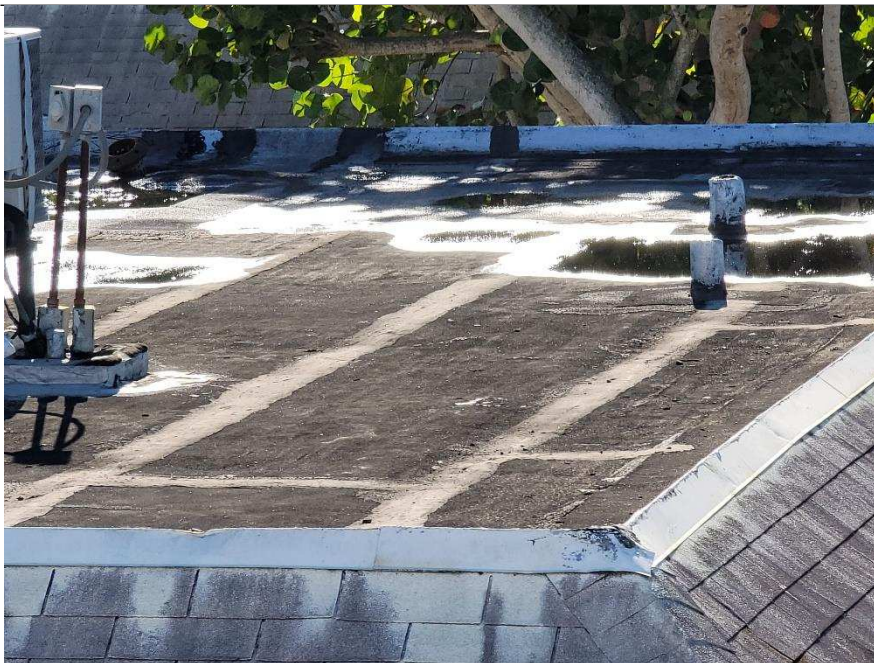
Photo #2:

Water ponding stains observed on the roof.

The bituminous roof membrane was deemed to be in fair condition with signs of weathering/distress at many locations.

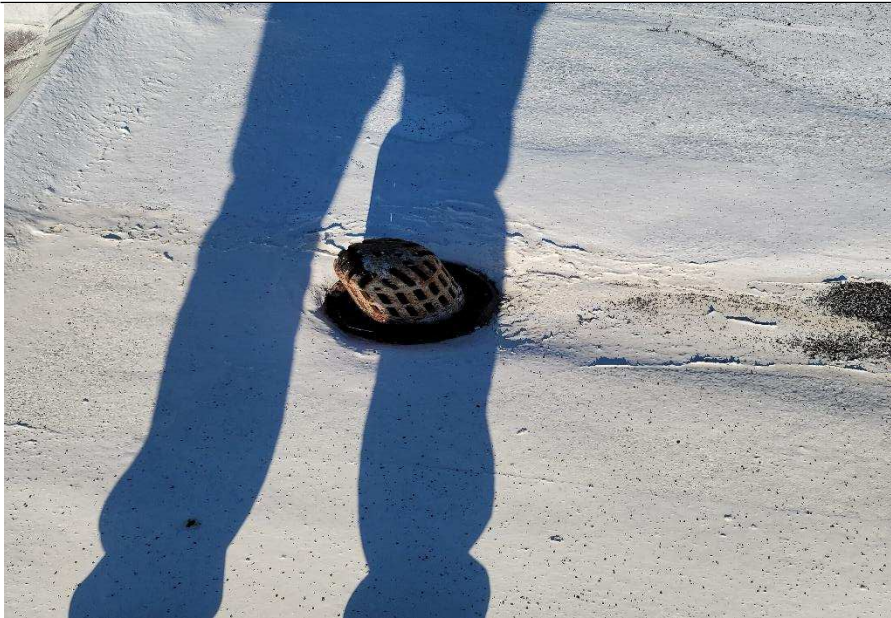
Photo #3:

The strainers for the interior drain lines were found to be rusted or non-functional since many of them are missing or not in their proper position. Others need maintenance to remove debris.

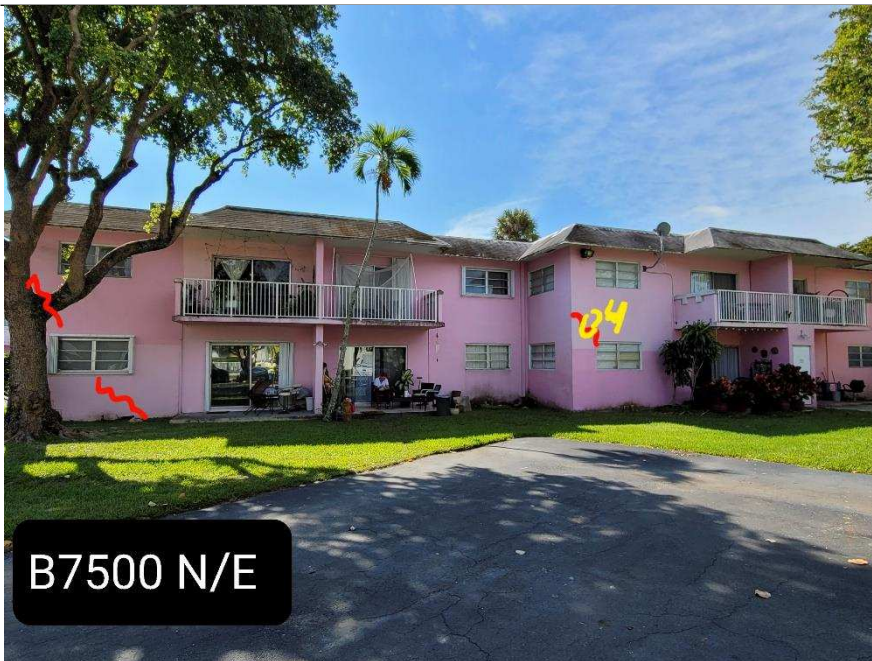
Photo #4:

The stuccoed envelope requires maintenance of the stucco exterior surfaces throughout the building. Fine horizontal and steps cracks observed sporadically. Most cracks located near the corners of the buildings or at the top/bottom corners of the wall openings.

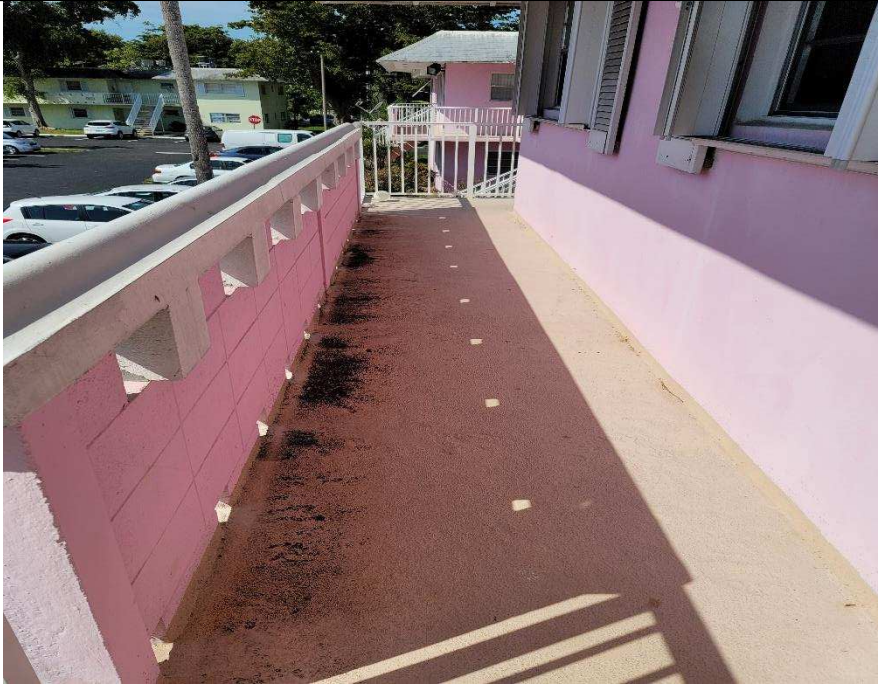
Photo #5:

The top wearing surface of the catwalks are stained or weathered and require maintenance.

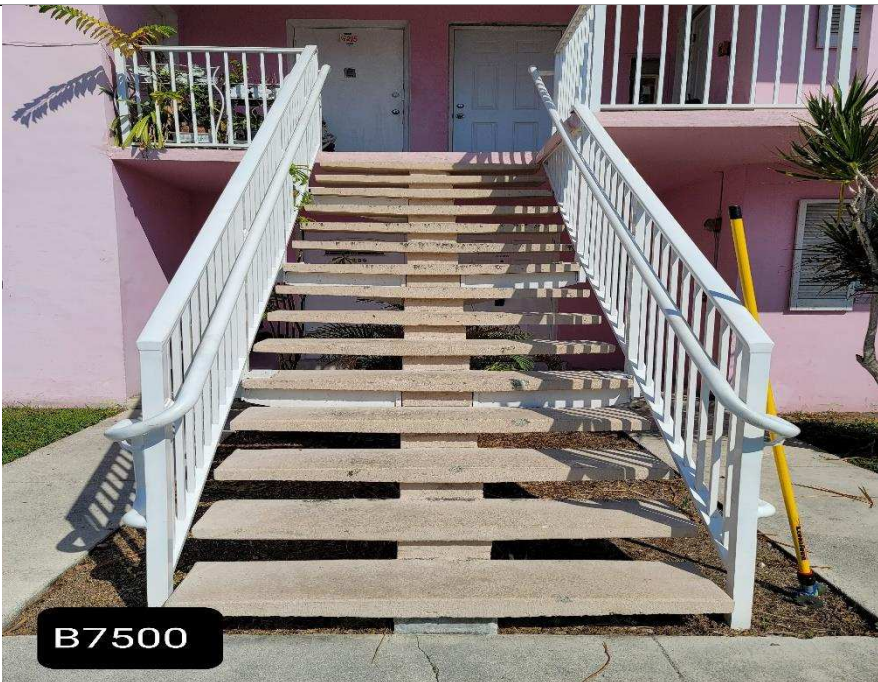
Photo #6:

The railings were deemed to be in fair/good condition.

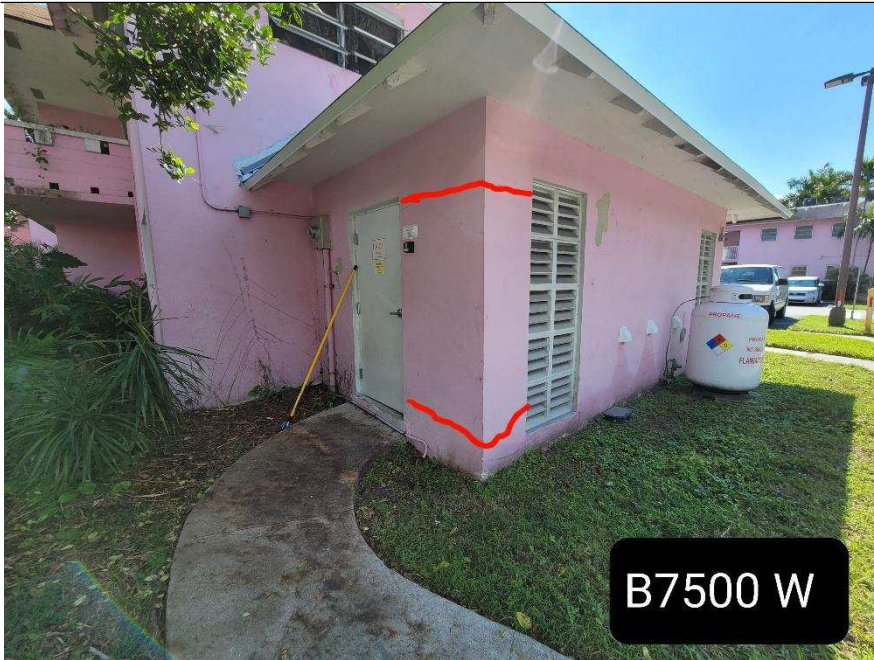
Photo #7:

Thru wall/pier cracks found at the corner of the laundry room.

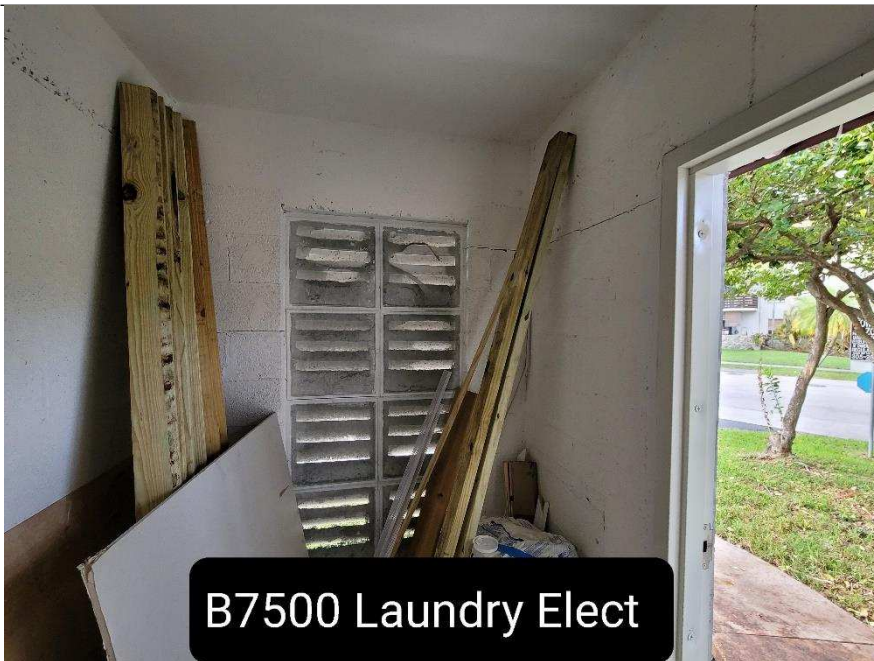
Photo #8:

Thru wall/pier cracks found at the corner of the laundry room.

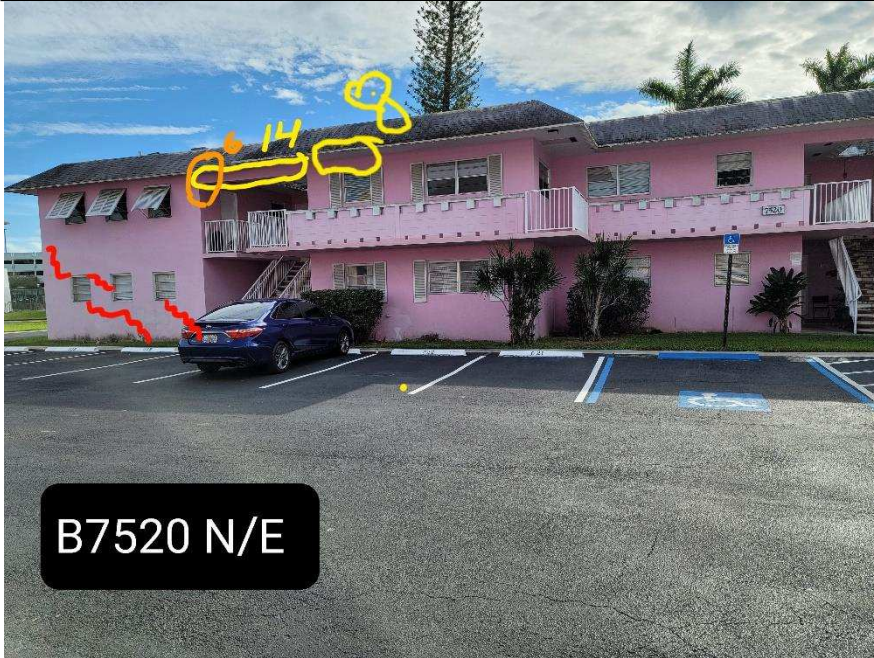
Photo #1:

Front elevation of building 7520 (Villa G)

The stuccoed envelope requires maintenance of the stucco exterior surfaces at many locations. Unsound stucco surfaces and surface cracks discovered at many areas of the exterior envelope.

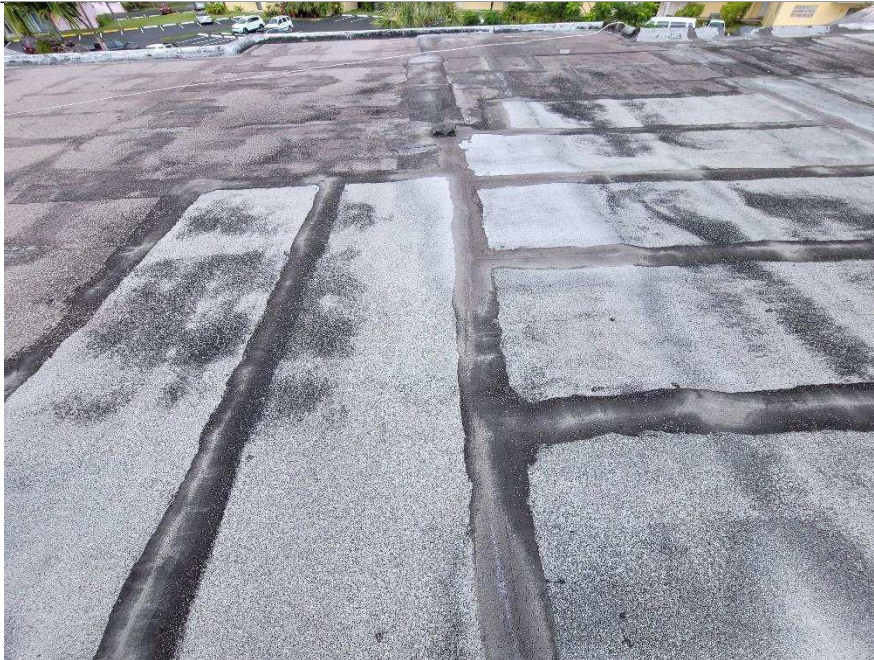
Photo #2:

Water ponding stains observed on the roof.

The bituminous roof membrane was deemed to be in fair condition with signs of weathering/distress at many locations.

The shingles of the mansard roof are also heavily weathered down.

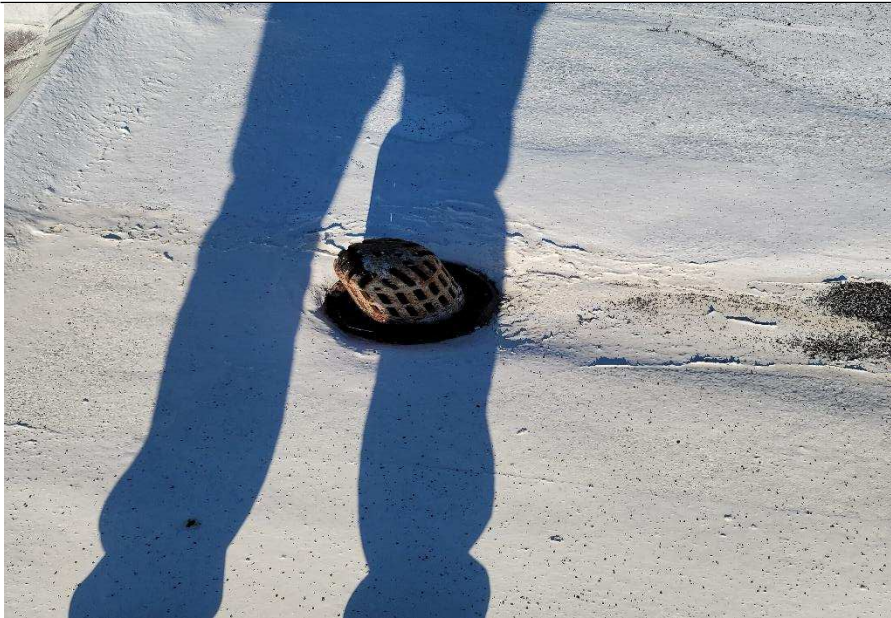
Photo #3:

The strainers for the interior drain lines were found to be rusted or non-functional since many of them are missing or not in their proper position. Others need maintenance to remove debris.

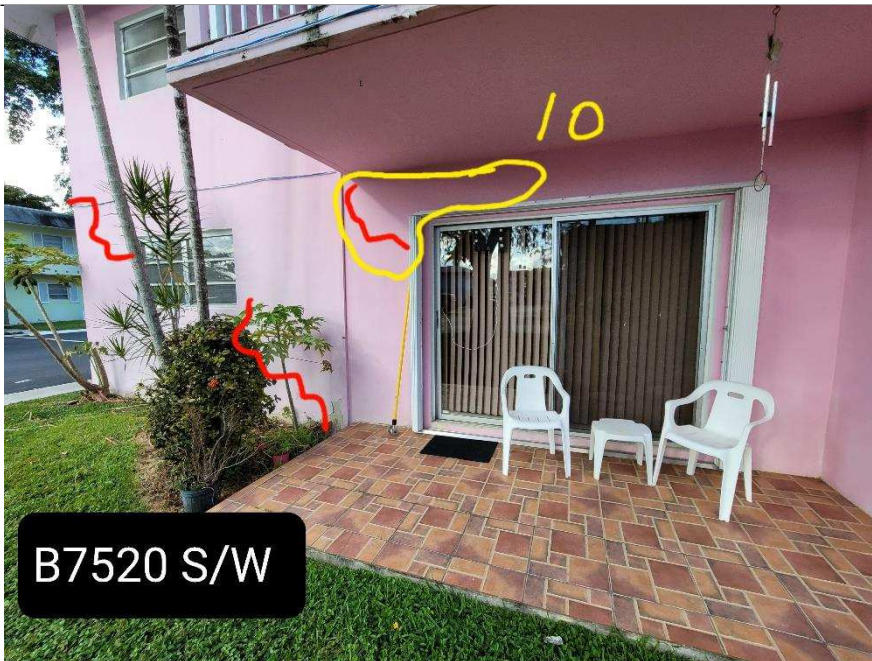
Photo #4:

The stuccoed envelope requires maintenance of the stucco exterior surfaces throughout the building. Fine horizontal and steps cracks observed sporadically. Most cracks located near the corners of the buildings or at the top/bottom corners of the wall openings.

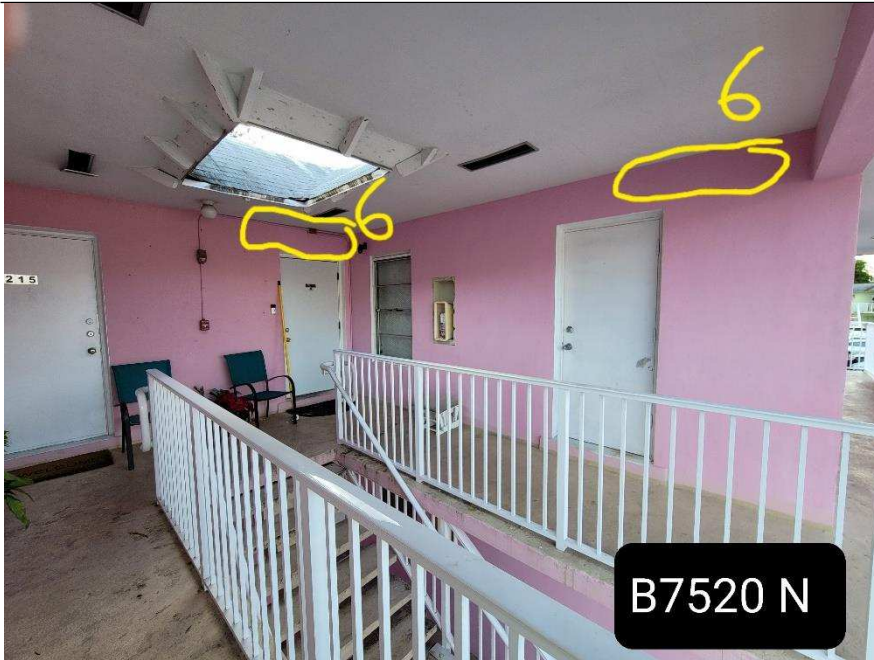
Photo #5:

The top wearing surface of the catwalks are stained or weathered and require maintenance.

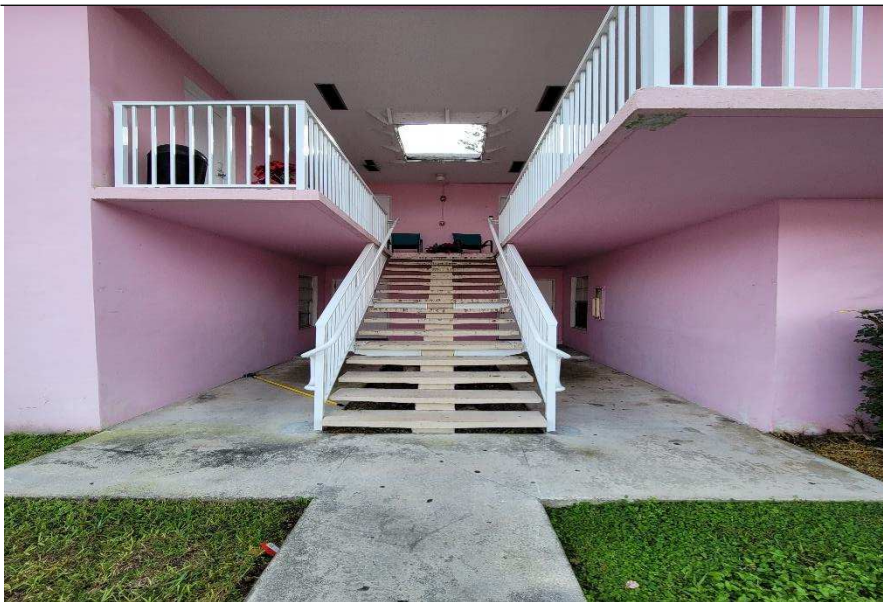
Photo #6:

The railings were deemed to be in fair/good condition.

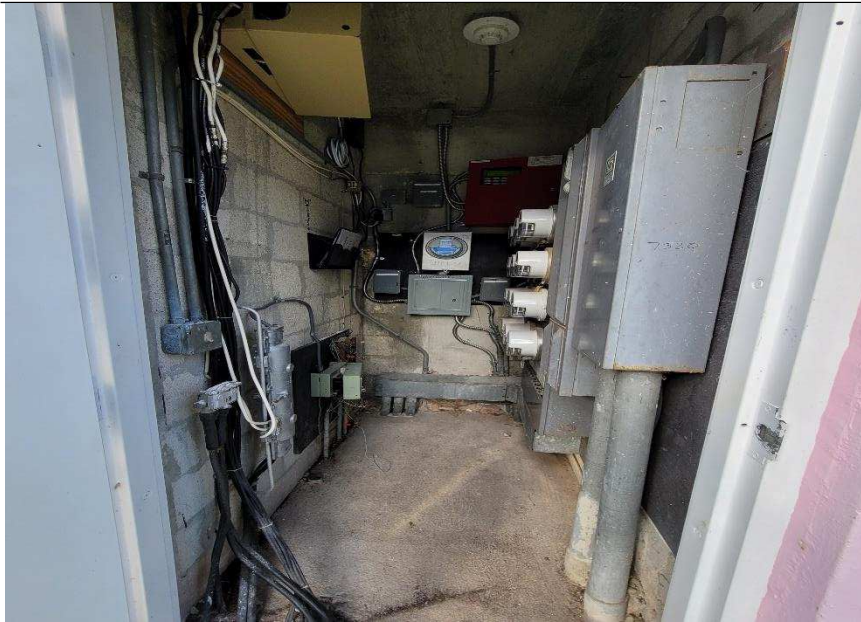
Photo #7:

The mechanical room was observed to be in good condition. Wall/ceiling penetration should be sealed.

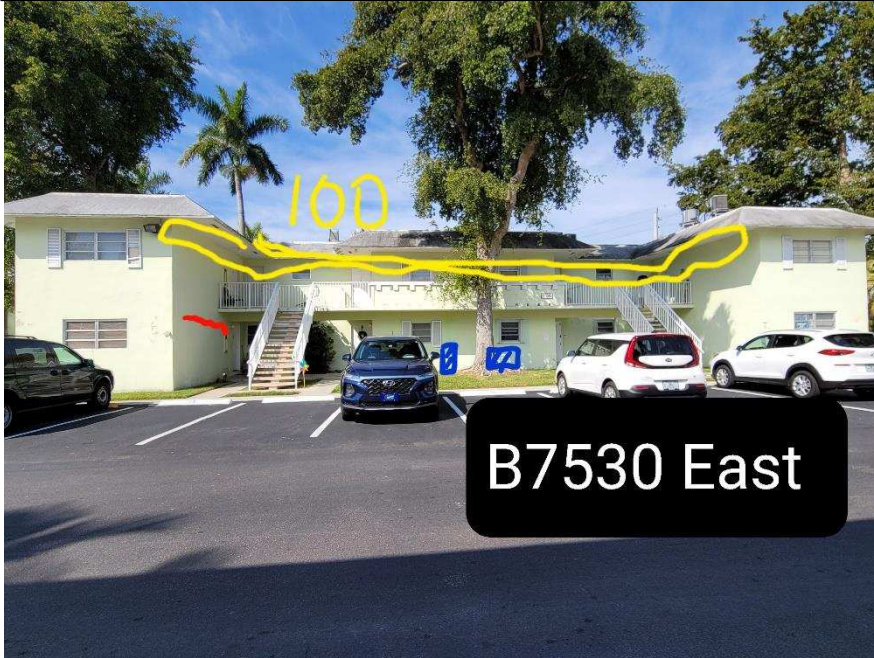
Photo #1:

Front elevation of building 7530 (Villa G)

The stuccoed envelope requires maintenance of the stucco exterior surfaces at many locations. Unsound stucco surfaces and surface cracks discovered at many areas of the exterior envelope.

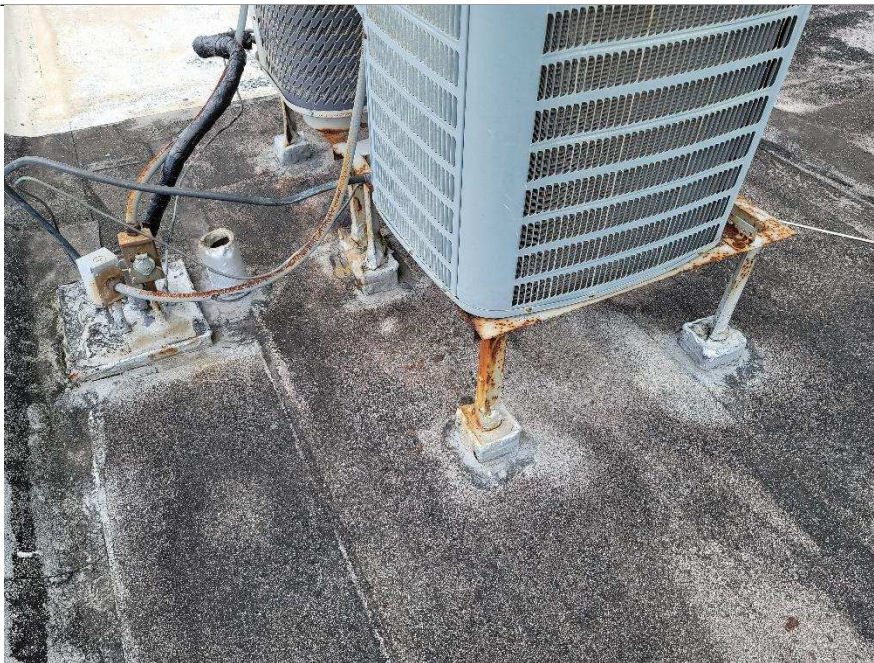
Photo #2:

Water ponding stains observed on the roof.

The bituminous roof membrane was deemed to be in fair condition with signs of weathering/distress at many locations.

The shingles of the mansard roof are also heavily weathered down.

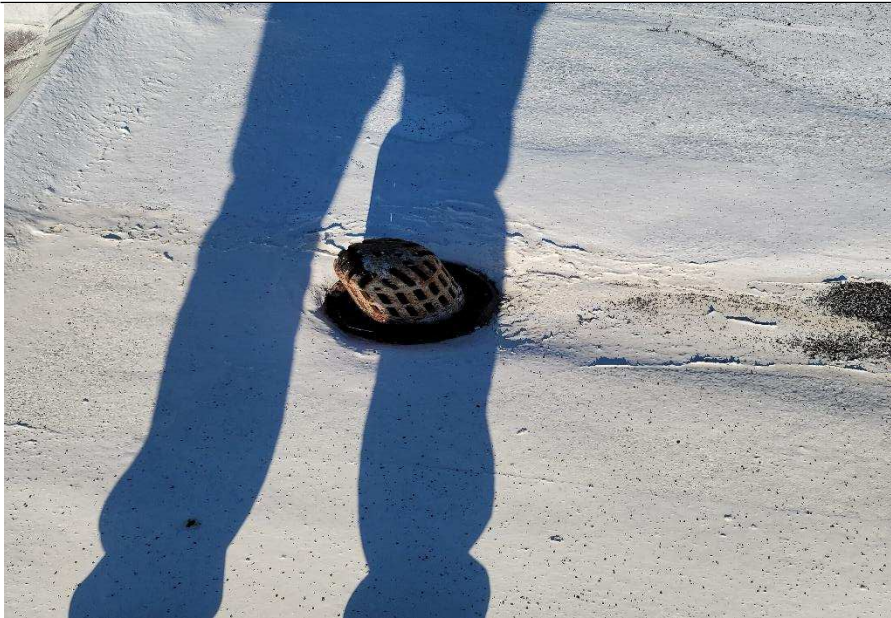
Photo #3:

The strainers for the interior drain lines were found to be rusted or non-functional since many of them are missing or not in their proper position. Others need maintenance to remove debris.

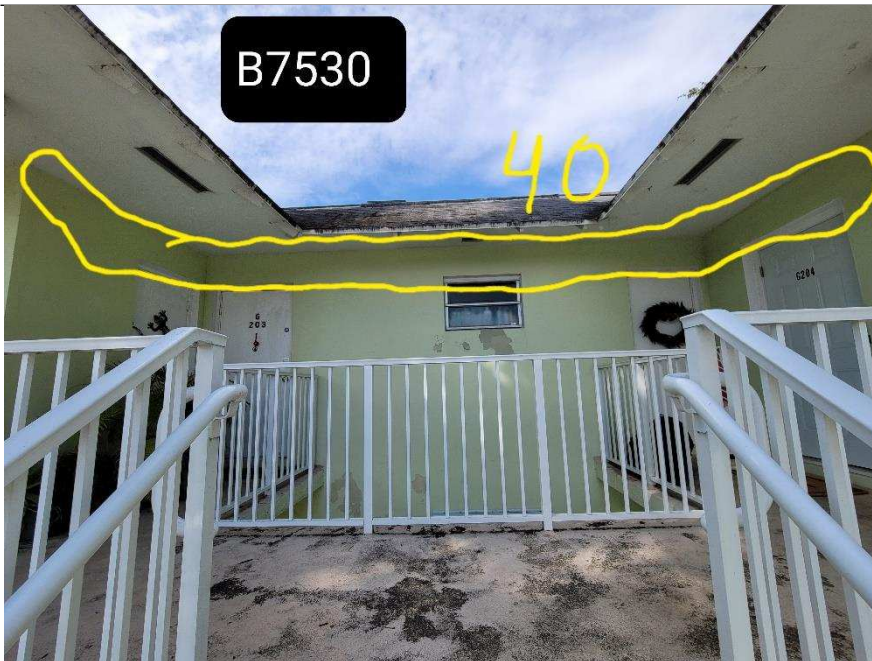
Photo #4:

The stuccoed envelope requires maintenance of the stucco exterior surfaces throughout the building.

The top wearing surface of the catwalks are stained or weathered and require maintenance.

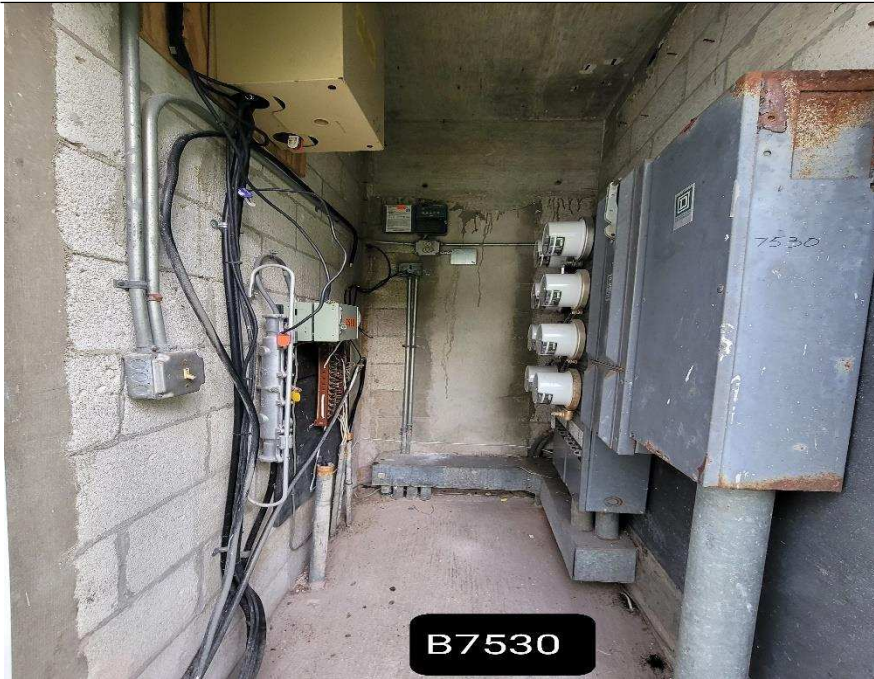
Photo #5:

The mechanical room was observed to be in good condition. Wall/ceiling penetration should be sealed.

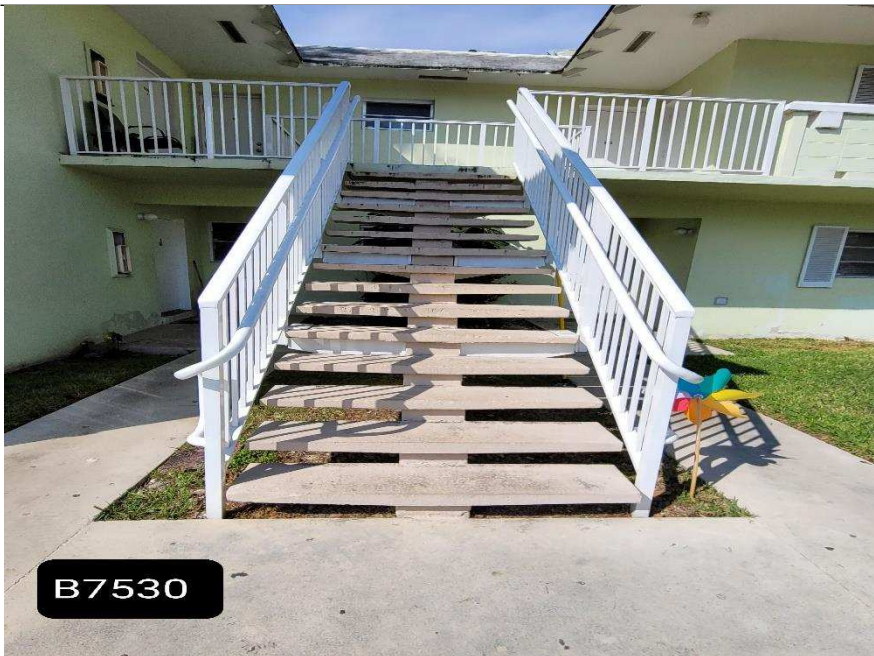
Photo #6:

The railings were deemed to be in fair/good condition.

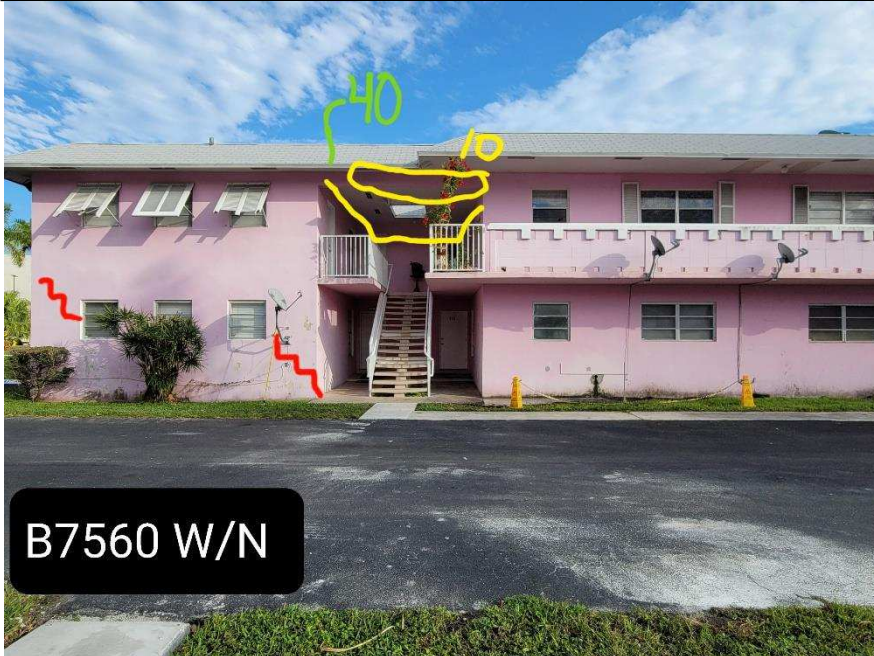
Photo #1:

Front elevation of building 7560 (Villa G)

The stuccoed envelope requires maintenance of the stucco exterior surfaces at many locations. Unsound stucco surfaces and surface cracks discovered at many areas of the exterior envelope.

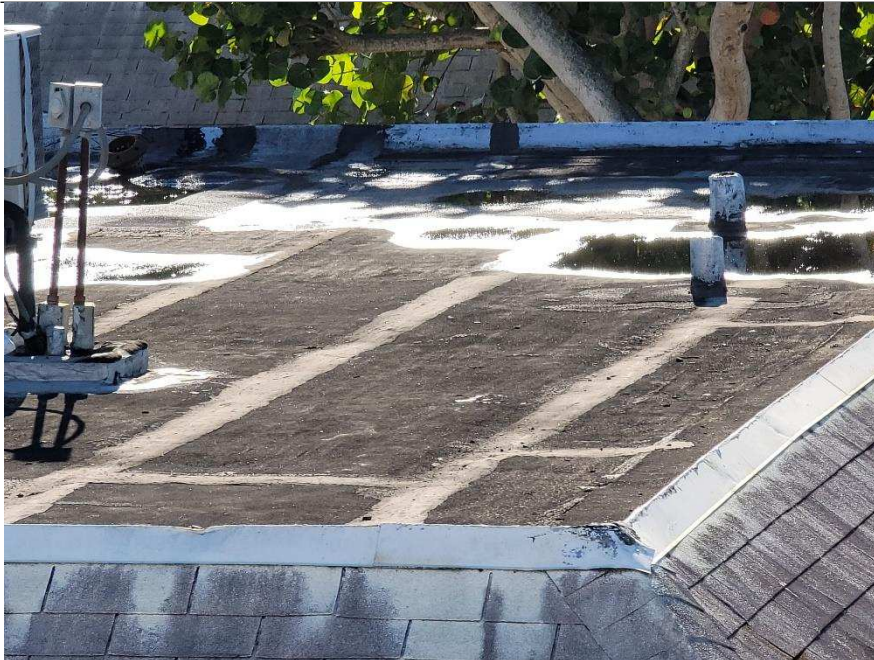
Photo #2:

Water ponding stains observed on the roof.

The bituminous roof membrane was deemed to be in fair condition with signs of weathering/distress at many locations.

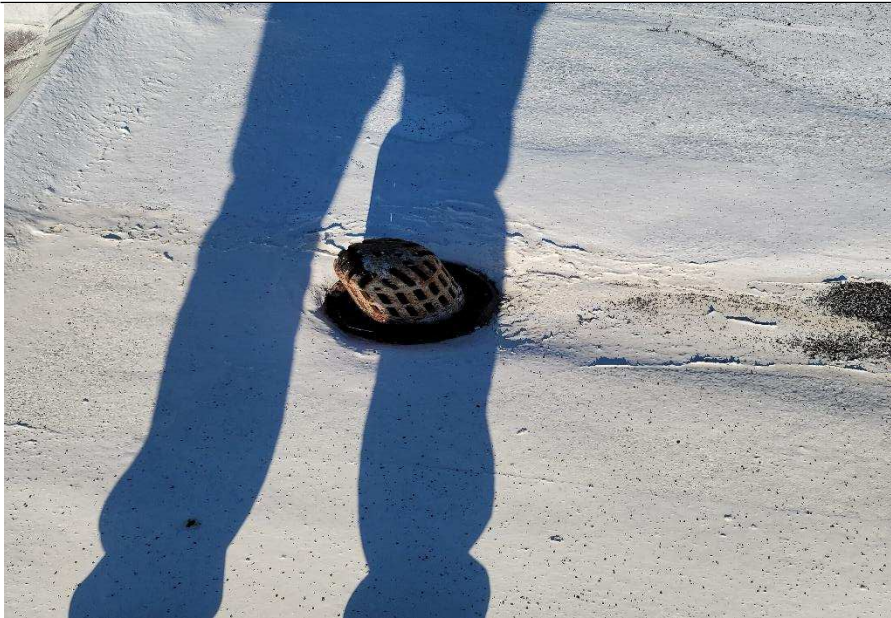
Photo #3:

The strainers for the interior drain lines were found to be rusted or non-functional since many of them are missing or not in their proper position. Others need maintenance to remove debris.

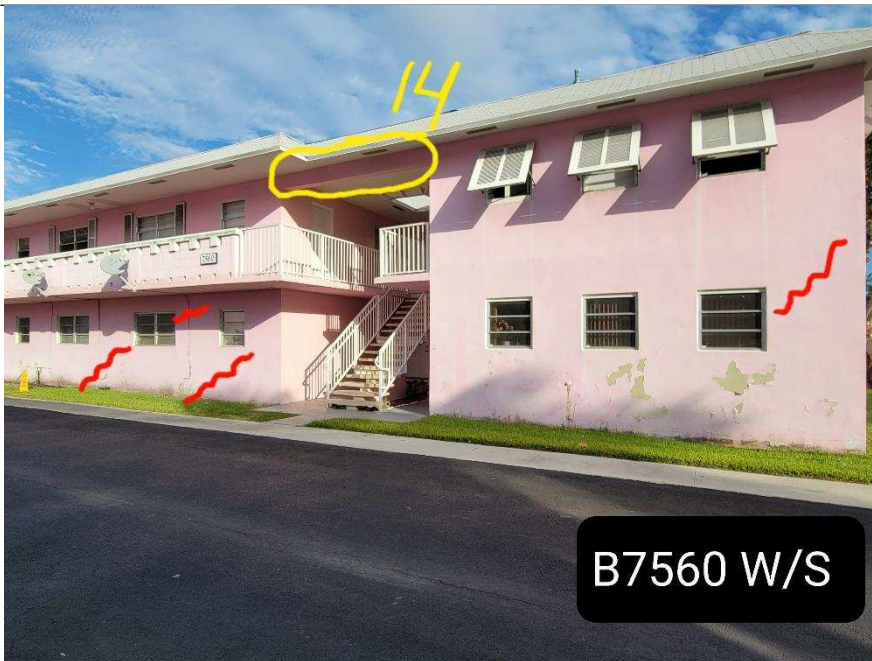
Photo #4:

The stuccoed envelope requires maintenance of the stucco exterior surfaces throughout the building. Fine horizontal and steps cracks observed sporadically. Most cracks located near the corners of the buildings or at the top/bottom corners of the wall openings.

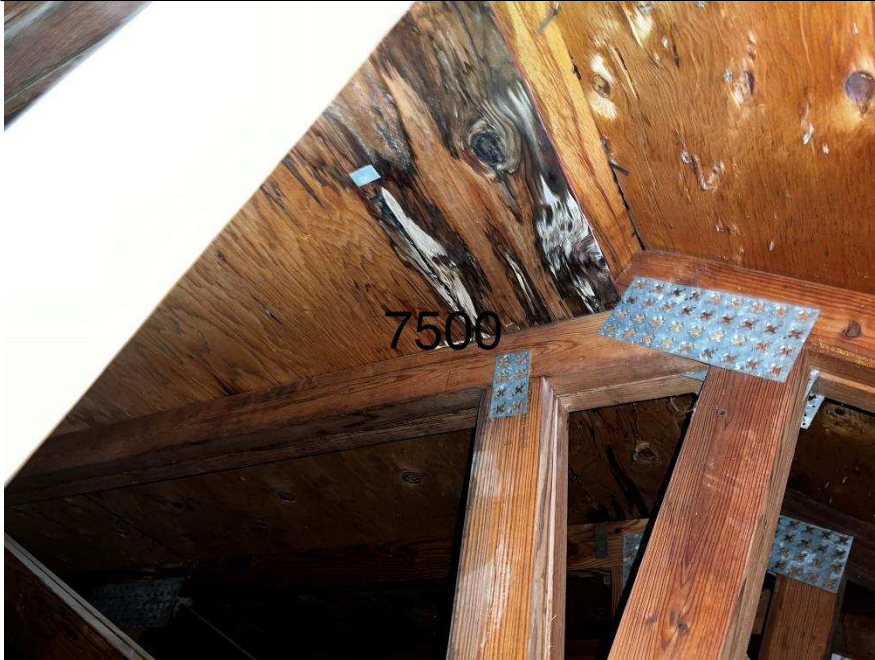
Photo #5:

Where accessible the roof structure was observed and found to be in fair condition.

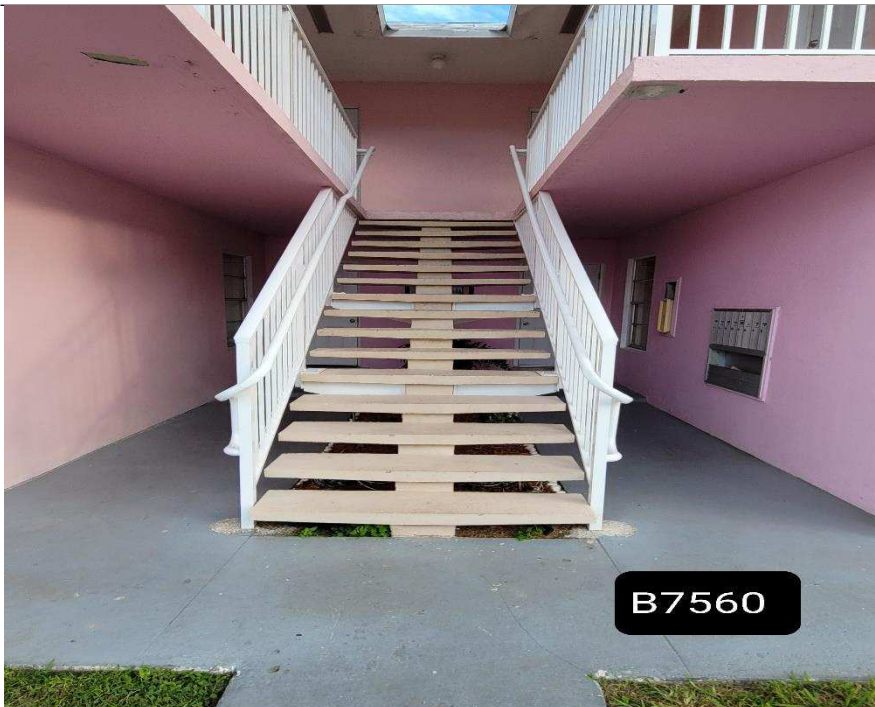
Photo #6:

The railings were deemed to be in fair/good condition.
