The Journal of RCI

THE DAY AFTER:

Documentation of Damage to Roofs from a Hailstorm and the Subsequent Restoration Efforts

By Karl A. Schaack, RRC, PE

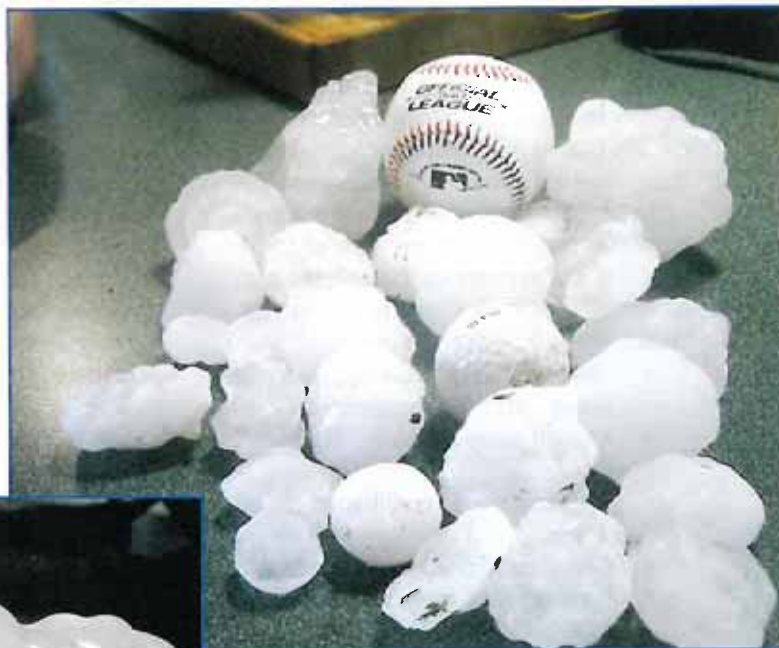
Photo 2 – Hailstones collected by homeowner on May 4, 2006⁽⁴⁾.

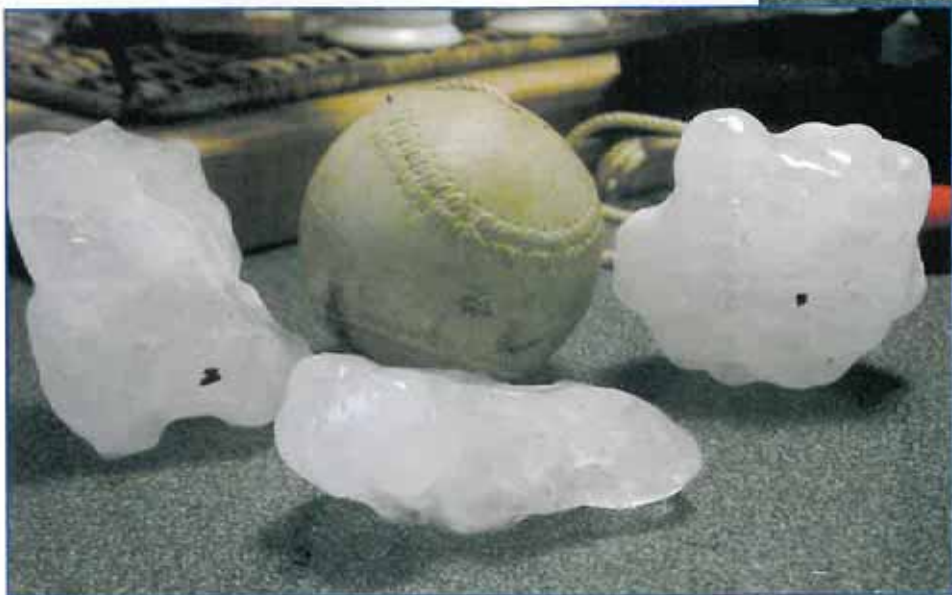
stones⁽¹⁾ were reported at various times and locations within this storm. According to a HailTrax map from Weather Decision Technologies⁽³⁾, the center linear portion of the storm was populated with hailstones 2 inches and greater in diameter, and the periphery of the storm was populated with hailstones 0.75 inch to 1.75 inches in diameter. Several homeowners located within the storm area confirmed reported hail sizes with photographic documentation of stones collected from accumulations on the grounds

Photo 1 – Hailstones collected by homeowner on May 4, 2006⁽⁴⁾.

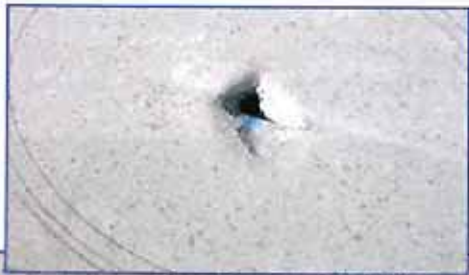
Damage observed on the single-ply membranes on the schools located within the area subjected to the hail greater than 2 inches in diameter included large punctures completely through the membrane, exposing the underlying insulation (Photos

Photo 3 – Large puncture in single-ply membrane.

3 and 4). This level of damage was widespread but sporadic, with no uniformity across the roofs. These punctures were found in approximately one to four locations within a 100-sq-ft area.

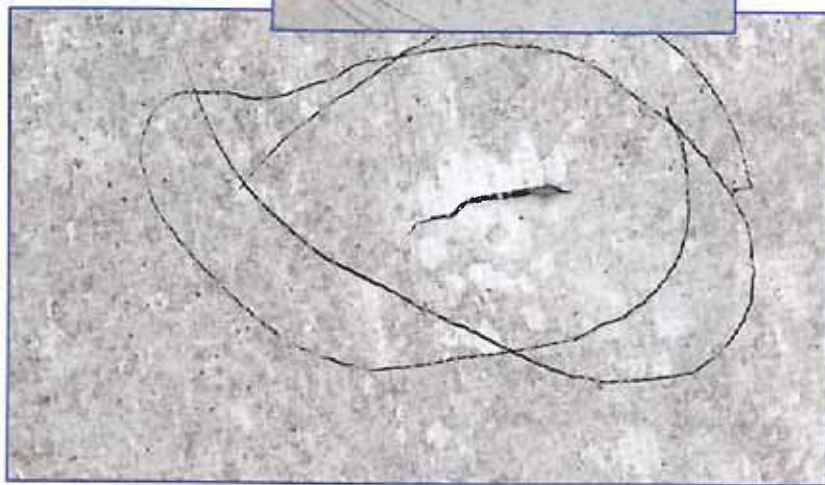
Right: Photo 4 – Large puncture in single-ply membrane.

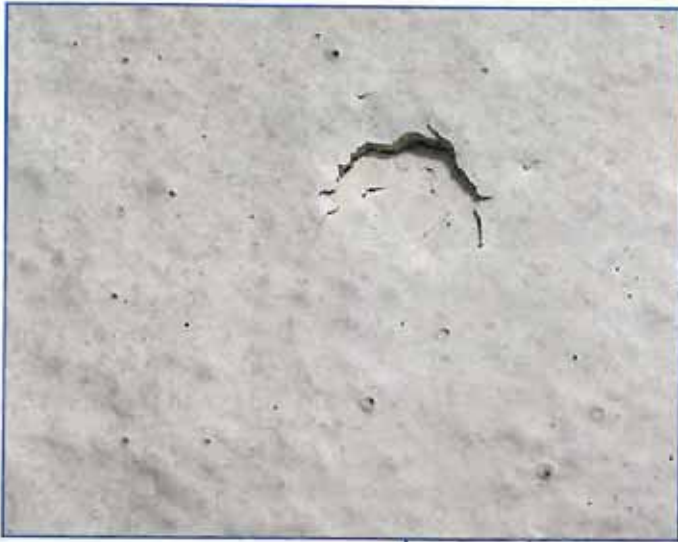
Similar damage was also observed on the spray-applied polyurethane foam roofs on the high school. This damage ranged from spiral-shaped cracks in the elastomeric coating to punctures through the coating, exposing the underlying foam core (Photos 7 and 8). The foam was more readily damaged in areas containing blisters. However, physical damage was also observed where the foam was sound and intact.

Photo 7 – Hail impact on SPUF.

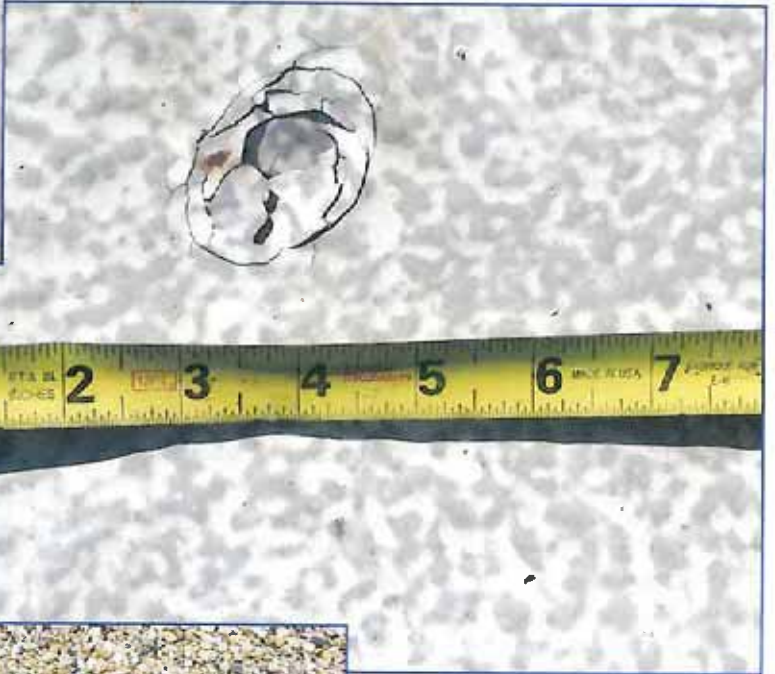
Photo 8 – Hail impact on SPUF.

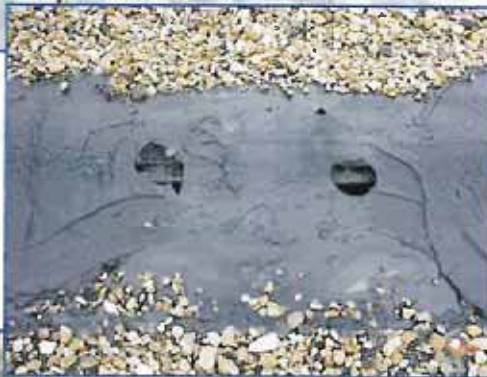
There was no obvious evidence of any physical damage on the gravel-surfaced, built-up roof membrane. Physical damage did occur to an elastomeric bellows expansion joint cover. Many large punctures (approximately 2 inches in diameter) were observed throughout the length of the bel-

lows (Photo 9), which was somewhat brittle and weathered.

Photo 9 – Punctures in weathered expansion joint.

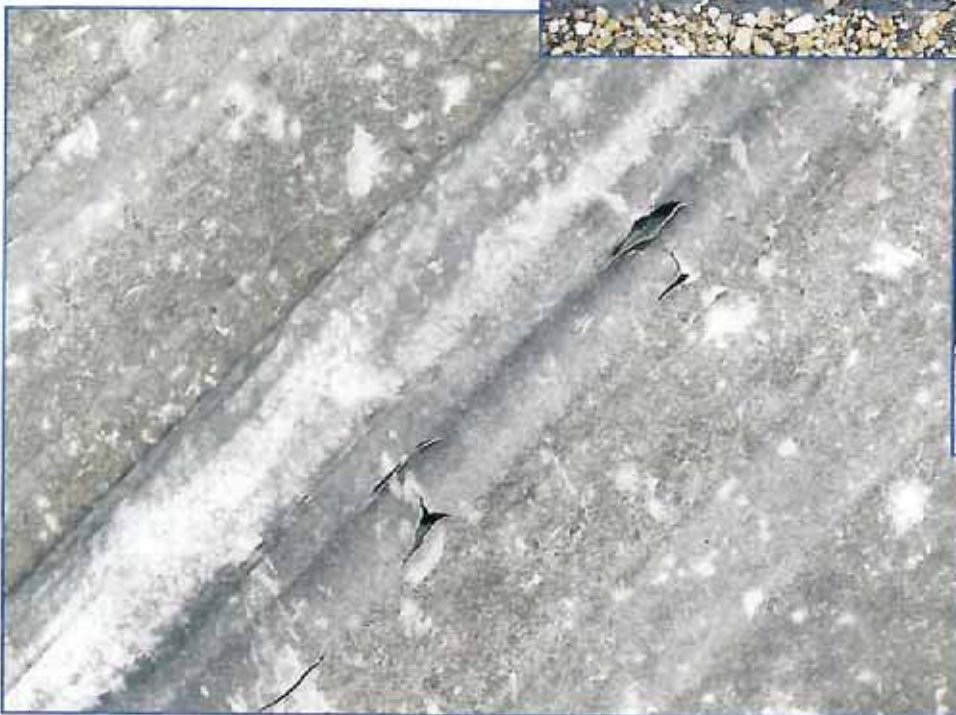
Observations of metal roofs indicated that damage was more cosmetic than damaging to the weatherproofing ability of the panel. Indentations were observed in prefinished metal panels, but the paint finish did not appear to have been affected. On the coated corrugated metal panels, chips were observed in the coating, which exposed the underlying metal core (Photo 10). Large indentations were observed in light-gauge corrugated metal panels that were installed over building entrances (Photo 11).

Photo 10 – Fractures in coating on metal roof.

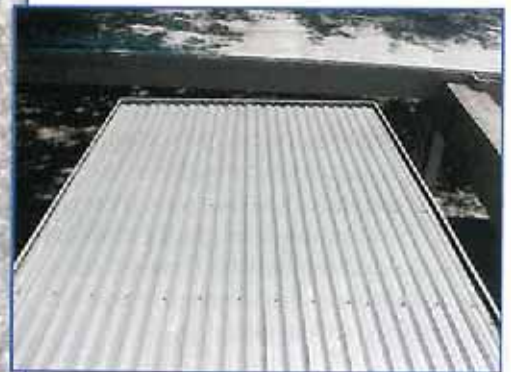
Photo 11 – Large dents in metal canopy.

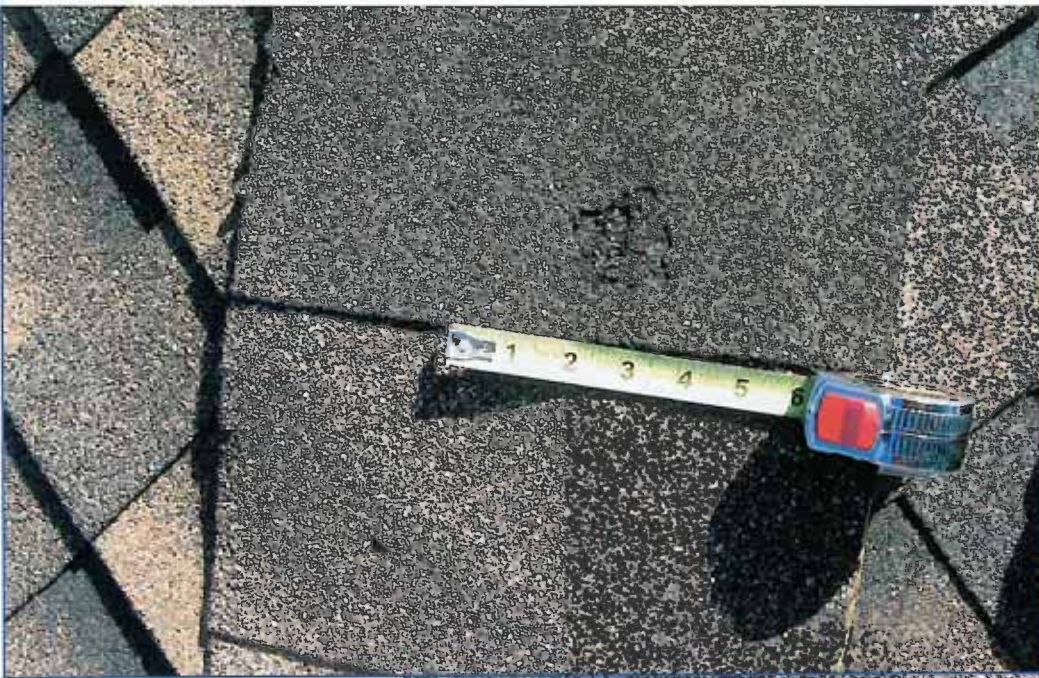
Photo 12 – Large impact on ridge shingle.

Damage observed on asphalt shingles varied from granule loss and breakage at unsupported ends and sides to large abrasions and indentations (*Photo 12*). Physical damage was more prevalent along the ridges (*Photo 13*).

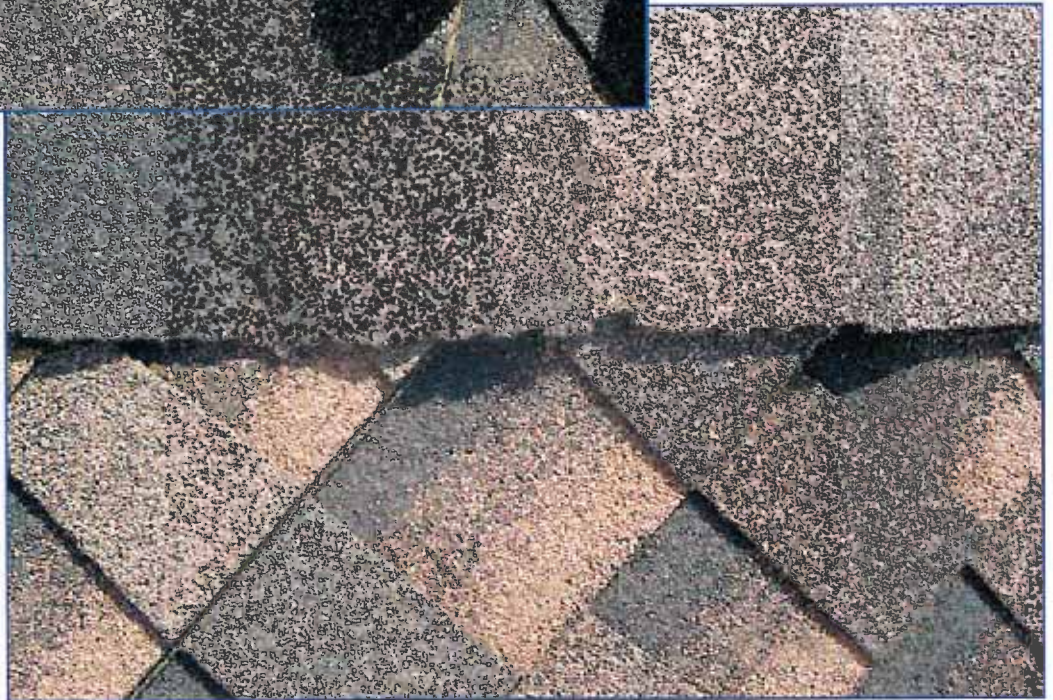
Photo 13 – Damage to edges of ridge shingles.

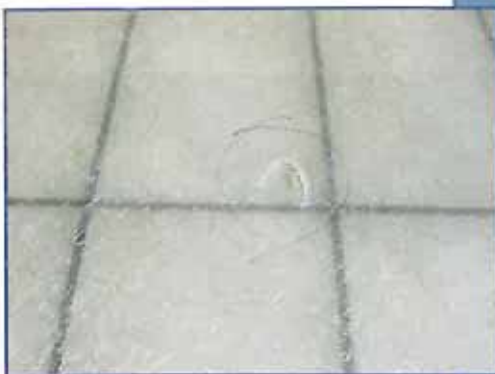
Damage to skylights included fracturing of glazing material (i.e., fiberglass and acrylic). See *Photos 14* and *15*. Large punctures and holes completely penetrated the glazing material (*Photos 16* and

Photo 14 – Fracture in fiberglass skylight.

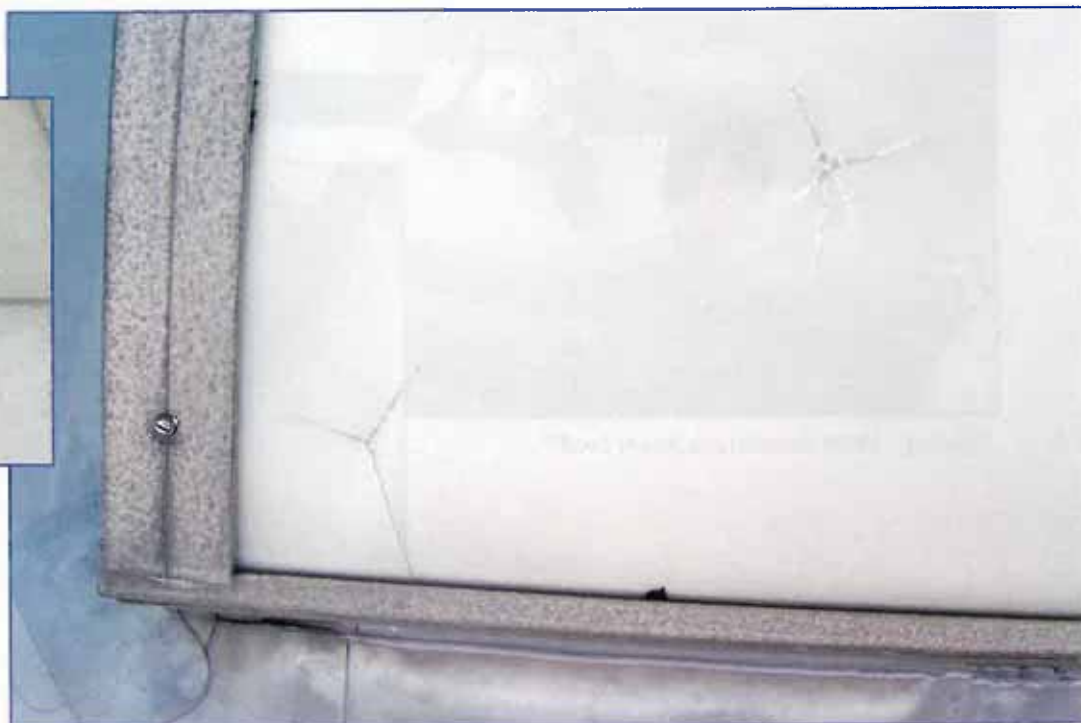
Photo 15 – Fracture in acrylic skylight.

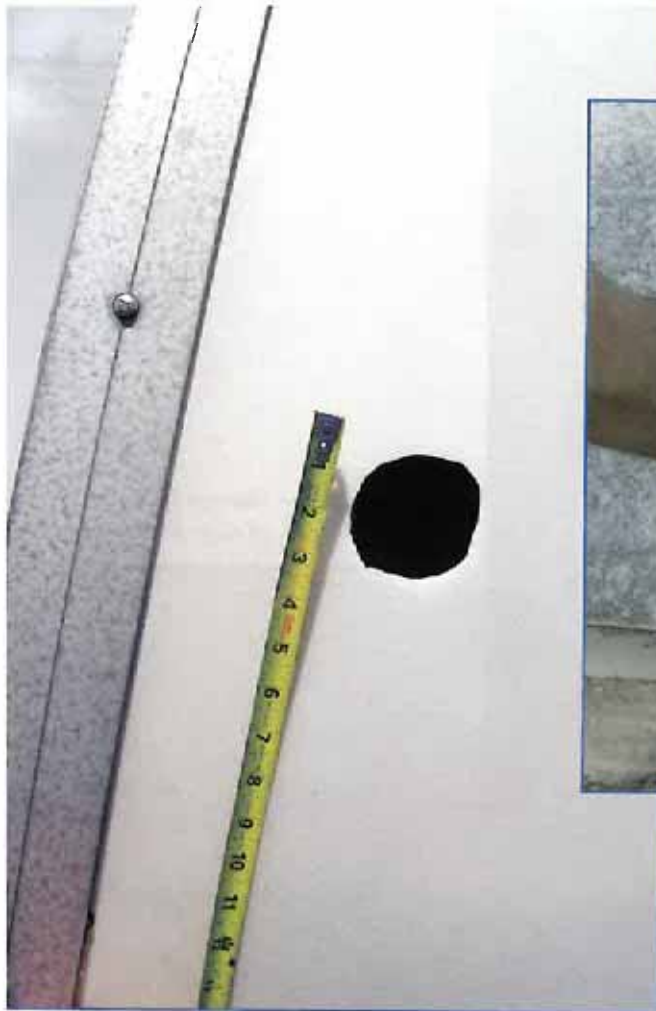
Photo 16 – Hole in barrel skylight.

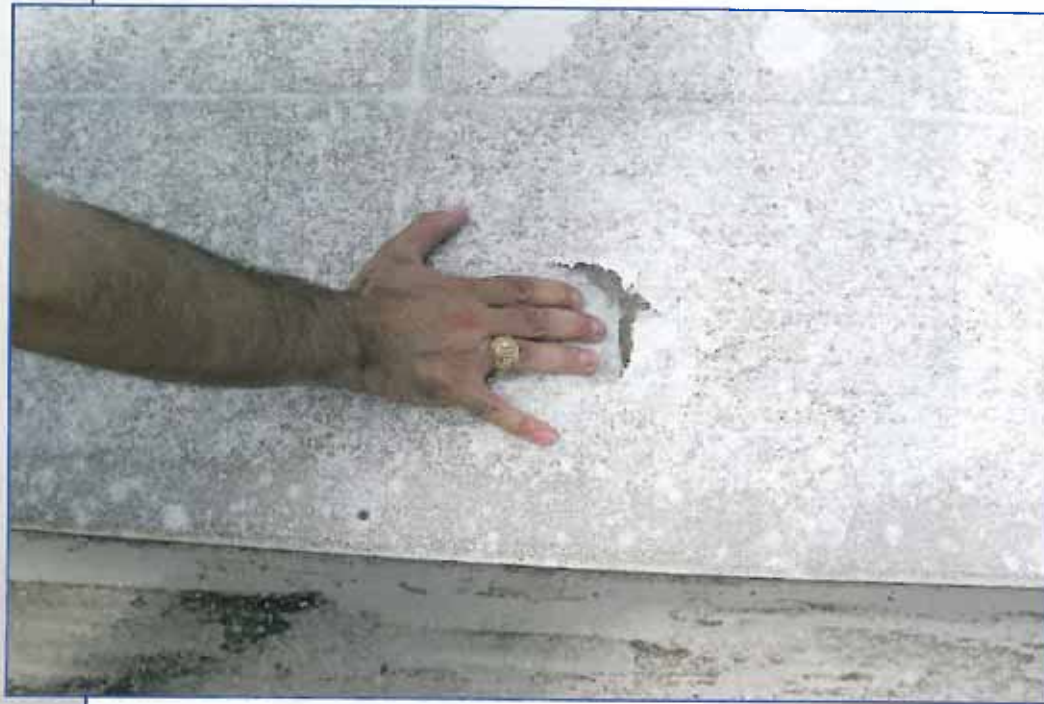
Photo 17 – Puncture in fabric skylight.

17). Damage on the fiberglass sandwich panels occurred only on the top layer of fiberglass. Some domes did not exhibit any visible damage.

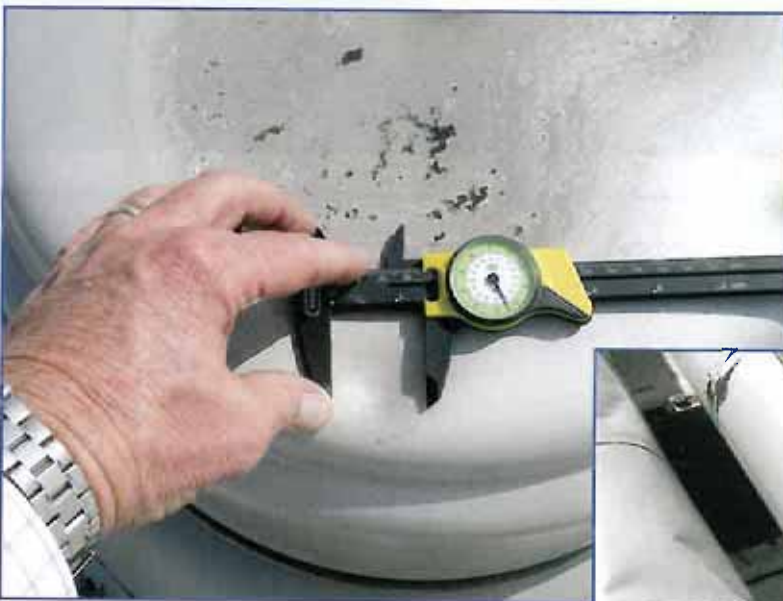
Indentations were observed on many light-gauge sheet-metal equipment hoods (Photo 18), as well as metal jackets on insulated water piping (Photo 19).

Photo 18 – Dents in metal equipment hood.⁽⁵⁾

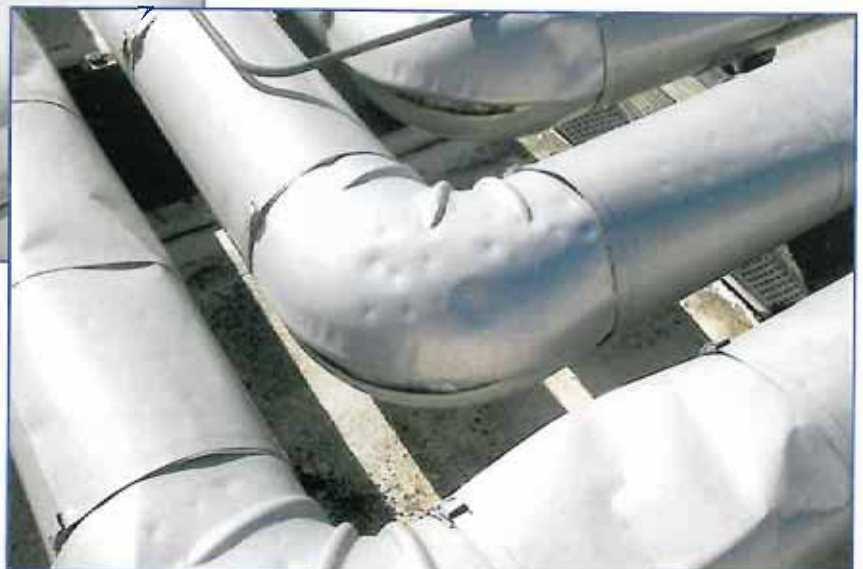
Photo 19: Dents in metal jacket on insulated piping.

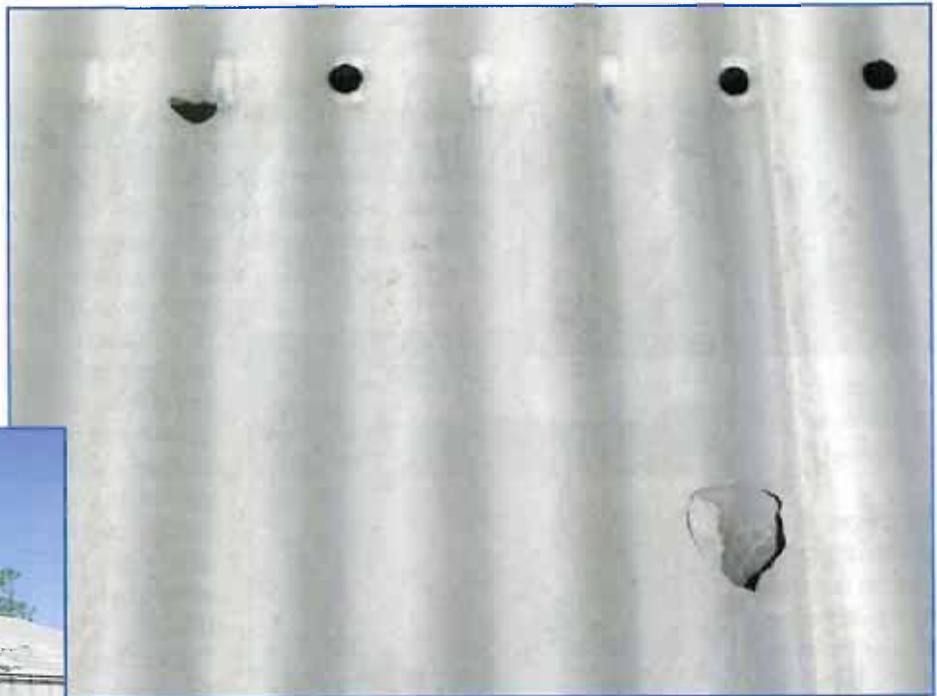
Both corrugated fiberglass-reinforced panels and flat-glass panels utilized as sloped glazing for greenhouses sustained damage. Punctures and isolated fractures were noted in fiberglass-reinforced panels (Photo 20). Glass panels sustained widespread breakage (Photo 21). Exterior insulated ductwork exhibited similar large punctures extending through the fabric covering and into the fiberglass insulation (Photos 22 and 23).

Photo 20 – Puncture in corrugated fiberglass panel.

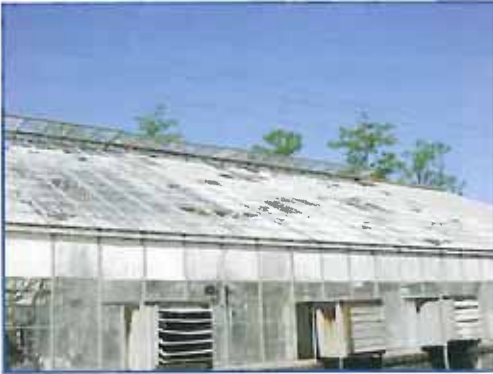
Photo 21 – Significant damage to glass panels.

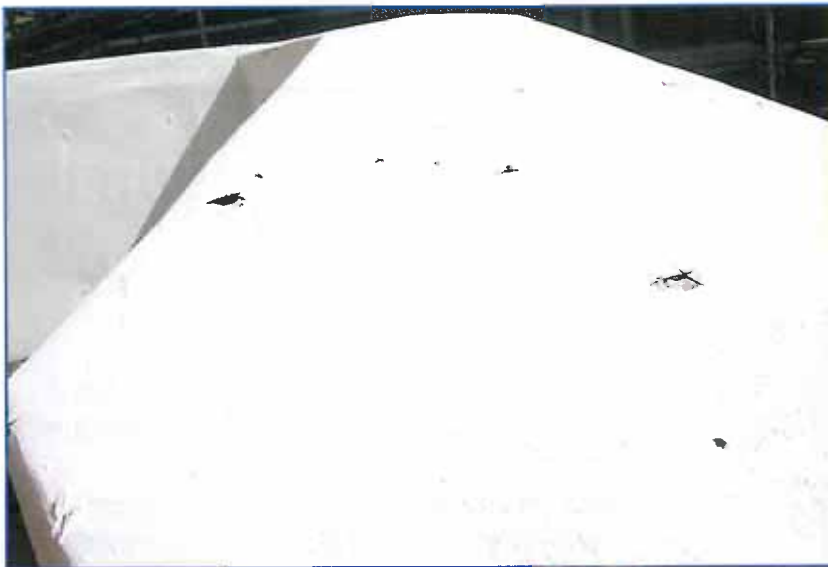
Photo 22 – Punctures in exterior insulated duct.

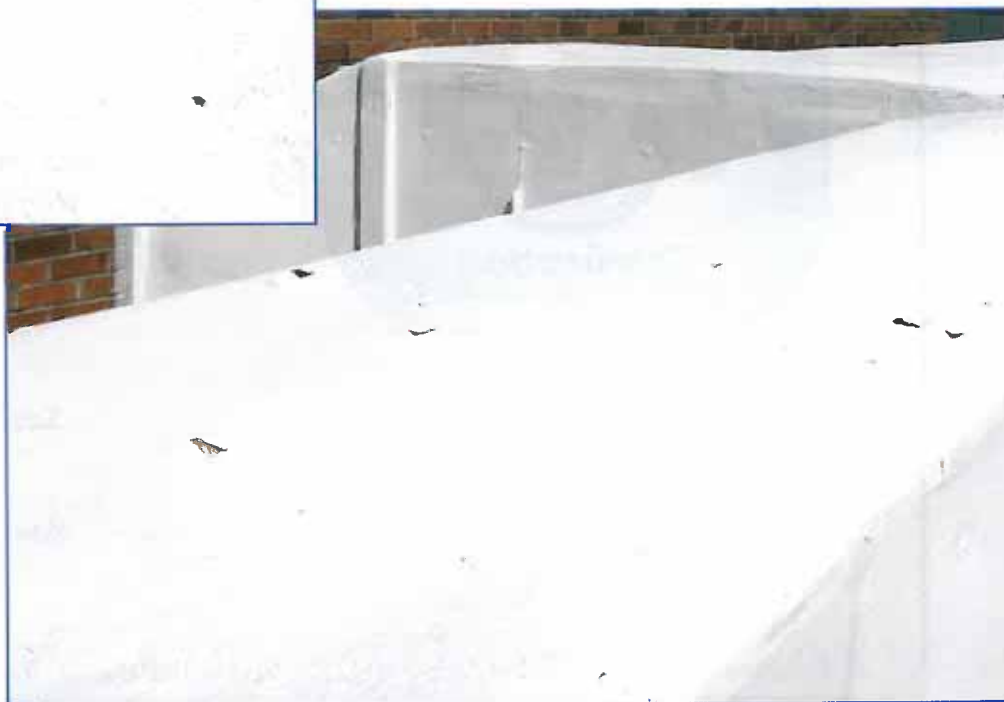
Photo 23 – Punctures in exterior insulated duct.

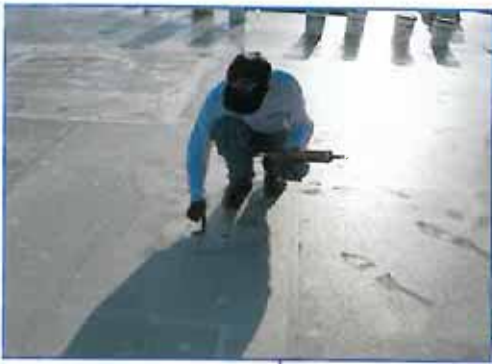
Photo 24 – Applying sealant to damaged areas on single-ply.

Immediately after the storm, school district personnel performed emergency repairs on damaged single plies until more permanent repairs could be implemented. This was to alleviate water infiltration into the buildings and to prevent subsequent damage to interior finishes and goods. Emergency repairs consisted of wiping the area of the membrane clean with a damp towel (to remove surface dirt), gunning a dollop of polyurethane sealant over the puncture, and troweling or tooling sealant to form a cap bead over the damaged area (Photo 24). This repair was performed in each area that exhibited an obvious puncture or fracture through the membrane. It was effective in stopping direct water infiltration during brief rain.

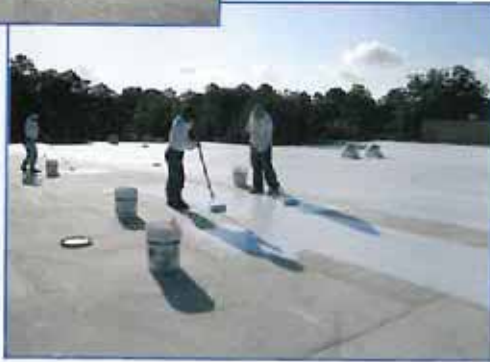
Photo 25 – Applying coating to damaged single-ply membrane.

On these subject roofs, an elastomeric coating was applied to the surface of the single-ply membranes (Photo 25). The surface of the single-ply membrane was initially swept clean of

performed, due to the chances of further introduction of moisture into the roof and building. After the surface preparation, a single layer of an elastomeric coating was applied with a roller to the roof membrane and flashings. This repair process was performed on a total of three schools and was found to be effective in alleviating further water infiltration until the roofs could be replaced.

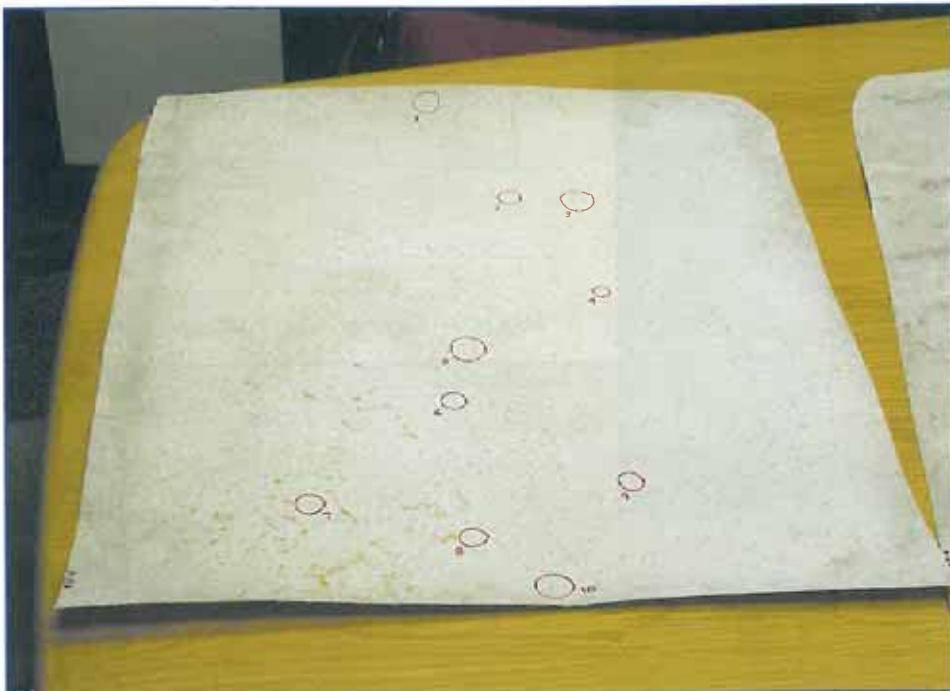
Upon initial review, physical damage was evident at approximately four to six random locations (Photos 26 and 27). However, after cleaning the top surface of

Photo 26 – Top view of typical sample.

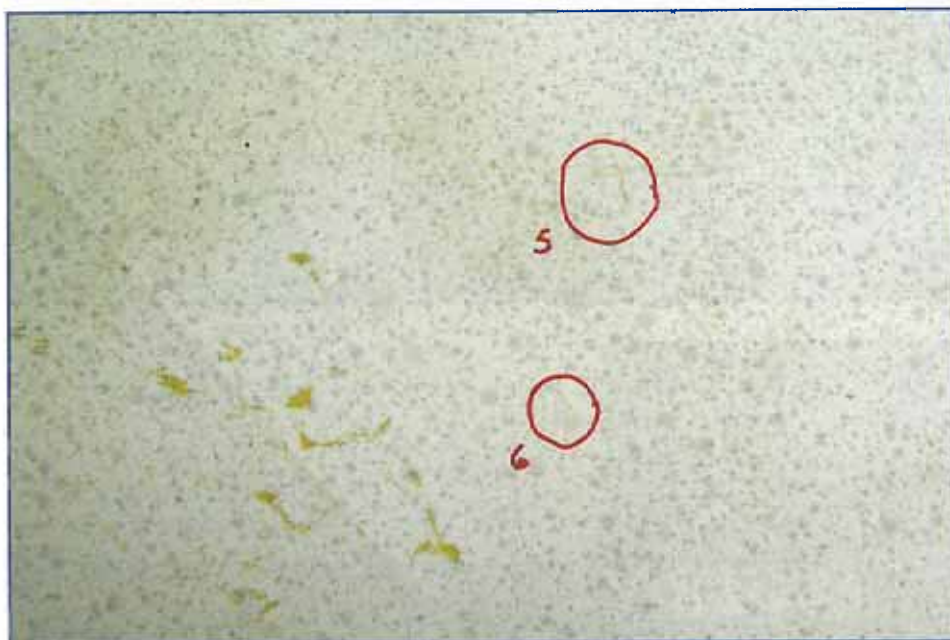
Photo 27 – Close-up view of typical damage on top side.

the membrane and upon closer visual inspection, physical damage was observed at three to four locations, which were considered to be relatively small, at 1/4 in to 1/2 in long. This extent of damage was not readily visible when walking the roof or handling the uncleaned sample at arm's length, due to the small size of the actual damage (1/8 inch to 1/4 inch in length) and to dirt accumulation on the membrane top surface.

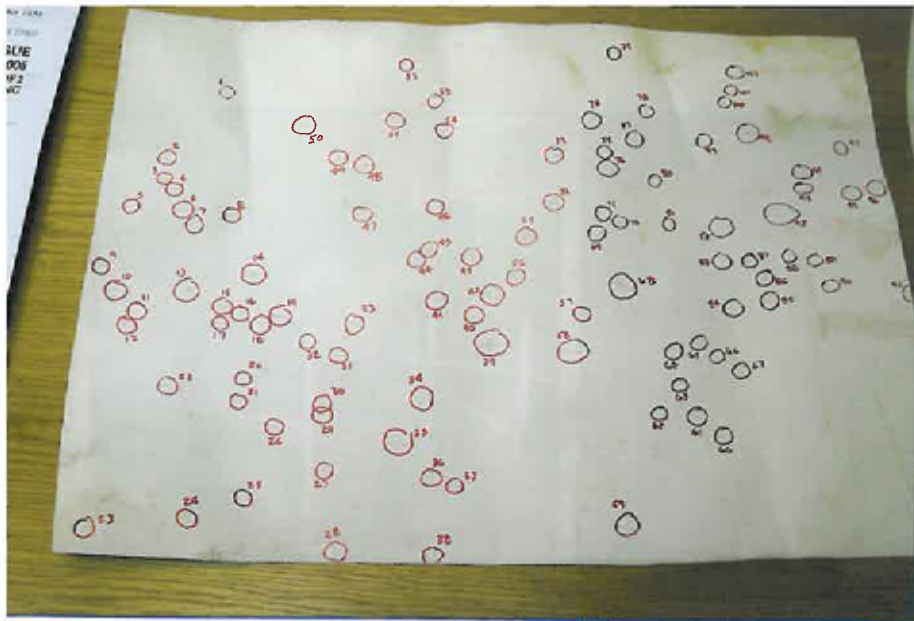
only at the locations corresponding to the top surface spots but also at additional problem locations throughout the samples (Photos 28 and 29). Since the underside of the membrane was relatively clean, the damage was readily evident.

Photo 28 – View of damage from bottom of sample.

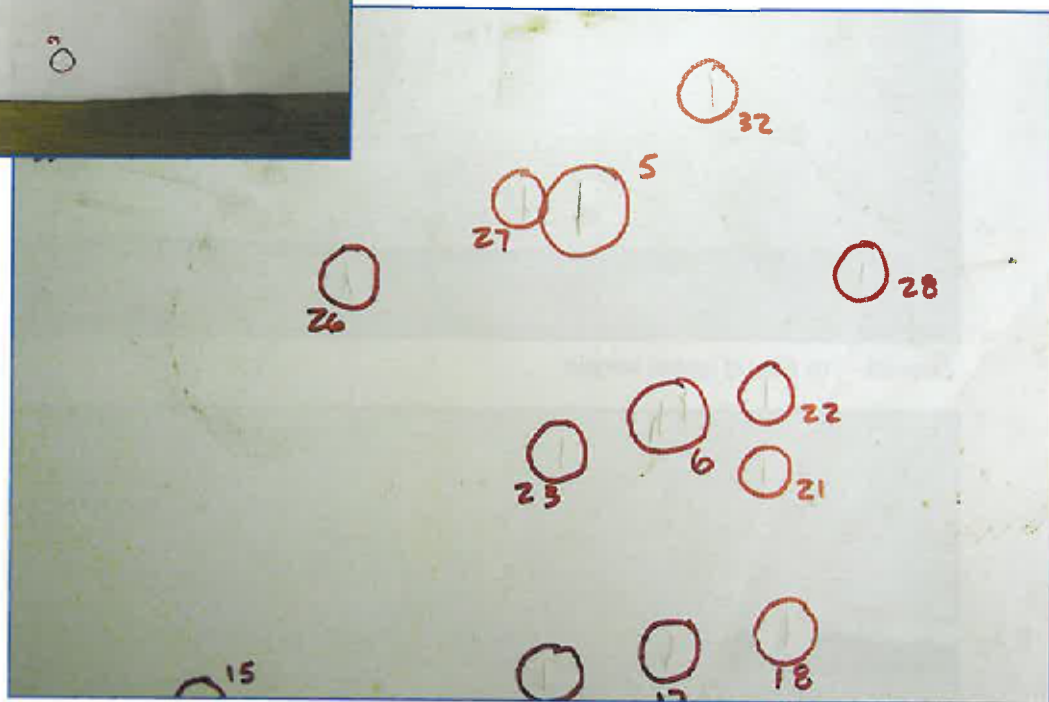
Photo 29 – Close-up view of damage on bottom side.

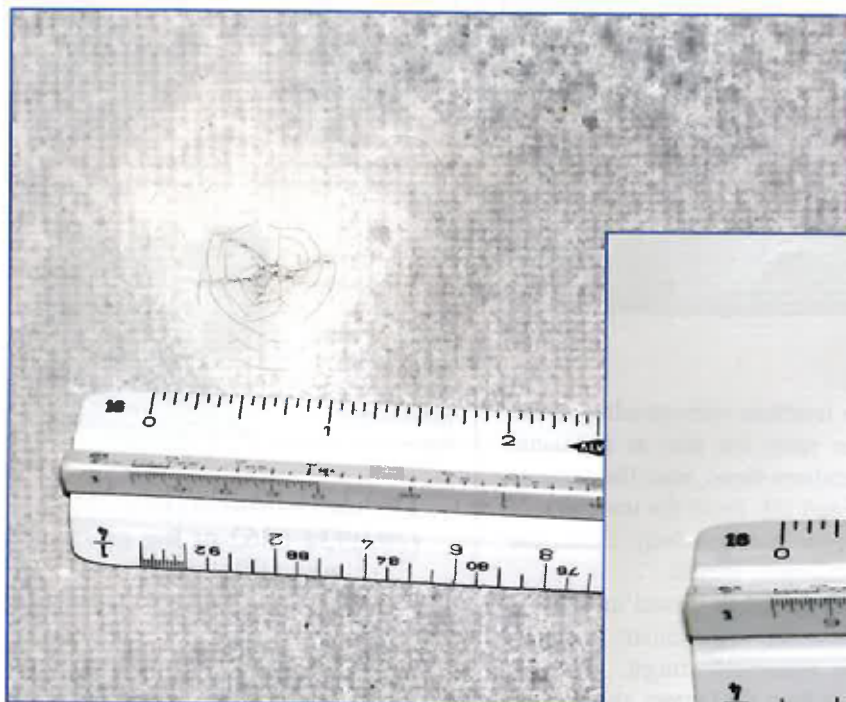
The damage, when viewed on the top surface (Photo 30), was circular- or spiral-shaped (or concentric rings). However, when viewed from the bottom, the damage typically appeared to be more "star-shaped," or composed of linear cracks intersecting at midpoint or propagating from a central focal point (Photo 31).

Photo 30 – Typical fracture in top side of membrane.

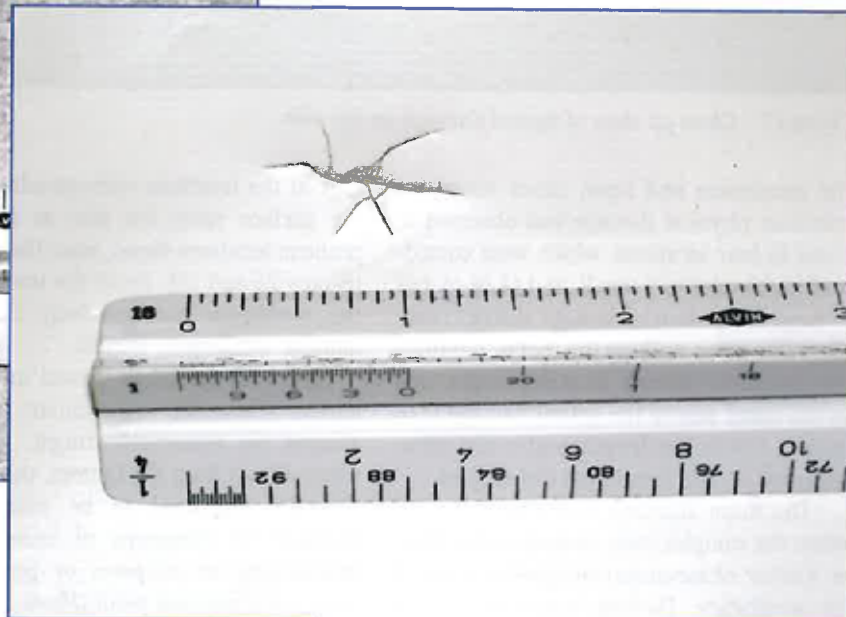
Photo 31 – Typical view of fracture from bottom of membrane.

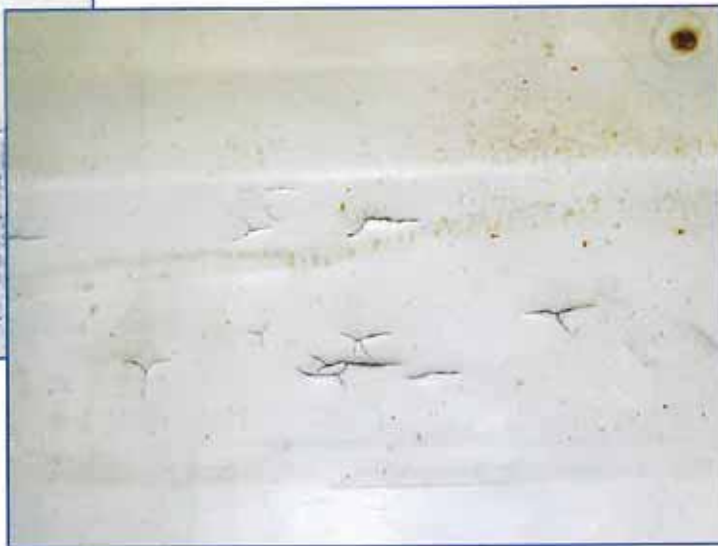
Photo 33 - View of damage on bottom of membrane.

mentioned manner. At one of these schools, similar conditions were revealed when the underside of the membrane was inspected in a closer manner (Photos 32 and 33). Based on this more detailed inspection, an additional

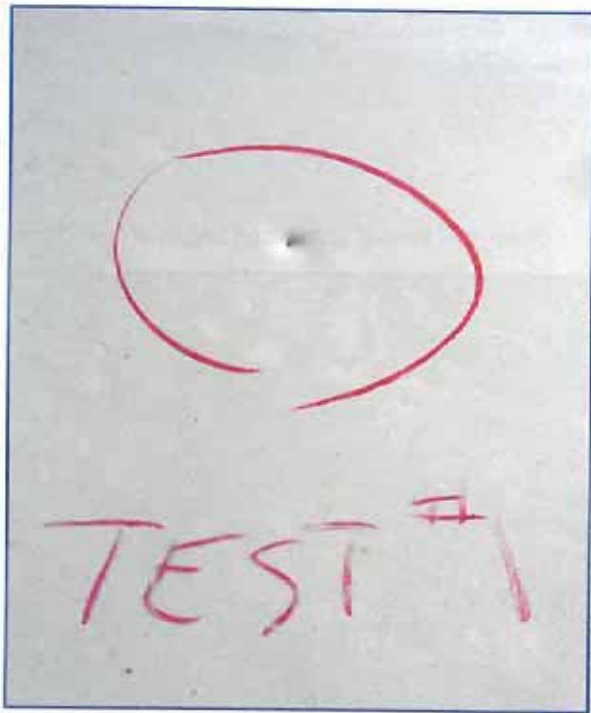
Photo 34 – Depression in membrane.

At two schools with relatively new roofs that were less than five years old (one Hypalon over extruded polystyrene and one TPO over expanded polystyrene), the original inspection did not reveal any obvious evidence of damage. However, upon further visual inspections at later dates, suspect areas were observed that indicated possible damage. These suspect areas typically resembled thumb-sized depressions in the membranes (Photo 34). Again, additional and more detailed inspections and analyses were performed. Upon removal of the membrane, relatively large depressions (over 2 inches in diameter) were observed in the top surface of the insulation board (Photos 35 and 36). These inspections included close-up, in-place visual inspections (with the aid of a magnifying eyepiece) and collection of membrane samples to perform photographic laboratory documentation.

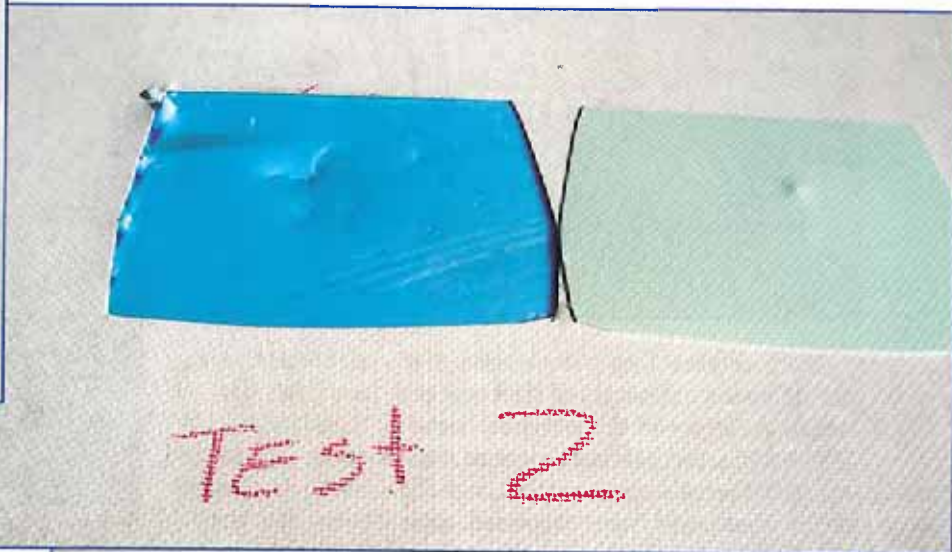
Photo 35 – Large depression in insulation board.

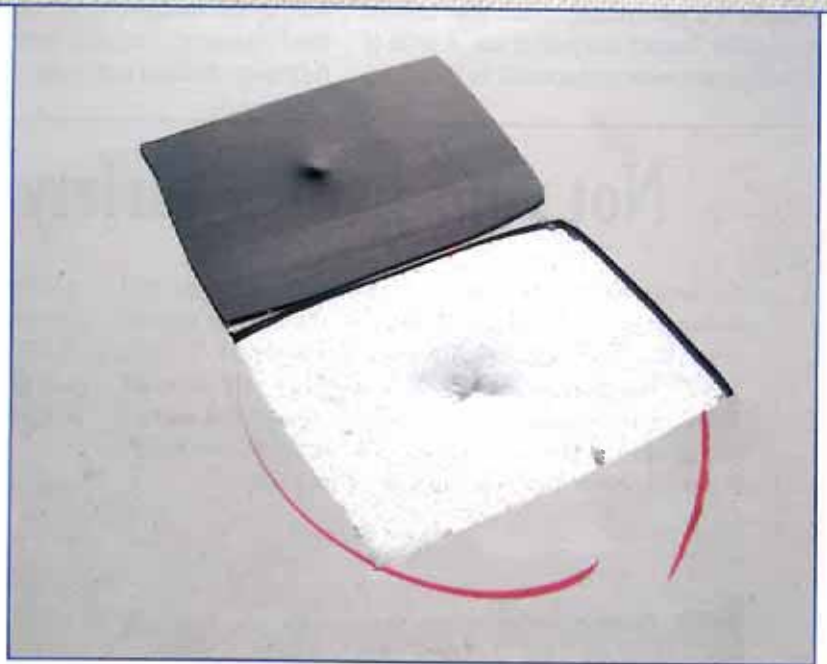
Photo 36 – Large depression in insulation board.

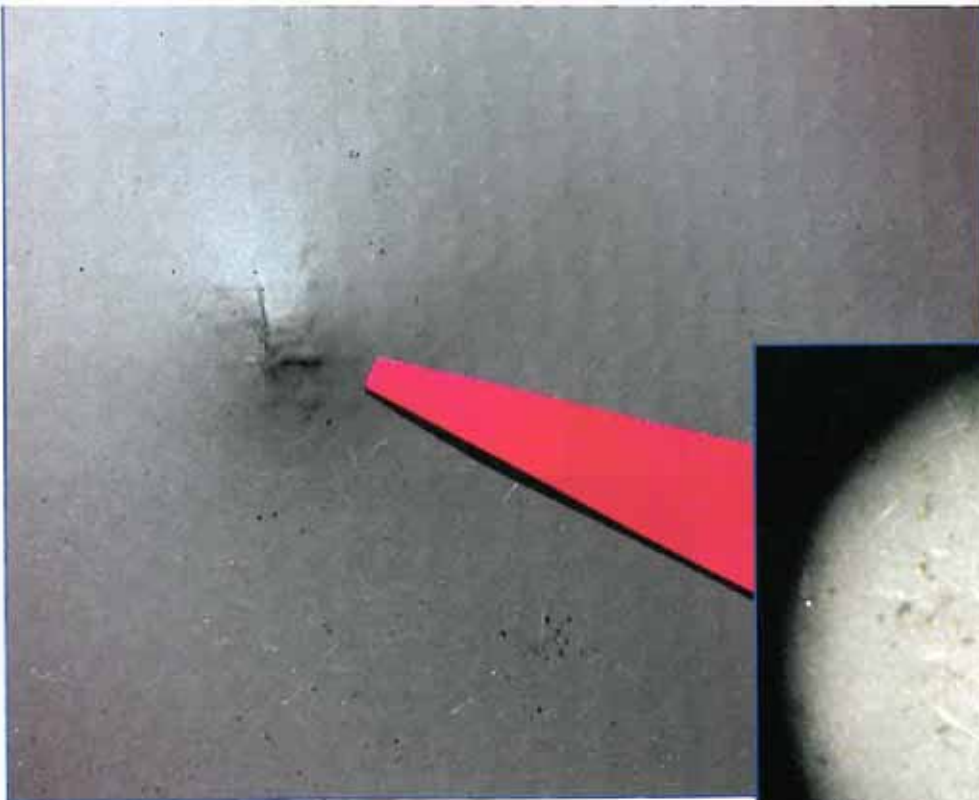
Photo 37 – Close-up view of underside of membrane at depression.⁽⁵⁾

The damage was small linear fractures in the membrane polymer coating, either on the top or bottom surface (*Photos 37 through 40*). Due to the isolated location and minimal frequency of this level of damage, the affected areas were repaired. This damage appears to have been caused by the larger-sized hailstones. These membranes also did not appear to have been affected by the smaller-sized hailstones.

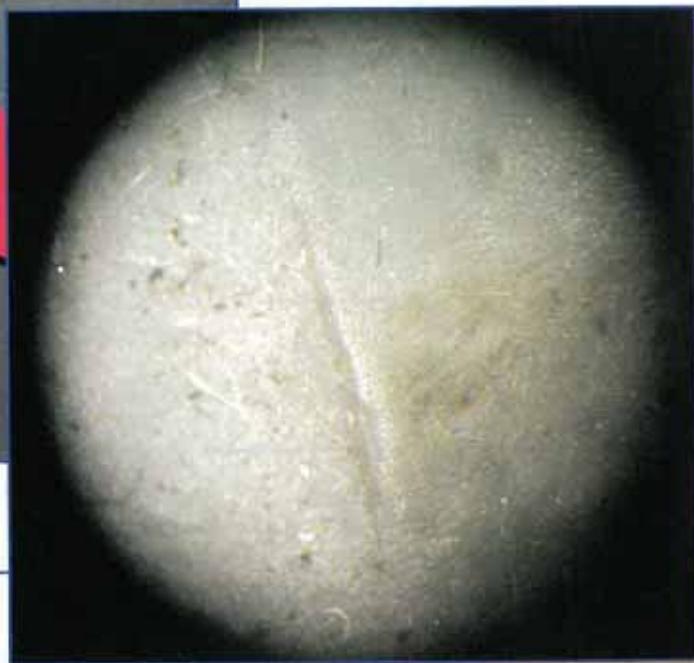
Photo 38 – Magnified view (10x) of depression showing minor crease in membrane.⁽⁵⁾

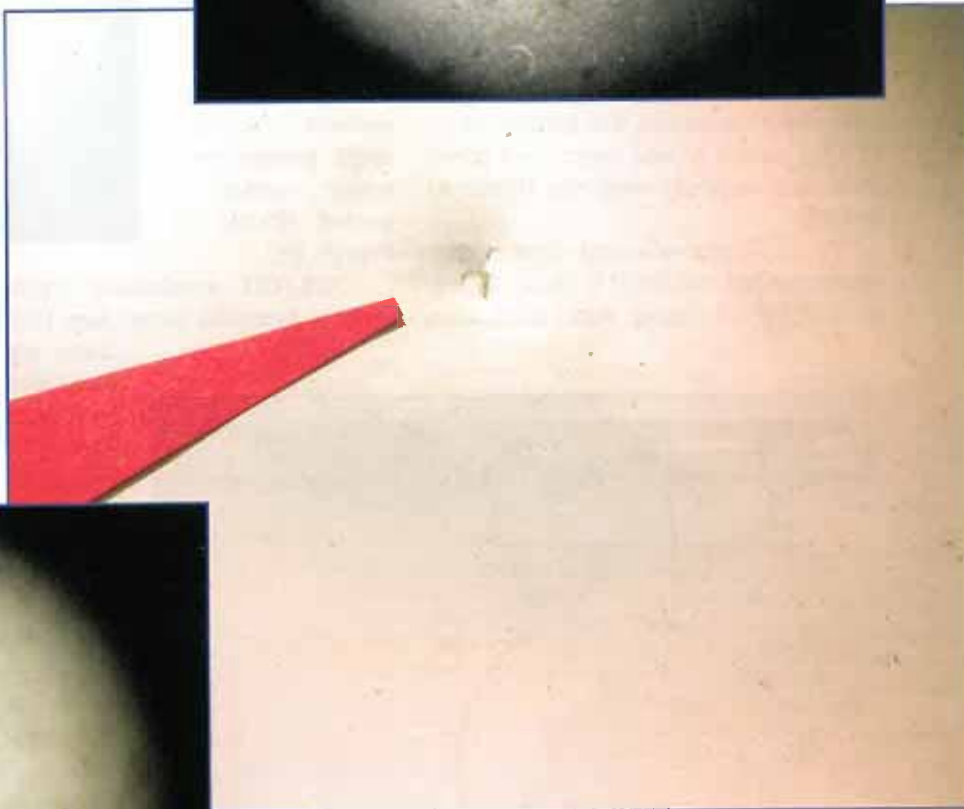
Photo 39 – Close-up view of top side of depression.⁽⁵⁾

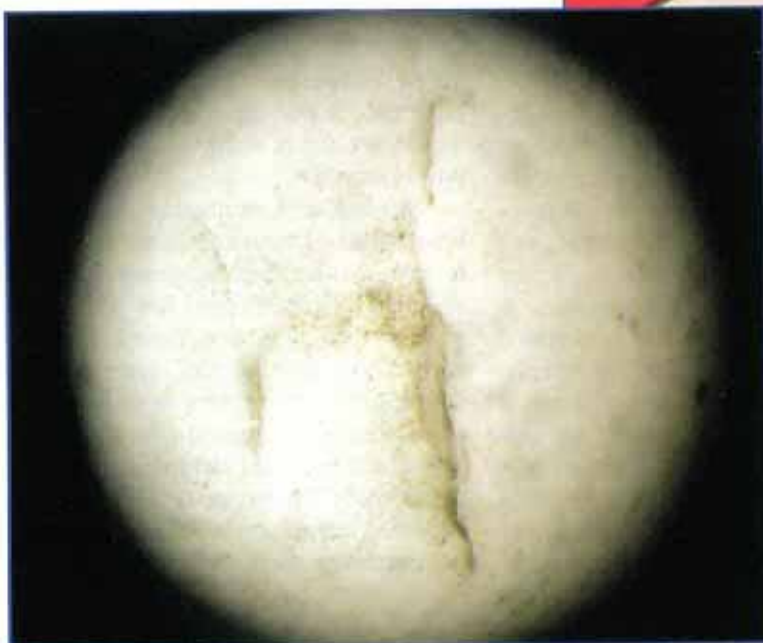
Photo 40 – Magnified view (10x) of top side of depression showing minor crack in membrane coating.⁽⁵⁾

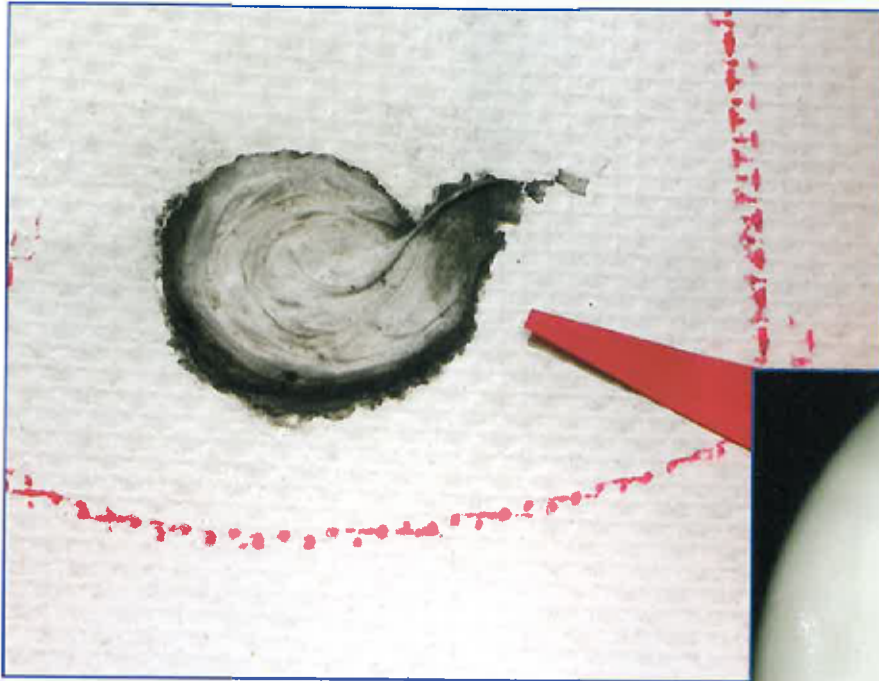
Photo 41 – Sealant applied over damaged area.⁽⁵⁾

The “temporary” emergency repair, using urethane sealant, was found to be an effective means to seal larger-sized punctures on a single-ply membrane (Photos 41 and 42).

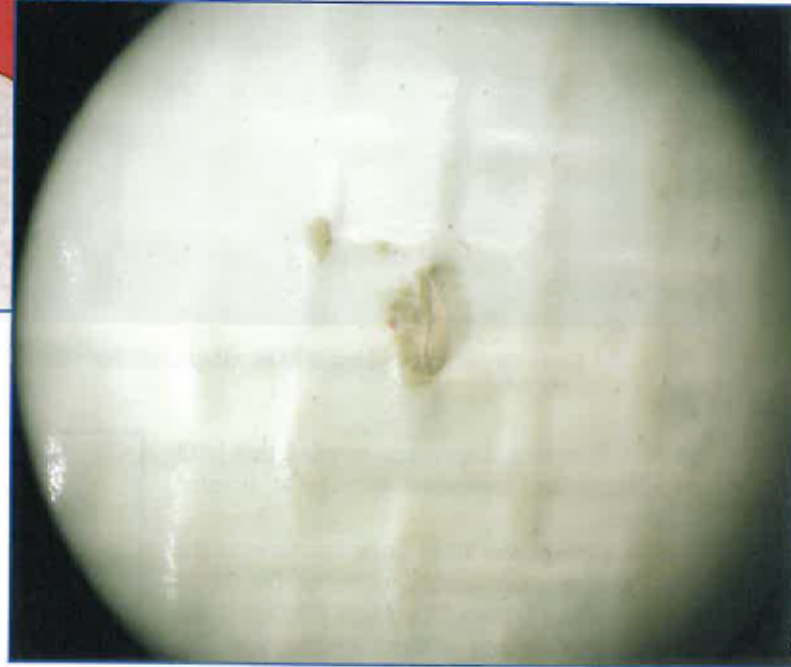
Photo 42 – Close-up view (10x) of underside of membrane showing sealant permeating the fracture.⁽⁵⁾
