The Journal of RCI

THE DAY AFTER:

Documentation of Damage to Roofs from a Hailstorm and the Subsequent Restoration Efforts

By Karl A. Schaack, RRC, PE

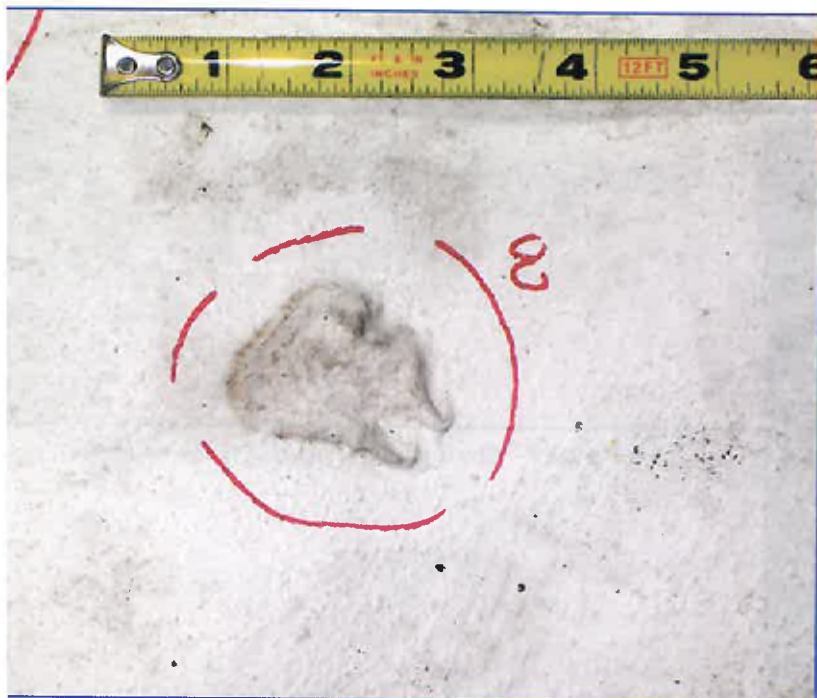
Photo 43 – Sealant and coating applied over membrane.

The application of a single layer of elastomeric coating was found to be an effective method for alleviating water infiltration

through the numerous fractures in the single-ply membrane for a relatively effective time frame (six months) and, in the author’s opinion, could provide even longer service if needed (Photos 43 through 45).

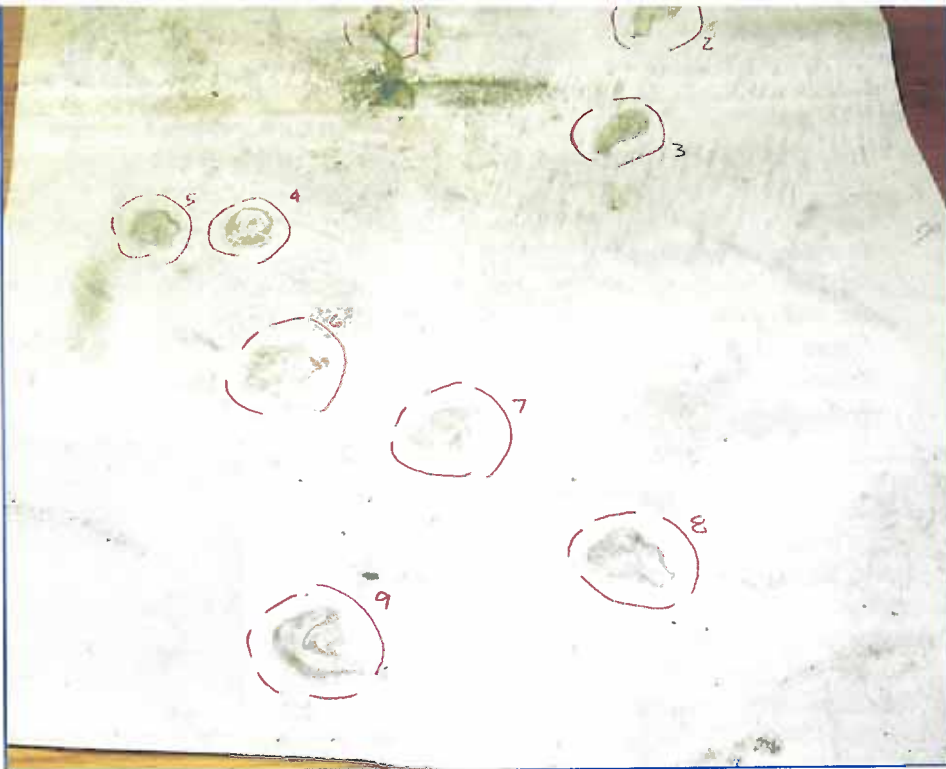
Photo 44 – Sealant and coating applied over membrane.

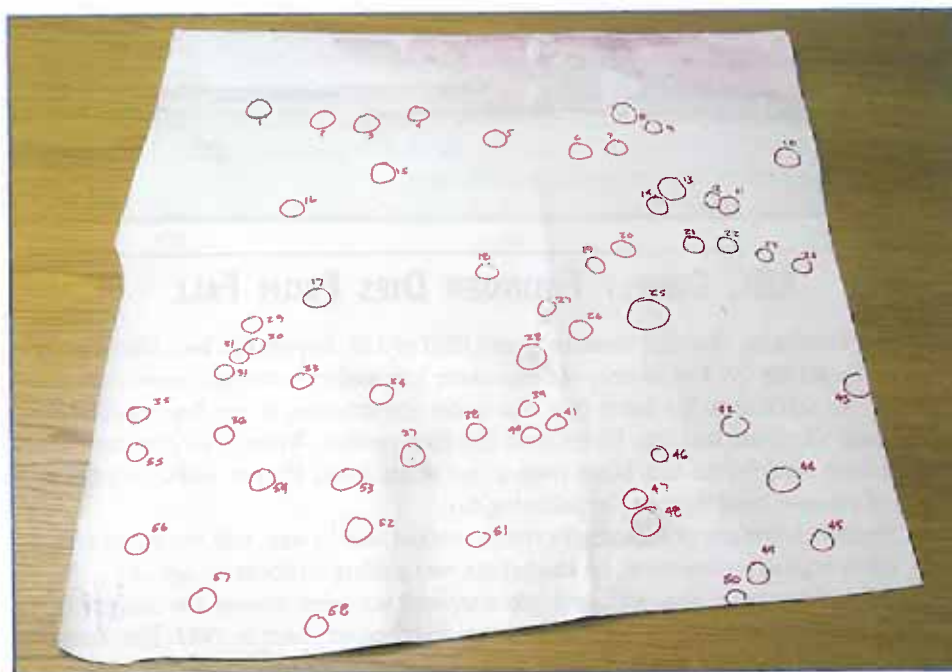
Photo 45 – View of underside of membrane showing numerous areas of damage.
