SAGUACHE CREEK DIVERSION INFRASTRUCTURE INVENTORY

Structure Name: HODDING D 3

Saguache Creek Stream
Management Plan

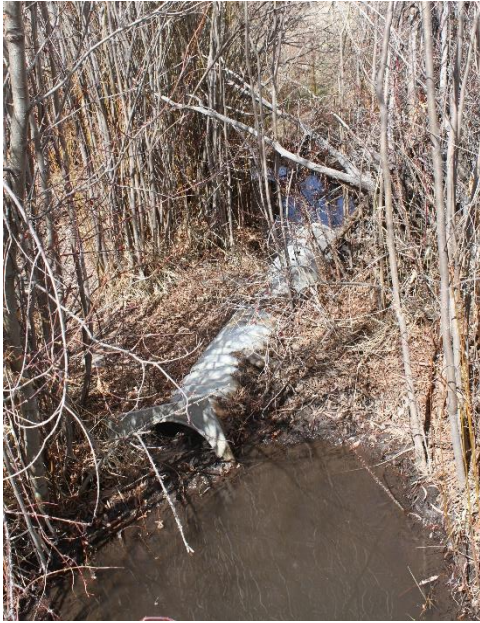
Culvert looking downstream

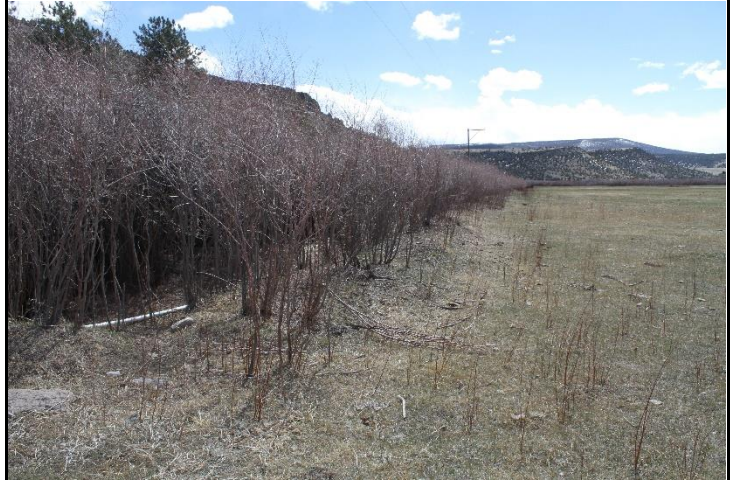
Ditch looking upstream

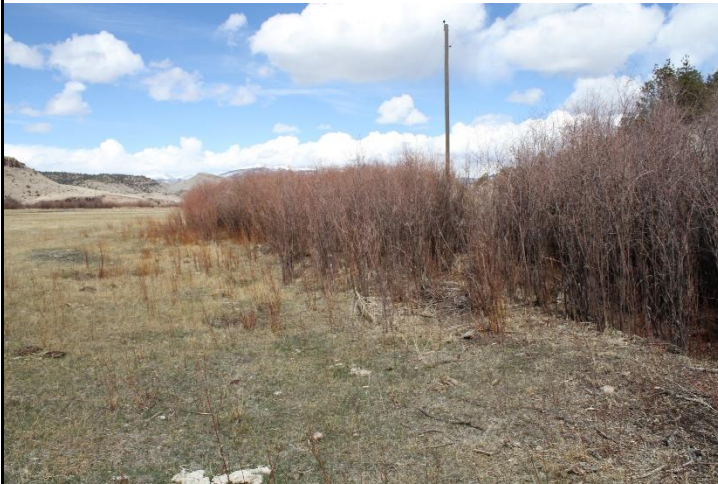
Ditch looking downstream
