**15 7217 0313 0001**  
Hess Mill Road  
over  
West Branch of White Clay Creek

Franklin Township  
Chester County, Pennsylvania

INSPECTED: January 3, 2018 - Interim

BMS No. 15 7217 0313 0001  
Hess Mill Road over West Branch of White Clay Creek

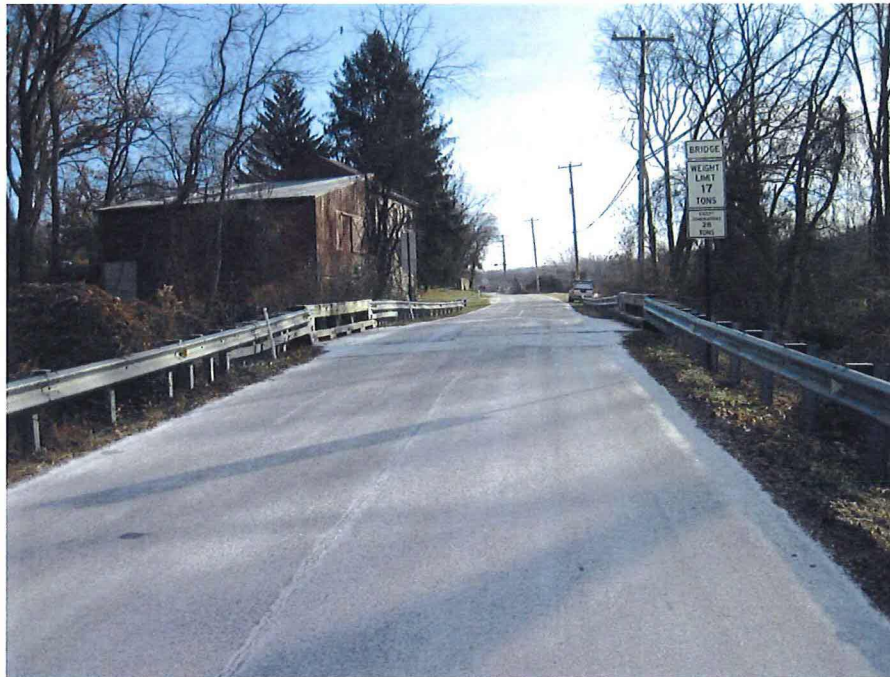
1. Near approach, looking ahead.

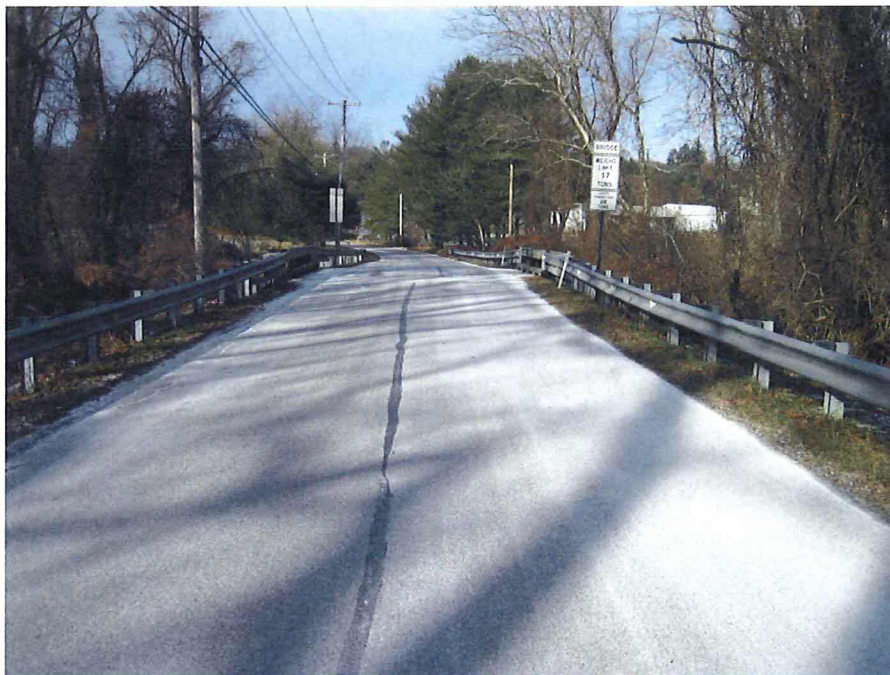
2. Far approach, looking back.

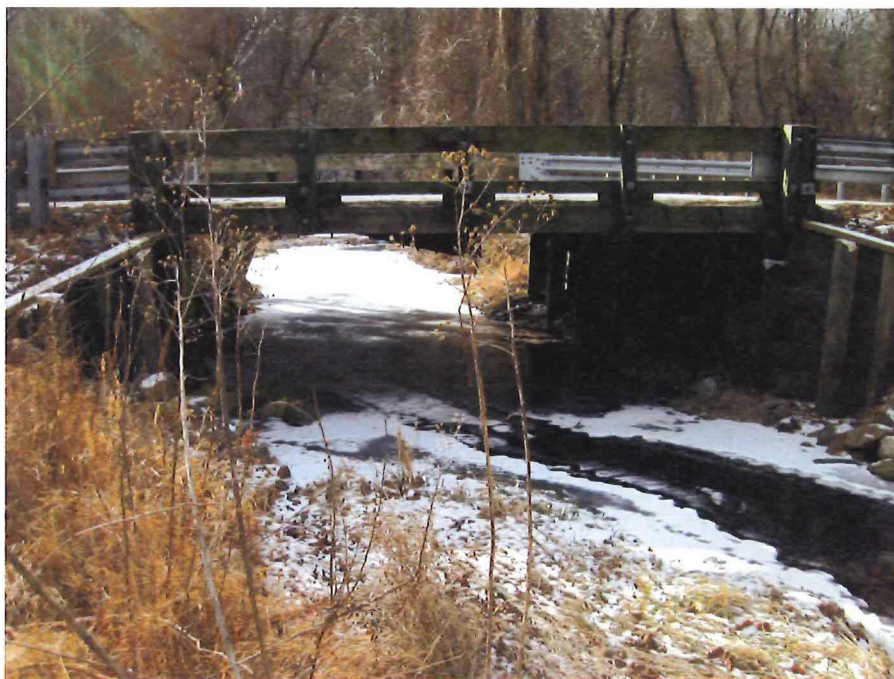
3. Left (upstream) elevation.

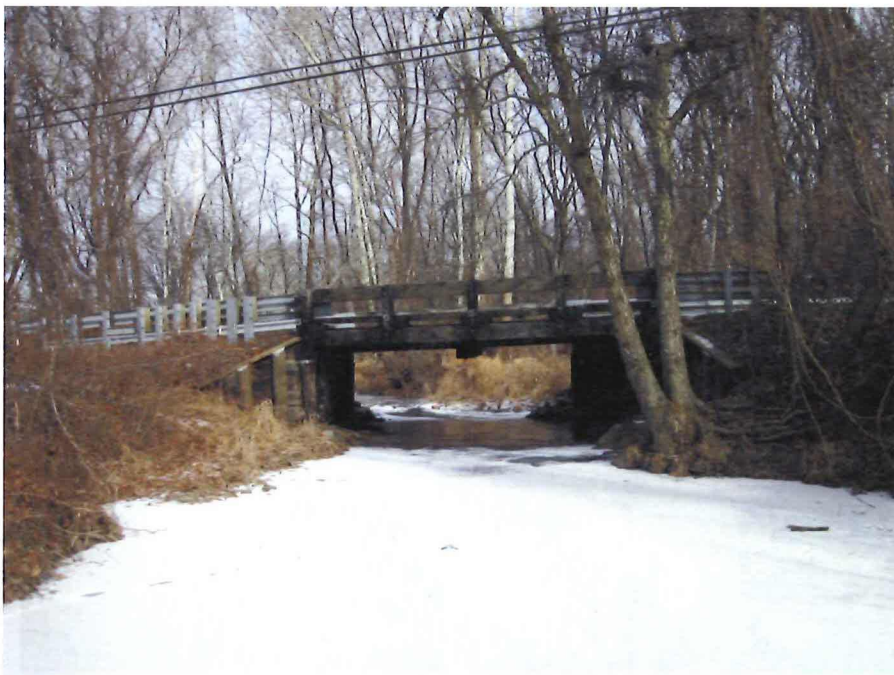
4. Right (downstream) elevation.

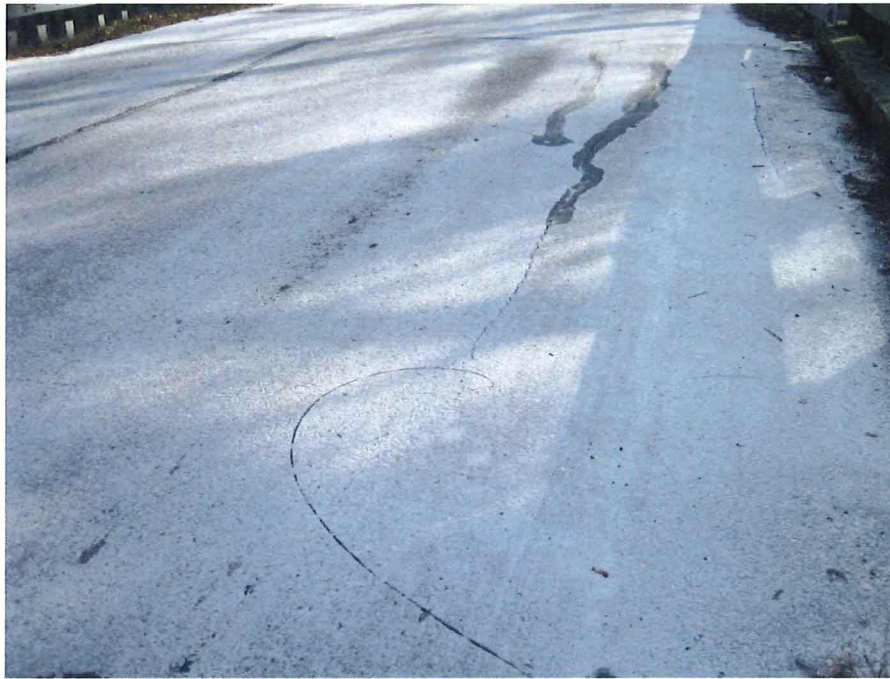
The bituminous wearing surface is in overall good condition with minor to moderate wear and a few sealed/unsealed (up to 1/4" wide) longitudinal cracks in the right travel lane. A large bituminous patch in the left travel lane is new since the 1/20/16 interim inspection.

5. General view of the deck wearing surface, looking ahead.

Mill existing bituminous, install waterproof membrane and repave the deck wearing surface (thickness not to exceed 3").				
72 SY	x	\$48		\$3,456

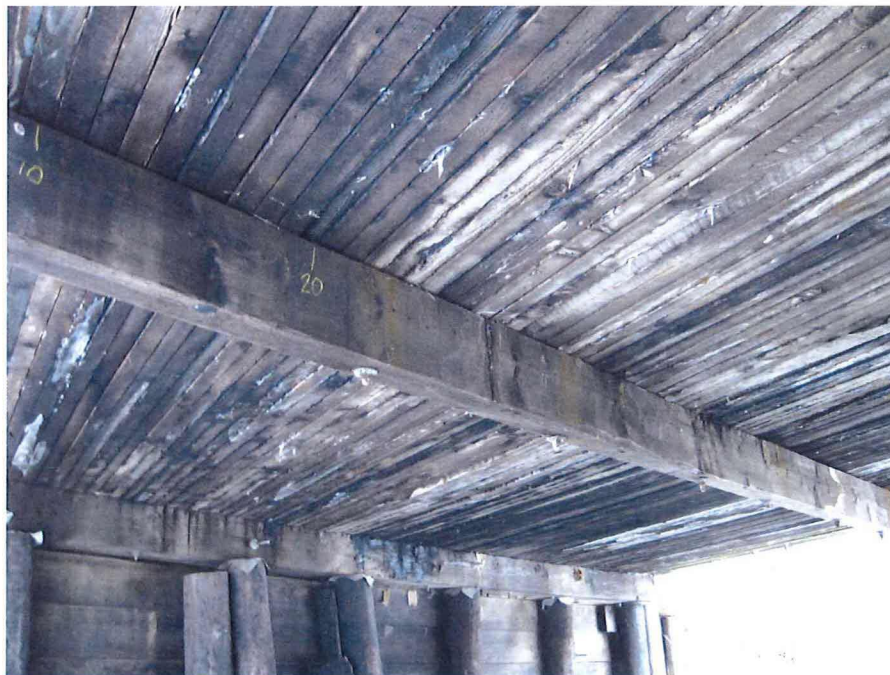
The 3" x 12" nail laminated longitudinal treated timbers on edge are in overall poor condition. There is typical tar seepage and misalignment between the planks and active water leakage. The planks exhibit several splits and checks throughout with random areas of rot with up to 3/8" awl penetrations. There is a 12" x 6" transverse timber tie that spans the full-width at mid-span. The tie has a split with propagating cracks at the right end.

6. General view of the superstructure, looking ahead.

Repair/replace the cracked superstructure timbers.				
21 EA	x	\$1,165		\$24,465

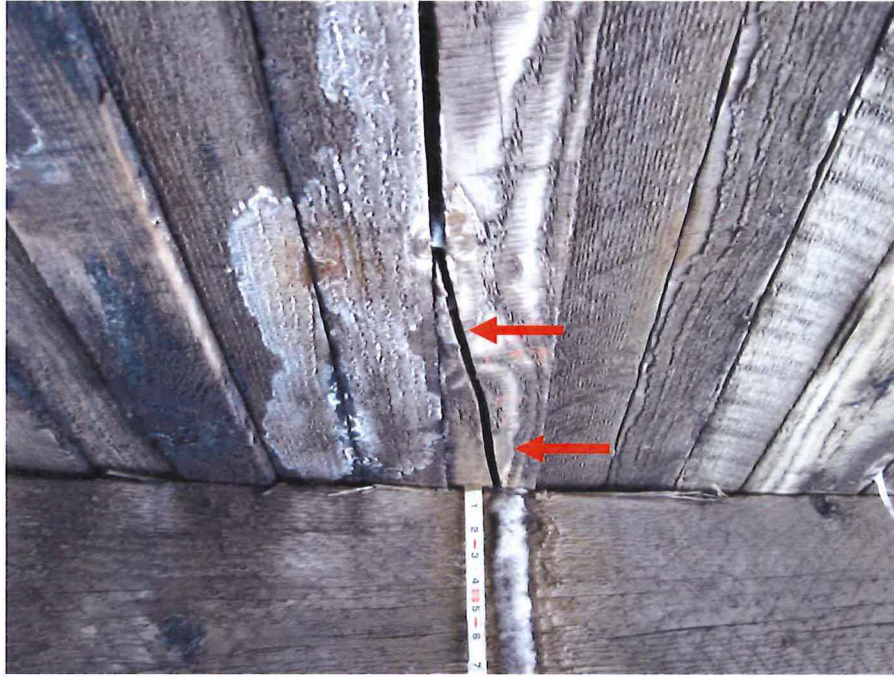
7. Timber plank 35 in bay 2, looking back. Note the diagonal split with vertical displacement.

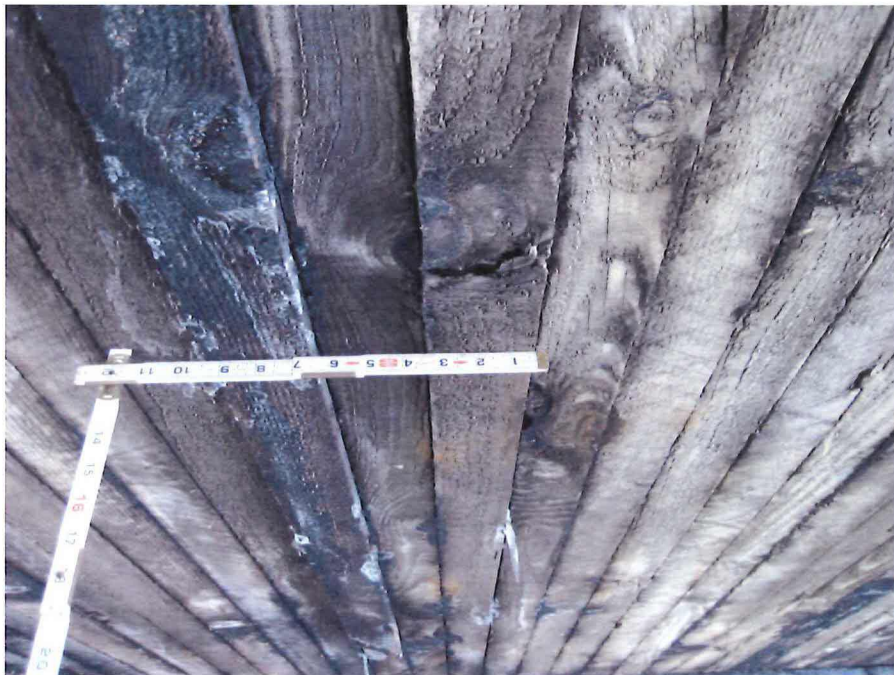
8. Timber plank 36 in bay 1, looking back. Note the horizontal split with vertical displacement.

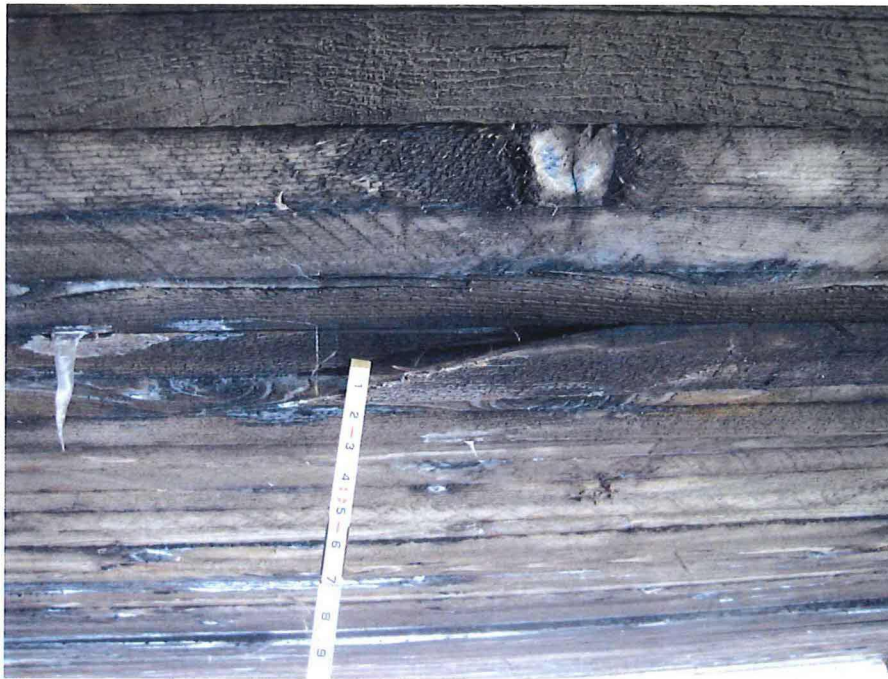
9. Timber plank 38 in bay 1, looking left. Note the diagonal split with vertical displacement.

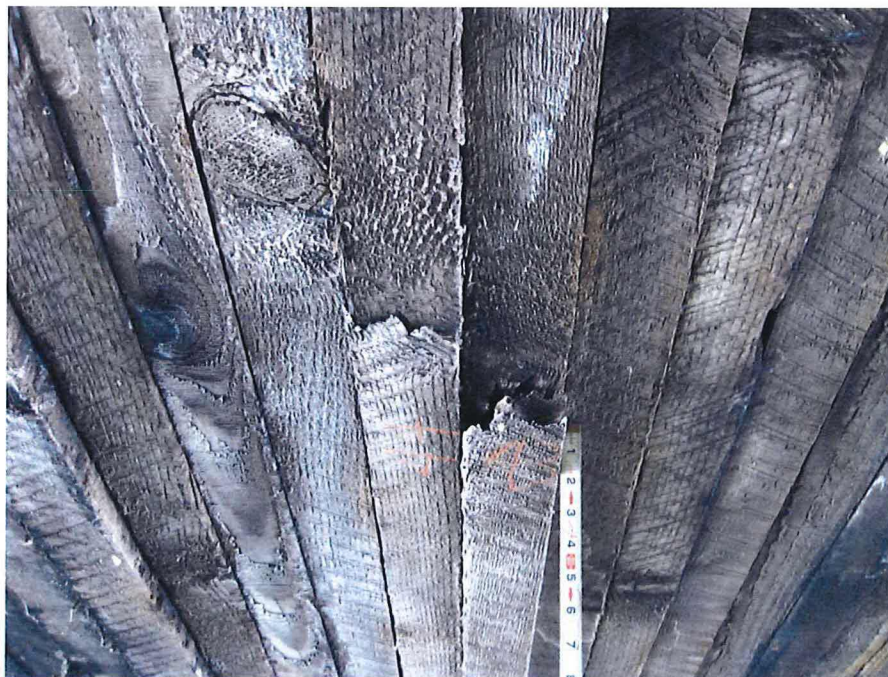
10. Timber planks 43 and 44 in bay 2, looking back. Note the splits with vertical displacement.

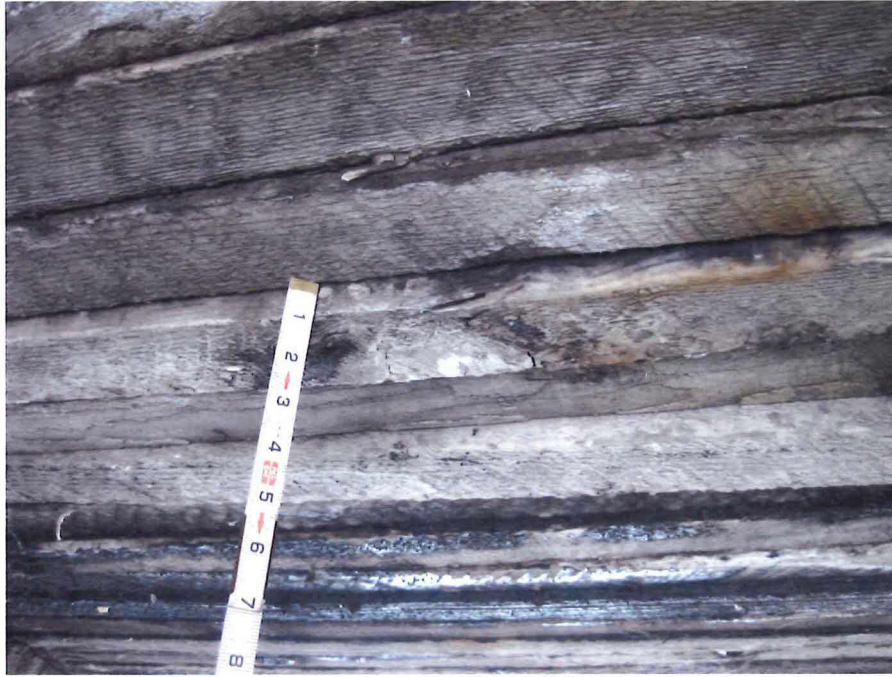
11. Timber plank 45 in bay 1, looking right. Note the horizontal split with vertical displacement.

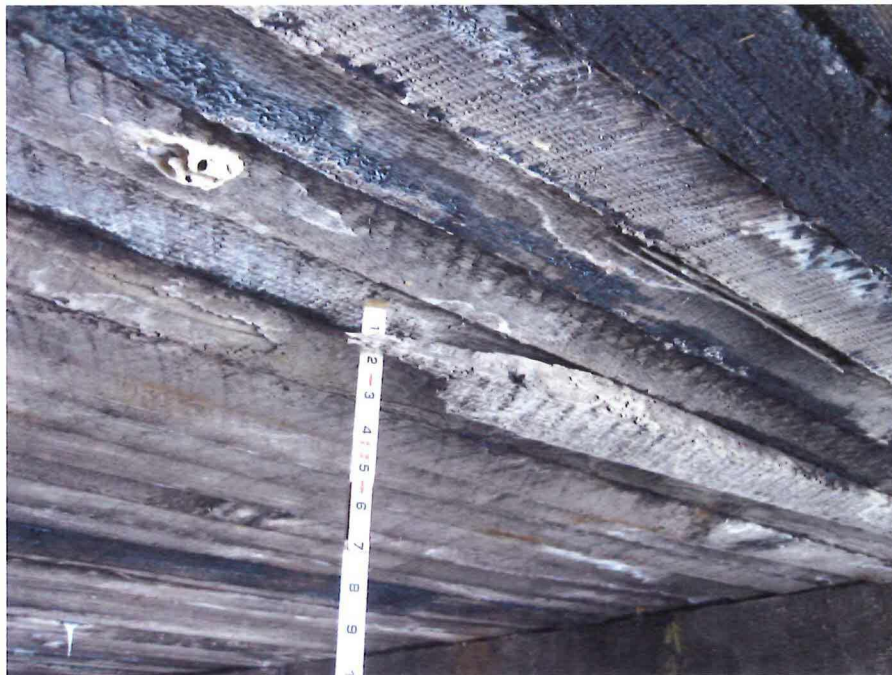
12. Timber plank 47 in bay 1, looking left. Note the diagonal split with vertical displacement.

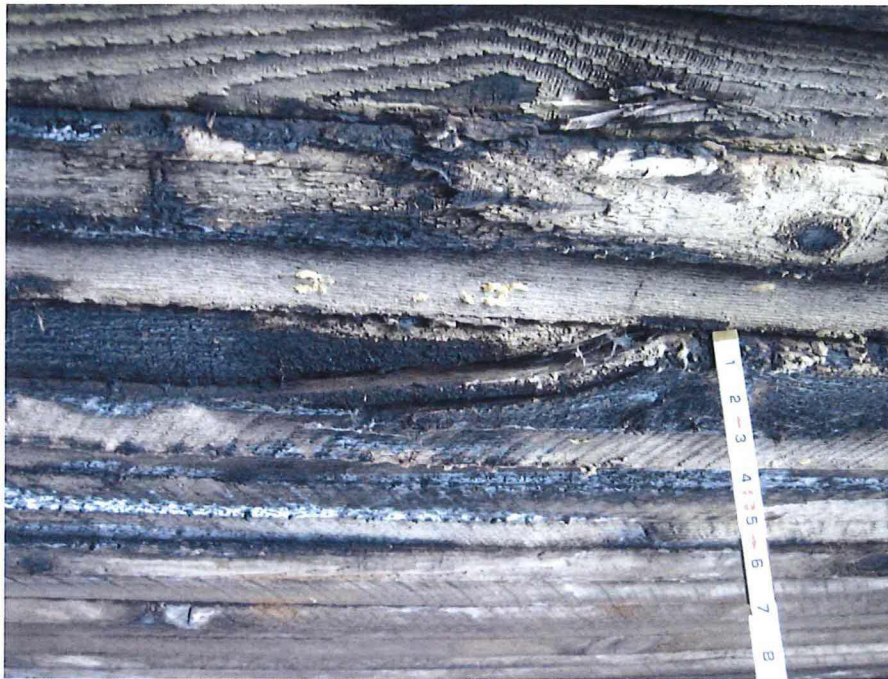
13. Timber plank 51 in bay 1, looking ahead. Note the diagonal split with vertical displacement.

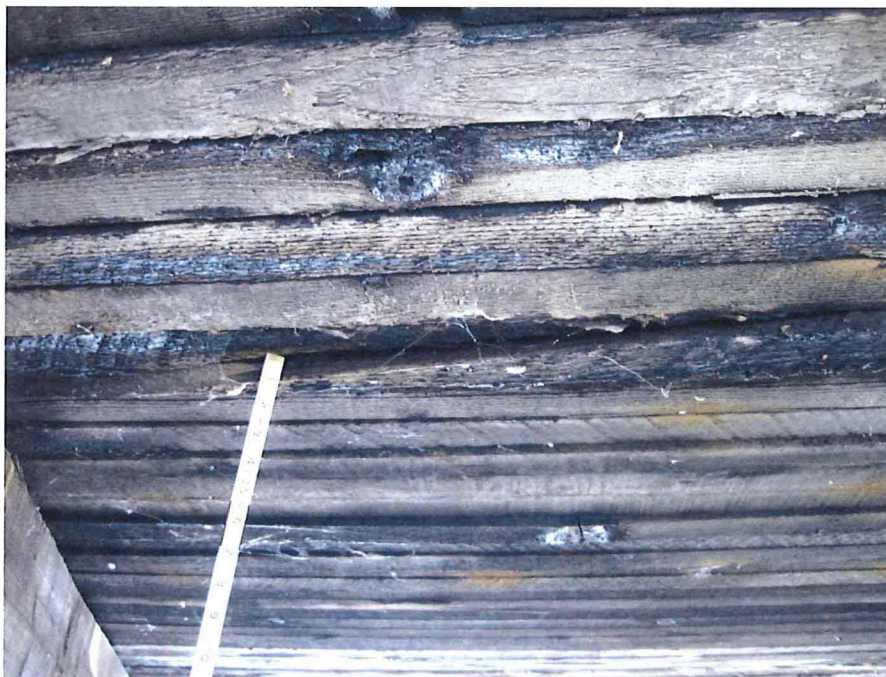
14. Timber plank 57 in bay 1, looking right. Note the diagonal split with vertical displacement.

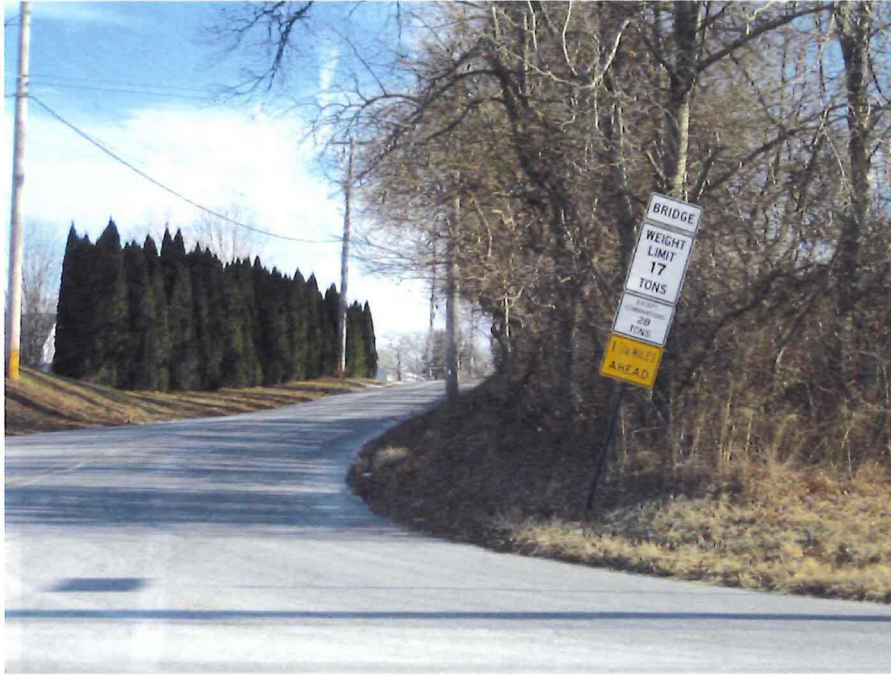
15. Near advance load posting sign at Newark Road (S.R. 0896). Note the sign is leaning.

Reset the leaning near advance posting signs at Newark Road.				
1 EA	x	\$360		\$360
