SAGUACHE CREEK DIVERSION INFRASTRUCTURE INVENTORY

Structure Name: FULLERTON D 3

Date: August 8, 2019

Saguache Creek Stream Management Plan

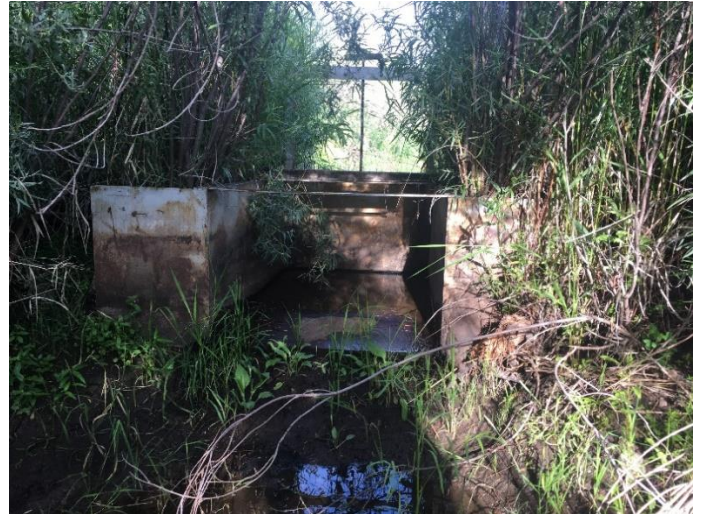
Headgate outlet

Repair(s) or Improvement(s) Currently Needed: The headgate could be repaired or replaced. The diversion dam should be improved to more effectively divert water despite sediment and debris accumulation. The flume should be leveled, reset, and regularly cleaned. Fish passage and riparian restoration should be considered as part of any future repairs or improvements.

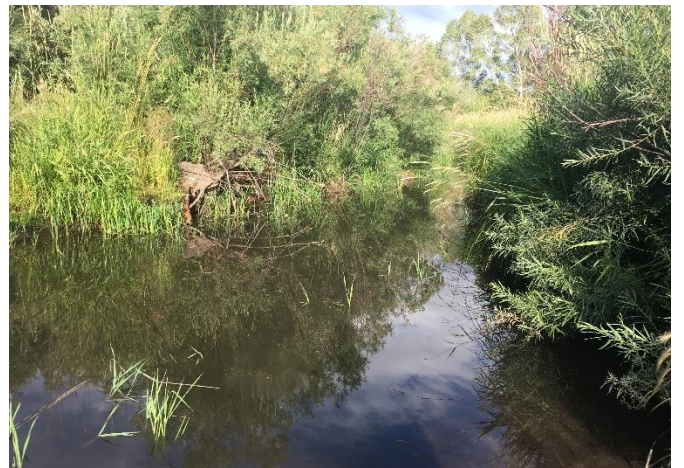
Structure Description: This structure is located just downstream of Fullerton Ditch 2 on the Werner Arroyo. The diversion dam is a combination of a checkboard structure and stacked rocks, but the checkboards were recently removed due to debris accumulation and should be repaired or replaced. Beaver dams also negatively impact the diversion structure and channel capacity. The headgate leaks and its frame is twisted. The flume does not measure accurately due to woody vegetation encroachment and sediment accumulation.

Diversion dam

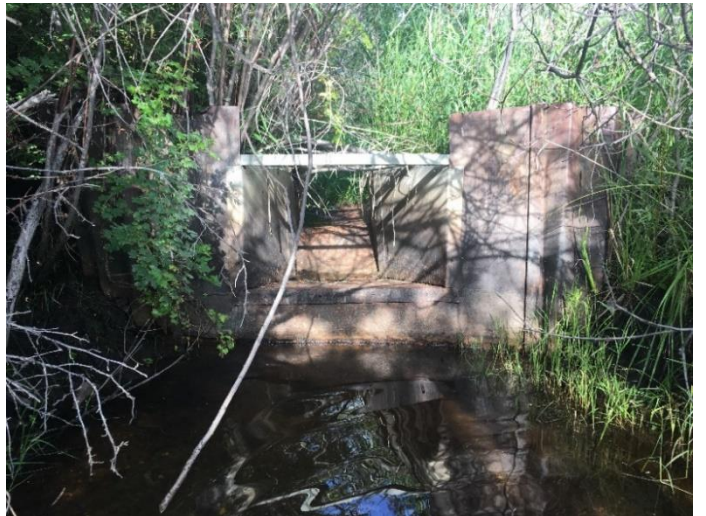
Flume looking upstream
