DAM INSPECTION CHECKLIST
DEPARTMENT OF ENVIRONMENTAL PROTECTION
DIVISION OF DAM SAFETY

Name of Dam: **QUEEN ESTHER LAKE**

DEP ID NO: **08-070**

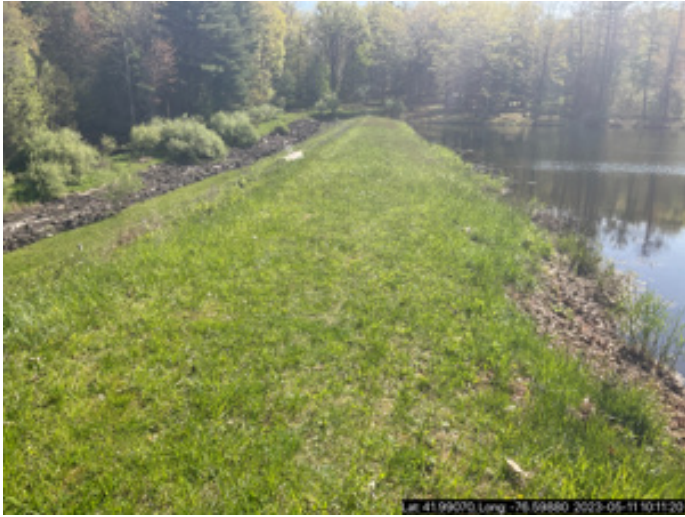
6. VEGETATION CONDITION crest

5. RUTS AND/OR PUDDLES		N/A	✓ No ISSUE	Monitor	Investigate	Repair
6. VEGETATION CONDITION	Low grass cover	N/A	✓ No ISSUE	Monitor	Investigate	Repair
7. RETAINING WALL		✓ N/A	No ISSUE	Monitor	Investigate	Repair
INBOARD FACE (U/S SLOPE)

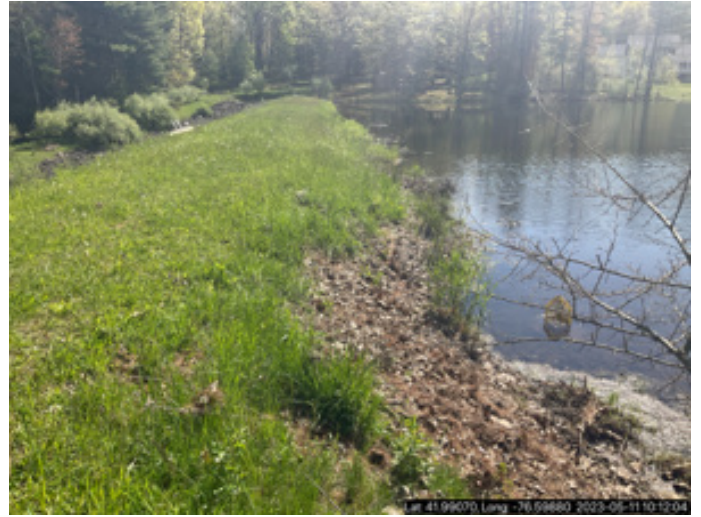
13. VEGETATION CONDITION upstream

13. VEGETATION CONDITION	Low grass cover. Some old woody veg noted along the waters edge that has either been killed with herbicide or cut and killed.	N/A	✓ No ISSUE	Monitor	Investigate	Repair

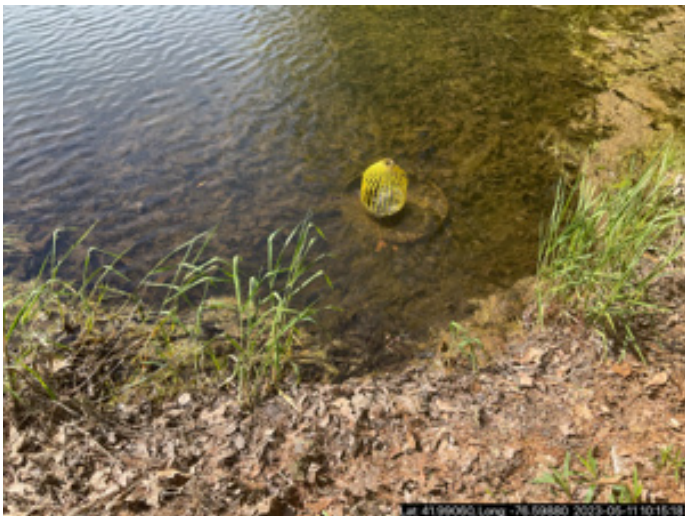
Condition Observed	Comments	N/A	No ISSUE	Monitor	Investigate	Repair
44. INTAKE STRUCTURE	Unobstructed flow over the riser pipe	N/A	✓ No ISSUE	Monitor	Investigate	Repair

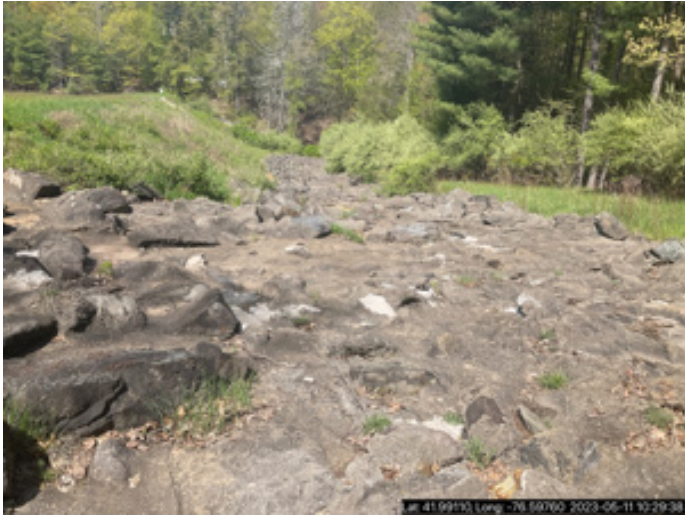
35. SIDEWALLS	Earthen sidewalls	N/A	✓ No ISSUE	Monitor	Investigate	Repair
36. CHANNEL FLOOR	Grouted Riprap floor. Some minor vegetations throughout. Recommend workto clear any woody vegetation	N/A	No ISSUE	✓ Monitor	Investigate	Repair
37. UNUSUAL MOVEMENT		N/A	✓ No ISSUE	Monitor	Investigate	Repair
38. APPROACH AREA	Clear lake	N/A	✓ No ISSUE	Monitor	Investigate	Repair
39. WEIR OR CONTROL	Some minor cracking and spalling. Monitor and repair as necessary	N/A	✓ No ISSUE	✓ Monitor	Investigate	Repair
40. DISCHARGE AREA	Recomend removing vegetation from outlet for clear unobstructed flow	N/A	No ISSUE	Monitor	Investigate	✓ Repair

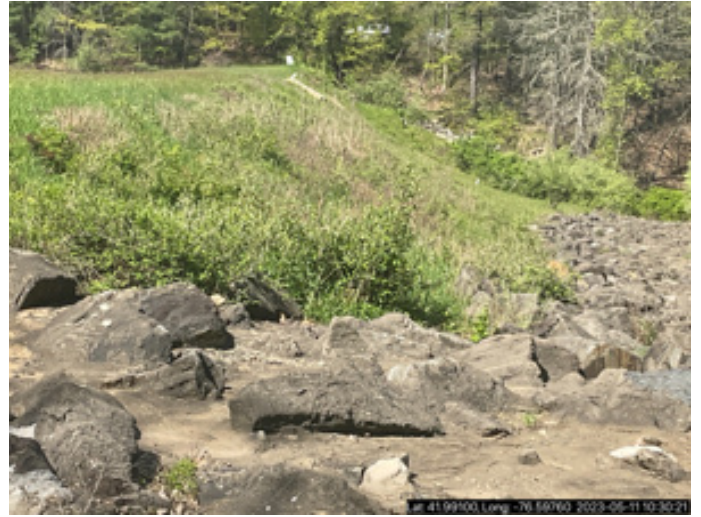
20. EROSION		N/A	✓ No ISSUE	Monitor	Investigate	Repair
21. UNUSUAL MOVEMENT	None noted this inspection	N/A	✓ No ISSUE	Monitor	Investigate	Repair
22. VEGETATION CONDITION	Mostly grass cover with some woody veg throughout. Owner is actively removing woody veg on annual basis	N/A	No ISSUE	✓ Monitor	Investigate	✓ Repair

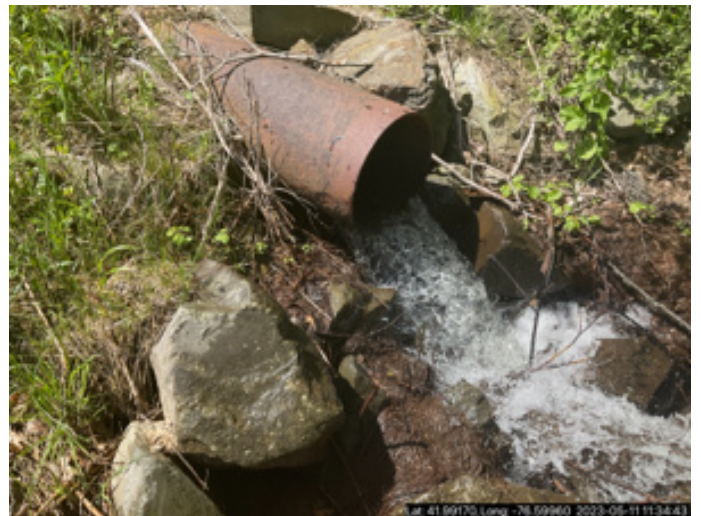
50. OUTLET PIPE	Appears that the outlet from the riser has some structure loss at the outlet. Recommend investigating and possible investigating the structural capacity of the entire riser and discharge pipe	N/A	No ISSUE	✓ Monitor	Investigate	Repair
