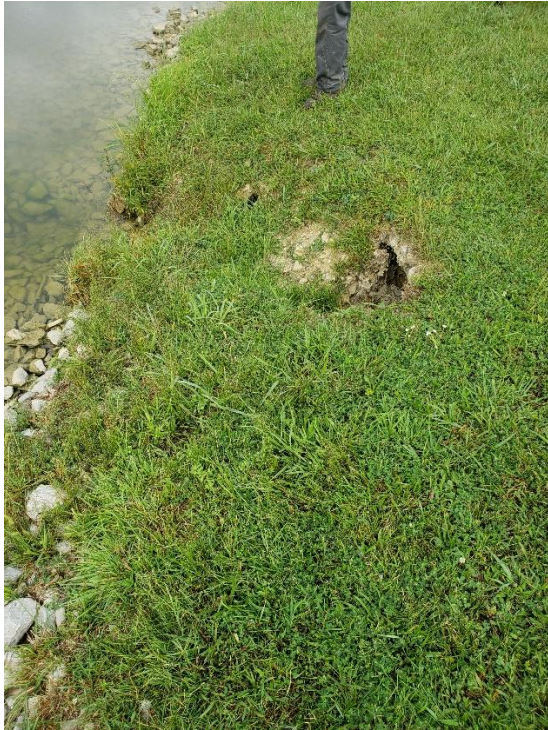
- 1) About 3 weeks ago (about 24 Aug) Bruce noticed and reported to George a hole in the earthen dam near the no parking sign, Jasons side of the spillway. We all agreed it looked like a muskrat den that had collapsed and decided to watch it. (Muskrat Hole)

- 11) on Sept 12 Bruce Introduced leak dye into the Muskrat hole, thinking it would come out the stinky trench. WELL it came out the lower right of the spillway just past the bottom, no dye in the stinky trench. So we have a leak at the muskrat hole with a confirmed exit spillway left that needs grouted and a leak feeding the stinky trench as of now unknown origin.

Pictures below Muskrat hole, Sunken area near muskrat hole, Stinky trench at bottom of hill stream right, and blue dye from muskrat hole spillway left

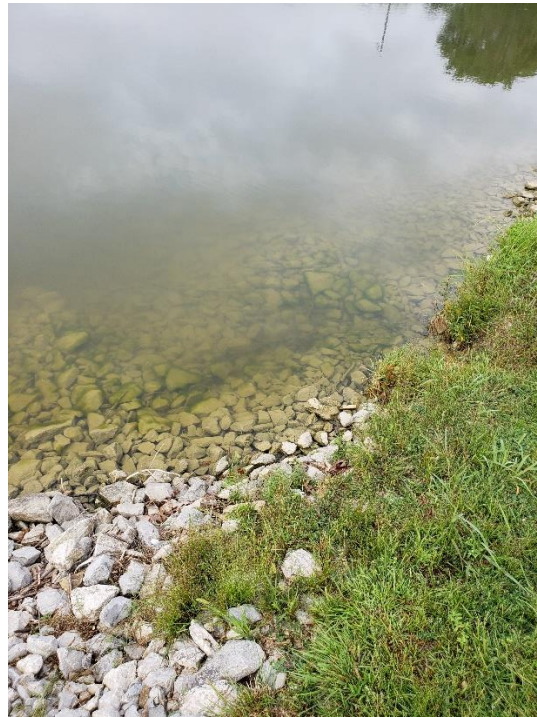
- 3) On Sept 6 George found the source of the smell about 150 feet downstream right from the spillway near sycamore trees. Several leaks estimated at 100 gallons per minute, with a black color and extreme sewage smell (Sinky Leak). Jason was shown the leak on 6 Sept and both looked at the (Muskrat hole). and the noticed an area just into the lake that looked sunken.

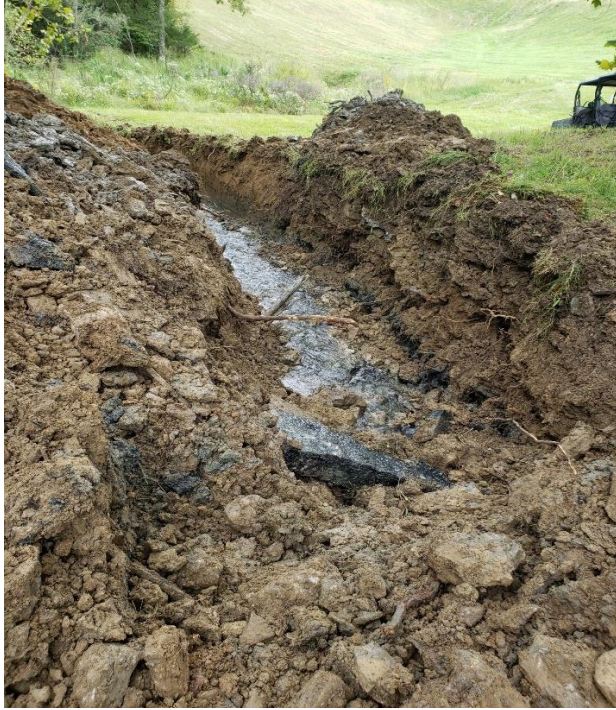
- 10) It was agreed that a trench to consolidate the stinky leaks into one, so we can monitor flow was a good Idea. And on evening of 11 Sept Bruce dug the trench. And the leak was more than we had thought earlier.
