SAGUACHE CREEK DIVERSION INFRASTRUCTURE INVENTORY

Structure Name: MALONE SULLIVAN COMMUNITY D

Date: April 3, 2019

Saguache Creek Stream Management Plan

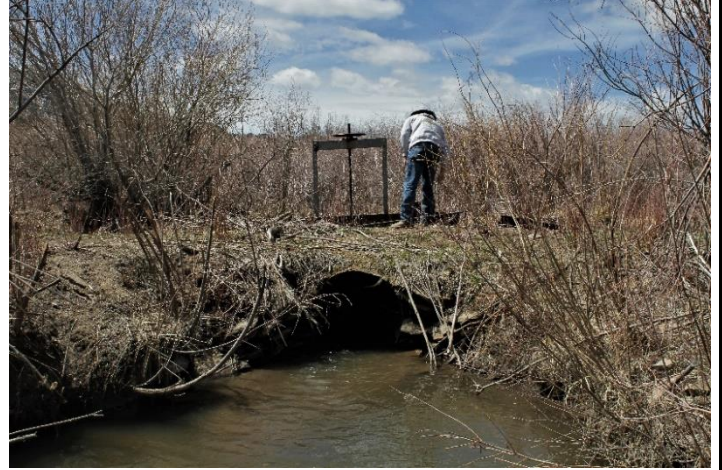
Headgate outlet

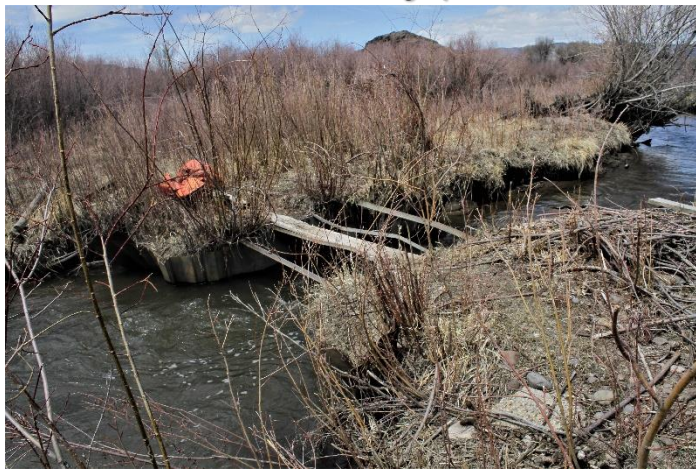
Diversion dam looking upstream

Repair(s) or Improvement(s) Currently Needed: The diversion dam needs to be repaired to prevent further degradation. It could also be elevated to improve the ditch's access to its full decree at low flows. The flume does not consistently measure accurately, but functions moderately well. Fish passage and riparian restoration should be considered as part of any future repairs or improvements.

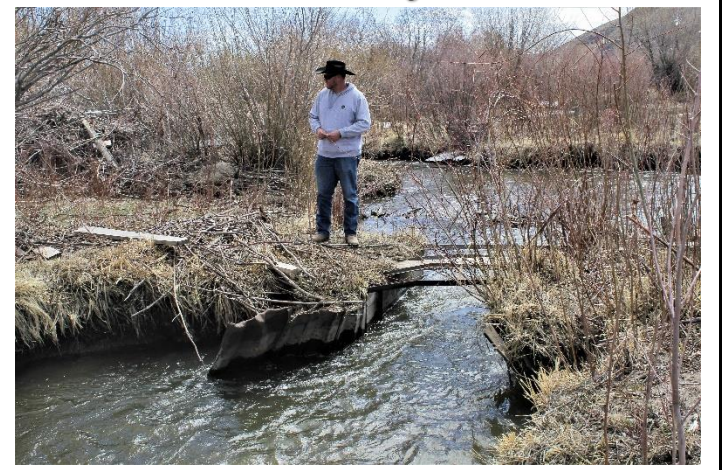
Diversion dam looking downstream

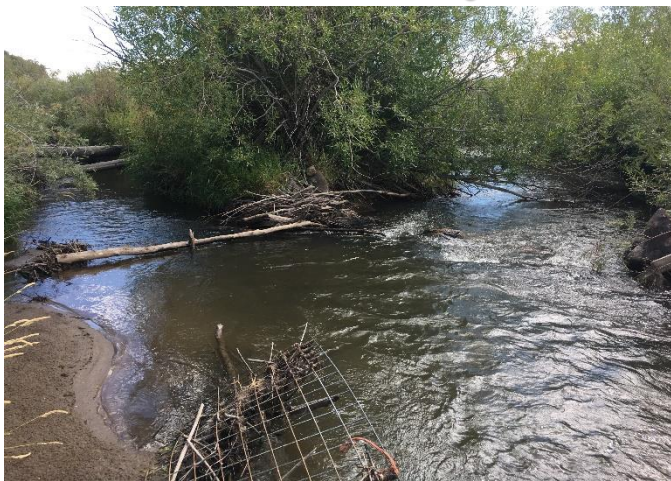
Diversion off main channel looking downstream

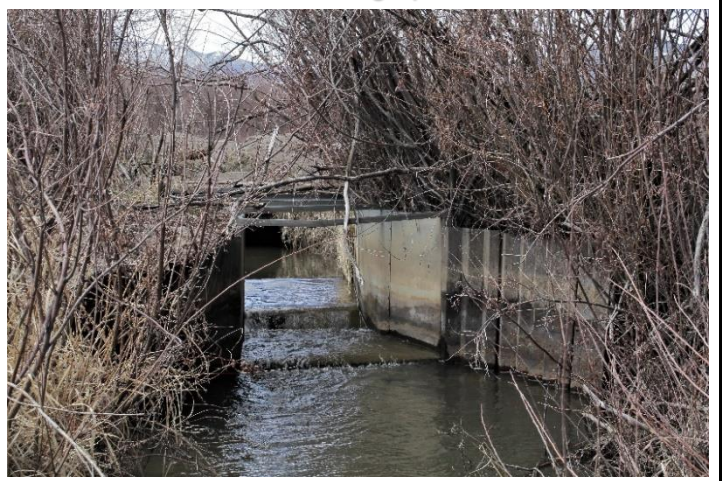
Flume looking upstream
