SAGUACHE CREEK DIVERSION INFRASTRUCTURE INVENTORY

Structure Name: GOTTHELF SAMORA D

Date: April 11, 2019

Saguache Creek Stream
Management Plan

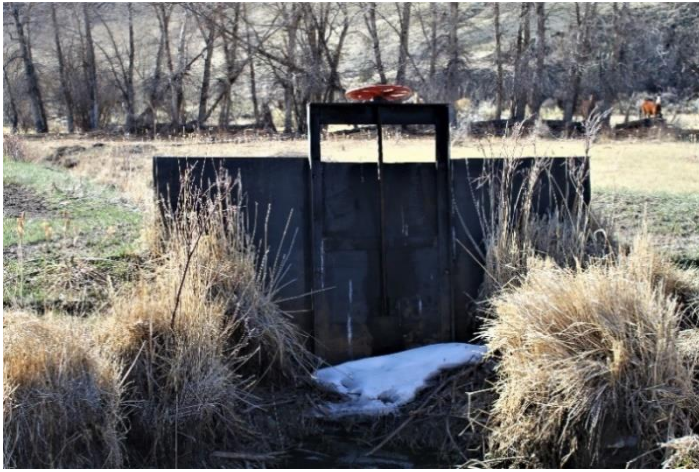
Headgate looking downstream

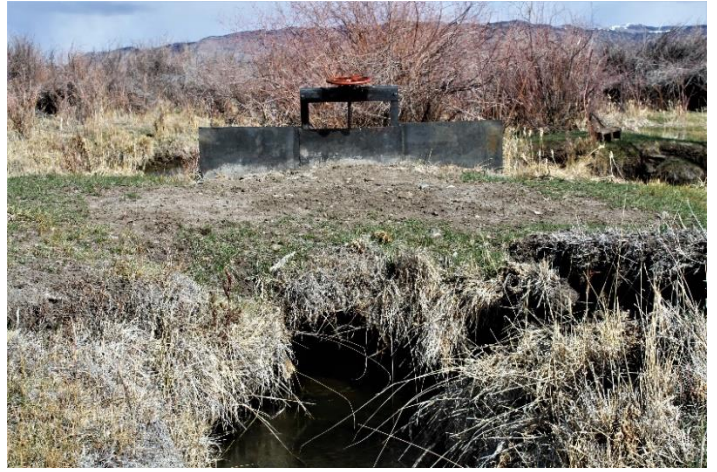
Headgate outlet

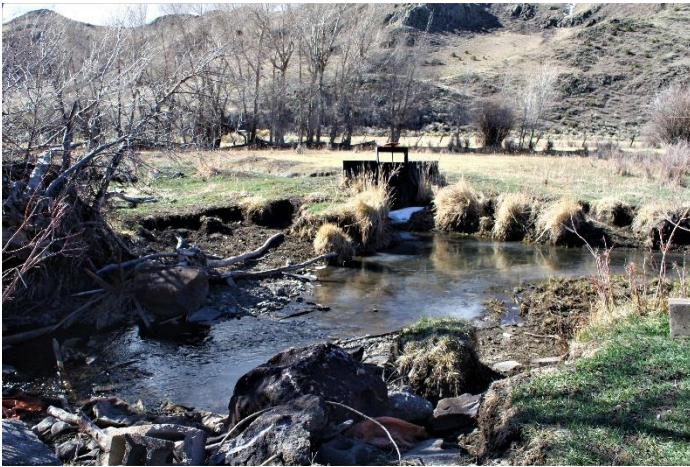
Headgate and diversion dam

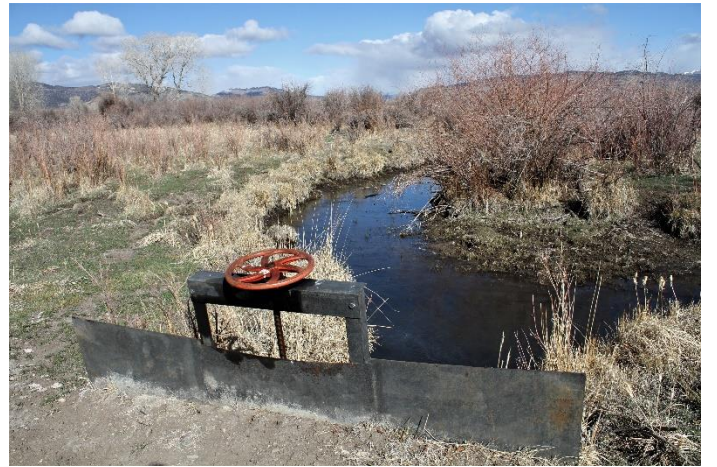
Diversion dam

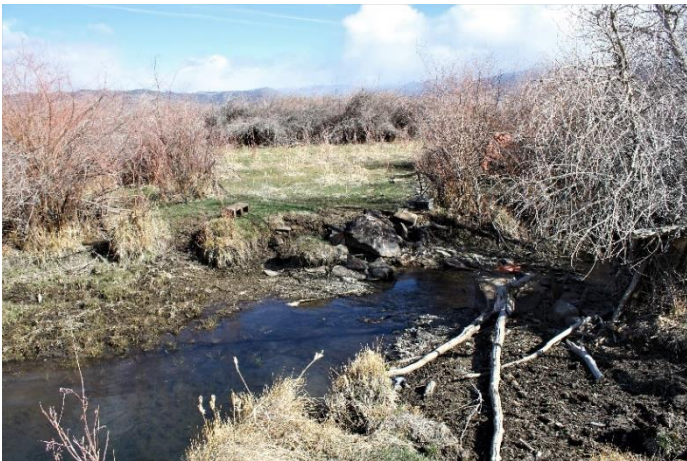
Flume looking downstream

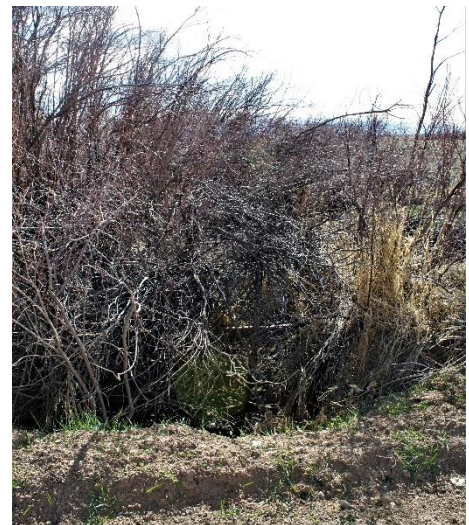
Measurement location

Repair(s) or Improvement(s) Currently Needed: A measurement device should be installed at this structure. Fish passage and riparian restoration should be considered as part of any future repairs or improvements.
